Causeway Geotech Ltd
 Dynamic Cone Penetrometer (DCP) test results and estimated CBR
 Project: Lands at Ballymakully
 Test Number: TP02

CBR estimated using TRL Road Note 8:
 $\text{Log CBR} = 2.48 - 1.057 \text{ Log (mm/blow)}$
 Project No: 18-0827
 Date: 25-Jul-18

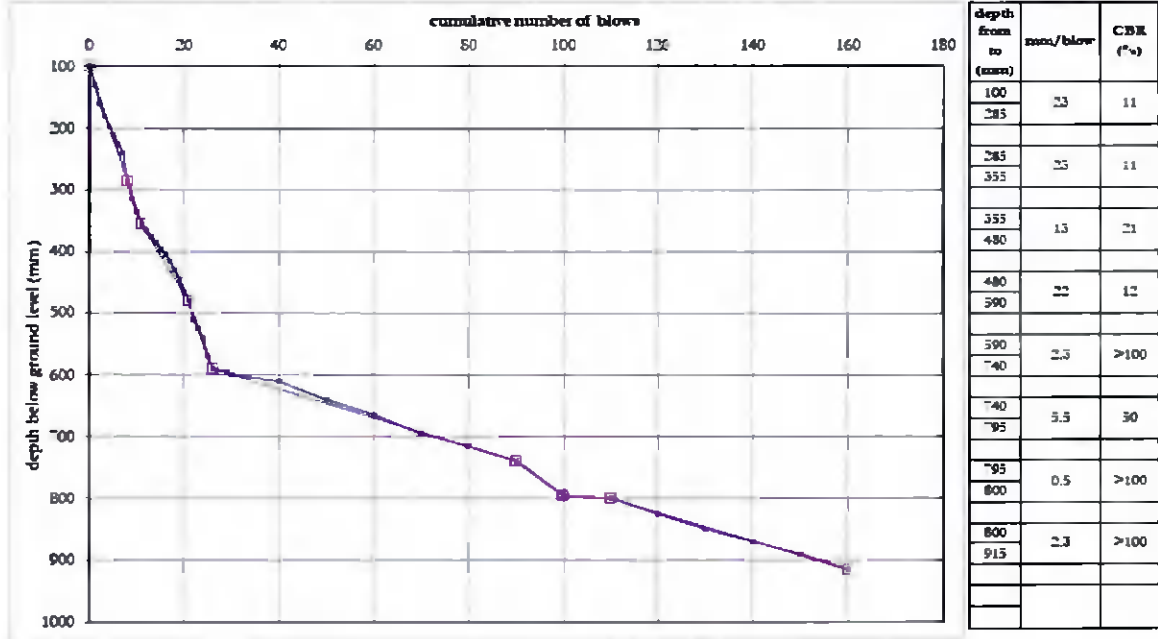
Causeway Geotech Ltd
 Dynamic Cone Penetrometer (DCP) test results and estimated CBR
 Project: Lands at Ballymakully
 Test Number: TP03

CBR estimated using TRL Road Note 8:
 $\text{Log CBR} = 2.48 - 1.057 \text{ Log (mm/blow)}$
 Project No: 18-0827
 Date: 25-Jul-18

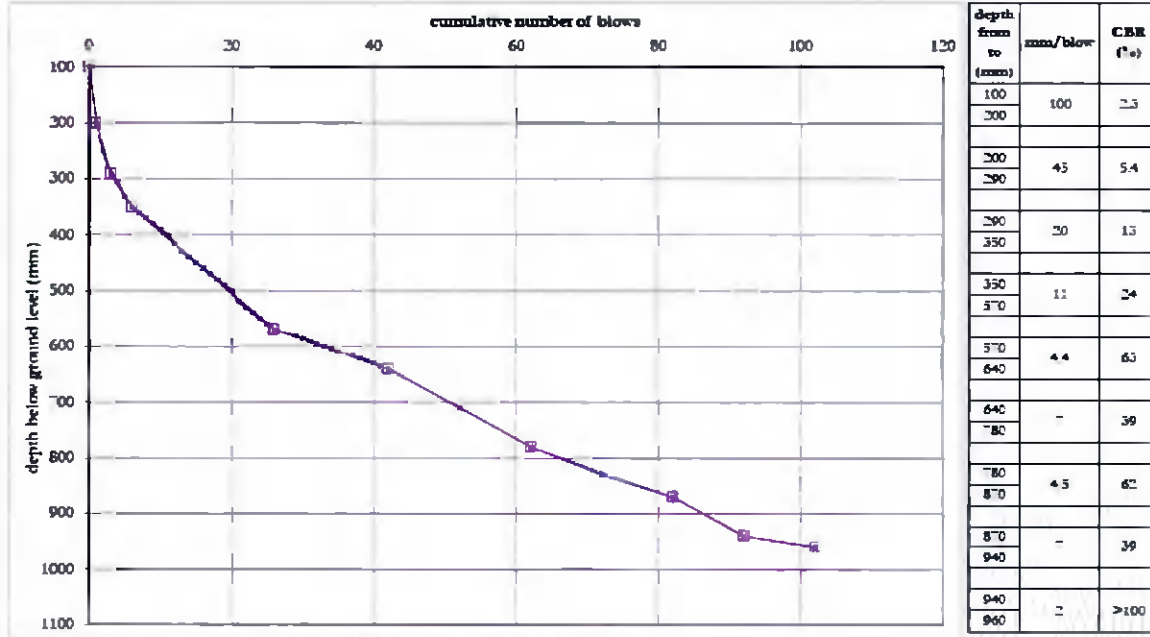
Test Number: TP04

Dynamic Cone Penetrometer (DCP) test results and estimated CBR

CBR estimated using TRL Road Note 8:

$\text{Log CBR} = 2.48 - 1.05 \text{ Log (mm/blow)}$

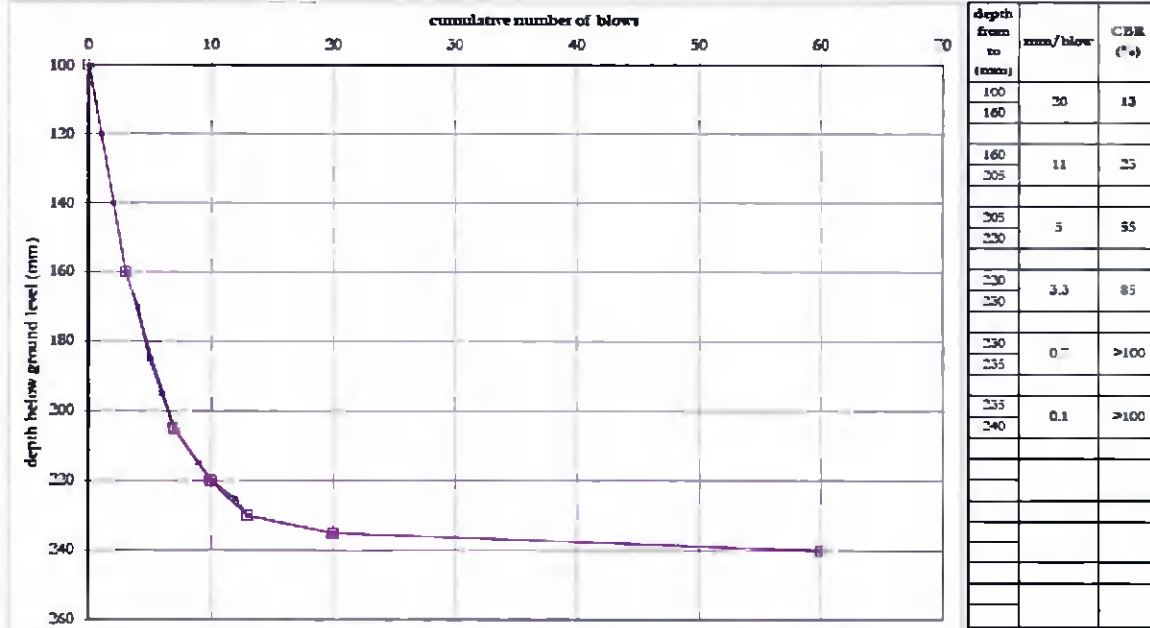
Test Number: TP05

Dynamic Cone Penetrometer (DCP) test results and estimated CBR

CBR estimated using TRL Road Note 8:

$\text{Log CBR} = 2.48 - 1.05 \text{ Log (mm/blow)}$

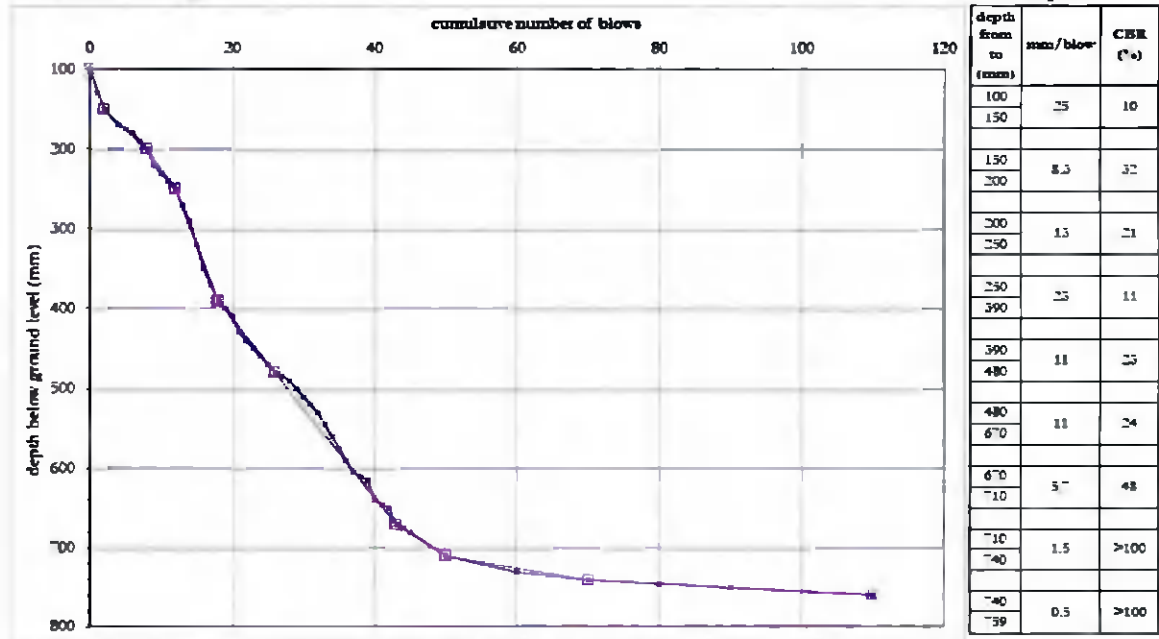
Causeway Geotech Ltd
 Dynamic Cone Penetrometer (DCP) test results and estimated CBR
 Project: Lands at Ballymakilly
 Test Number: TP06

CBR estimated using TRL Road Note 8
 $\text{Log CBR} = 2.48 - 1.05 \text{ Log (mm/blow)}$
 Project No: 18-0827
 Date: 25-Jul-18

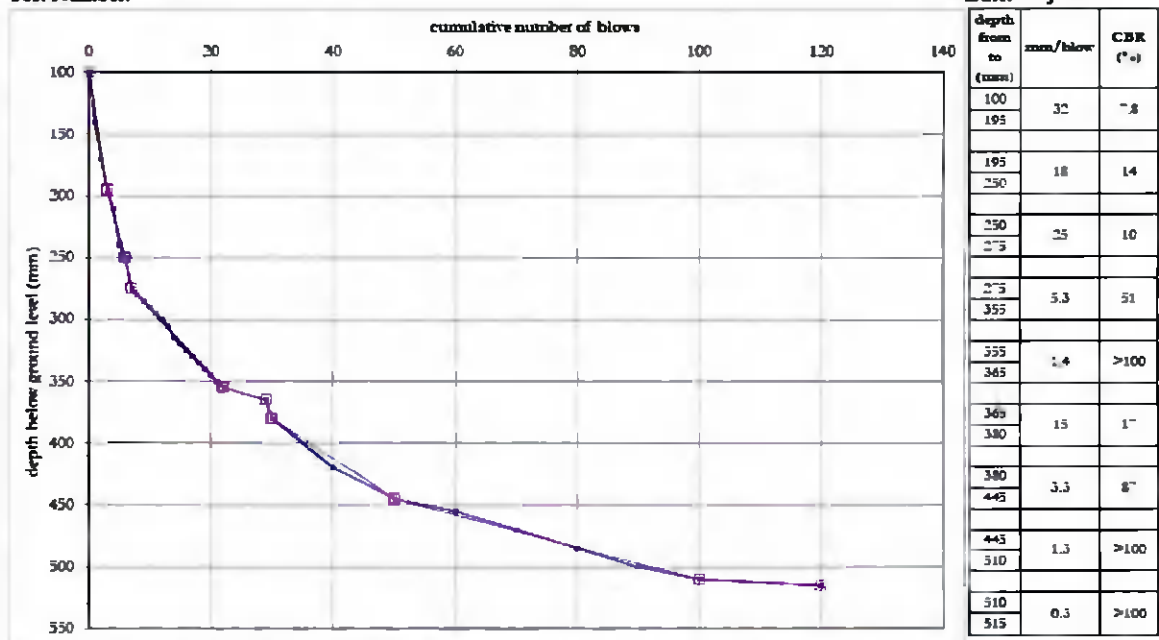
Causeway Geotech Ltd
 Dynamic Cone Penetrometer (DCP) test results and estimated CBR
 Project: Lands at Ballymakilly
 Test Number: TP07

CBR estimated using TRL Road Note 8
 $\text{Log CBR} = 2.48 - 1.05 \text{ Log (mm/blow)}$
 Project No: 18-0827
 Date: 25-Jul-18

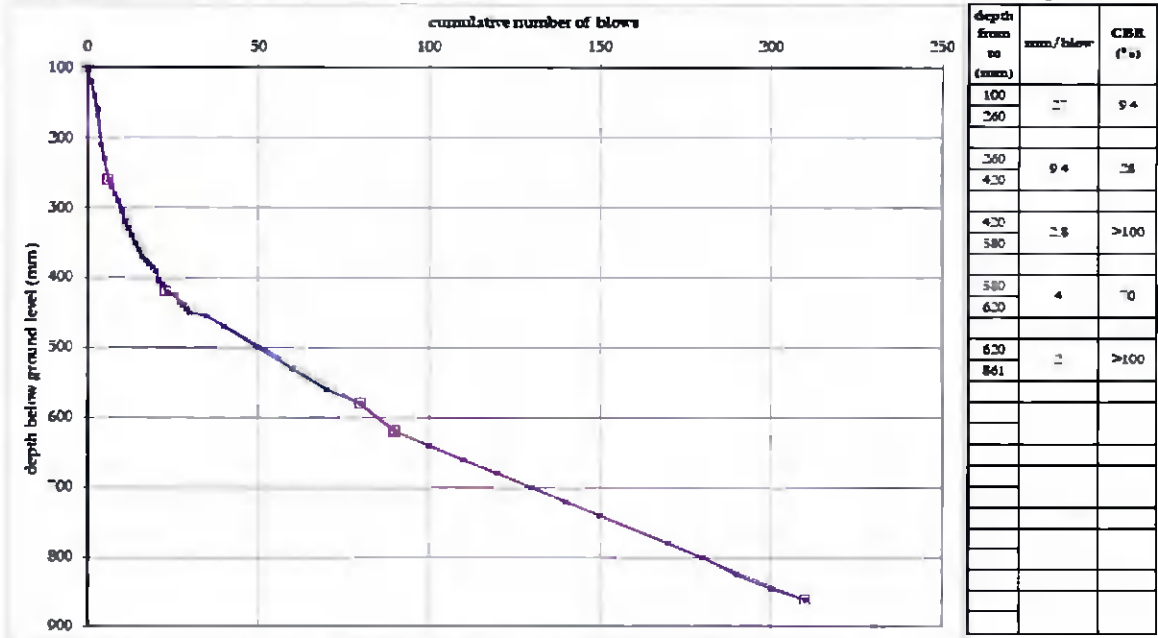
Causeway Geotech Ltd
 Dynamic Cone Penetrometer (DCP) test results and estimated CBR
 Project: Lands at Ballymakully
 Test Number: TP10

CBR estimated using TRL Road Note 8:
 $\text{Log CBR} = 2.45 - 1.05 \text{ Log (mm/blow)}$
 Project No: 18-0827
 Date: 25-Jul-18

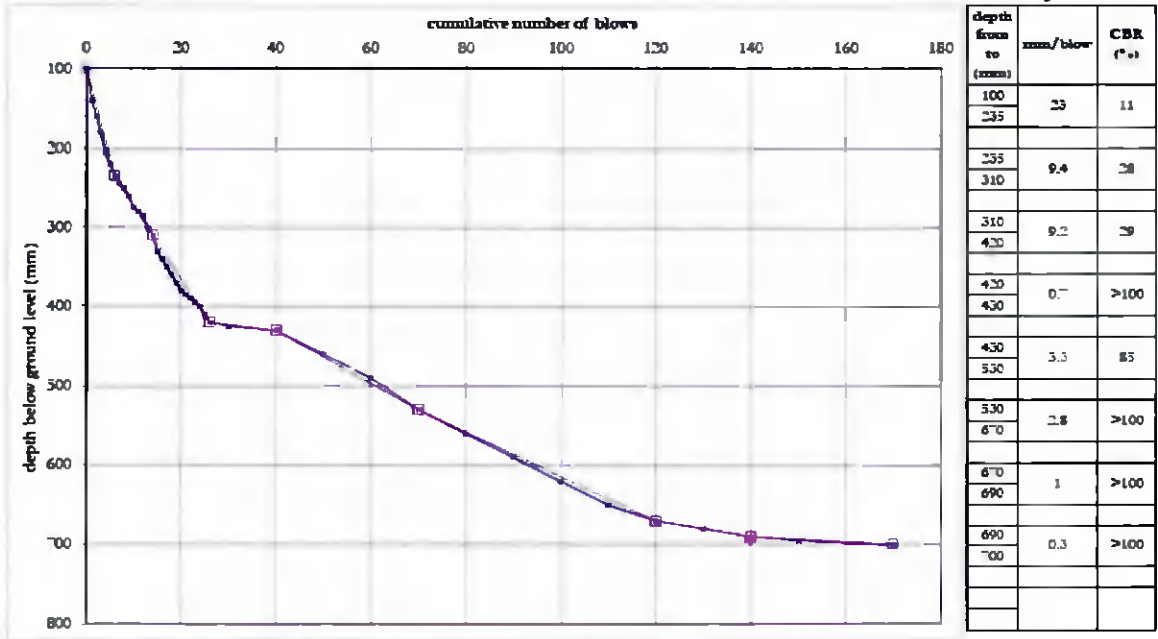
Causeway Geotech Ltd
 Dynamic Cone Penetrometer (DCP) test results and estimated CBR
 Project: Lands at Ballymakully
 Test Number: TP11

CBR estimated using TRL Road Note 8:
 $\text{Log CBR} = 2.45 - 1.05 \text{ Log (mm/blow)}$
 Project No: 18-0827
 Date: 25-Jul-18

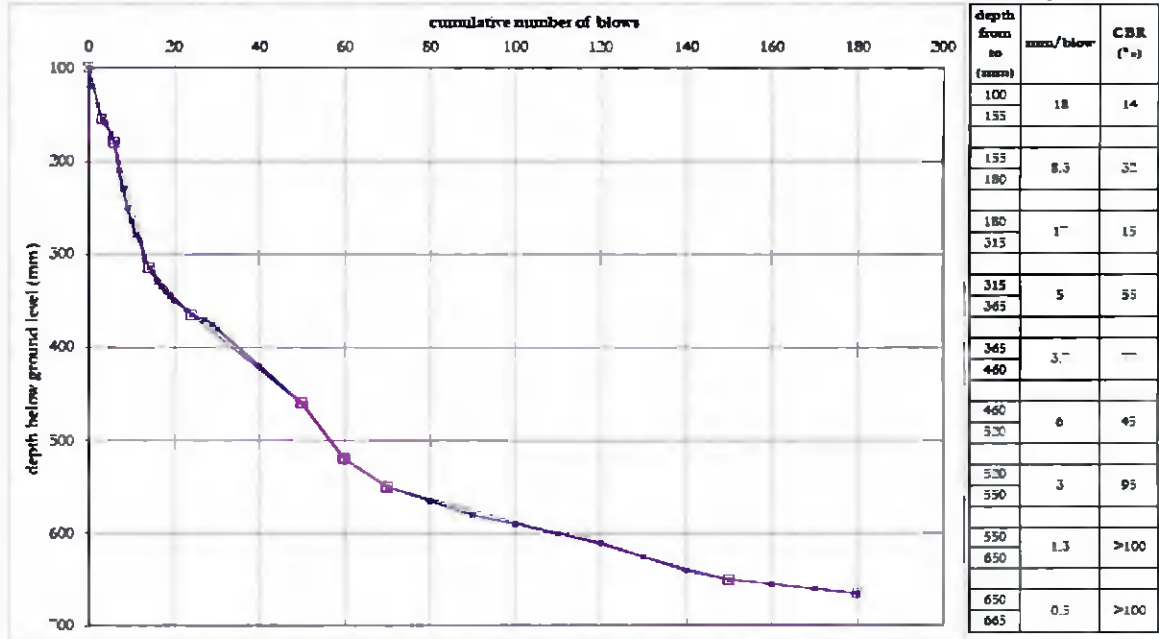
Causeway Geotech Ltd
 Dynamic Cone Penetrometer (DCP) test results and estimated CBR
 Project: Lands at Ballymakilly
 Test Number: TP14

CBR estimated using TRI Road Note 8:
 $\text{Log CBR} = 2.48 - 1.03 \text{ Log (mm/blow)}$
 Project No: 18-0827
 Date: 25-Jul-18

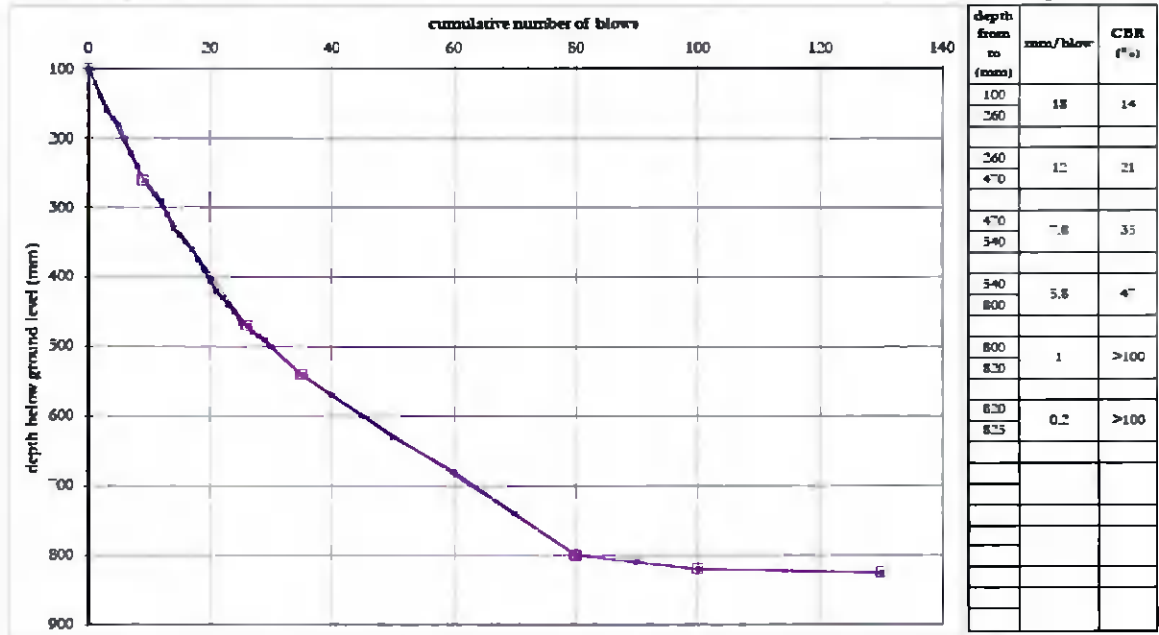
Causeway Geotech Ltd
 Dynamic Cone Penetrometer (DCP) test results and estimated CBR
 Project: Lands at Ballymakilly
 Test Number: TP15

CBR estimated using TRI Road Note 8:
 $\text{Log CBR} = 2.48 - 1.03 \text{ Log (mm/blow)}$
 Project No: 18-0827
 Date: 25-Jul-18

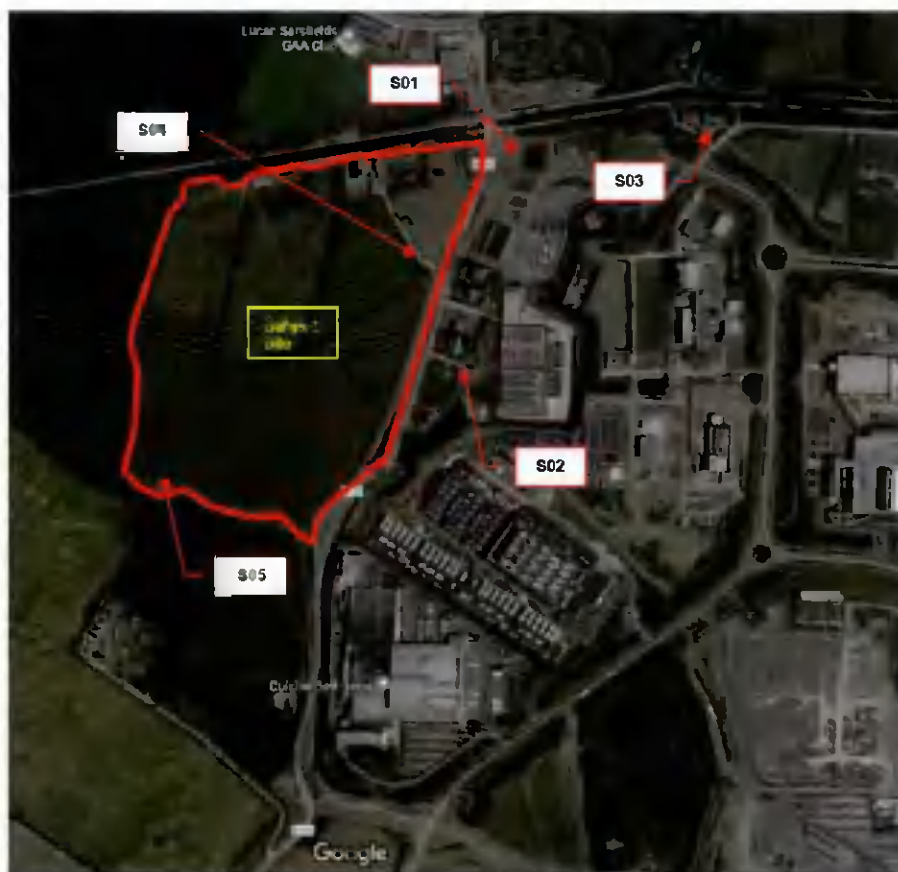
- Location S04** Located in the north eastern concern of the development lands. This location is considered to be representative of noise levels currently experienced in the vicinity of the residential properties on the Royal Canal to the north.

- Location S05** Located in the south western concern of the development lands. The location is considered to be representative of noise levels currently experienced in the vicinity of the halting site located to the south west at some 200 m distance.

Figure A Noise monitoring locations (Source: Bing Maps)

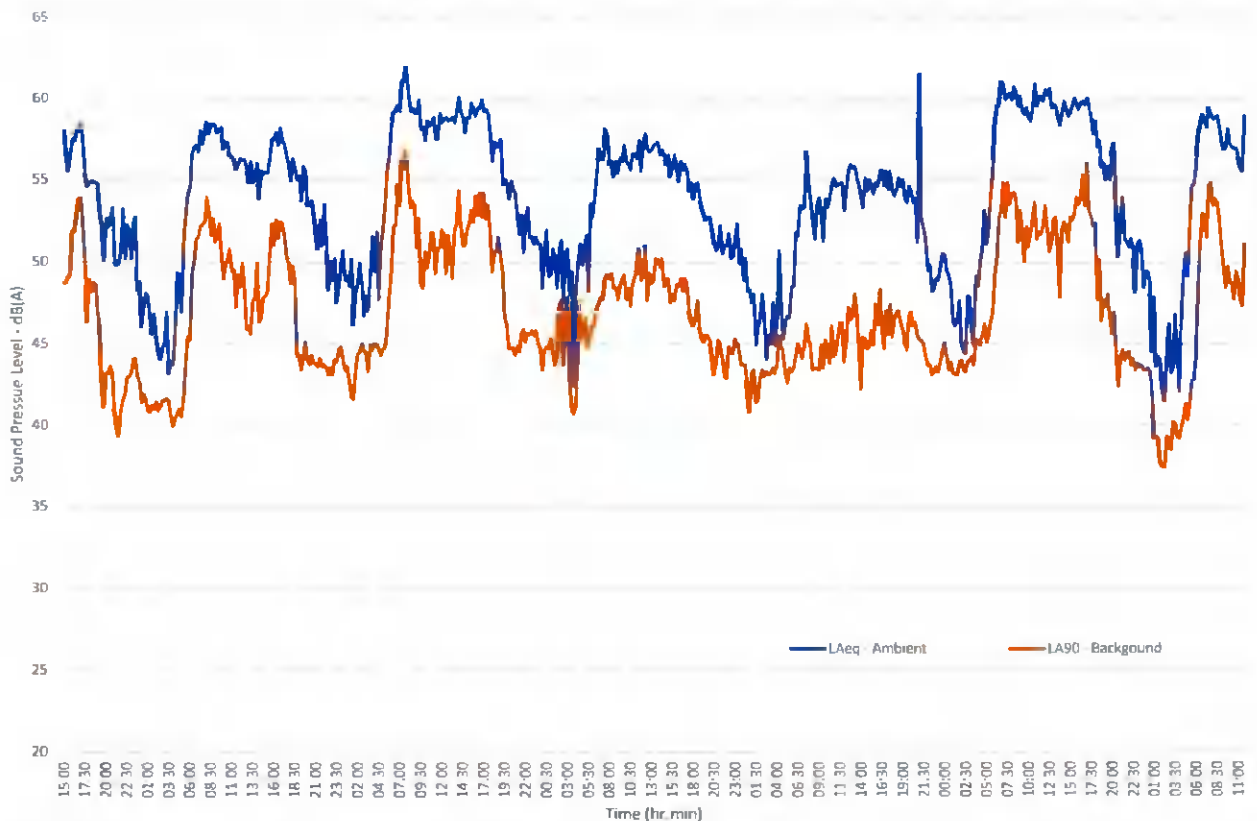
Figure B Unattended Noise Monitoring – Location S04

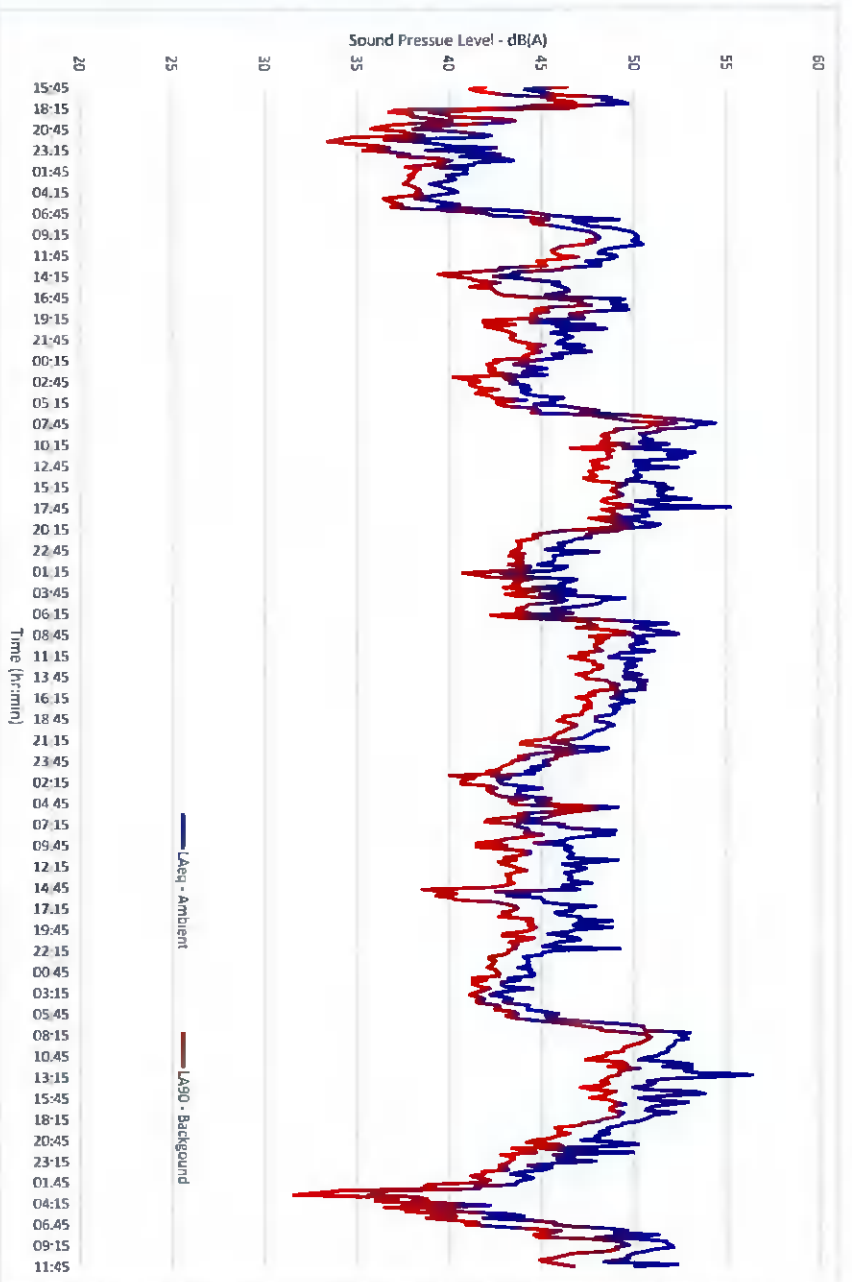
Figure C Unattended Noise Monitoring – Location S05

Location	
S05	
<ul style="list-style-type: none"> R120 road traffic noise. Water flow from nearby watercourse. During night time plant noise from the adjacent facility and water flow from nearby watercourse noted.

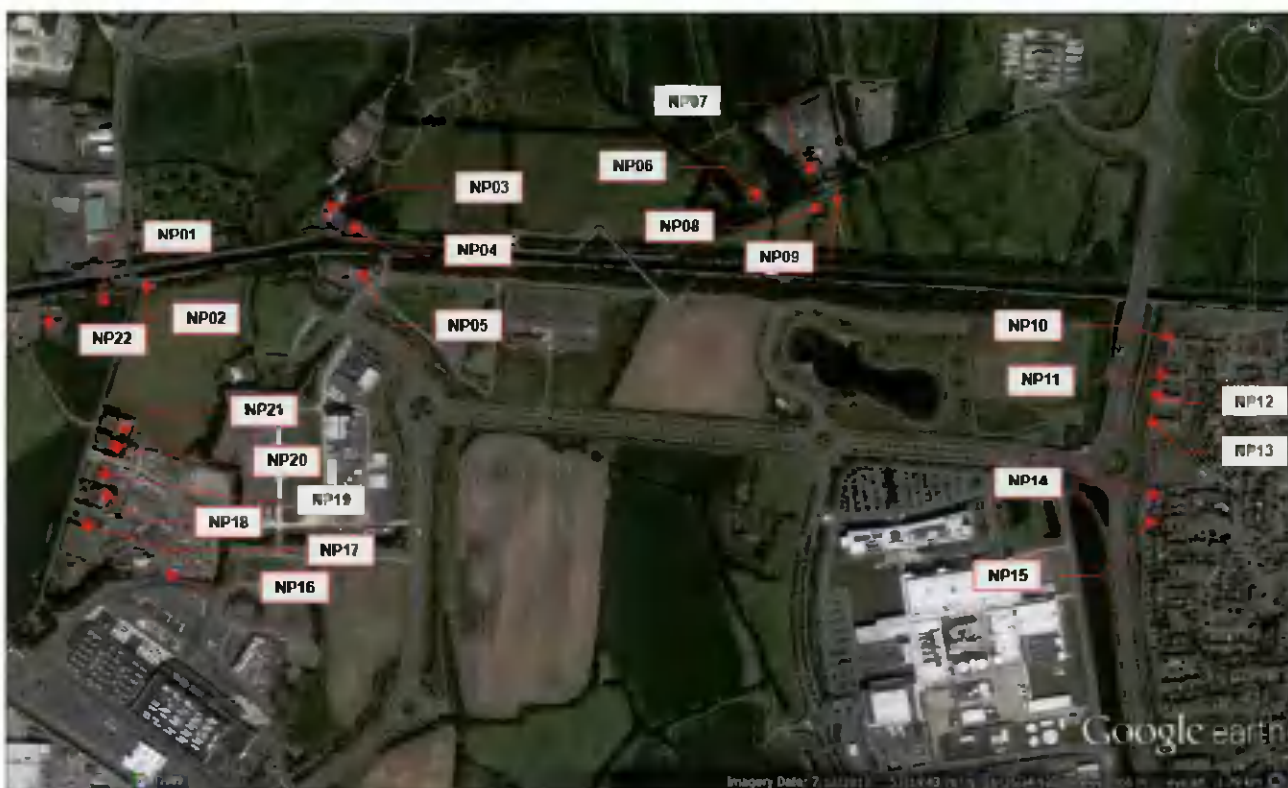
Nearby sensitive properties in the vicinity of the proposed development are summarised in Figure A overleaf:

Figure A Sensitive receptors

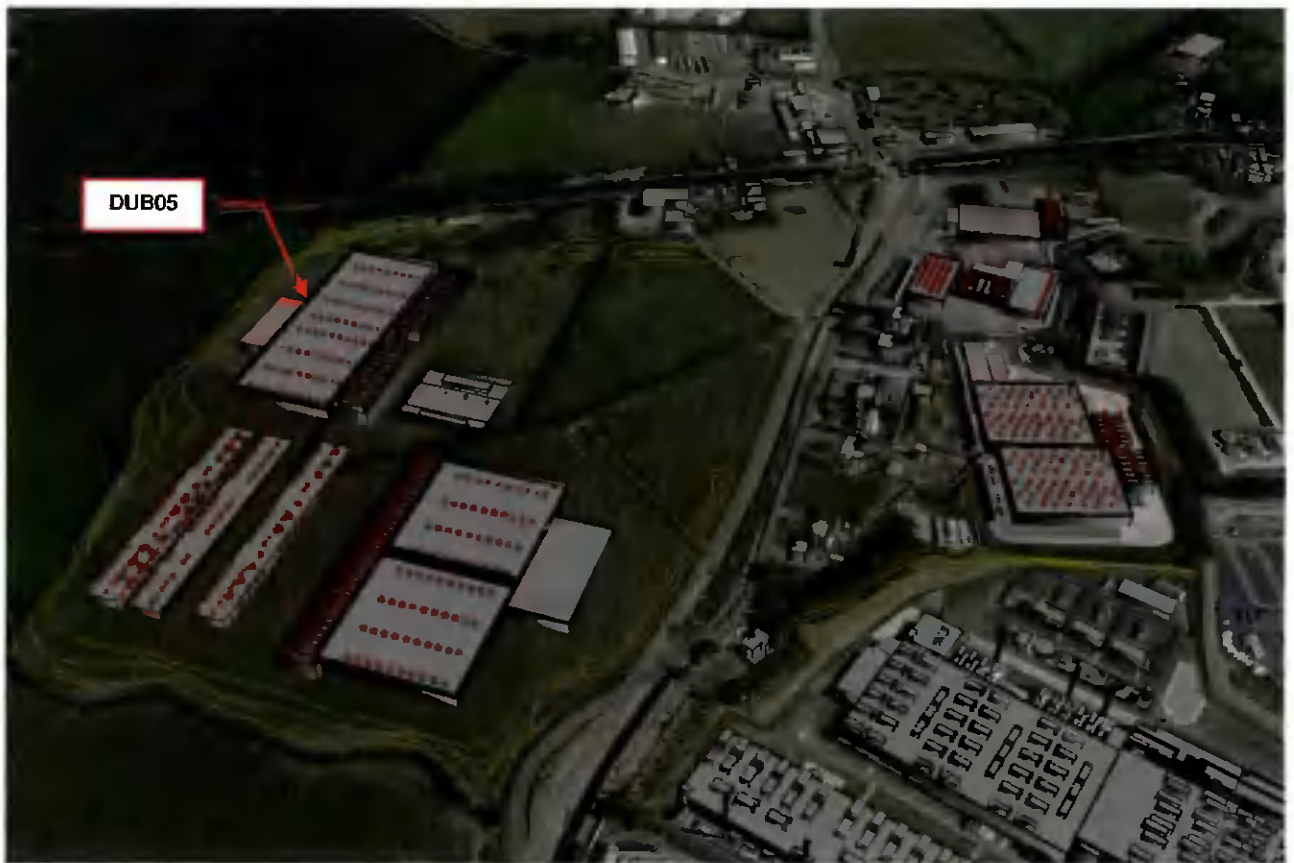
Figure A presents a 3D render of the developed site noise model.

Figure A Images of Developed Noise Model – View of Site

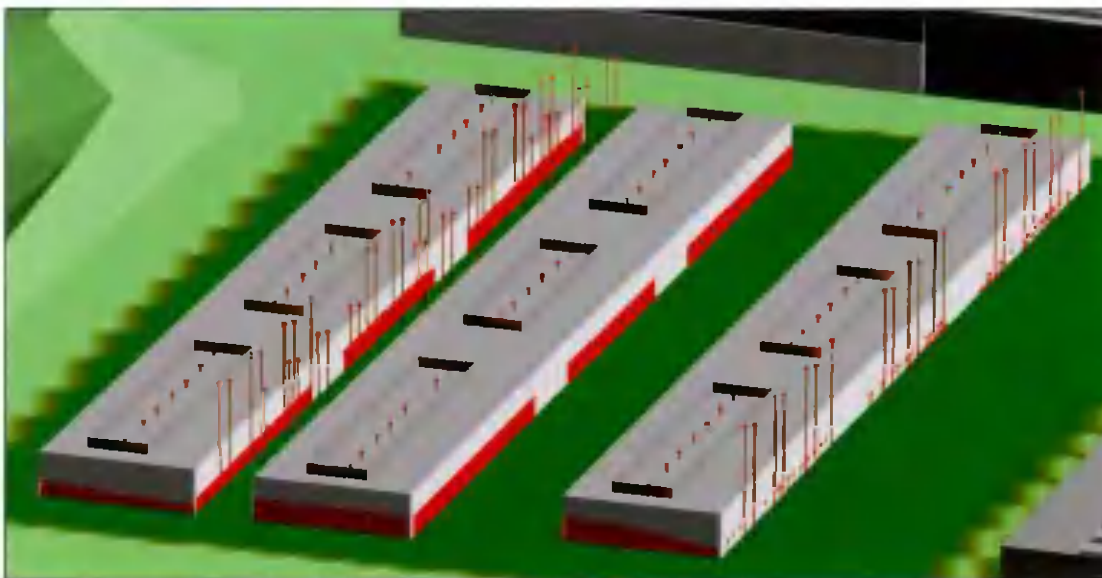
It is advised generator exhaust stacks will need to be attenuated to achieve a sound pressure level of no more than 65 dB(A) at 1 m. Based on this we have assumed a sound power level of some 76 dB(A) in relation to these sources. Solid screens to the radiator units are assumed. These screens will be assumed to be at least 1m above the top of the radiator plant. Figure 2 illustrates the principle and location of the screening assumed here.

Figure C Indicative Radiator Screening

Note that as part of detailed design the above assumptions will be given due consideration and any alternate proposals would be designed such that the relevant noise conditions are satisfied.

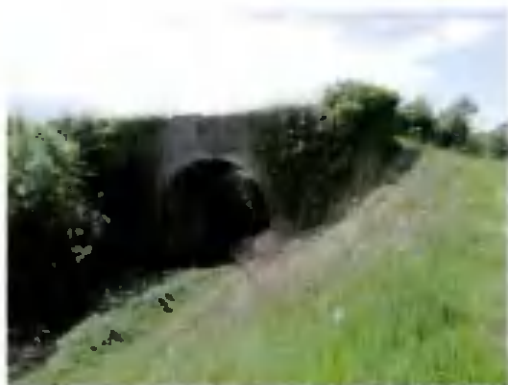
Gollierstown Bridge, GOLLIERSTOWN, Milltown, DUBLIN

Reg No	11208014
Rating	Regional
Categories of Special Interest	Architectural, Social, Technical
Original Use	Bridge
In Use As	Bridge
Date	1770 - 1790
Coordinates	301517, 231971
Date Recorded	10/06/2002
Date Updated	--/--

This noticeably elevated bridge is a fine example of the canal bridges to be found on the Grand Canal. It is all the more stunning due to its remote location and idyllic setting amongst the lush natural environment.

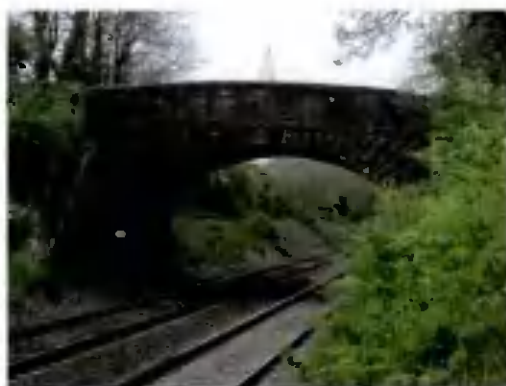
R120, ADAMSTOWN (NE. BY.), DUBLIN

Reg No	11204051
Rating	Regional
Categories of Special Interest	Architectural, Technical
Original Use	Bridge
In Use As	Bridge
Date	1900 - 1930
Coordinates	303016, 232768
Date Recorded	16/05/2002
Date Updated	--/--/--

This handsome road bridge is an integral part of the railway network, built to a standard design with well-executed stonework and a graceful arch.

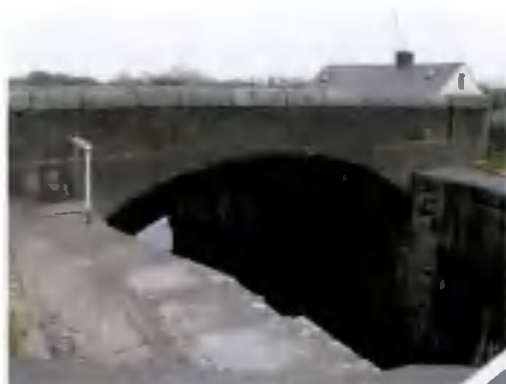
12th Lock Bridge, R120, BALLYMAKAILY, DUBLIN

Reg No	11204052
Rating	Regional
Categories of Special Interest	Architectural, Technical
Original Use	Bridge
In Use As	Bridge
Date	1760 - 1780
Coordinates	302981, 232234
Date Recorded	16/05/2002
Date Updated	--/--/--

This bridge, though widened, retains much original fabric and remains a valuable element in this group of canal structures including the lock gates and mill buildings.

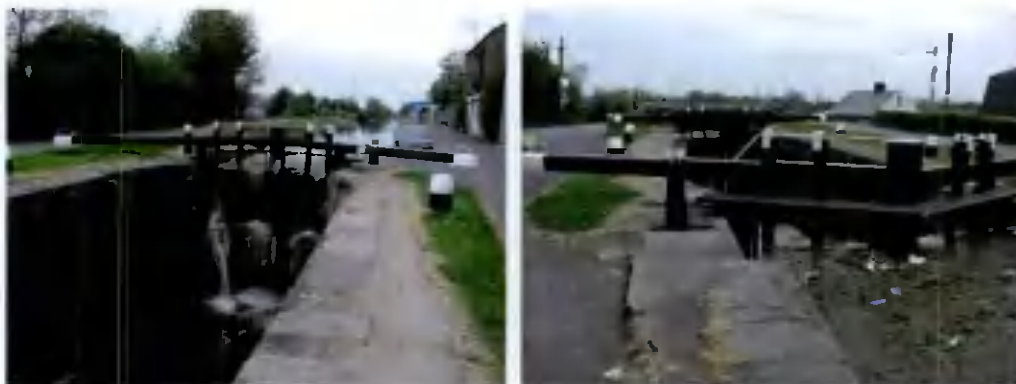
12th Lock, R120, BALLYMAKAILY, DUBLIN

Reg No	1204053
Rating	Regional
Categories of Special Interest	Architectural, Technical
Original Use	Lock
In Use As	Lock
Date	1760 - 1780
Coordinates	302957, 232232
Date Recorded	16/05/2002
Date Updated	--/--

A good example of a standard-type eighteenth-century canal lock, enhanced by its setting among such a rich group of canal structures.

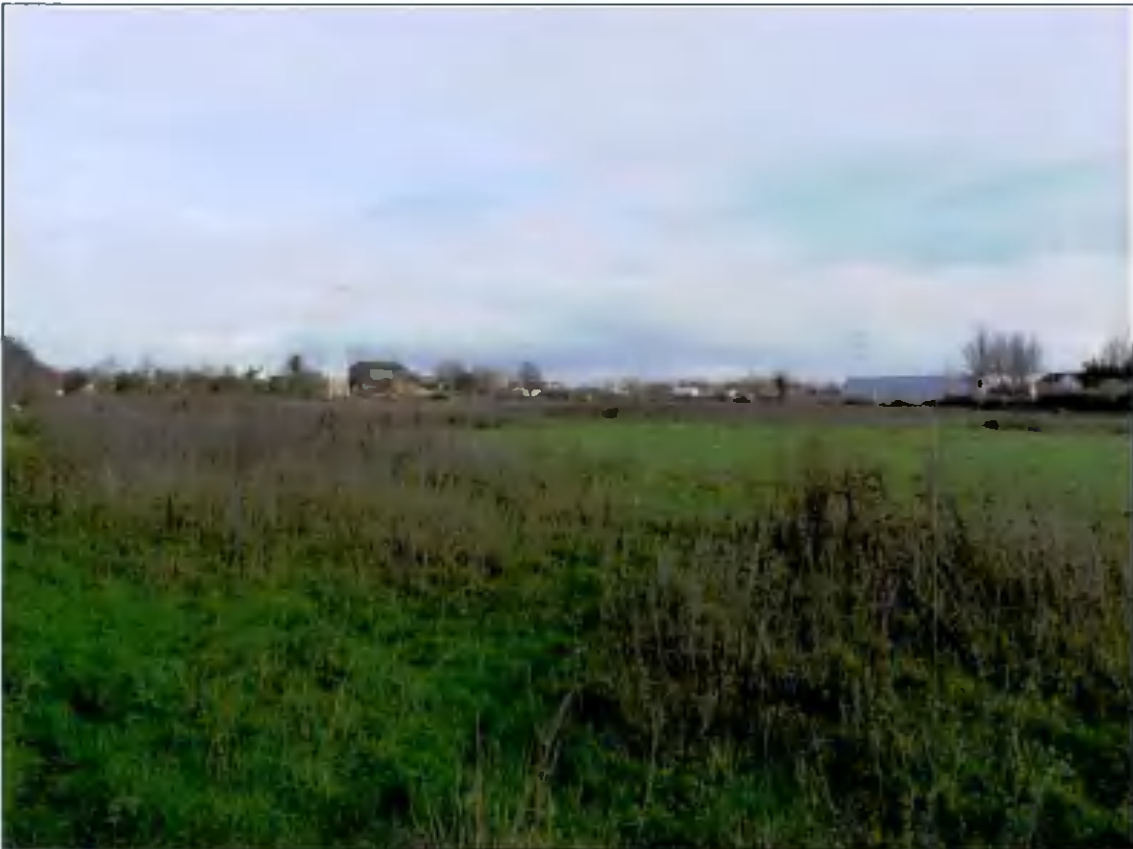
Figure 11 Field 3, embankment at site of old quarry.

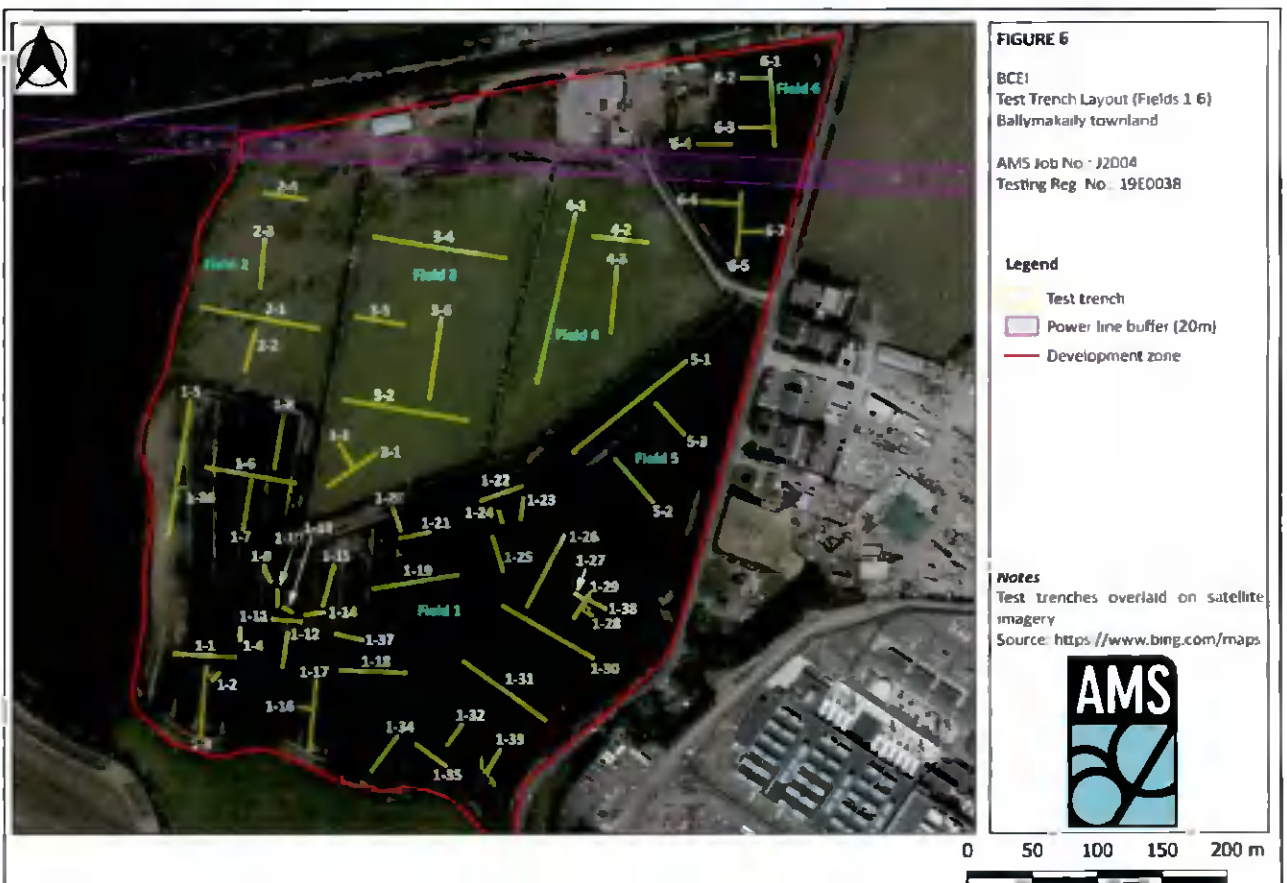
Figure 22 Archaeological testing of the site (undertaken by AMS Ltd; license no 19E0038)
