## **COMPLETION STATEMENT**

*Completion Statement for Decommissioning*

Priory Service Station,  
Nutgrove Avenue,  
Rathfarnham,  
Dublin 18

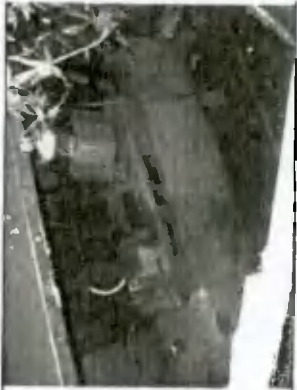
001
<b>Notes</b> Compressor located behind timber fence.	View of premises from roadway. Canopy metal supporting frame with metal profile sheeting fitted. No evidence of any asbestos. Mastic sealer on metal cladding tested no asbestos detected in sample. Presumed asbestos gaskets.

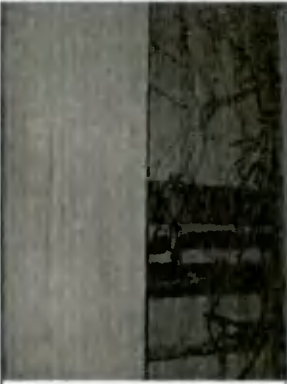
003
<b>Notes</b>	View of inside of shop solid floor solid walls suspended ceiling. No asbestos evident.
