Cultural Heritage Impact Assessment of a proposed development at Griffeen Community College, Lucan, County Dublin

Prepared for Department of Education and Skills

By William Anderson and Nigel Malcolm

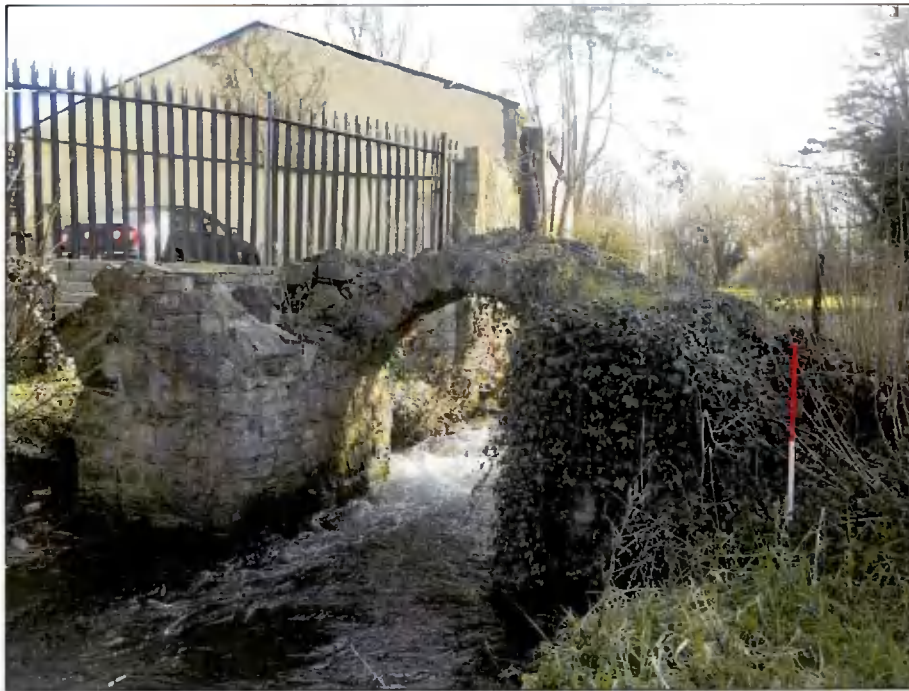
Description: Upriver or the later bridge named as Esker Bridge on the First Edition of the OSi 6 inch maps, this partially ruined hump-backed masonry bridge crosses the Griffeen River from SW to NE. According to O' Keeffe and Simington (1991, 134-6), the bridge is clearly marked on Rocque's map as 'King John's Bridge', placing its construction between 1199 and 1216. Esker was part of a demesne in the Liffey valley which Henry II annexed to the crown and which was organized under King John as a royal manor. The bridge probably fell into disuse between 1760 - the date of publication of Rocque's survey map of the County of Dublin and the 1837 First Edition of the Ordnance Survey map when the road is shown as re-aligned and Esker Bridge constructed. Originally a three arched structure, what survives is a partially intact central arch and accompanying piers, a short length of the NE arch and the demolished remains of the SE arch. The overall length of the visible remains is 7.7m and is 4.3m wide including cutwaters. The surviving central segmental arch is formed of narrow voussoirs set on edge rising from straight-sided piers. The keystone is wedge-shaped and was slightly too large to fit perfectly. The bridge spans an opening 2.1m wide and is approximately 3.8m in length. At its narrowest width it measures .80m surviving better at the upstream end to the SE where it measures 2.10m. The piers are composed of well-made coursed rubble masonry up to five courses high. In overall height the piers measure 1.5m from the river bed to the arch springing point with evidence for some rebuilding of on the inner edge of the N pier. Two triangular cutwaters project .50m upstream at 45 degrees each side the arch opening. Just beyond the intrados of the SE arch the imprint of a short length of wicker centering can be seen at the N side of the arch.

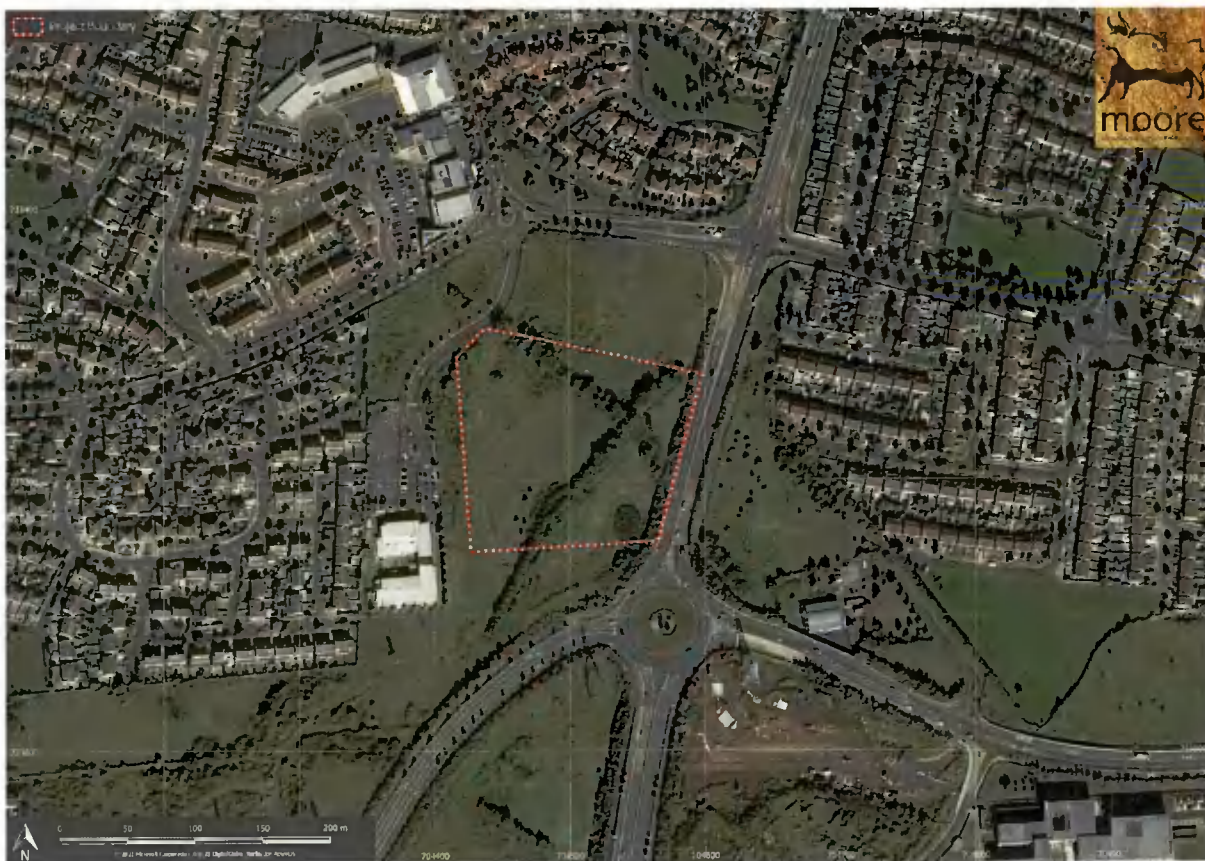
Aerial imagery of the project area was reviewed, including available satellite photographs on Google Earth, Bing and other platforms. These show the progressive development of roads and housing in the surroundings of the project area, as well as the building of the East Lucan Educate Together National School along the area's west boundary in 2008. The photographs show that the area has been largely unchanged, including the field boundaries which were already in place by the 1830s (Figure 9). However, there is evidence of ground disturbance at several locations, including associated with construction of the Outer Ring Road (including the pond at the east of the site) and the dumping of fill and use of access tracks during construction of the adjacent school. These indications of ground disturbance were further verified during the field inspection, described below.

Figure 9 Aerial image of the project area.

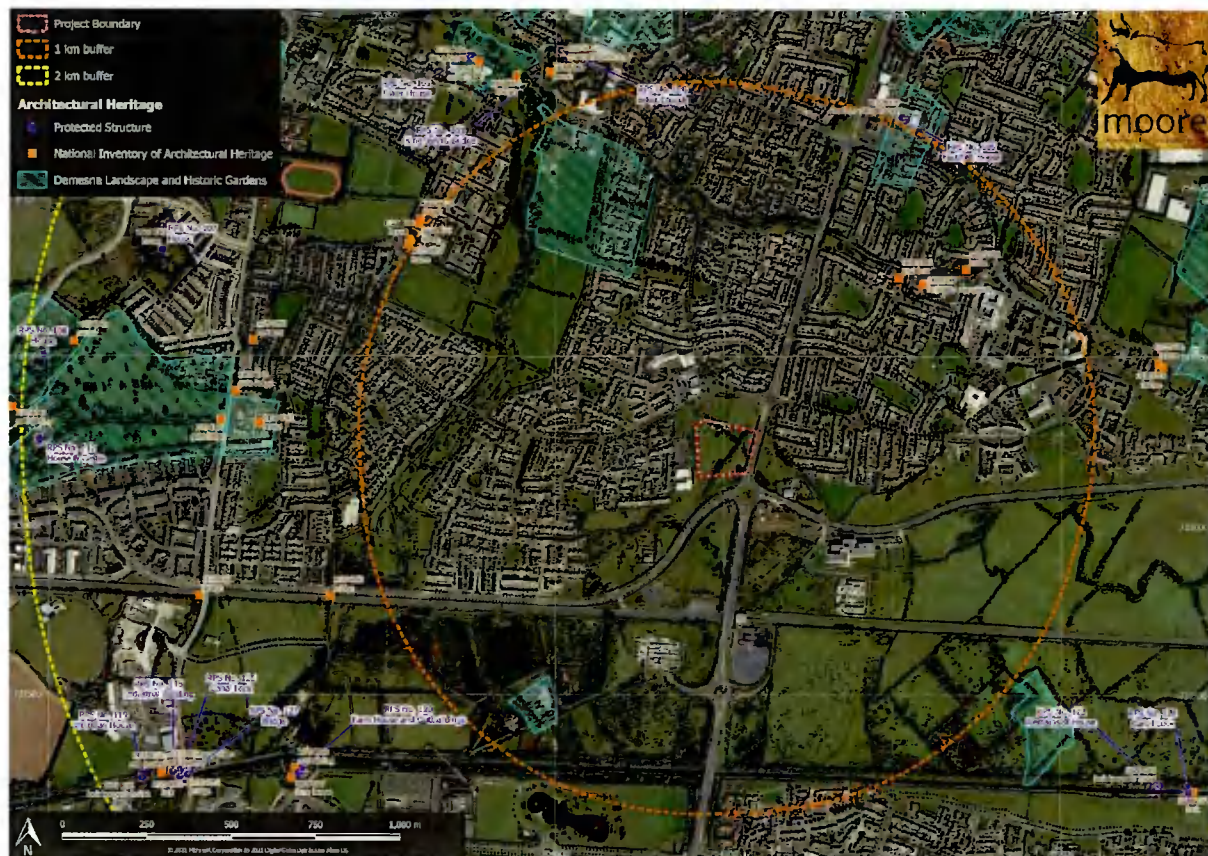
Three areas within 1km of the project area were identified as historic gardens from shading on the First Edition OS map (Figure 11). To the northwest of the area, a garden is associated with Esker Villa, a since-demolished building to the east of Esker House (NIAH 11204024) and Esker Abbey (NIAH 11205004). To the northeast, a garden is associated with Ballyowen Castle (RPS 105; NIAH 11205006), and to the southwest, a small area is associated with a building labelled on the First Edition map as Grange, just to the southwest of Kishogue Station.

Figure 11 Architectural features in the surroundings of the project area.

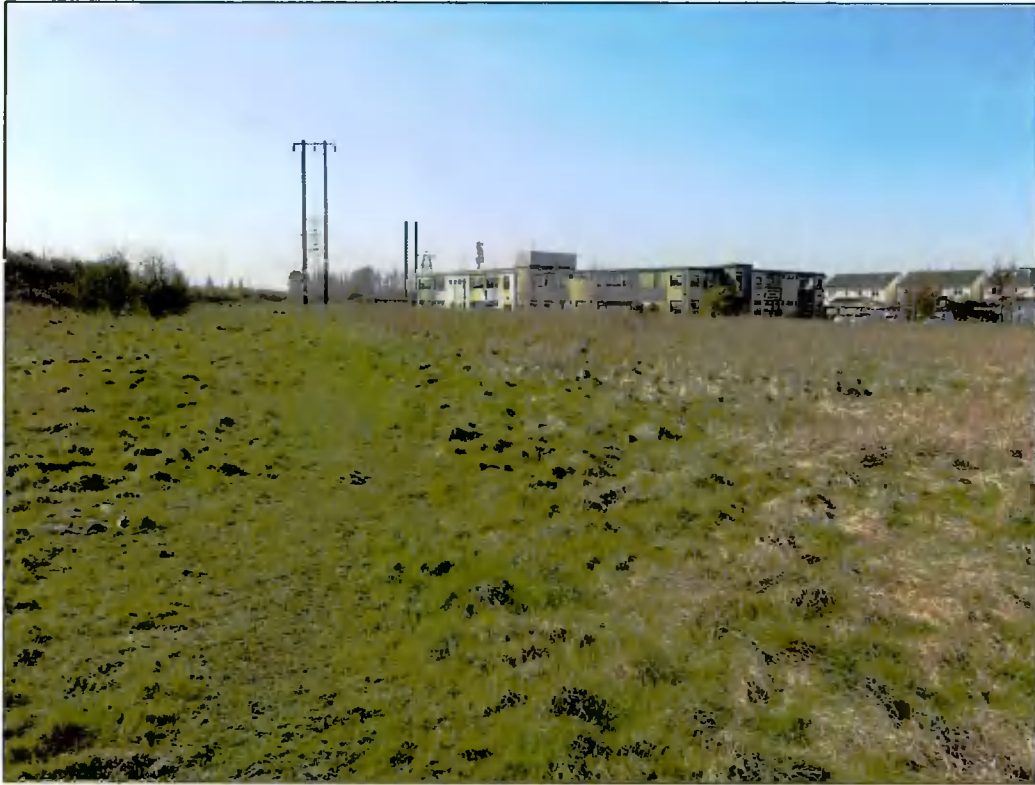
Plate 1 Northern part of the area, facing southwest towards the Educate Together school

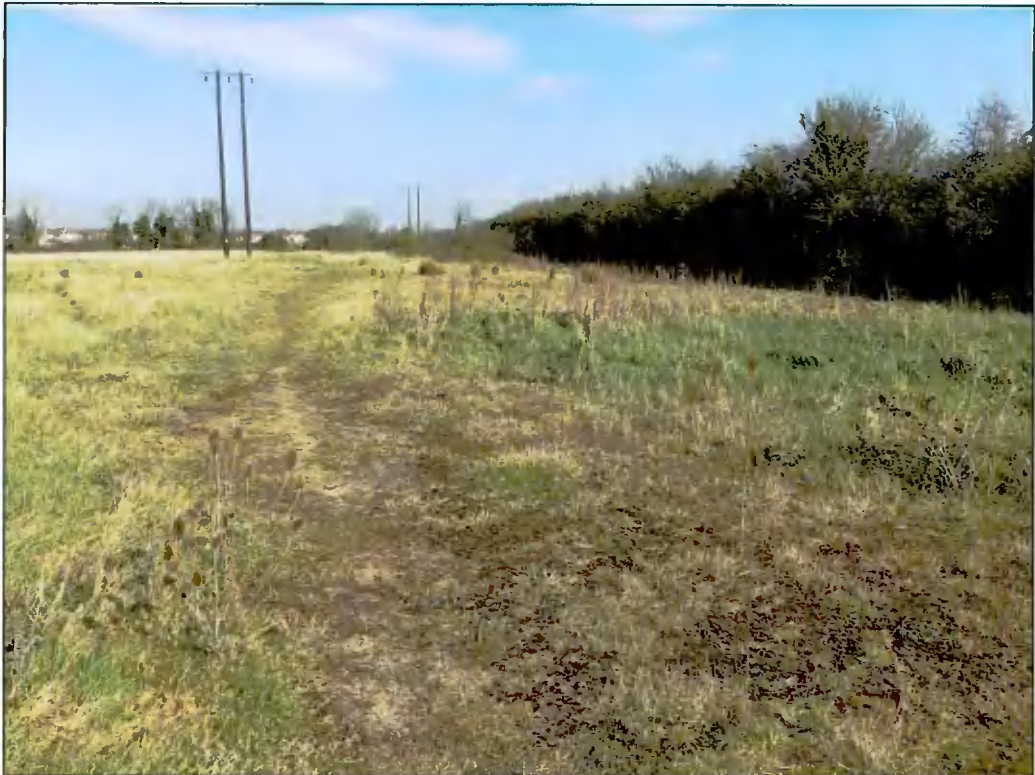
The southern part of the area also appears to have undergone ground disturbance, where areas of gravel is present on the surface. The portion of the land enclosed to the southwest of the crossing of the field boundaries appears to be less disturbed, where there are small hawthorn trees growing (Plate 6). From here, there are views south to the Wicklow Mountains in the distance. Further areas of ground disturbance were noted along the western margin of the area.

Plate 2 Southern part of the area, facing north

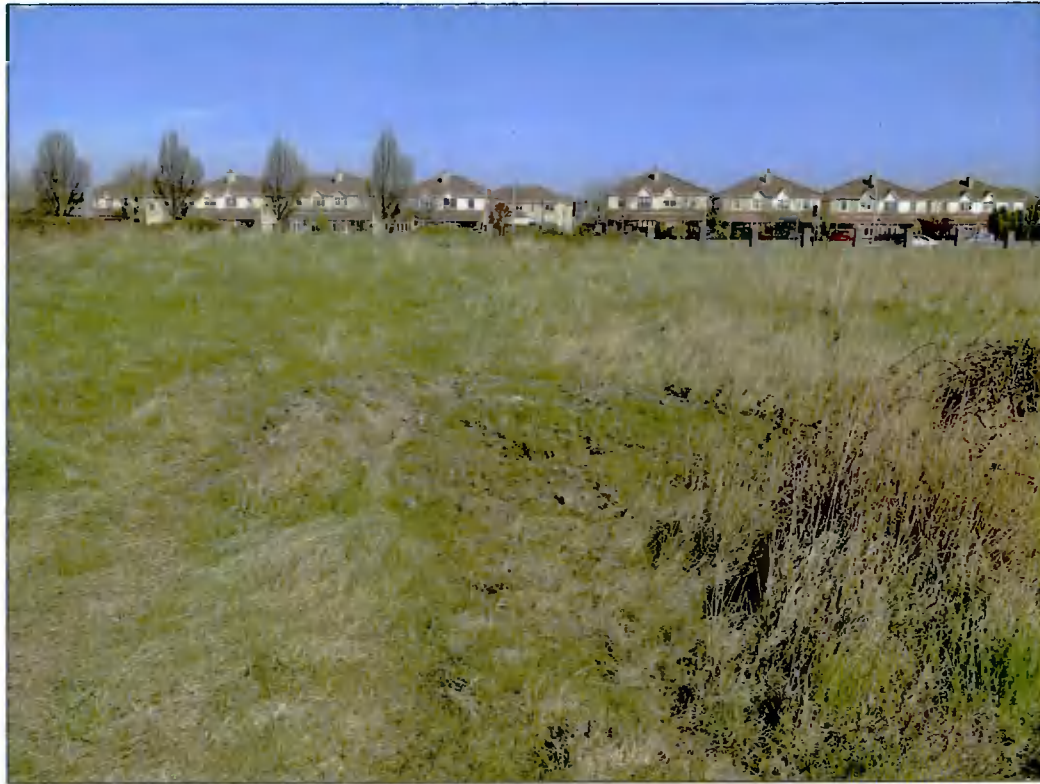
Plate 3 Disturbed ground in the northern part of the area, facing north

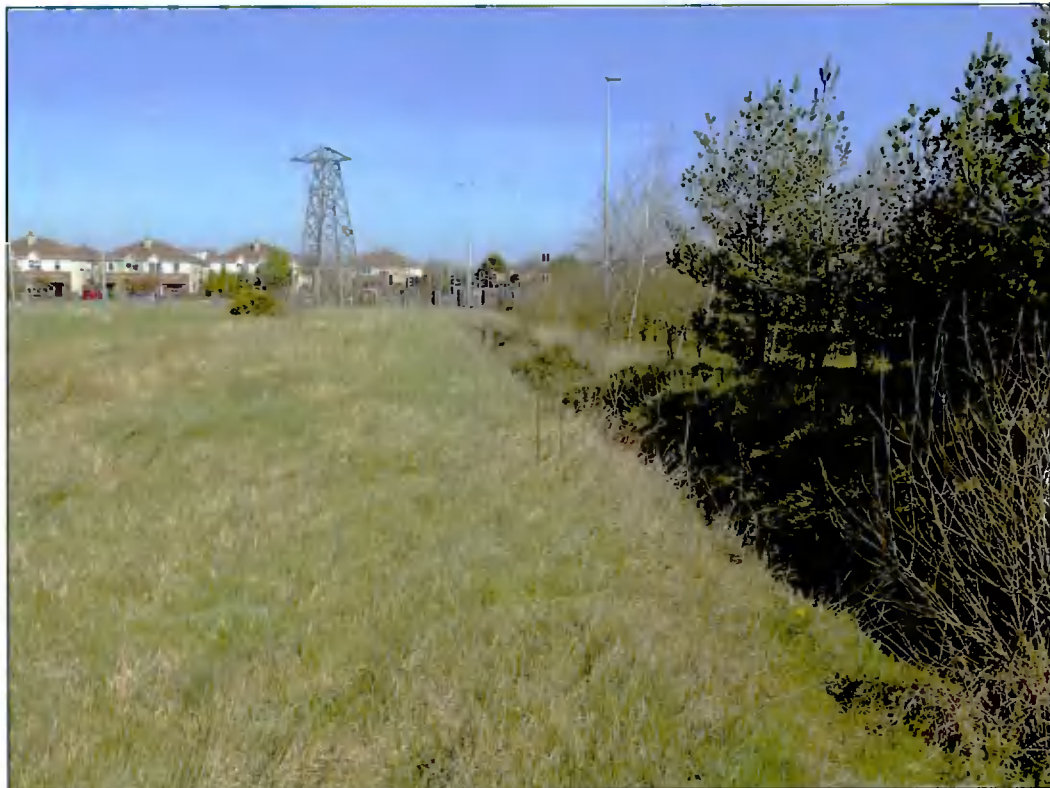
Plate 4 Drainage channel along the east of the area, facing north

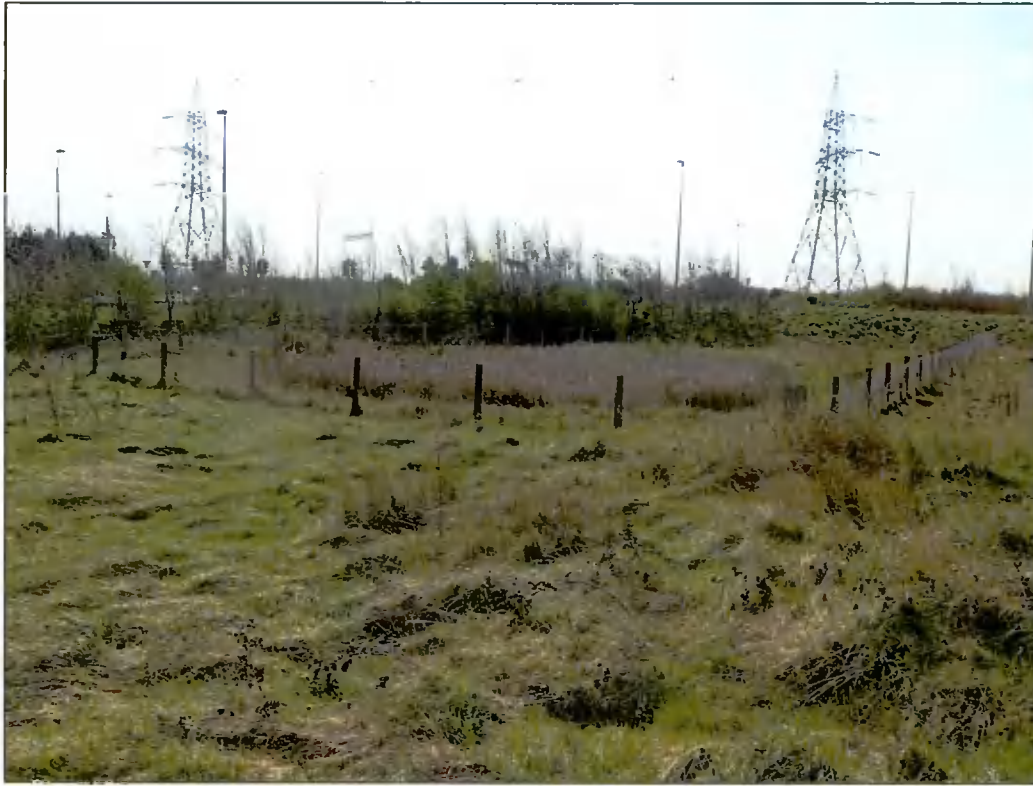
Plate 5 Attenuation pond in the southeast of the area, facing east over the R136

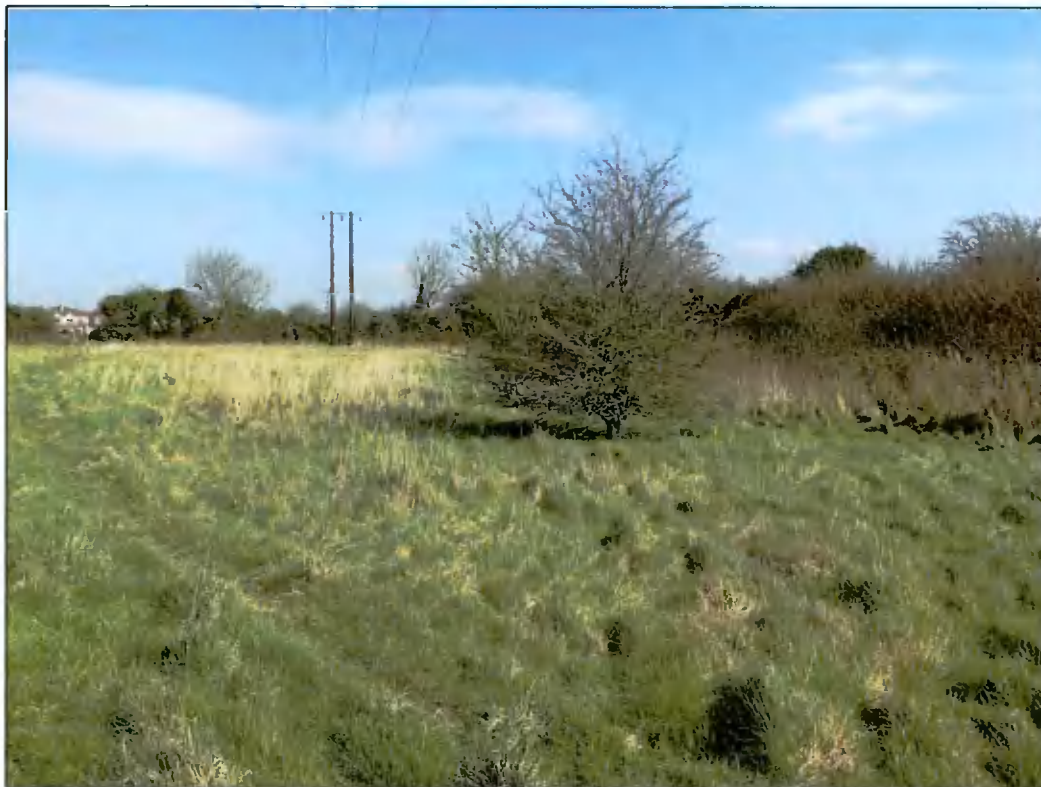
Plate 6 Hawthorn tree near to the southwest of the field boundary junction

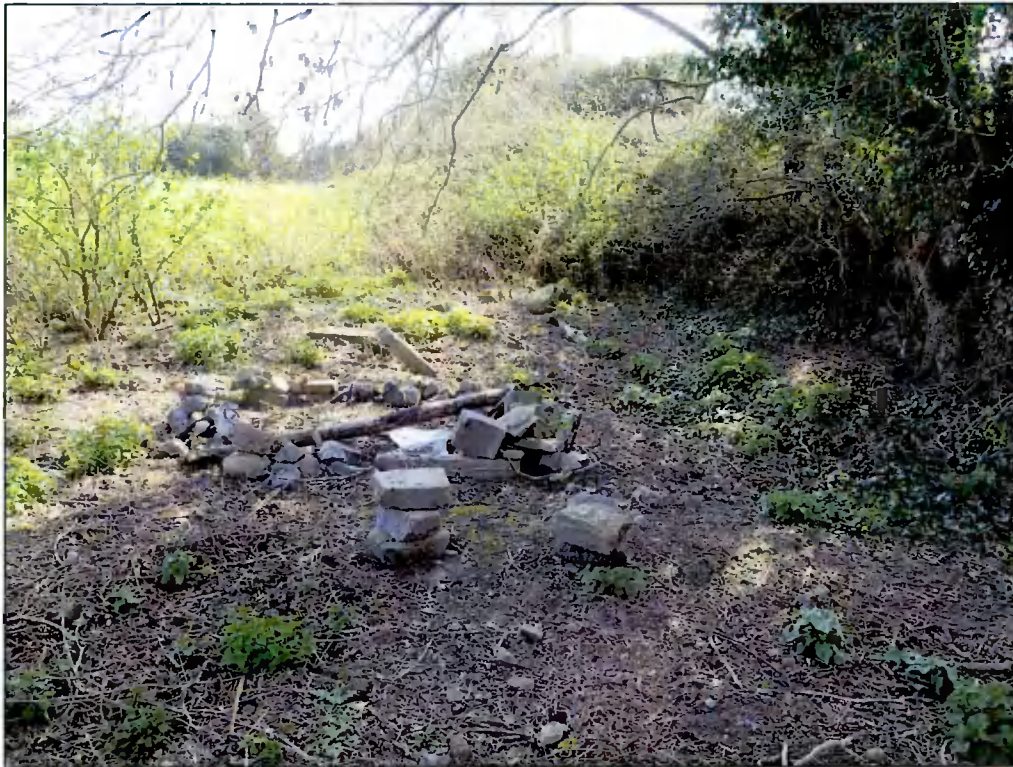
Plate 7 Encampment beside the earthen bank of the field boundary

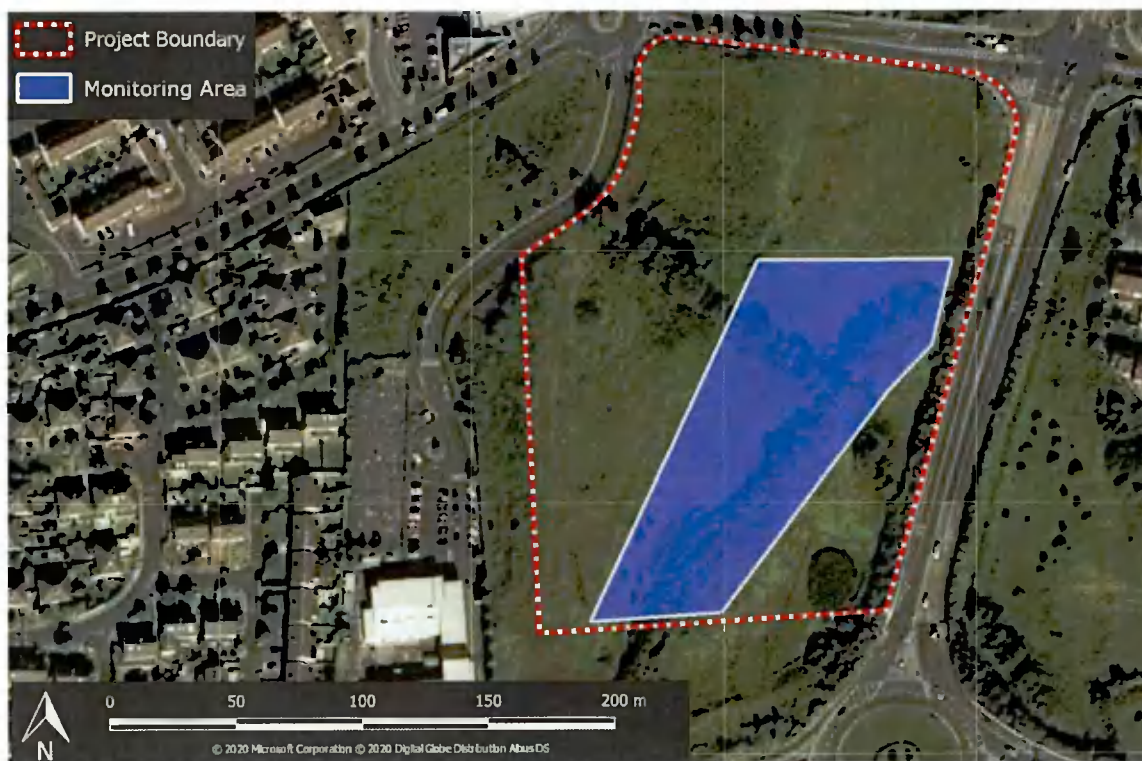
Figure 12 Area for archaeological monitoring of topsoil removal

The assessment found that the overall project area has low archaeological potential because of ground disturbance. However, where ground disturbance has not occurred, in the centre of the site and along field boundaries, there is some potential for previously unrecorded archaeology, which is supported by the recording of sites during developments in the south of Kishoge. The risk of impacting unrecorded archaeological deposits and material could be reduced by a suitably qualified archaeologist monitoring groundworks (topsoil removal) across the central part of the project area.

Areas where monitoring is recommended are illustrated in Figure 12. Topsoil stripping within this part of the development will be monitored by a suitably qualified archaeologist. Should archaeological material be uncovered during this monitoring, the feature will be trowelled back to determine its form, age, nature and extent then photographed and recorded to best professional standards. Based on this information and in consultation with the National Museum and the National Monuments Section of the Department of Culture, Heritage and the Gaeltacht, further investigation may be required.
