Appendix 3: Chemical Analysis and Report

River Camac Surface Water Monitoring 2021 Report 2021

Hinch Site, Saggart, Co. Dublin

Coffey Constructions Ltd

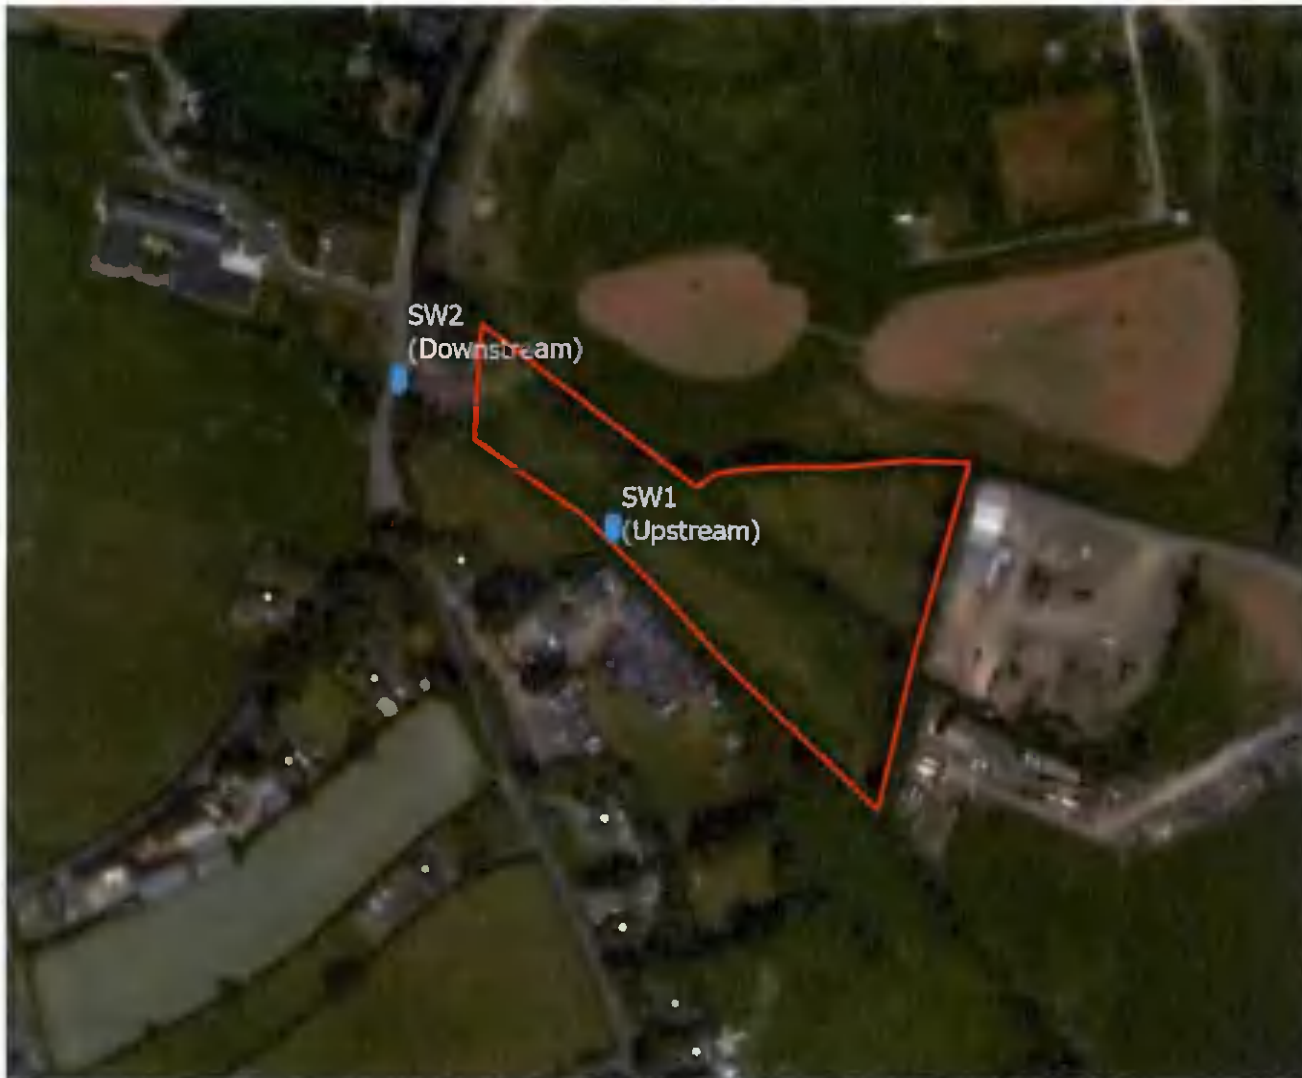
Figure 2: Site Sampling Locations

Table 1: River Camac sample locations

Sample No.	Description	Location (ITM)
SW1	Upstream	X703457 Y726019
SW2	Downstream	X703356 Y726089

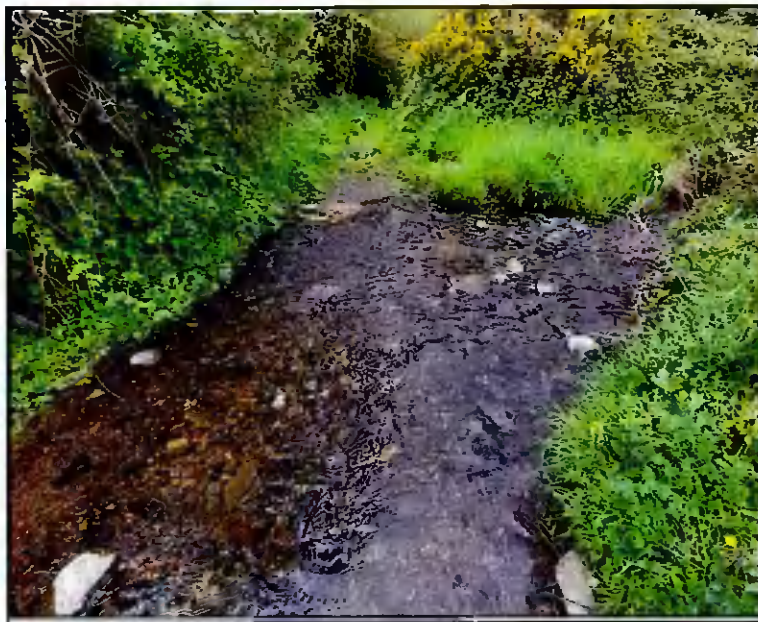
Photograph 1: SW1 (Upstream) Sampling Location

Surface water sampling was carried out by Mr. Ian Douglas and Ms. Eimear O'Brien of Rowan on 18th of May 2021 at monitoring locations SW1 and SW2. Monitoring locations are shown in Photographs 1&2 below and in Appendix A.

Monitoring Location	Visual Inspection 18 th May 2021	Other Comments
SW1	<ul style="list-style-type: none"> • Clear sample • No odour 	Dry weather.
SW2	<ul style="list-style-type: none"> • Clear sample • No odour 	Dry weather.
