**Site Development at Brownsbarn Drive,  
Citywest Business Campus, Dublin 24  
Stage 1 Road Safety Audit**

**March 2021**

## Stage 1 Road Safety Audit

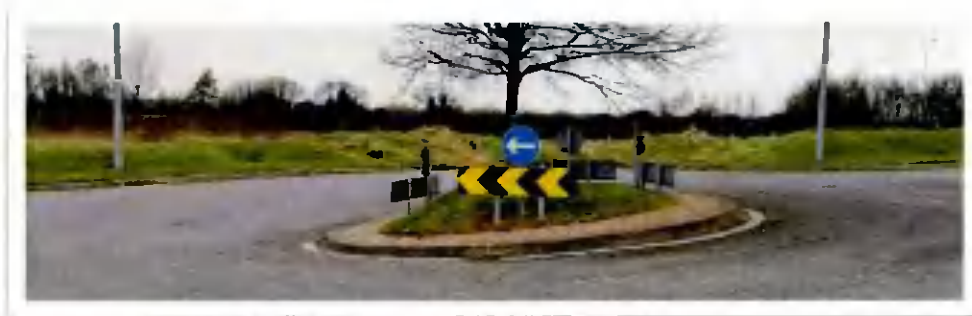
Figure 2.1 – Gradient on Compact Roundabout Circulating Area

The relatively small inscribed circle diameter of the compact roundabout combined with the observed vertical gradients on the roundabout circulatory area could result in HGV strikes on the central island. This could lead to shed loads and delays on the adjacent network.

The central island should be protected from HGV strikes and a vehicle over-run apron should be constructed around the island to slow circulating vehicle speeds.

2.1	Yes	No	Further to review the roundabout was identified as unsuitable for the type and volume of traffic movements which would be generated by the proposed development and the potential impact on the N7 interchange due to proximity of the compact roundabout to 'Roundabout 2' (the northern roundabout at the N7 J3). Therefore, the compact roundabout is to be removed and replaced by a longer section of roadway from 'Roundabout 2', with right turning lane provision and the exit arms from the development provided as priority stop controlled junctions.	Yes

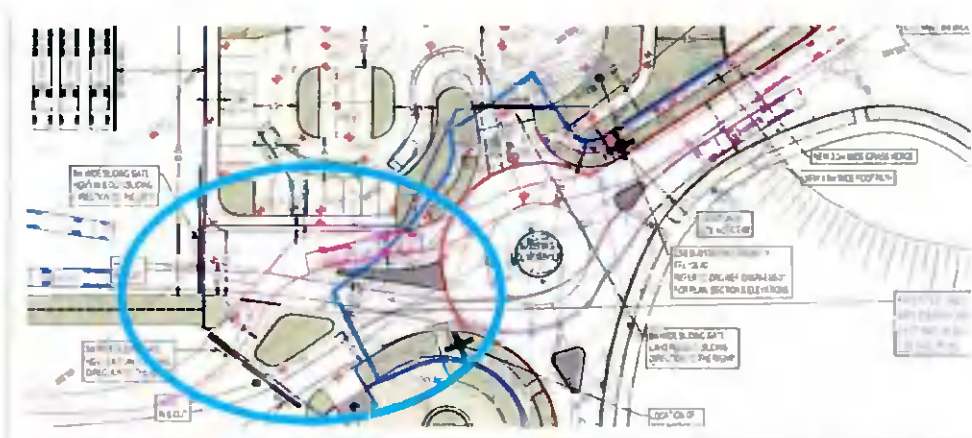
Figure 2.2 – HGV Conflicts at Access to Unit 1 and Unit 2

The HGV access arrangement for Unit 1 & Units 2 are in close proximity and could lead to conflicts between HGV's accessing the units which may result in collisions between HGV's and delays on the adjacent roundabout.

The access points should be separated and moved further away from the roundabout.

2.2	Yes	Yes	See also comments in response to item 2.1 with proposed removal of the compact roundabout.	Noted with thanks.
2.3	Yes	Yes	See also comments in response to item 2.1 with proposed removal of the compact roundabout, and note we have revised priorities within the access to Unit 1 car parking areas.	Noted with thanks.

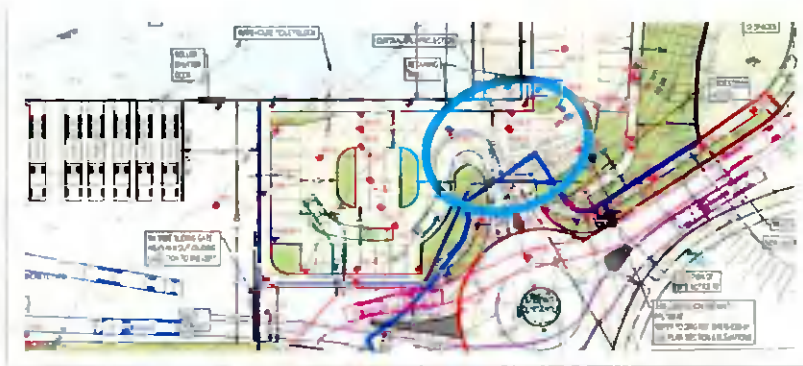
Figure 2.3 – Car Park Access onto Roundabout

The constrained nature of this car park may result in collisions between vehicles navigating the entrance to the car park and lead to delays or secondary collisions on the roundabout.

The car park access should be closed and relocated away from the roundabout circulatory area.

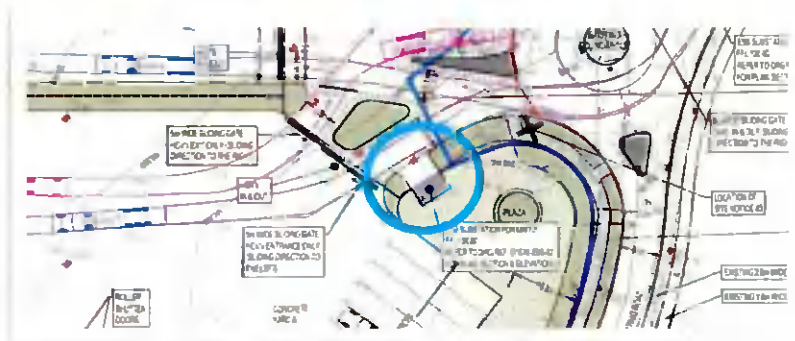
Figure 2.4 – Unit 2 ESB Sub-Station

ESB service vehicles and staff working in this location are at risk of accidental strike by HGV's. A stationary ESB service vehicle may also impede HGV access to unit 2, resulting in delays and conflict on the roundabout.

Service vehicle access to the sub-station should be relocated to a safer area, away from the access to Unit 2.

2.4	Yes	Yes	Proposed Sub-station relocated. See also comments in response to item 2.1 with proposed removal of the compact roundabout.	Noted with thanks.

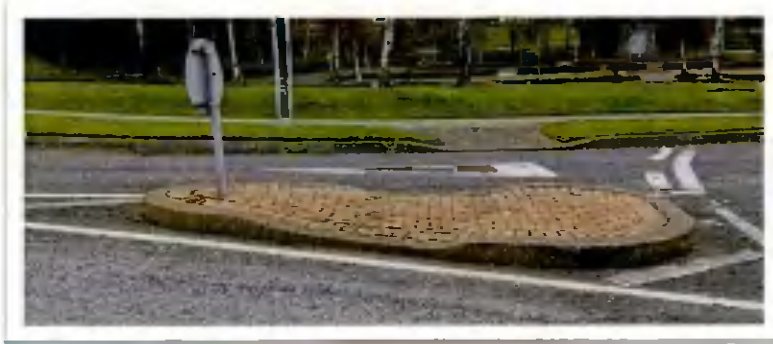
**Figure 2.5 – Roundabout Pedestrian Crossings**

The existing pedestrian crossings serving each arm of the roundabout have high kerbs which may result in trips for vulnerable or mobility impaired road users.

The crossing points should be improved to facilitate safe crossing for vulnerable and mobility impaired road users.

2.5	Yes	Yes	See also comments in response to item 2.1 with proposed removal of the compact roundabout.	Noted with thanks.
