## River Camac Surface Water Monitoring 2021 Report 2021

**Hurley Site, Saggart, Co. Dublin**

Coffey Constructions Ltd

*Client Ref: 6613/COF0001-6*

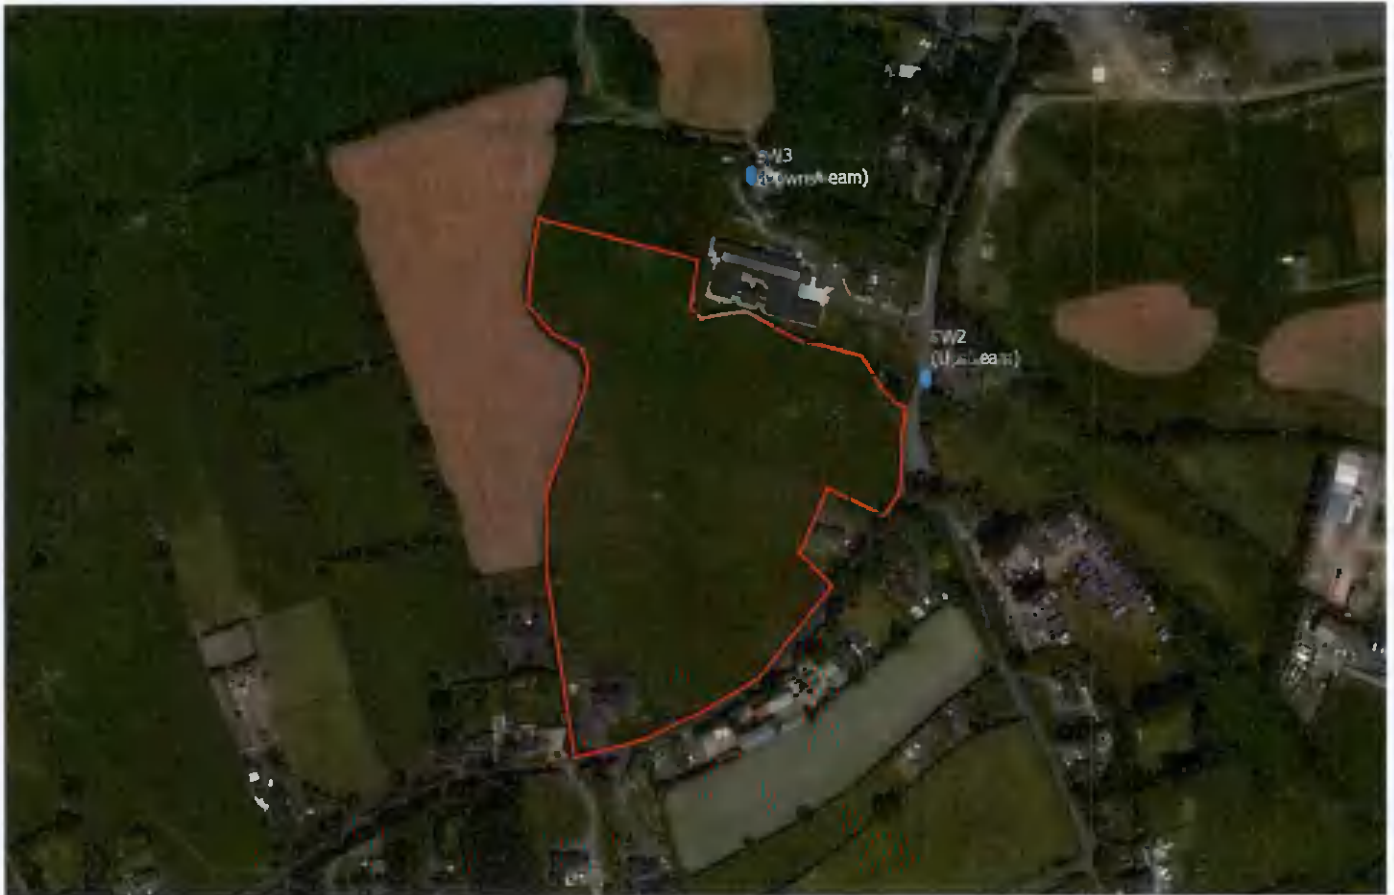
**Figure 2: Site Sampling Locations**

Sample No.	Description	Location (ITM)
SW2	Upstream	X703356 Y726089
SW3	Downstream	X703302 Y726180
