Bat Survey

Mrs Brenda Weir
Rookwood
Stocking Lane
Dublin 16

2020

Ecological Services

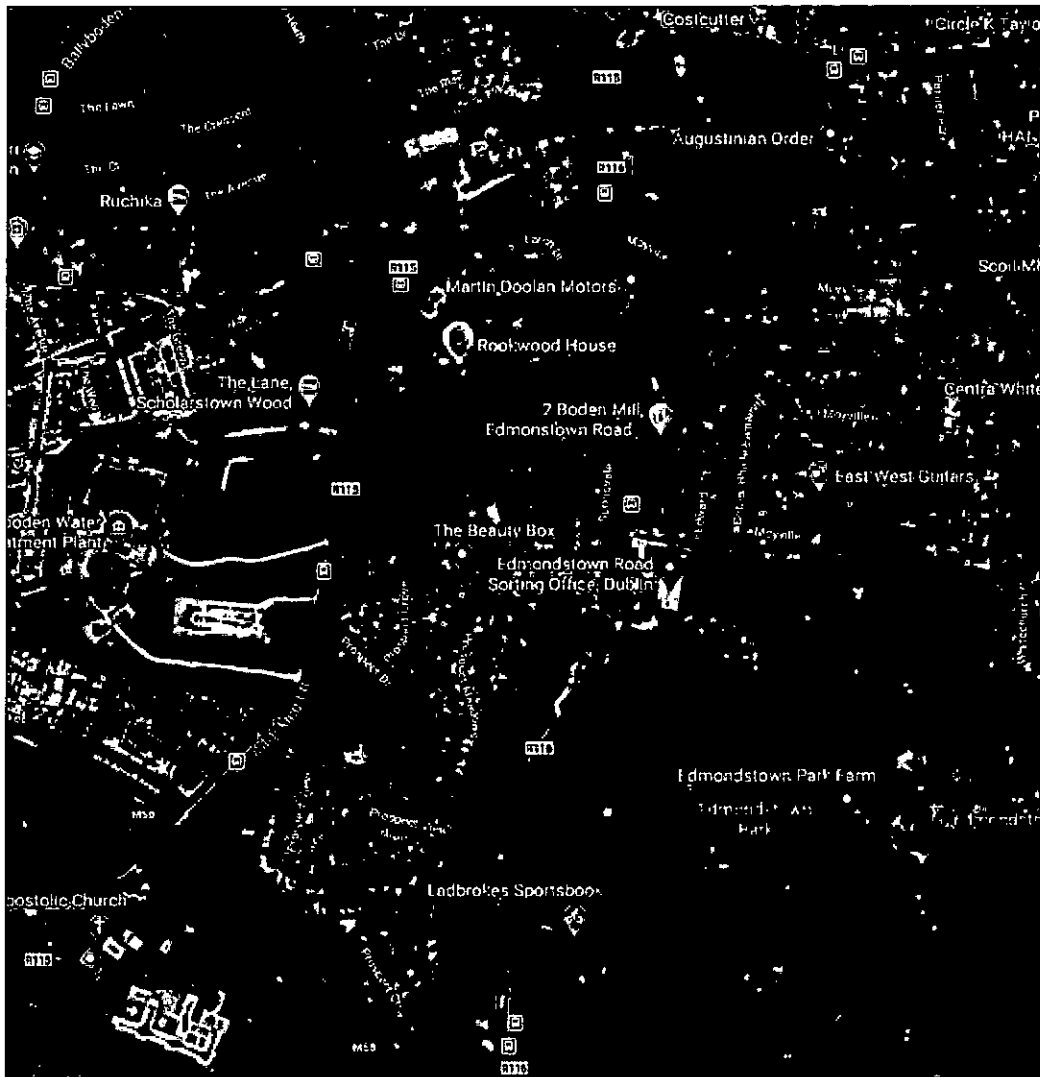
Fig.2: Aerial image of Rookwood House and its surrounds.

The property is situated in South County Dublin, inside the M50 ring road. It is bordered to the west by Stocking Lane, where its entrance is located. There is a new housing estate on the opposite side of Stocking Lane. To the north is Scholarstown Road and to the east Edmondstown Road which service more housing areas. To the south is a green field bounded by housing. Ballyboden water treatment plant can be found to the south west on the other side of Stocking Lane. There is a wooded area and older housing estates to the north east with the Owendoher River running north-south to the east of Rookwood. Edmondstown Farm Park and golf course can be found approximately 400m to the south east. There is therefore potential roosting and feeding grounds for bats in the area. See Figure 2.
