INXN DUB15/16

Soils and Geology

280503-GE-PLA-RP001

Issue | 23 July 2021

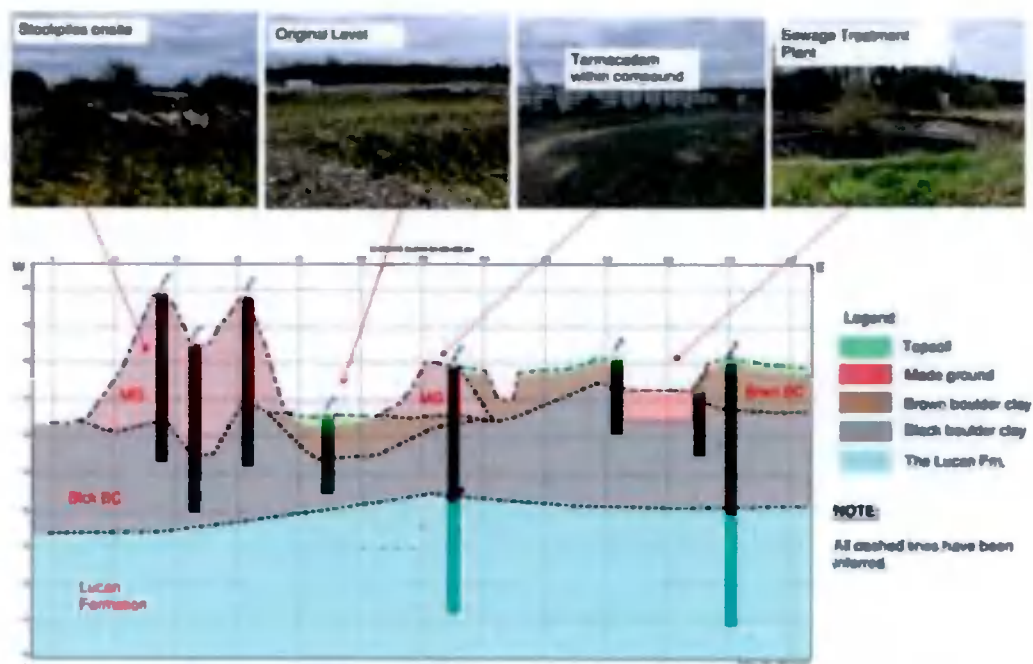
Figure II: Ground conditions West to East on site

Figure II provides a summary of the ground conditions encountered West to East. The section includes information on the existing ground conditions at locations around the site.

Further information on the geological cross sections across the site is included in Appendix D of this report.

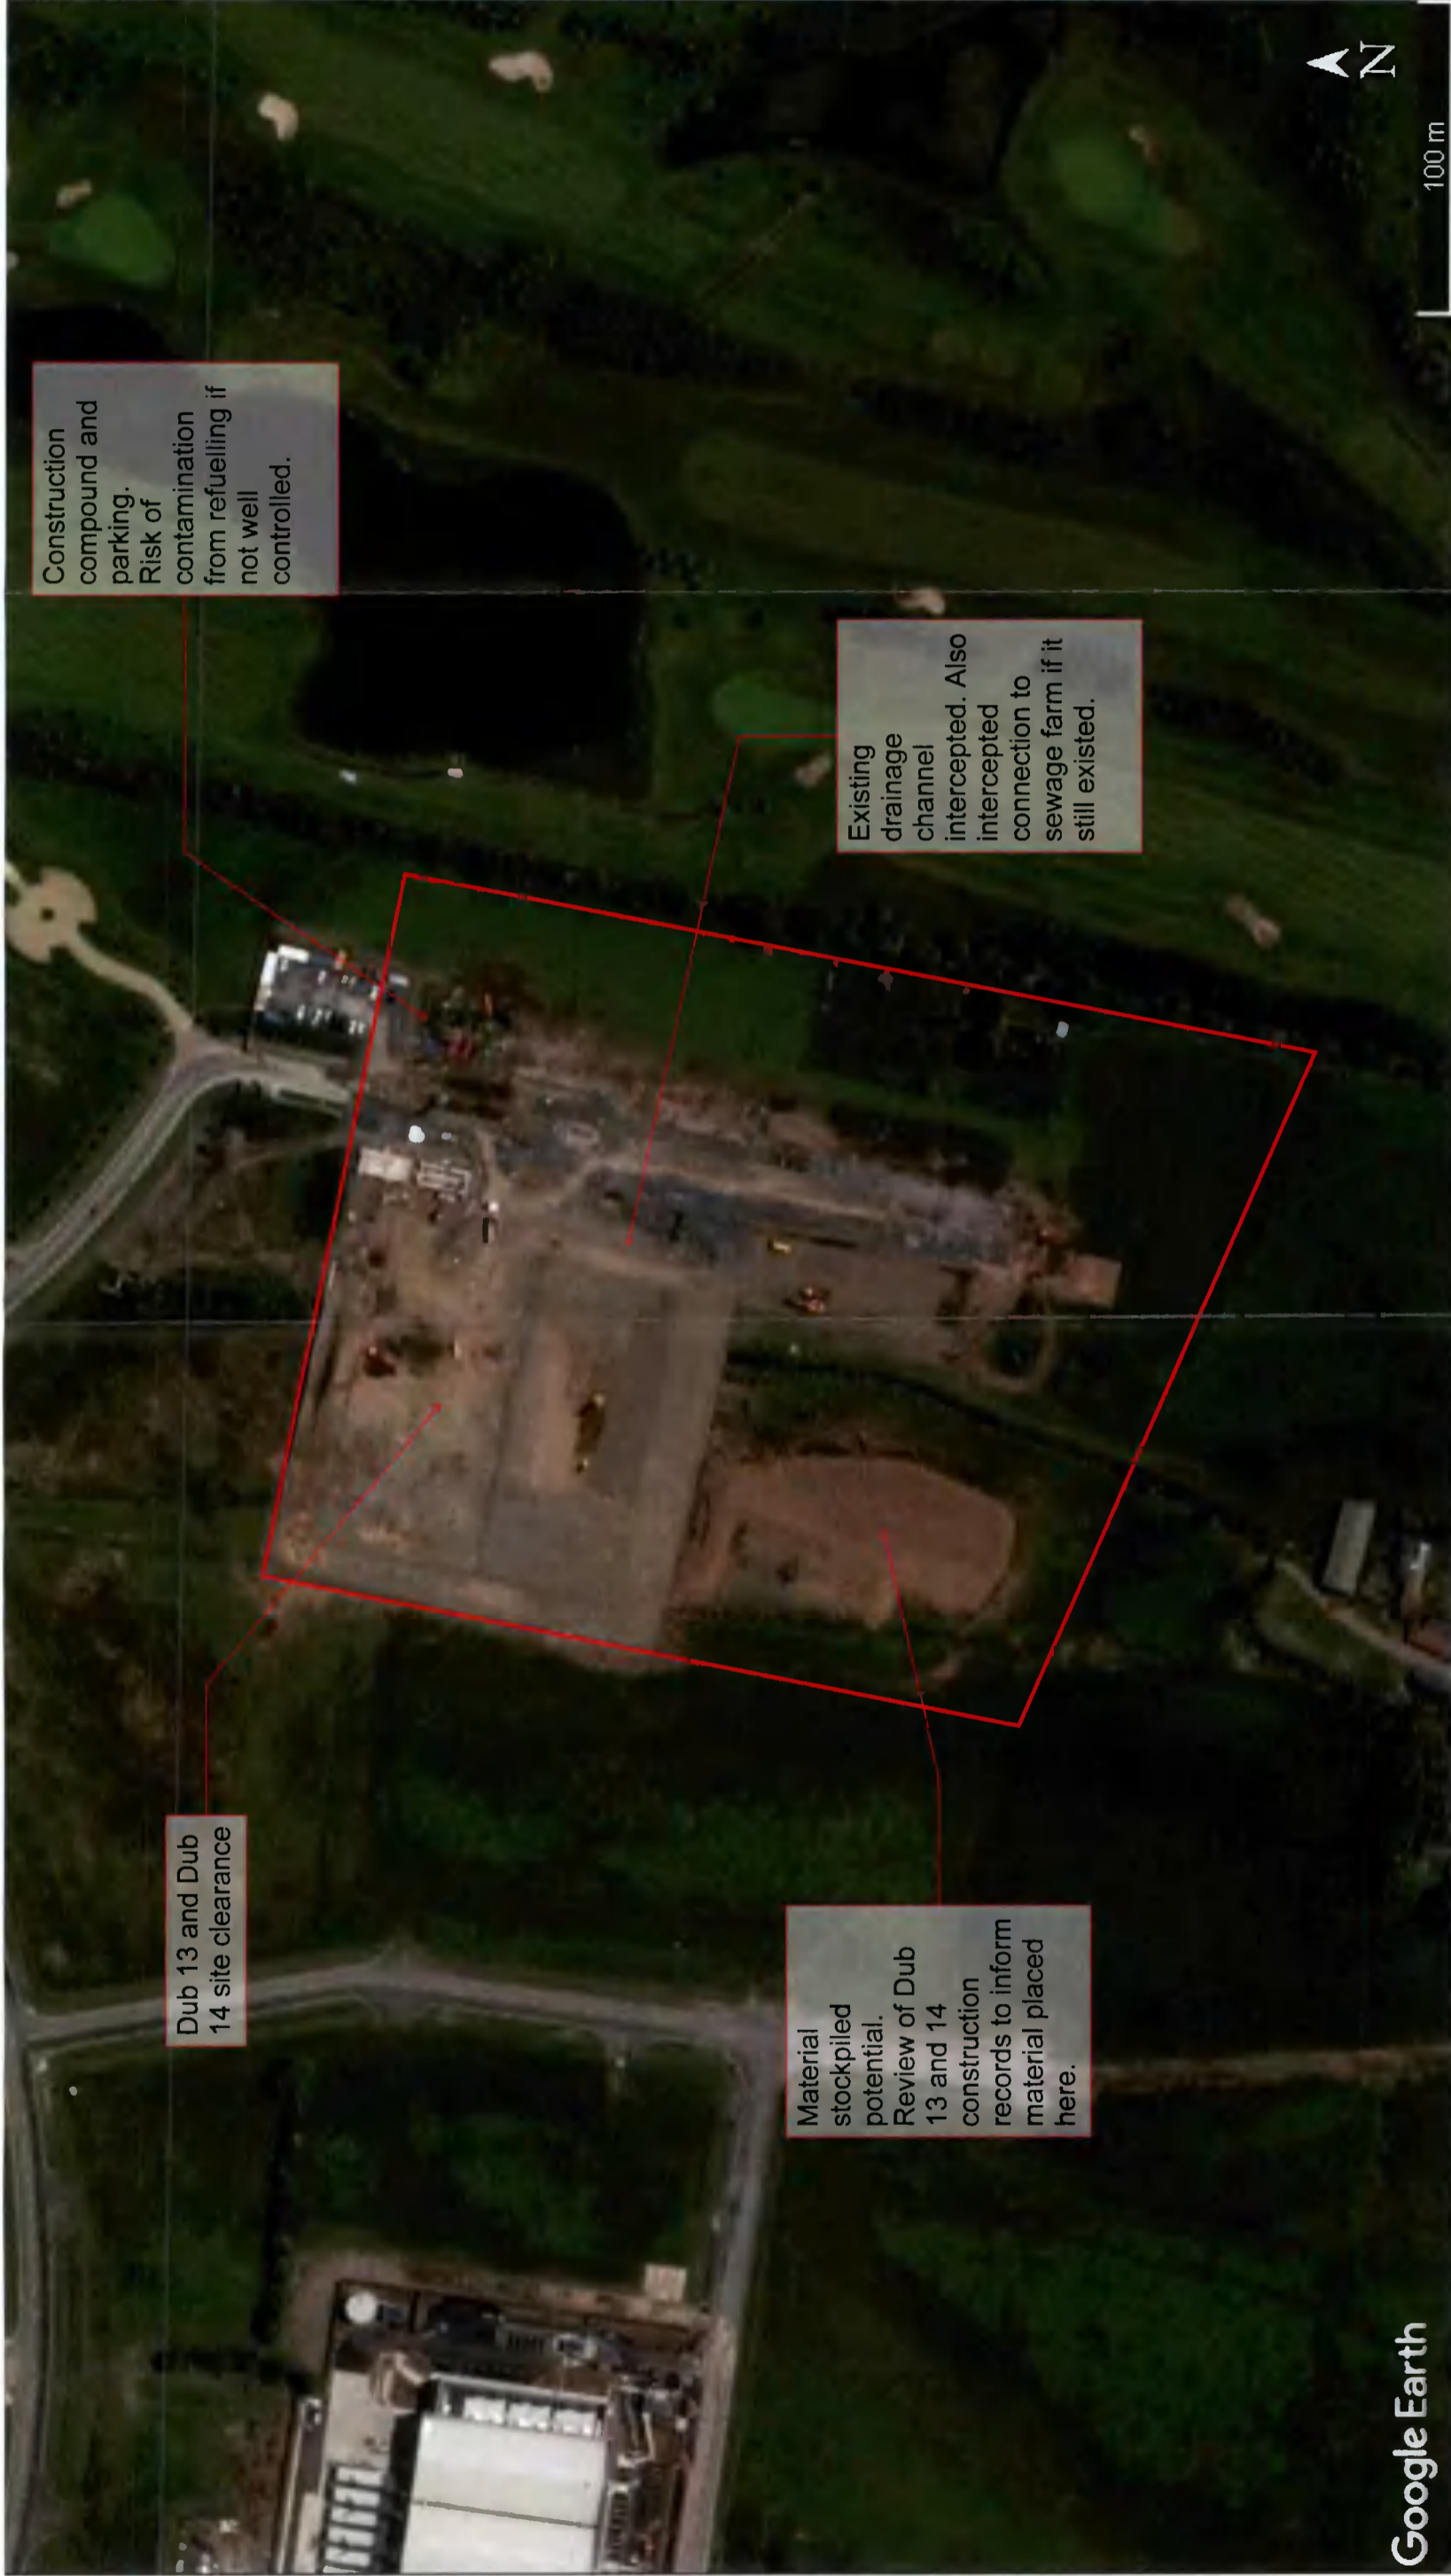
3.7

Construction compound and parking.
Risk of contamination from refuelling if not well controlled.

Existing drainage channel intercepted. Also connection to sewage farm if it still existed.

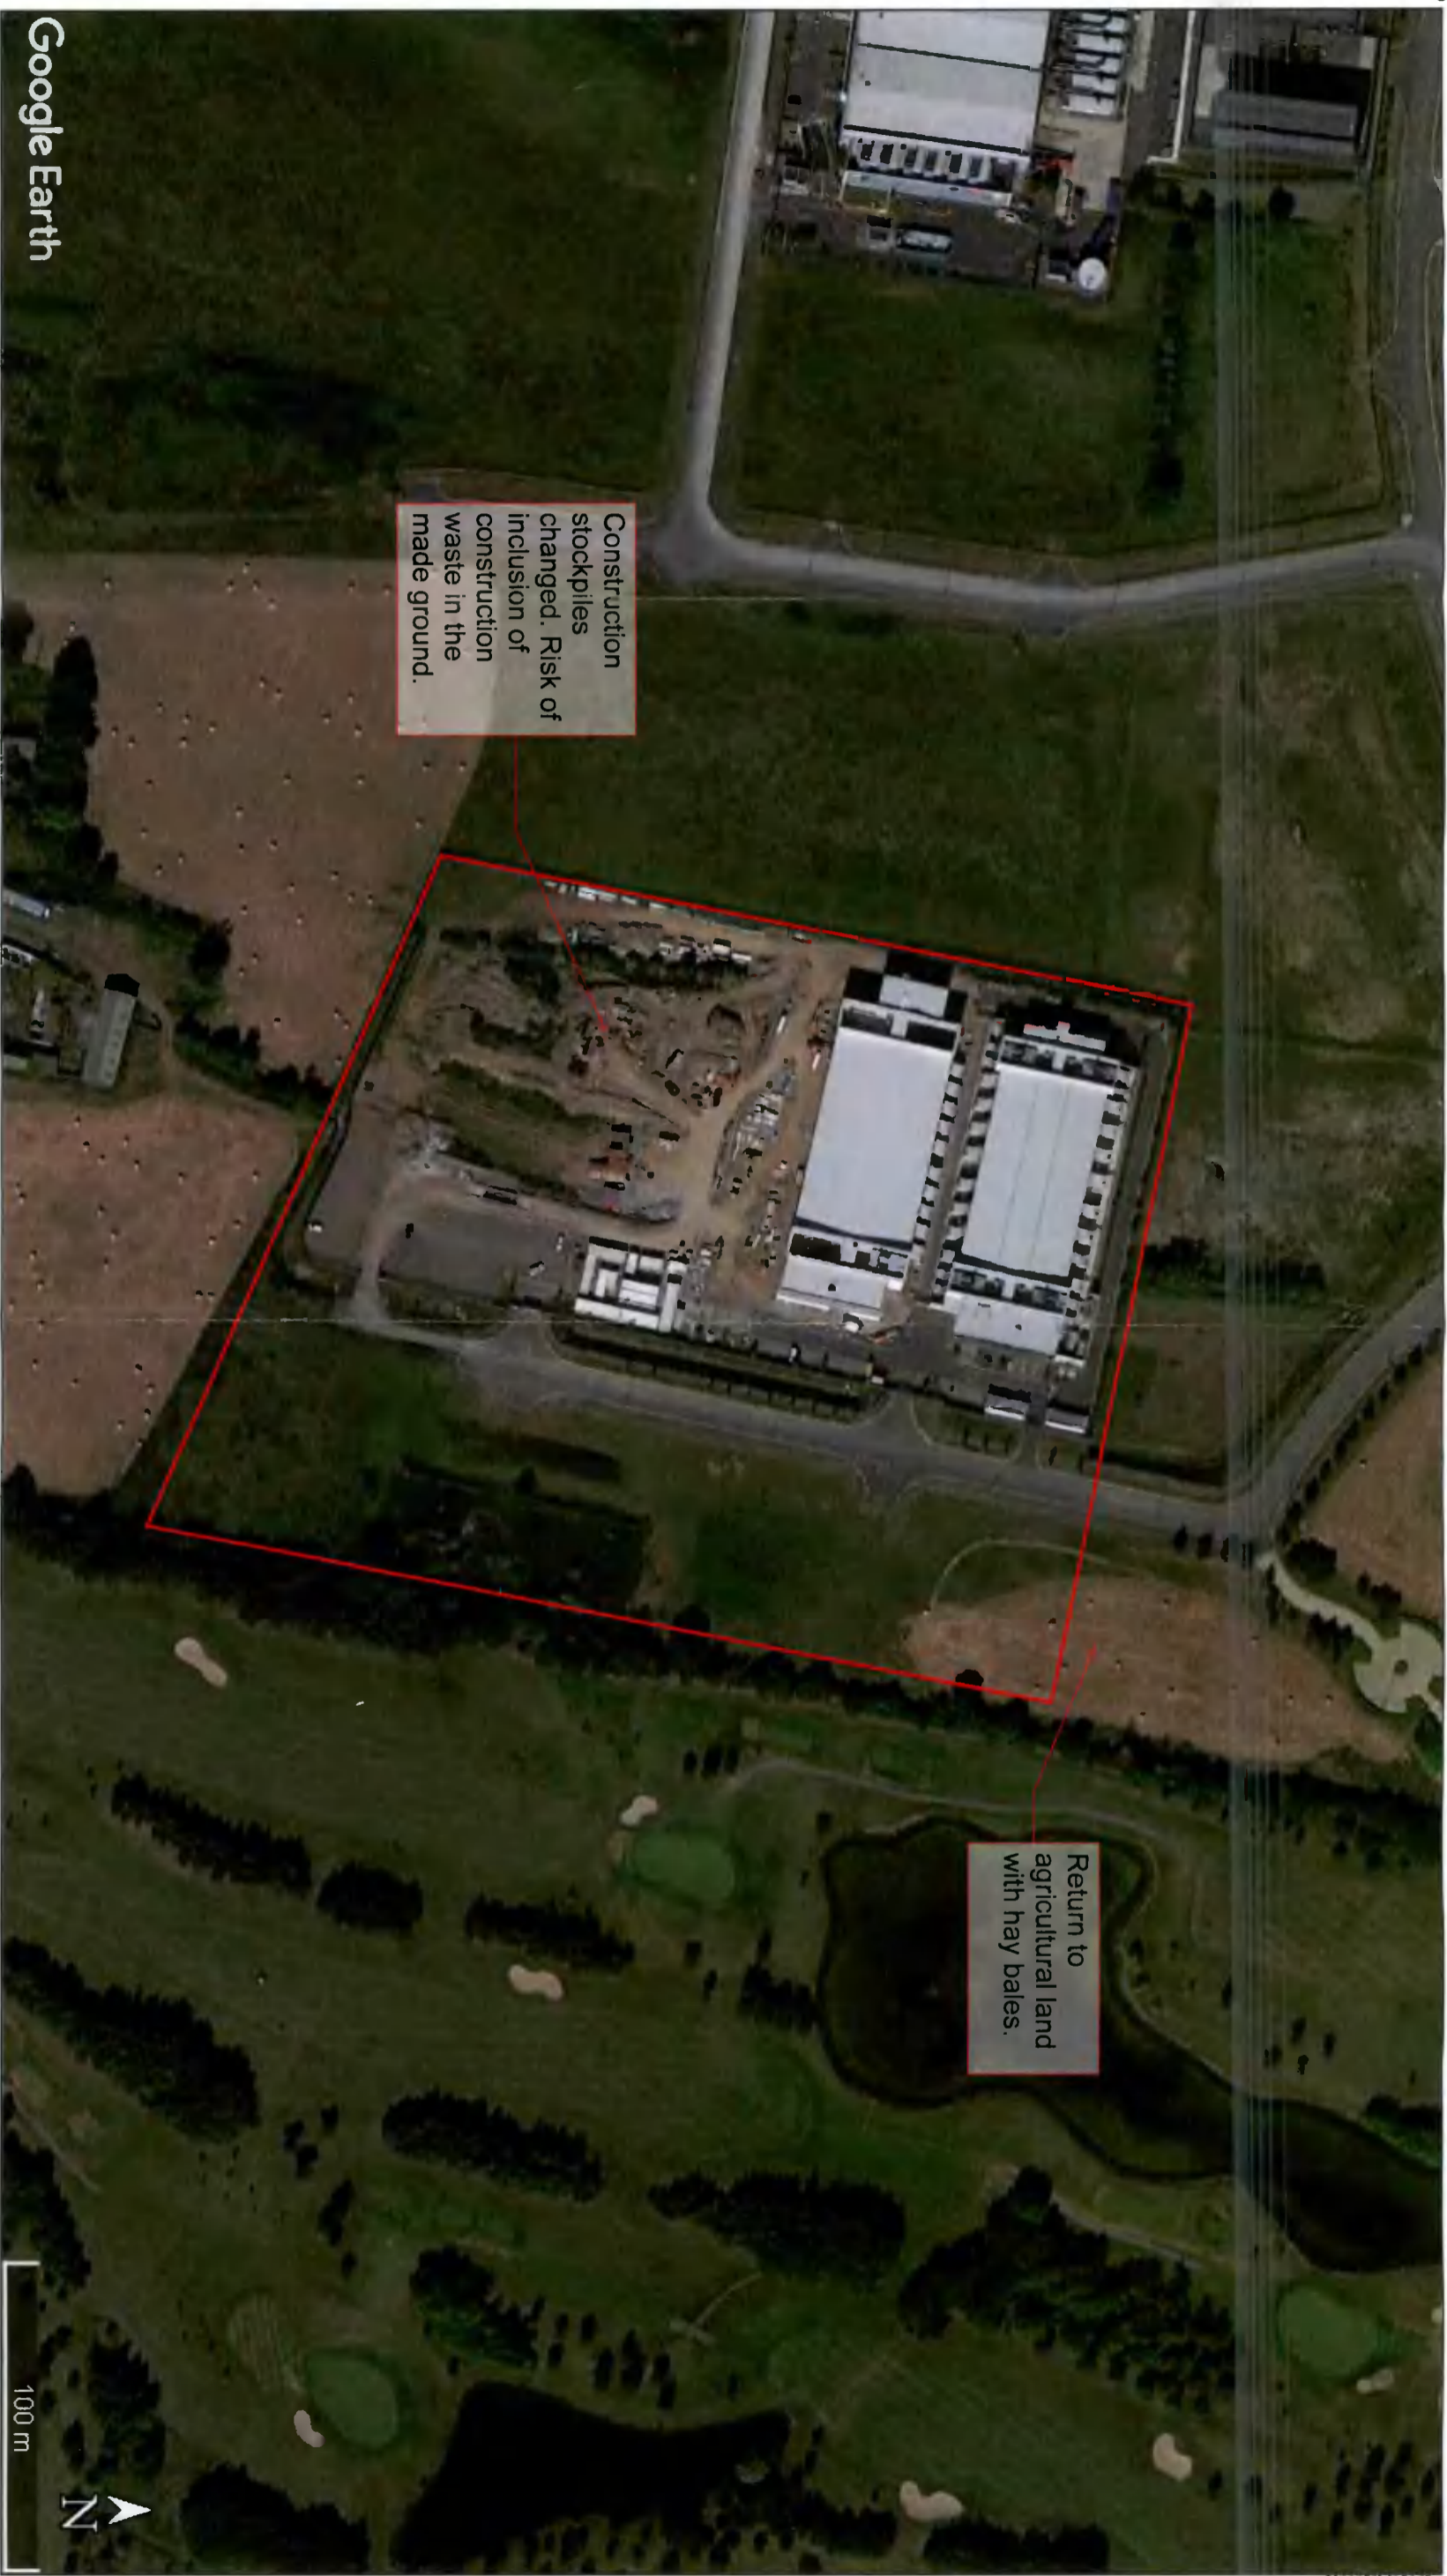
3.11

Construction stockpiles changed. Risk of inclusion of construction waste in the made ground.

Return to agricultural land with hay bales.

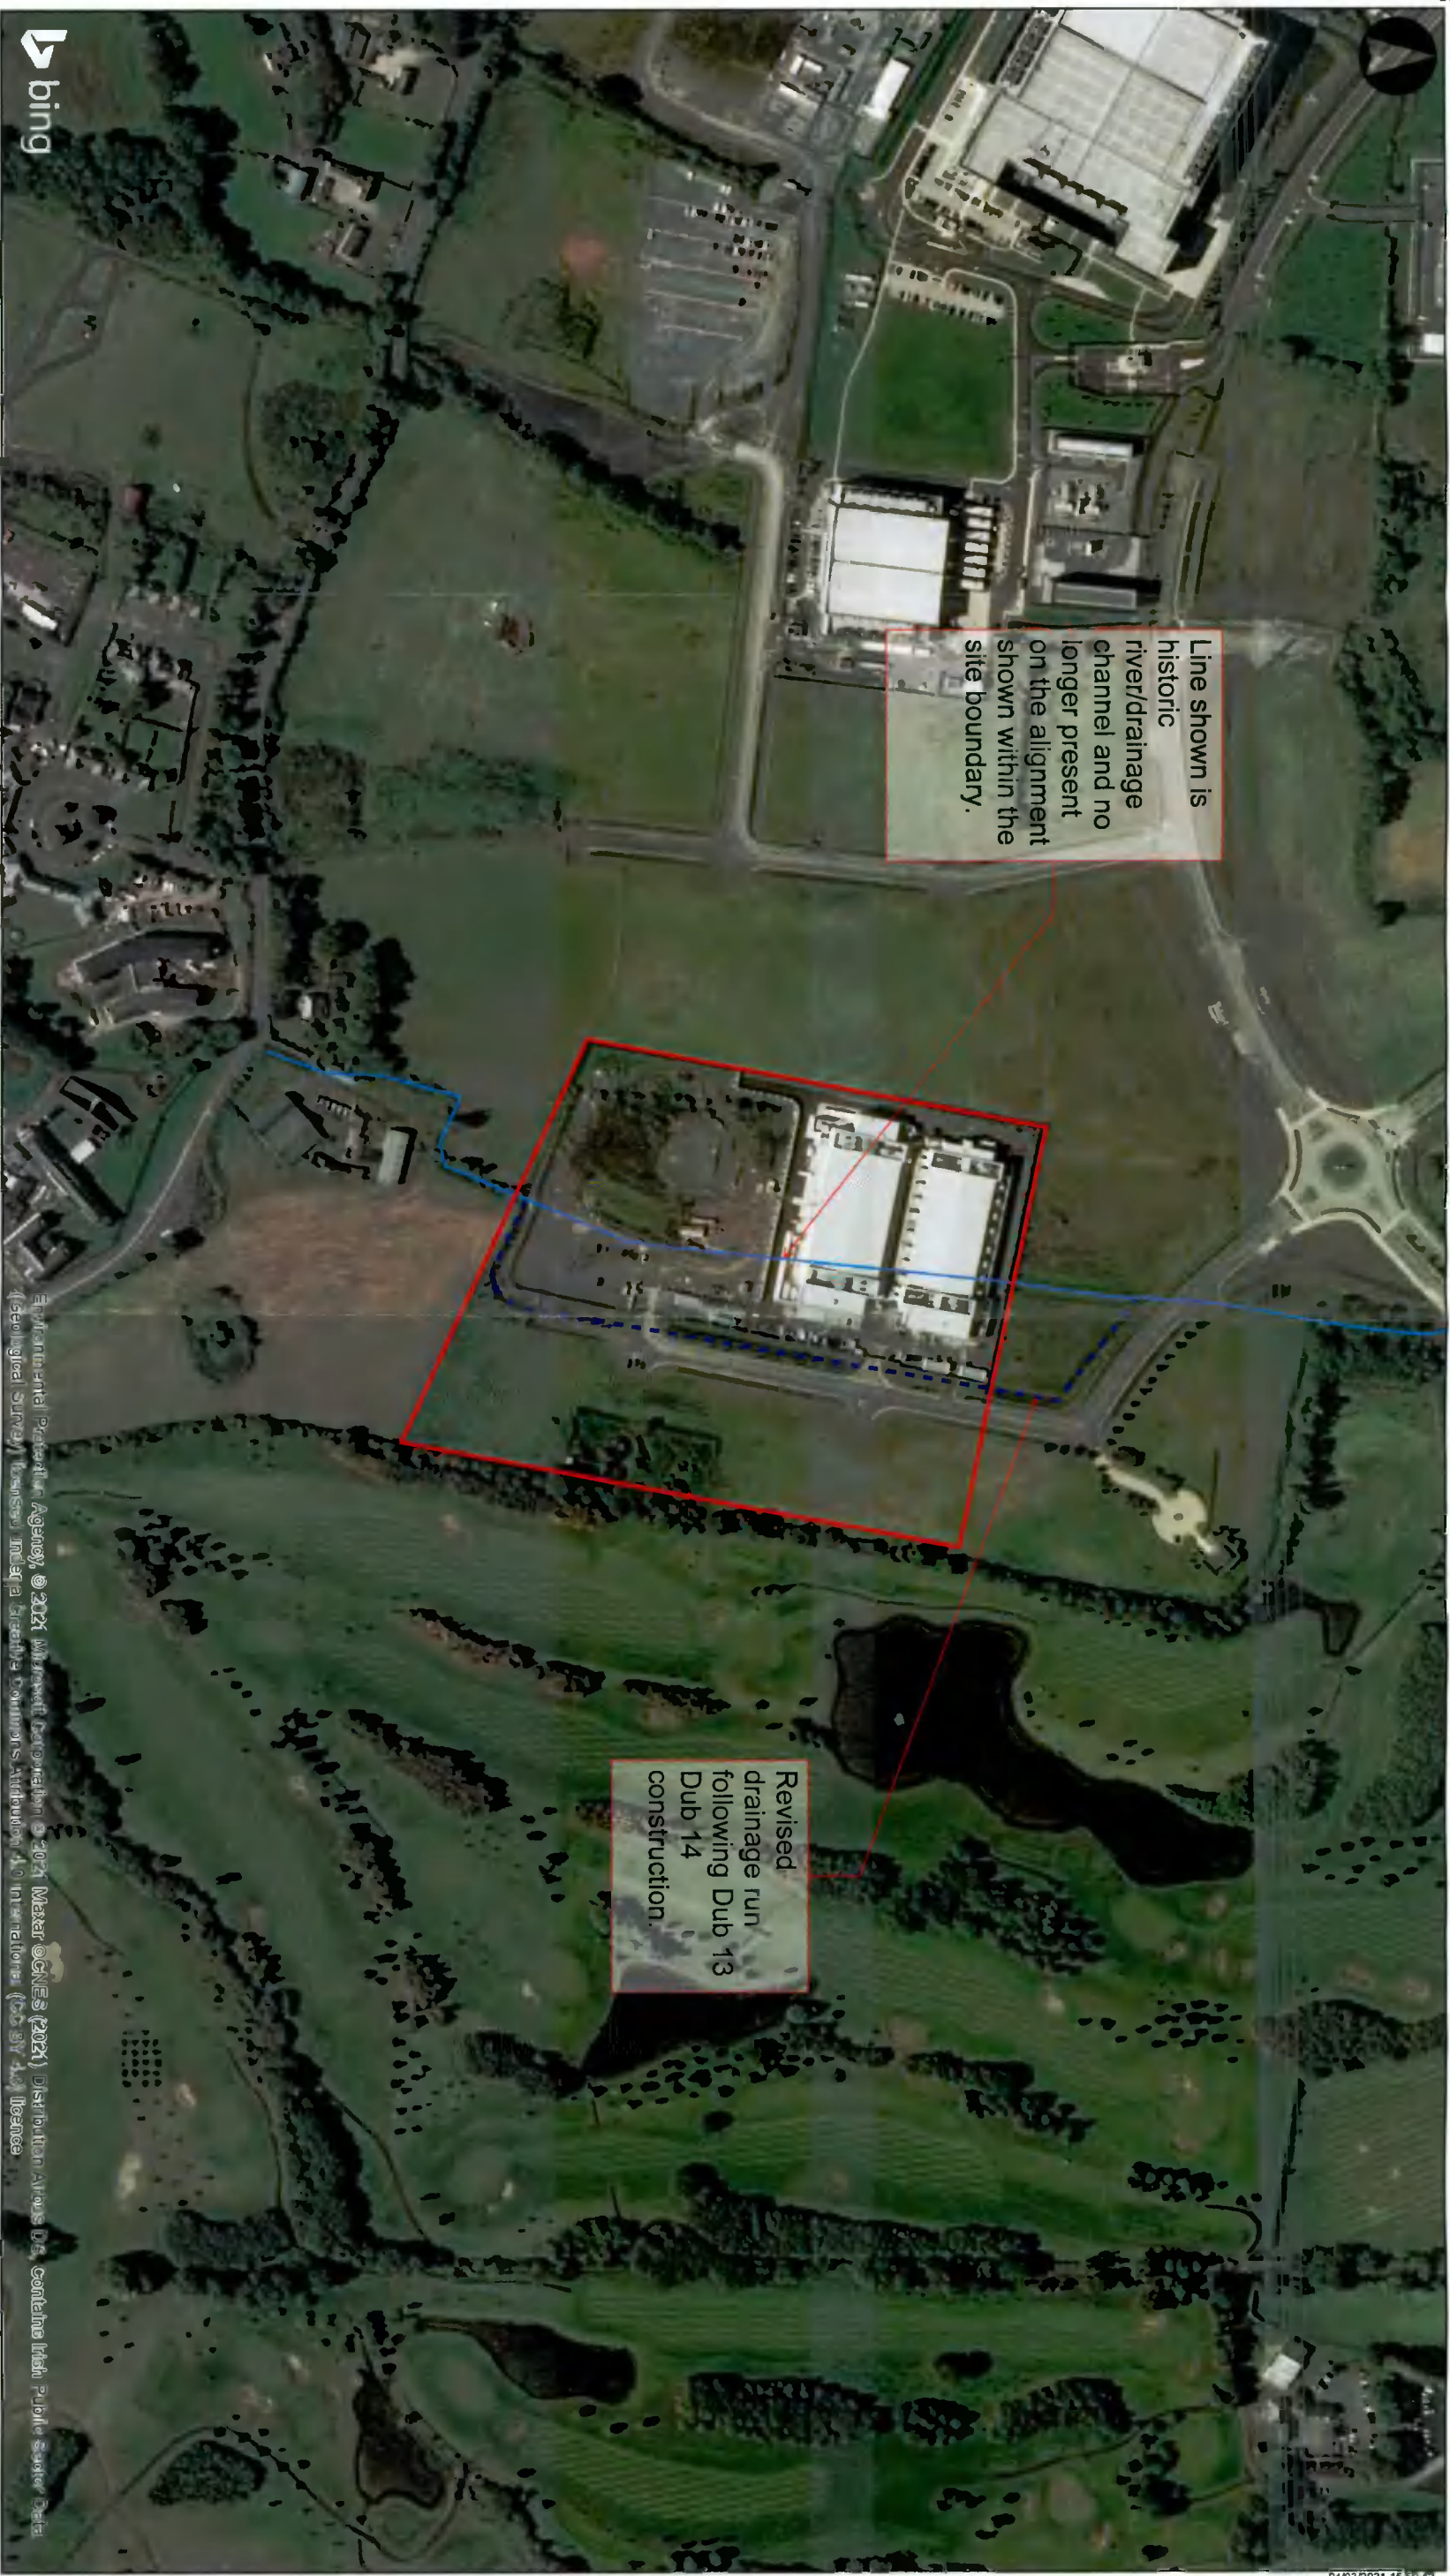
5.9

Line shown is historic river/drainage channel and no longer present on the alignment shown within the site boundary.

Revised drainage run following Dub 13 Dub 14 construction.

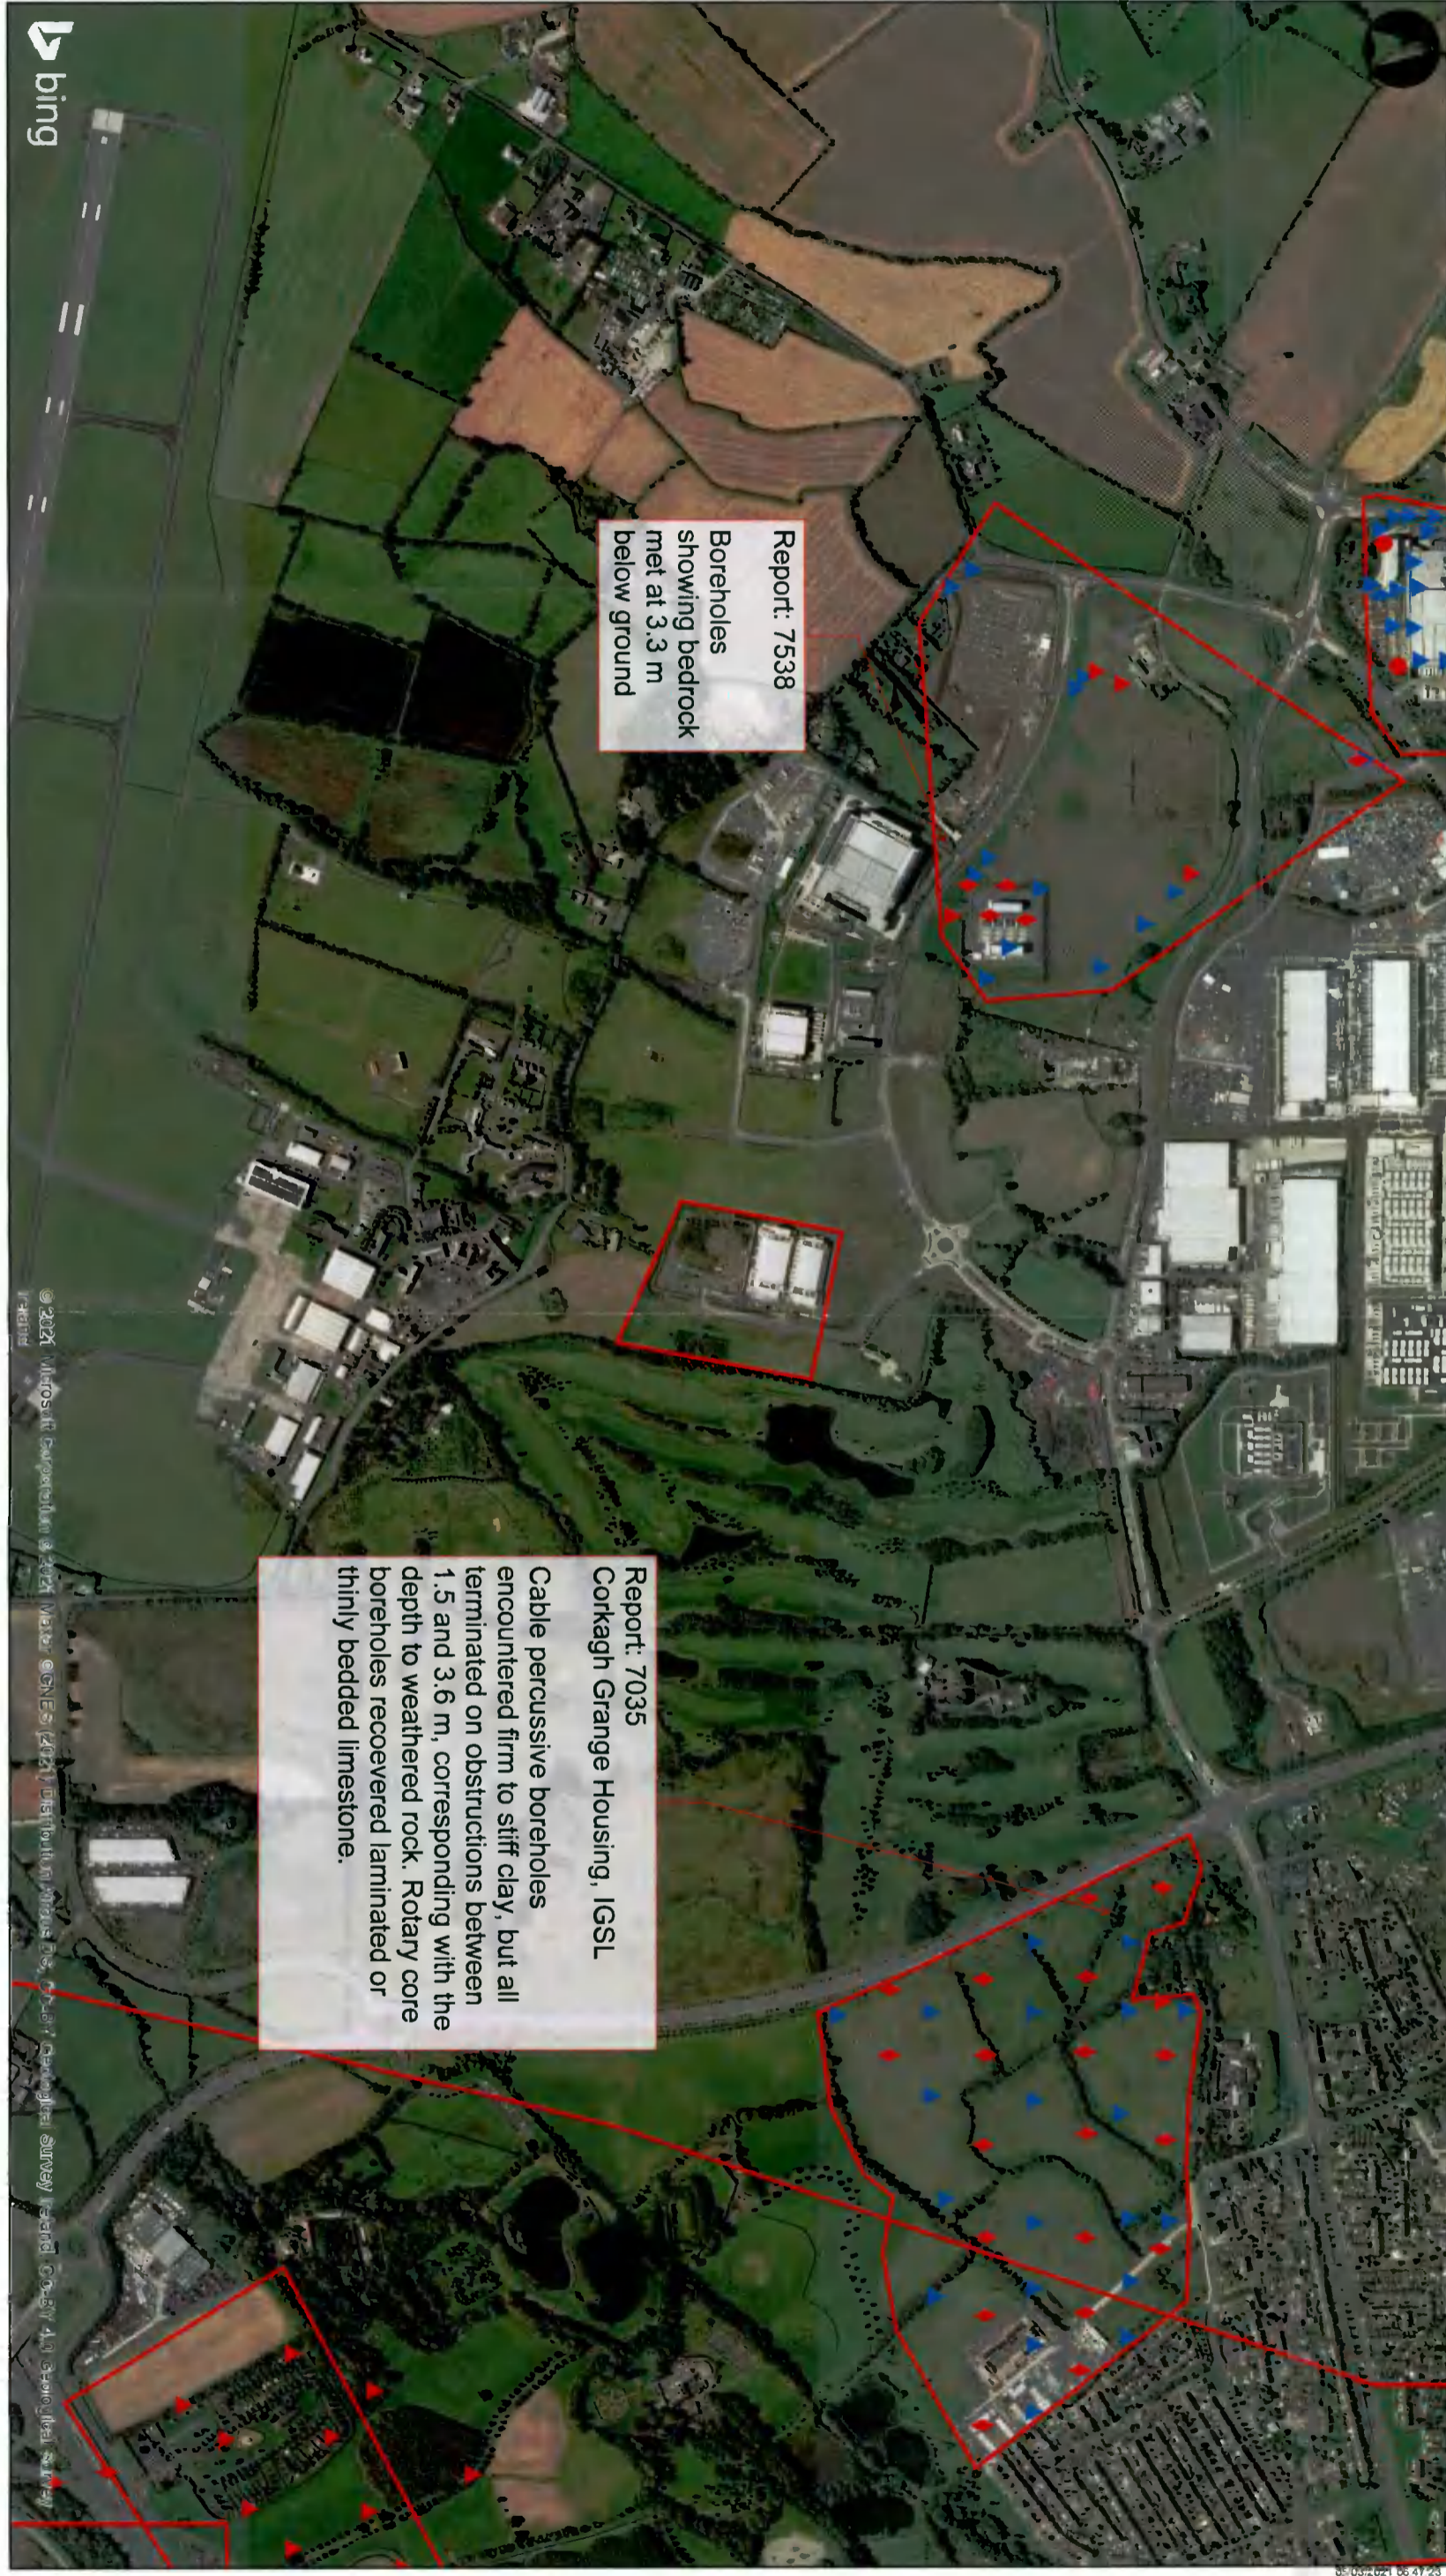
7.1

Report: 7538
Boreholes showing bedrock met at 3.3 m below ground

Report: 7035
Corkagh Grange Housing, IGSL
Cable percussive boreholes encountered firm to stiff clay, but all terminated on obstructions between 1.5 and 3.6 m, corresponding with the depth to weathered rock. Rotary core boreholes recovered laminated or thinly bedded limestone.

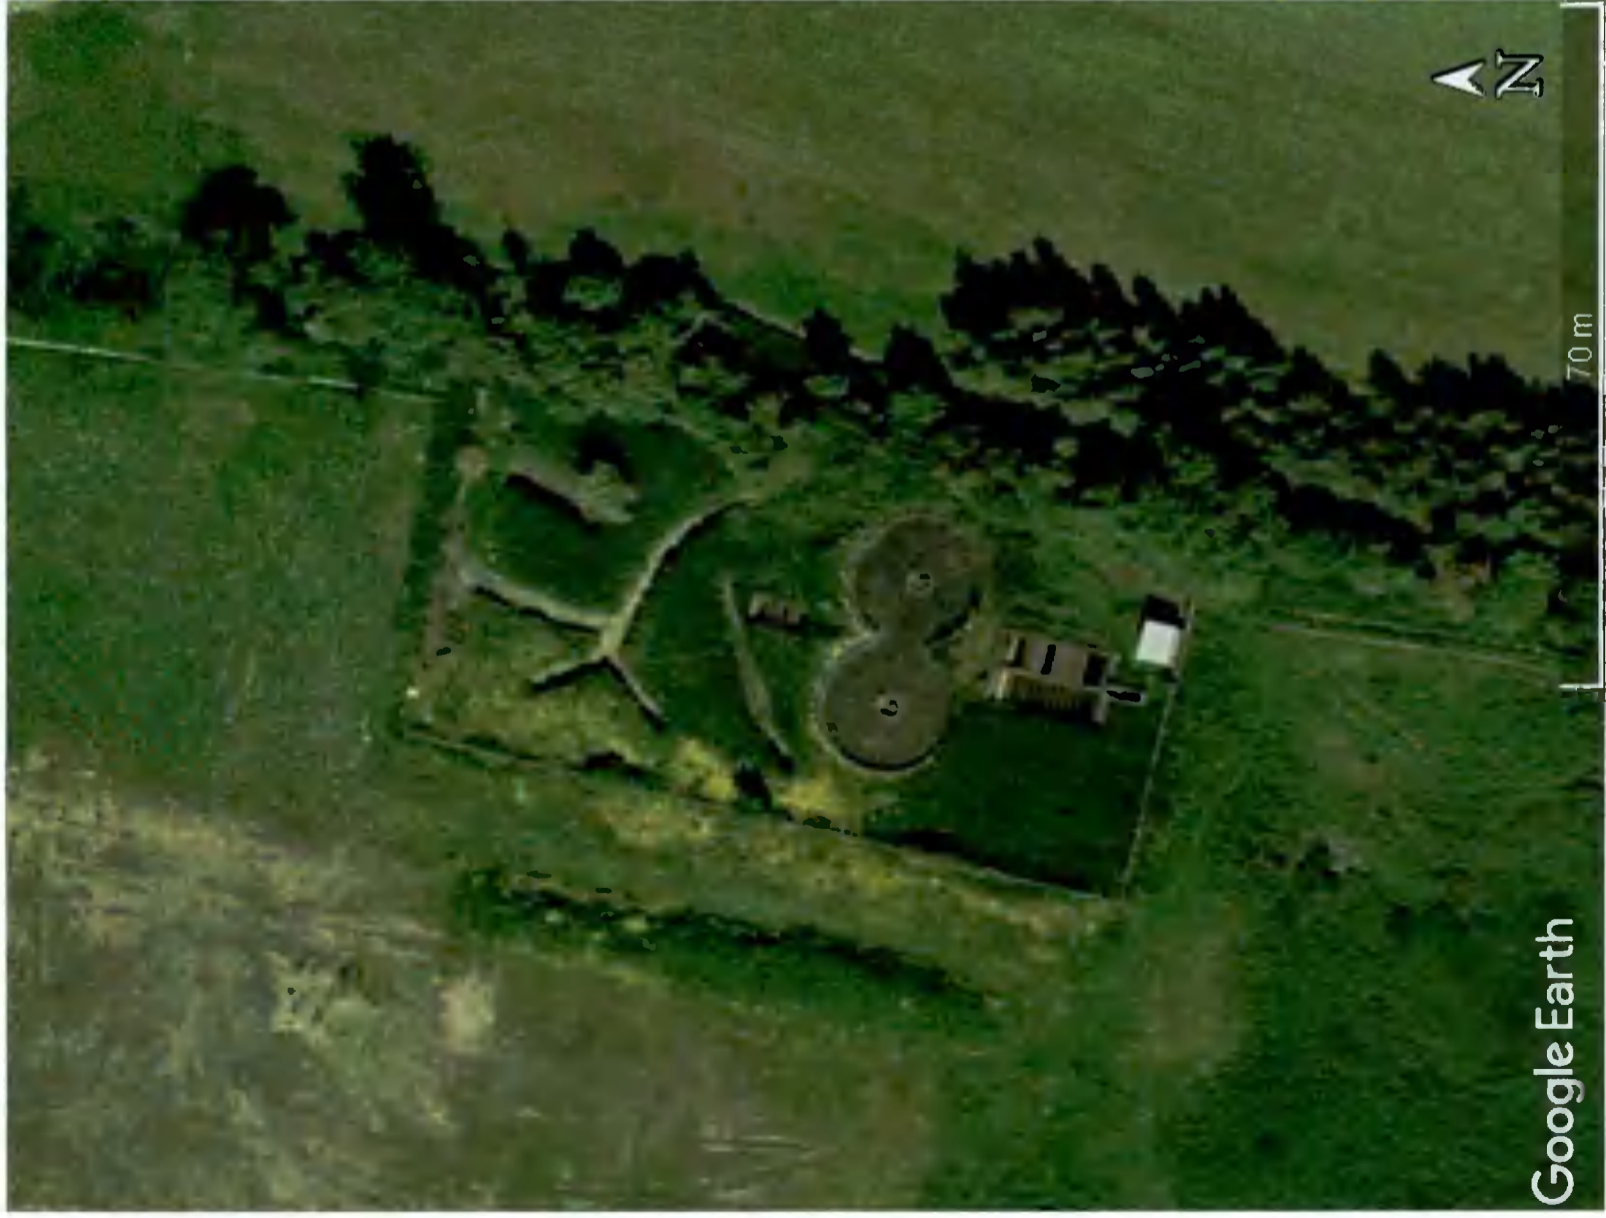
Sewage Farm / Sewage Treatment Plant

Constructed post 1920.

Enabling works will include the removal of these existing stockpiles on the site for recovery or disposal to a suitably licensed facility offsite. It will also include for the excavation and removal of the decommissioned sewage treatment works (unused waste water treatment facility) and associated buried structures and foundations.

It is envisaged that the area around the sewage treatment works will be excavated to a depth of approximately 2m BGL and replaced with suitable engineering fill to allow for the construction of Dub16, the proposed new water course at this location and associated site security fencing.
