**S.I. Ltd Contract No: 5840**

**DUB15 Digital Realty,**  
**Profile Park, Grange Castle, Co. Dublin**  
**Site Investigation Report**

Issue Date:	10/06/2021
Status	Final
Revision	1

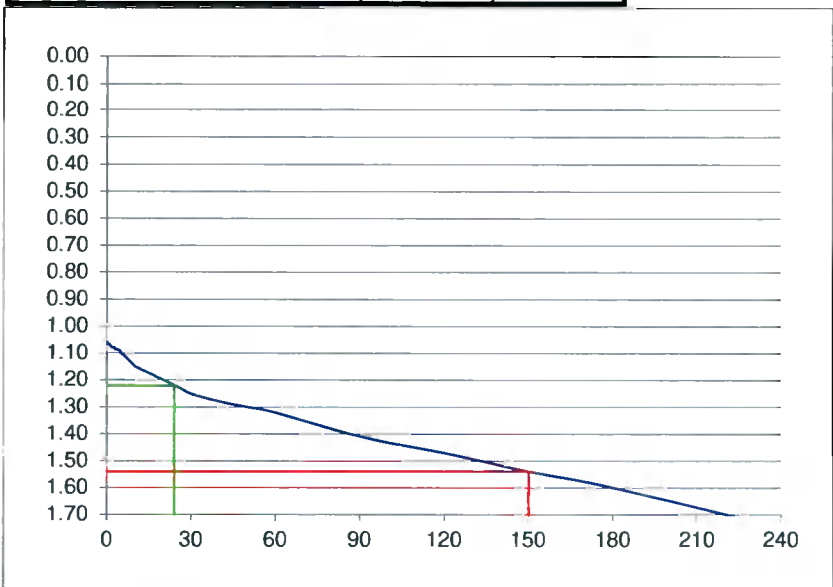
Elapsed Time (mins)	Fall of Water (m)
0	1.06
0.5	1.07
1	1.07
1.5	1.08
2	1.08
2.5	1.08
3	1.09
3.5	1.09
4	1.09
4.5	1.09
5	1.10
6	1.11
7	1.12
8	1.13
9	1.14
10	1.15
12	1.16
14	1.17
16	1.18
18	1.19
20	1.20
25	1.23
30	1.25
40	1.28
50	1.30
60	1.32
90	1.41
120	1.47
150	1.54
180	1.60
240	1.75

Pit Dimensions (m)	
Length (m)	1.90 m
Width (m)	0.60 m
Depth	1.70 m
Water	
Start Depth of Water	1.06 m
Depth of Water	0.64 m
75% Full	1.22 m
25% Full	1.54 m
75%-25%	0.32 m
Volume of water (75%-25%)	0.36 m <sup>3</sup>
Area of Drainage	8.5 m <sup>2</sup>
Area of Drainage (75%-25%)	2.74 m <sup>2</sup>
Time	
75% Full	24 min
25% Full	150 min
Time 75% to 25%	126 min
Time 75% to 25% (sec)	7560 sec

$f = \frac{0.00106}{\text{m/min}}$  or

$\frac{1.76E-05}{\text{m/s}}$

At two locations, soakaway tests were completed and logged by SIL geotechnical engineer. The soakaway test is used to identify possible areas for storm water drainage. The pit was filled with water and the level of the groundwater was recorded over time. As stipulated by BRE Special Digest 365, the pit should be filled three times and that the final cycle is used to provide the infiltration rate. The time taken for the water level to fall from 75% volume to 25% volume is required to calculate the rate of infiltration. However, if the water level does not fall at a steady rate, then the test is deemed to have failed and the area is unsuitable for storm water drainage.

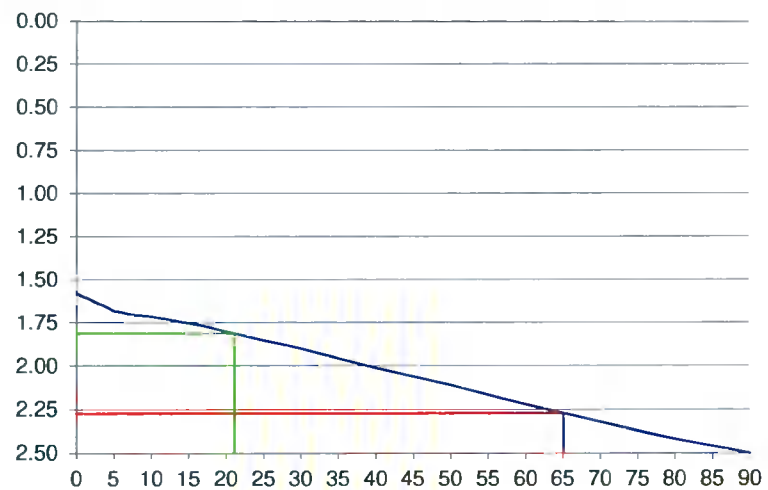
Elapsed Time (mins)	Fall of Water (m)
0	1.58
0.5	1.59
1	1.60
1.5	1.61
2	1.62
2.5	1.63
3	1.64
3.5	1.65
4	1.66
4.5	1.67
5	1.68
6	1.69
7	1.70
8	1.71
9	1.71
10	1.72
12	1.73
14	1.75
16	1.76
18	1.78
20	1.80
25	1.85
30	1.90
40	2.01
50	2.11
60	2.22
75	2.37
90	2.50

Pit Dimensions (m)	
Length (m)	2.60 m
Width (m)	0.60 m
Depth	2.50 m
Water	
Start Depth of Water	1.58 m
Depth of Water	0.92 m
75% Full	1.81 m
25% Full	2.27 m
75%-25%	0.46 m
Volume of water (75%-25%)	<b>0.72</b> m <sup>3</sup>
Area of Drainage	<b>16.00</b> m <sup>2</sup>
Area of Drainage (75%-25%)	<b>4.50</b> m <sup>2</sup>
Time	
75% Full	21 min
25% Full	65 min
Time 75% to 25%	<b>44</b> min
Time 75% to 25% (sec)	<b>2640</b> sec

$f = \frac{0.00362}{\text{m/min}}$  or

$\frac{6.04E-05}{\text{m/s}}$

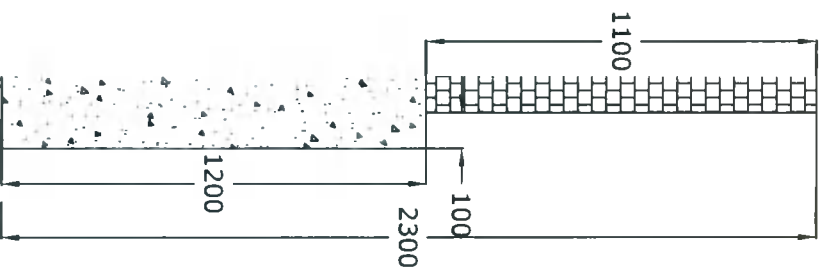
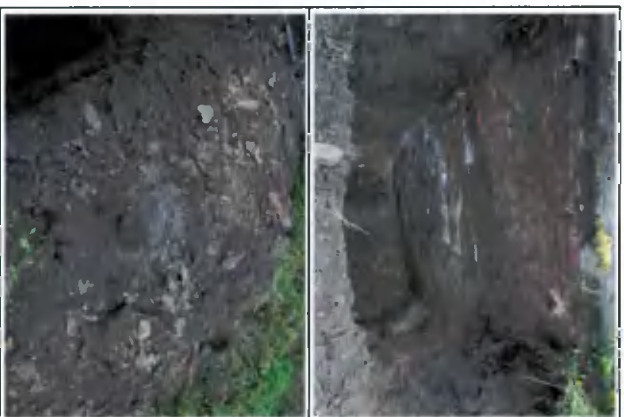
FP101 (TP104)

**Foundation Details:**  
Concrete extends 0.25m at ground level and then 0.15m at 0.90mbgl with base of concrete at 1.90mbgl. No underlying foundation.

**Ground Conditions:**  
**0.00m:** MADE GROUND: brown grey slightly sandy slightly gravelly silty clay with some red brick fragments.  
**0.90m:** Firm brown slightly sandy slightly gravelly silty CLAY with low cobble content.  
**1.10m:** Stiff grey slightly sandy gravelly silty CLAY with medium cobble content.  
**2.30m:** Pit terminated.  
 Samples: ES: 0.50m, 1.00m and 1.50m, B: 1.00m and 1.50m

At two locations and TP104, 3 No. foundation pits were excavated to investigate the depths of wall foundations on the site. This included hand excavating around the foundation to measure the depth to the top, extension out from the wall and the thickness of the foundation. The pits were then photographed, backfilled with arisings and reinstated.

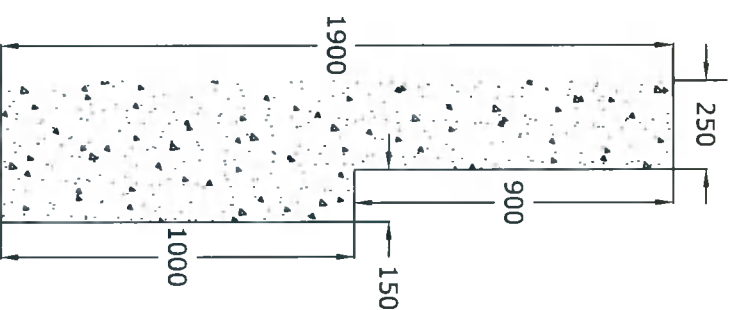
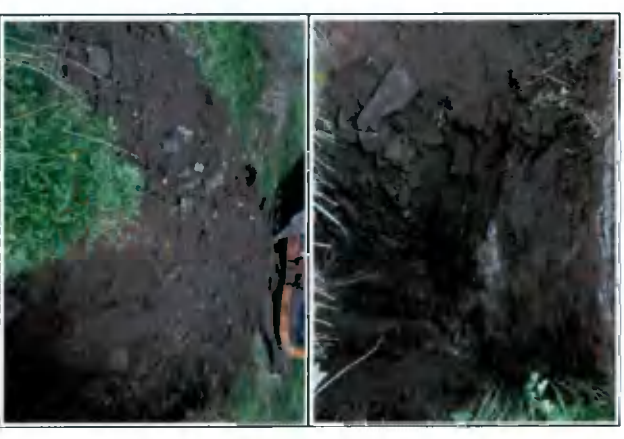
FP102

**Foundation Details:**  
Red brick wall extends to 1.10mbgl and foundation extends 0.10m and 1.20m thick.

**Ground Conditions:**  
**0.00m:** MADE GROUND: brown grey slightly sandy slightly gravelly silty clay with some red brick fragments.  
**1.40m:** Firm grey slightly sandy slightly gravelly silty CLAY with low cobble content.  
**1.80m:** Stiff dark grey slightly sandy slightly gravelly silty CLAY with medium cobble and low boulder content.  
**2.60m:** Pit terminated.

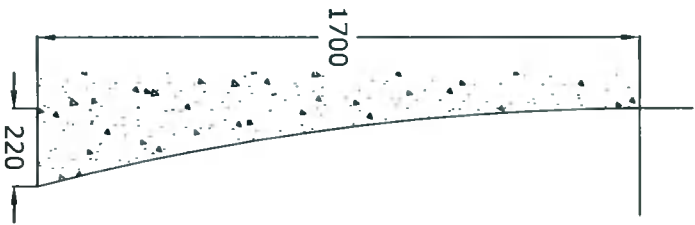
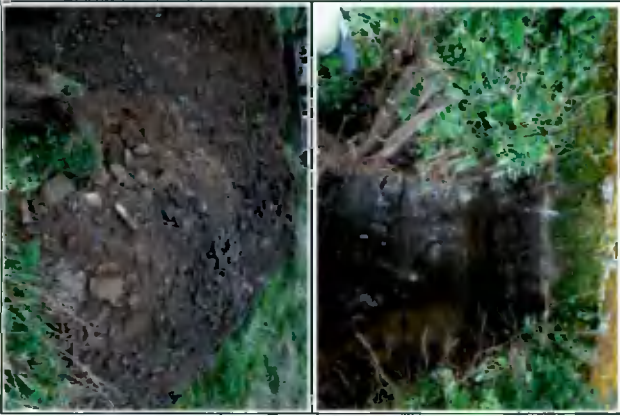
FP103

**Foundation Details:**

Wall extends to 1.70mbgl and tapers out 0.22m. No underlying foundation.

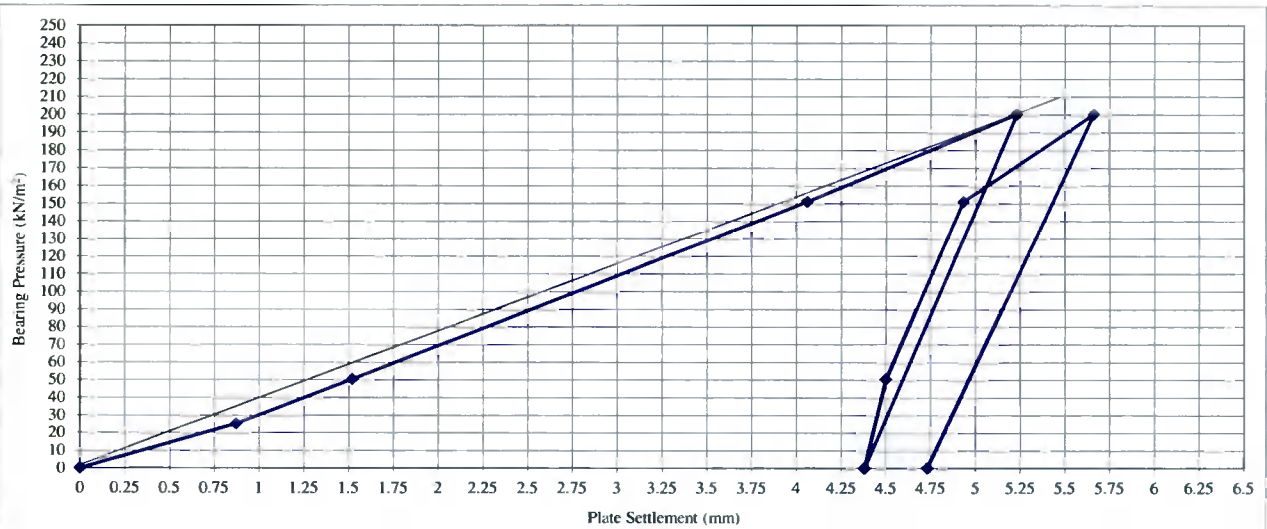
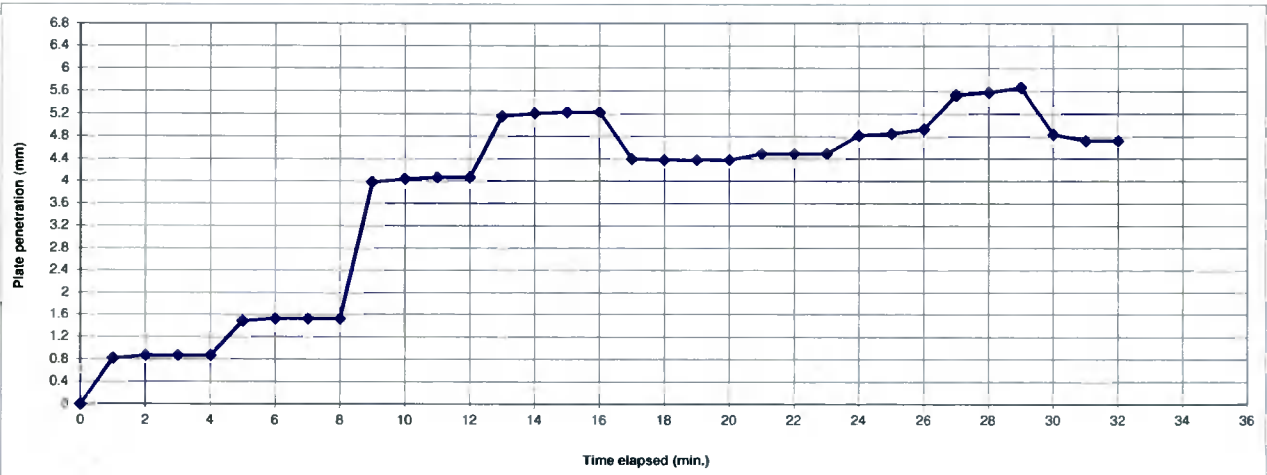
Pressure Stages	Bearing Pressure (kN/m <sup>2</sup> )	Plate Settlement (mm)
Initial	0.0	0.00
	25	0.87
	50	1.52
	151	4.06
	200	5.23
	0.0	4.38
Reload	50	4.50
	151	4.93
	200	5.66
Final Condition	0.0	4.73

1.25mm settlement (graph) for 762mm Plate (kPa)	49
Equivalent CBR Value-Initial loading (%)	6.2
Mod. of subgrade Reaction k for 600mm Plate(kPa)	42
Correction factor for 600mm Plate	0.85

At four trial pit locations, TP102, TP107, TP110 and TP117, plate tests were completed to provide a California Bearing Ratio value for pavement design. The tests were completed at 0.50mbgl and the 13T tracked excavator was used to provide kentledge. Pressure is then added to a 600mm diameter plate, via a hydraulic jack, with the settlement of the plate measured using gauges. The rate of settlement is used to calculate the CBR value.

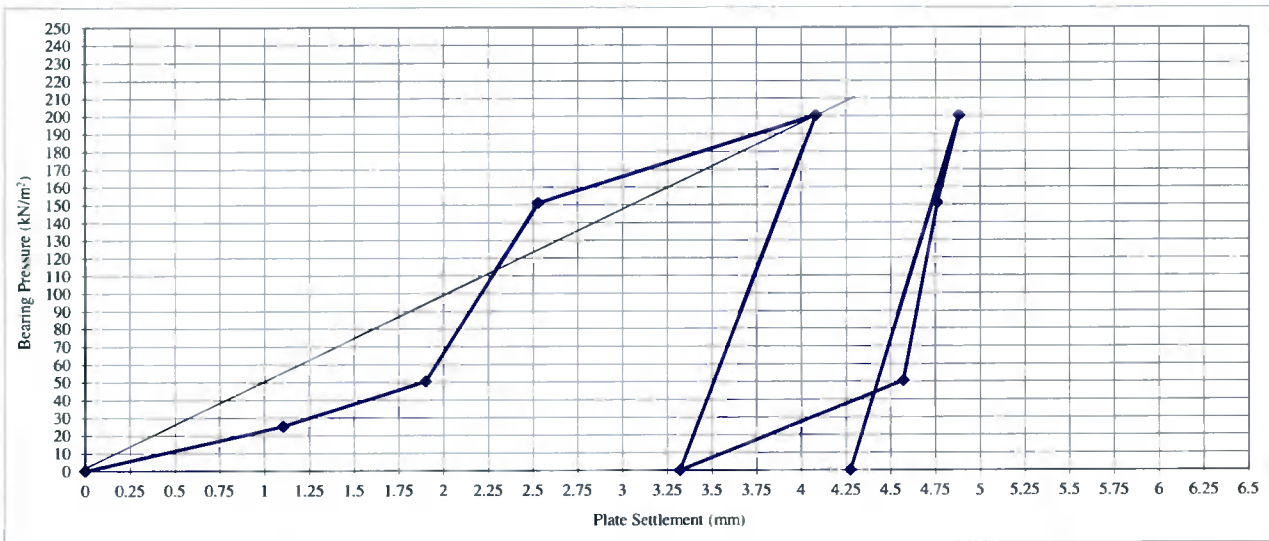
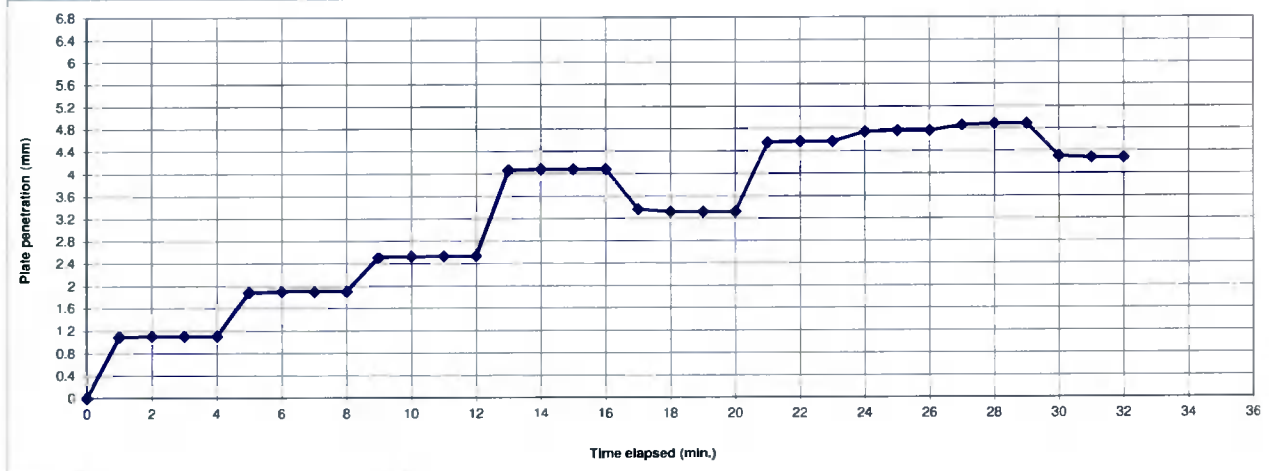
Pressure Stages	Bearing Pressure (kN/m <sup>2</sup> )	Plate Settlement (mm)
Initial	0.0	0.00
	25	1.10
	50	1.90
	151	2.53
	200	4.08
	0.0	3.32
Reload	50	4.57
	151	4.76
	200	4.88
Final Condition	0.0	4.27

1.25mm settlement (graph) for 762mm Plate (kPa)	<b>62</b>
Equivalent CBR Value-Initial loading (%)	<b>9.3</b>
Mod. of subgrade Reaction k for 600mm Plate(kPa)	<b>53</b>
Correction factor for 600mm Plate	<b>0.85</b>

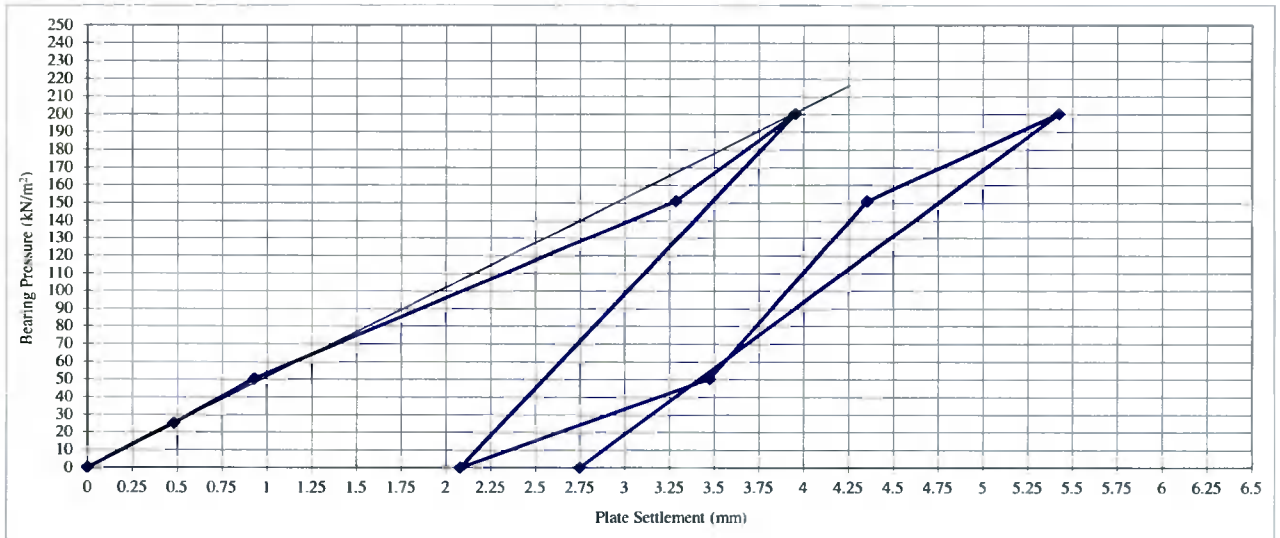
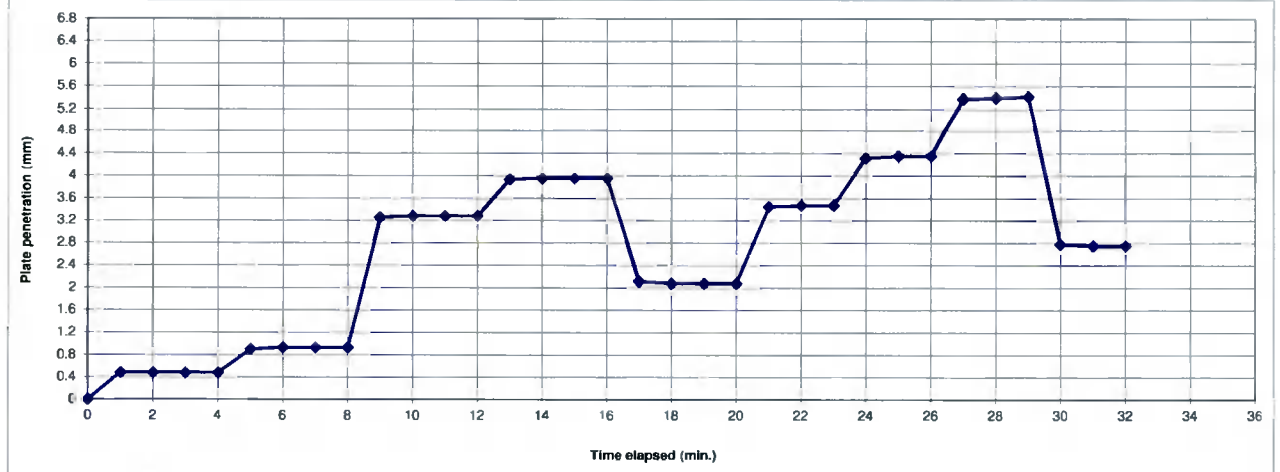
Pressure Stages	Bearing Pressure (kN/m <sup>2</sup> )	Plate Settlement (mm)
Initial	0.0	0.00
	25	0.48
	50	0.93
	151	3.28
	200	3.95
	0.0	2.08
Reload	50	3.47
	151	4.35
	200	5.42
Final Condition	0.0	2.75

1.25mm settlement (graph) for 762mm Plate (kPa)	<b>64</b>
Equivalent CBR Value- Initial loading (%)	<b>9.8</b>
Mod. of subgrade Reaction k for 600mm Plate(kPa)	<b>54</b>
Correction factor for 600mm Plate	<b>0.85</b>

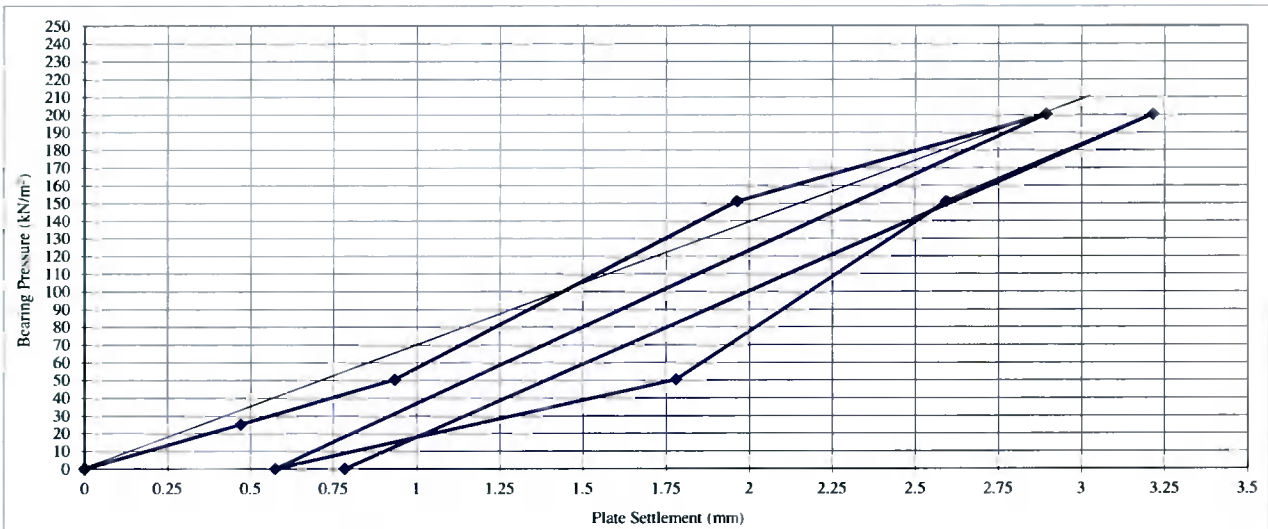
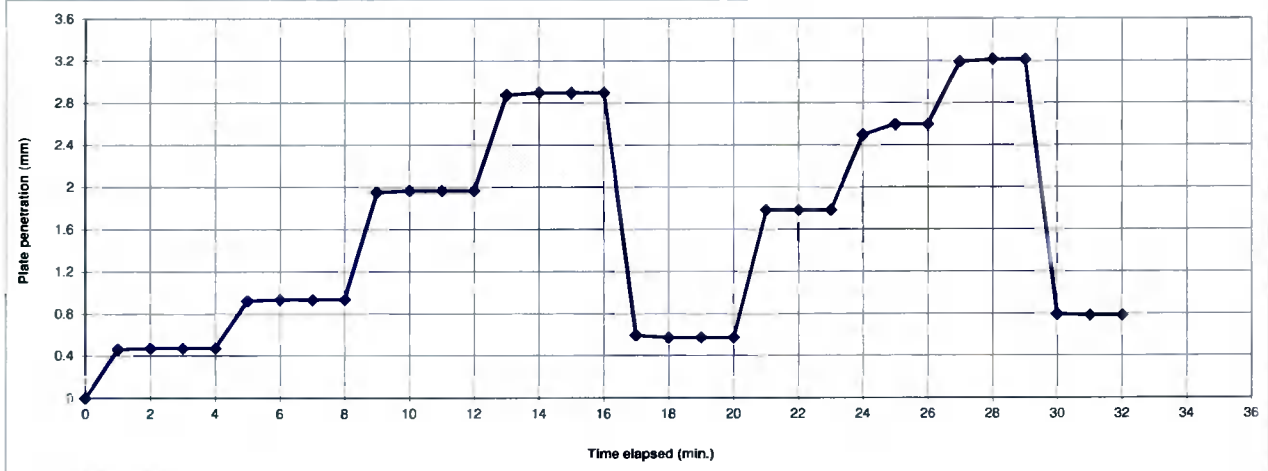
Pressure Stages	Bearing Pressure (kN/m <sup>2</sup> )	Plate Settlement (mm)
Initial	0.0	0.00
	25	0.47
	50	0.93
	151	1.96
	200	2.89
	0.0	0.57
Reload	50	1.78
	151	2.59
	200	3.21
Final Condition	0.0	0.78

1.25mm settlement (graph) for 762mm Plate (kPa)	87
Equivalent CBR Value-Initial loading (%)	16.7
Mod. of subgrade Reaction k for 600mm Plate(kPa)	74
Correction factor for 600mm Plate	0.85
