Project Name
Dublin data centre

Technical Appendix 2.2: Gazetteers of Archaeology and Architectural Heritage in the 1km study area

**Geophysical Survey of a Site at
Profile Park, Ballybane and Kilbride,
Co. Dublin**

Report on the Archaeological Assessment
(test trenching) at Profile Park,
Ballybane and Kilbride, Dublin,
Co. Dublin.

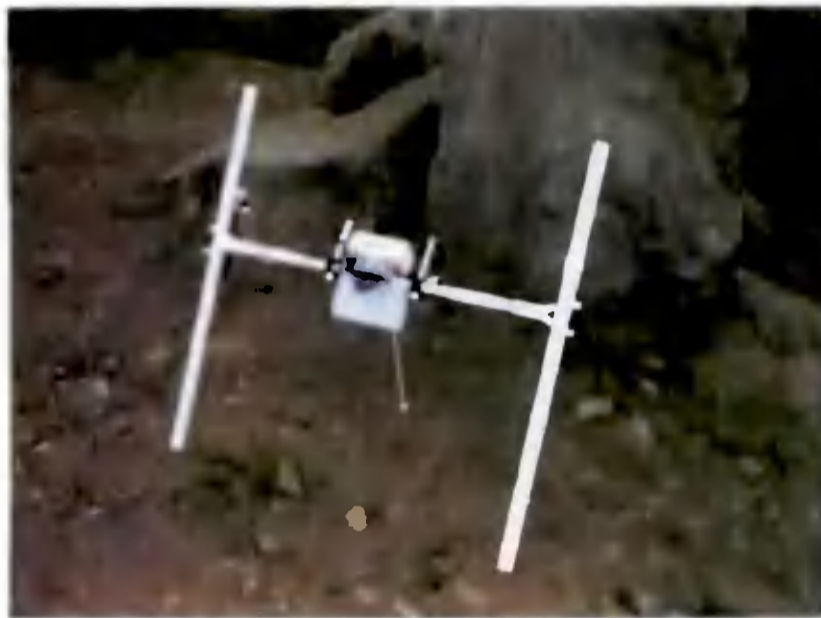
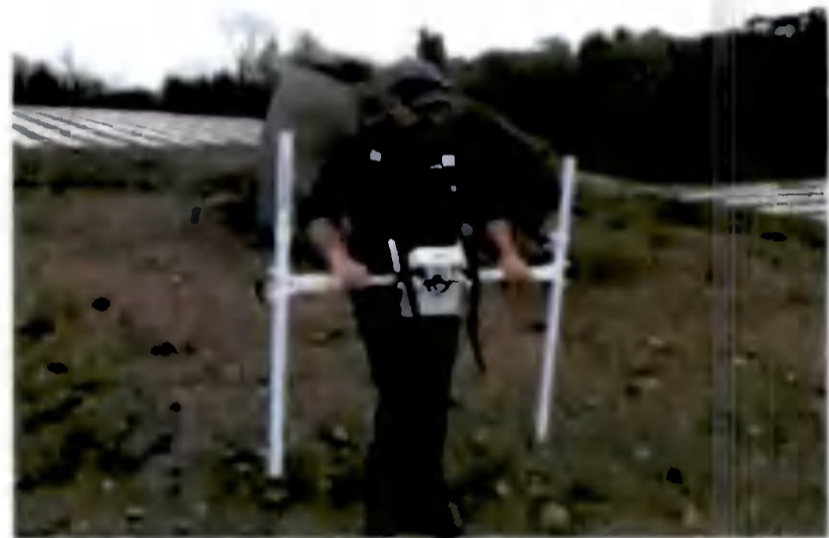
Bartington Grad 601-single axis dual sensor gradiometer.

Fluxgate Gradiometer Survey: Surveys are undertaken using the Bartington Grad 601-2 survey instrument which was specifically designed for archaeological prospection. It includes sensors that are highly stable, minimizing requirements for excess data processing. The instrument has a vertical 1 m sensor separation permitting finite resolution of buried archaeological features. Surveys can be undertaken in scan or detailed (zig-zag traverse) modes for reconnaissance or high-density mapping. The fluxgate enables reliable flexibility during fieldwork. Frequent realignment of the instruments and zero drift correction ensure a constant high quality of data. Extremely sensitive, these instruments can detect variations in soil magnetism to 0.1nT, affording diverse application throughout a variety of archaeological, soil morphological and geological conditions. The instrument can be employed in both commercial and research-based investigations allowing for completion of projects within short timescales. Regular grid sample densities from standard 1600 readings to 12800 readings per 20m by 20m grid are permitted. A constant high quality of data is assured by experienced field staff operating in accordance with English Heritage Research & Professional Guidelines No. 1, *Geophysical Survey In Archaeological Field Evaluation* (David 1995).

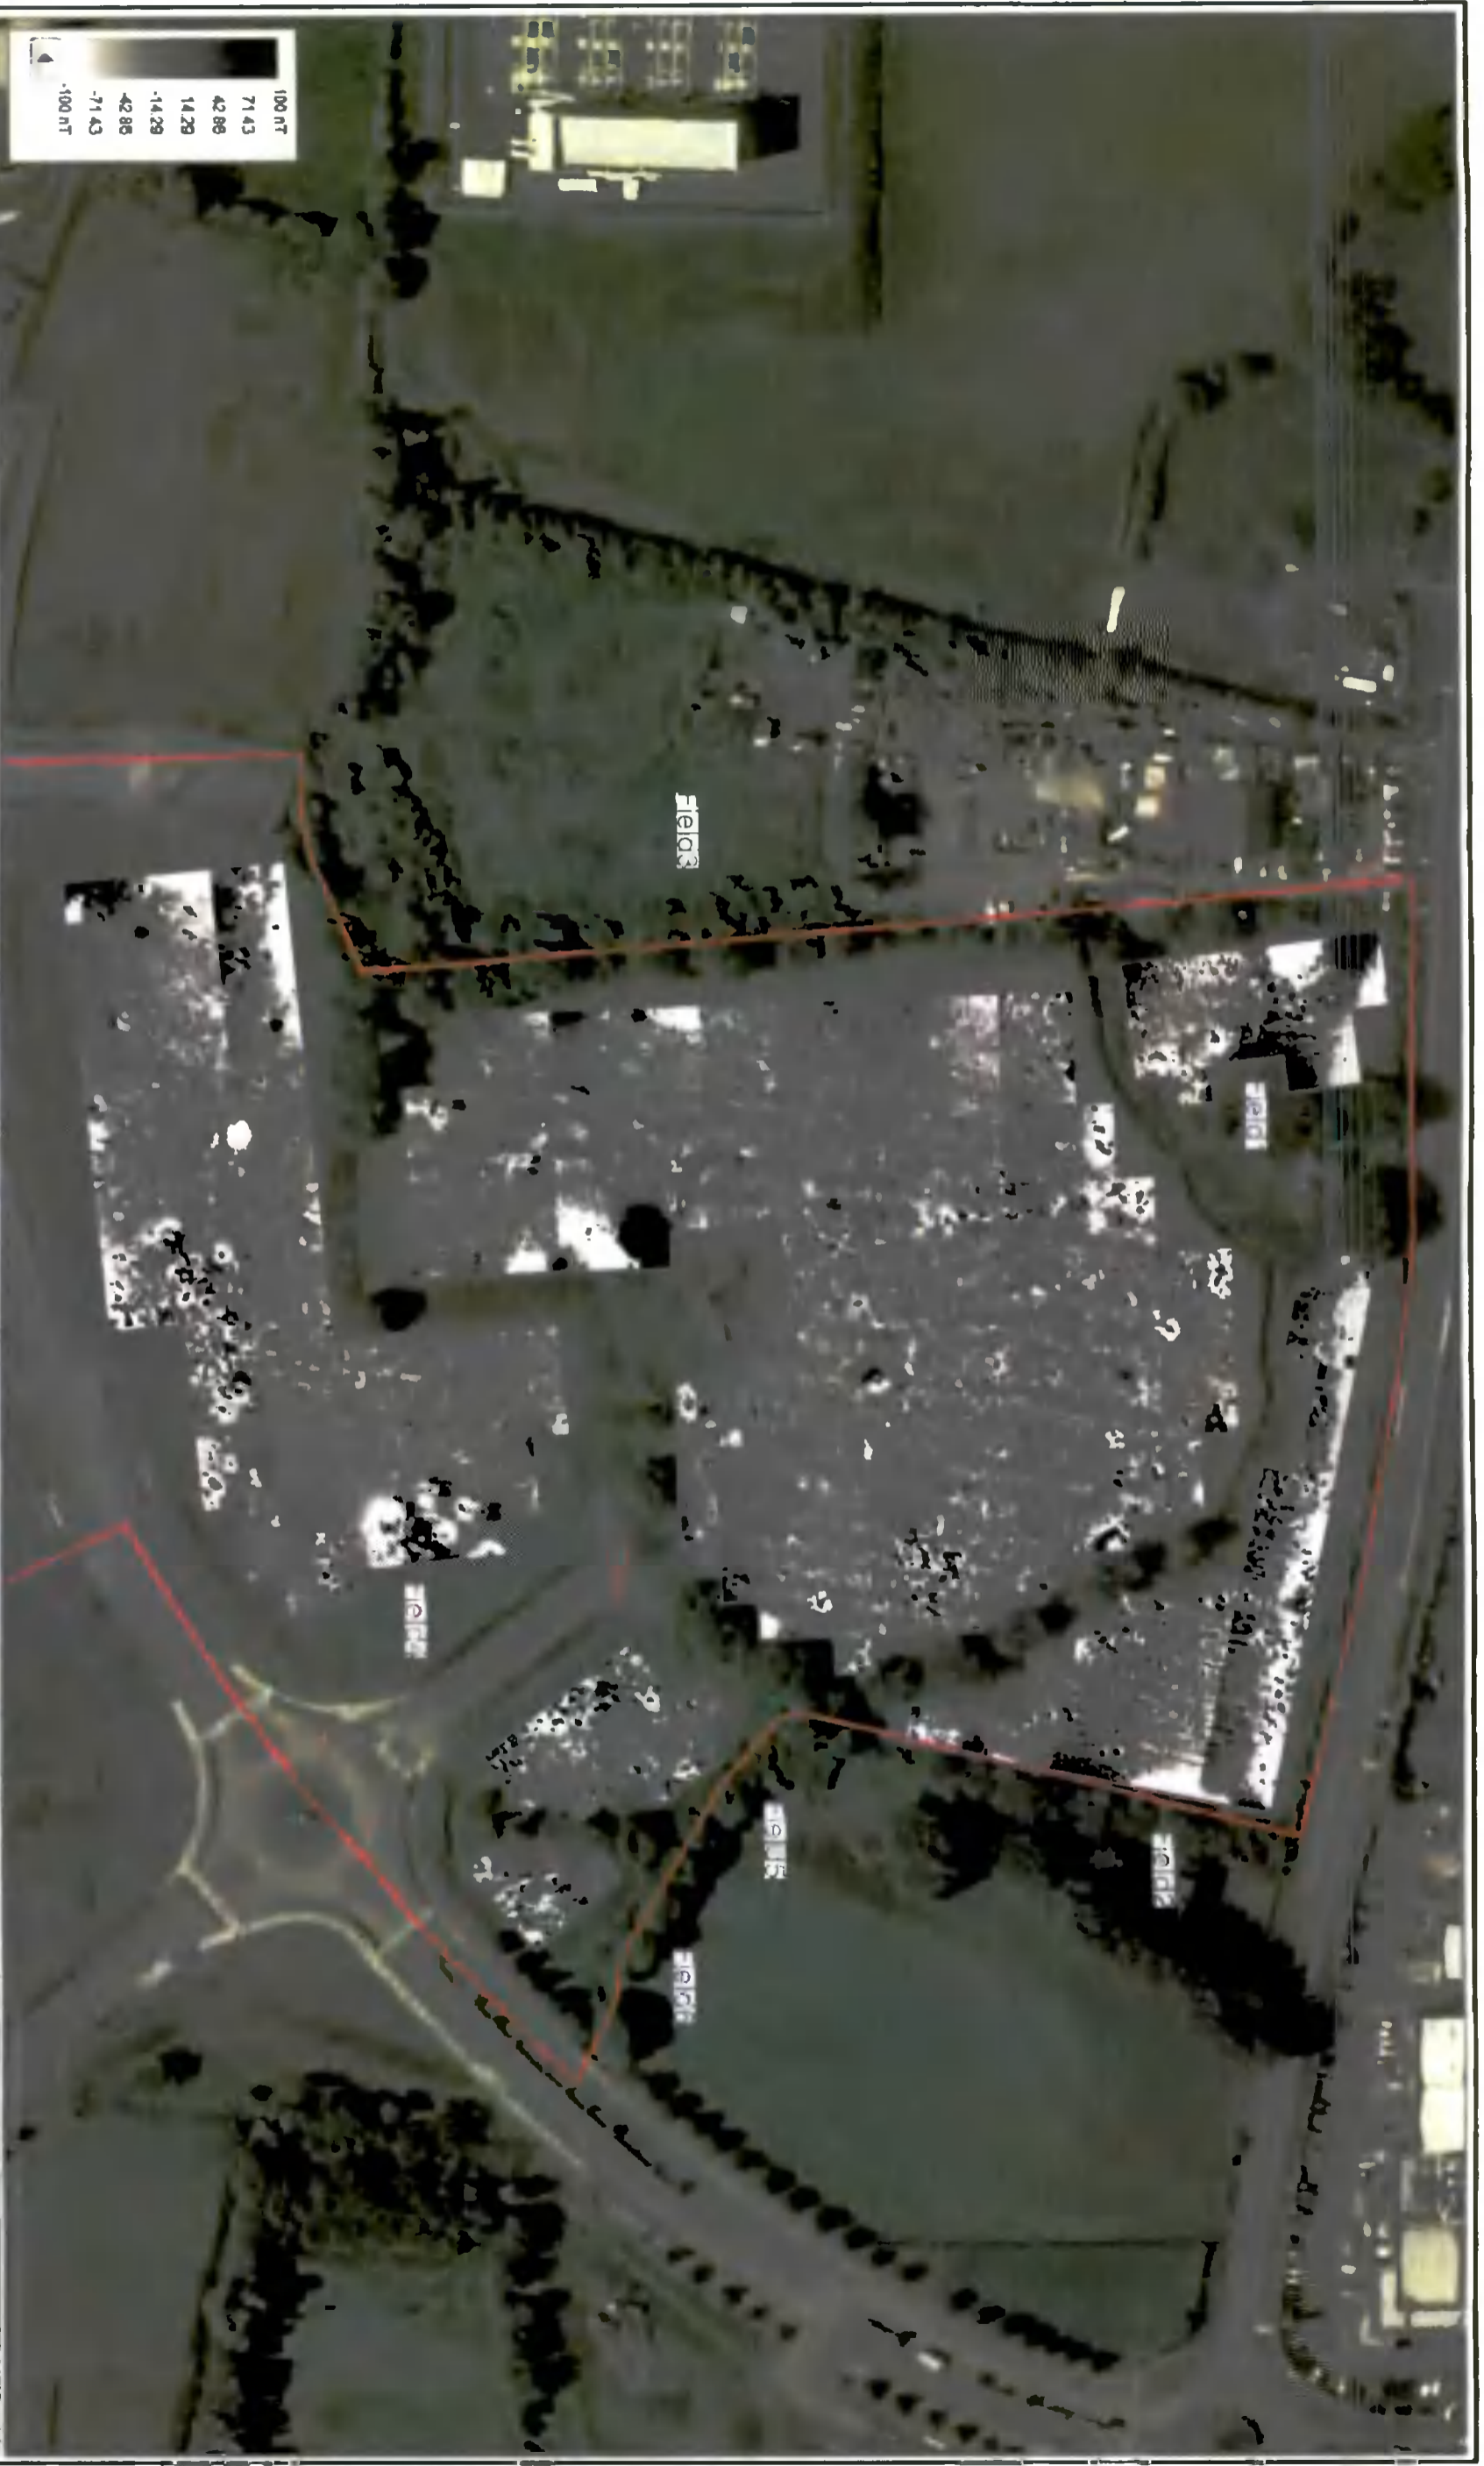
Figure 6: Aerial view of site, showing geophysical survey results (grayscale image) of fields 1 to 6

The Bartington GRAD 601-2 instrument is a specifically designed gradiometer for use in archaeological prospection. Extremely sensitive, these instruments can detect variations in soil magnetism to 0.01nT, affording diverse application throughout a variety of archaeological, soil morphological and geological conditions. The survey is geo-referenced with a Trimble Geo 7X unit accurate to within 1cm. Interpretation of the results was made by examination of the raw data as greyscale images, XY trace, relief and data plots. Archived raw data is presented in Figures 6 and 7 and an interpretation is presented in Figures 8 and 9.

The geophysical survey report recommended test trenching in order to determine the nature and significance of portion of the field, areas of magnetic disturbances are likely associated with recent groundworks (Figure 6, 7). series of faint parallel linears (A, C) likely representing the remains of agricultural plough marks in the eastern potential cut features were identified throughout the site that may be of archaeological significance as well as a historic field system. The current site consists of Fields 1-6, as described by Russell (2020). Here a number of field adjacent to and to the south of the current site, including a sub-circular enclosure and part of an early

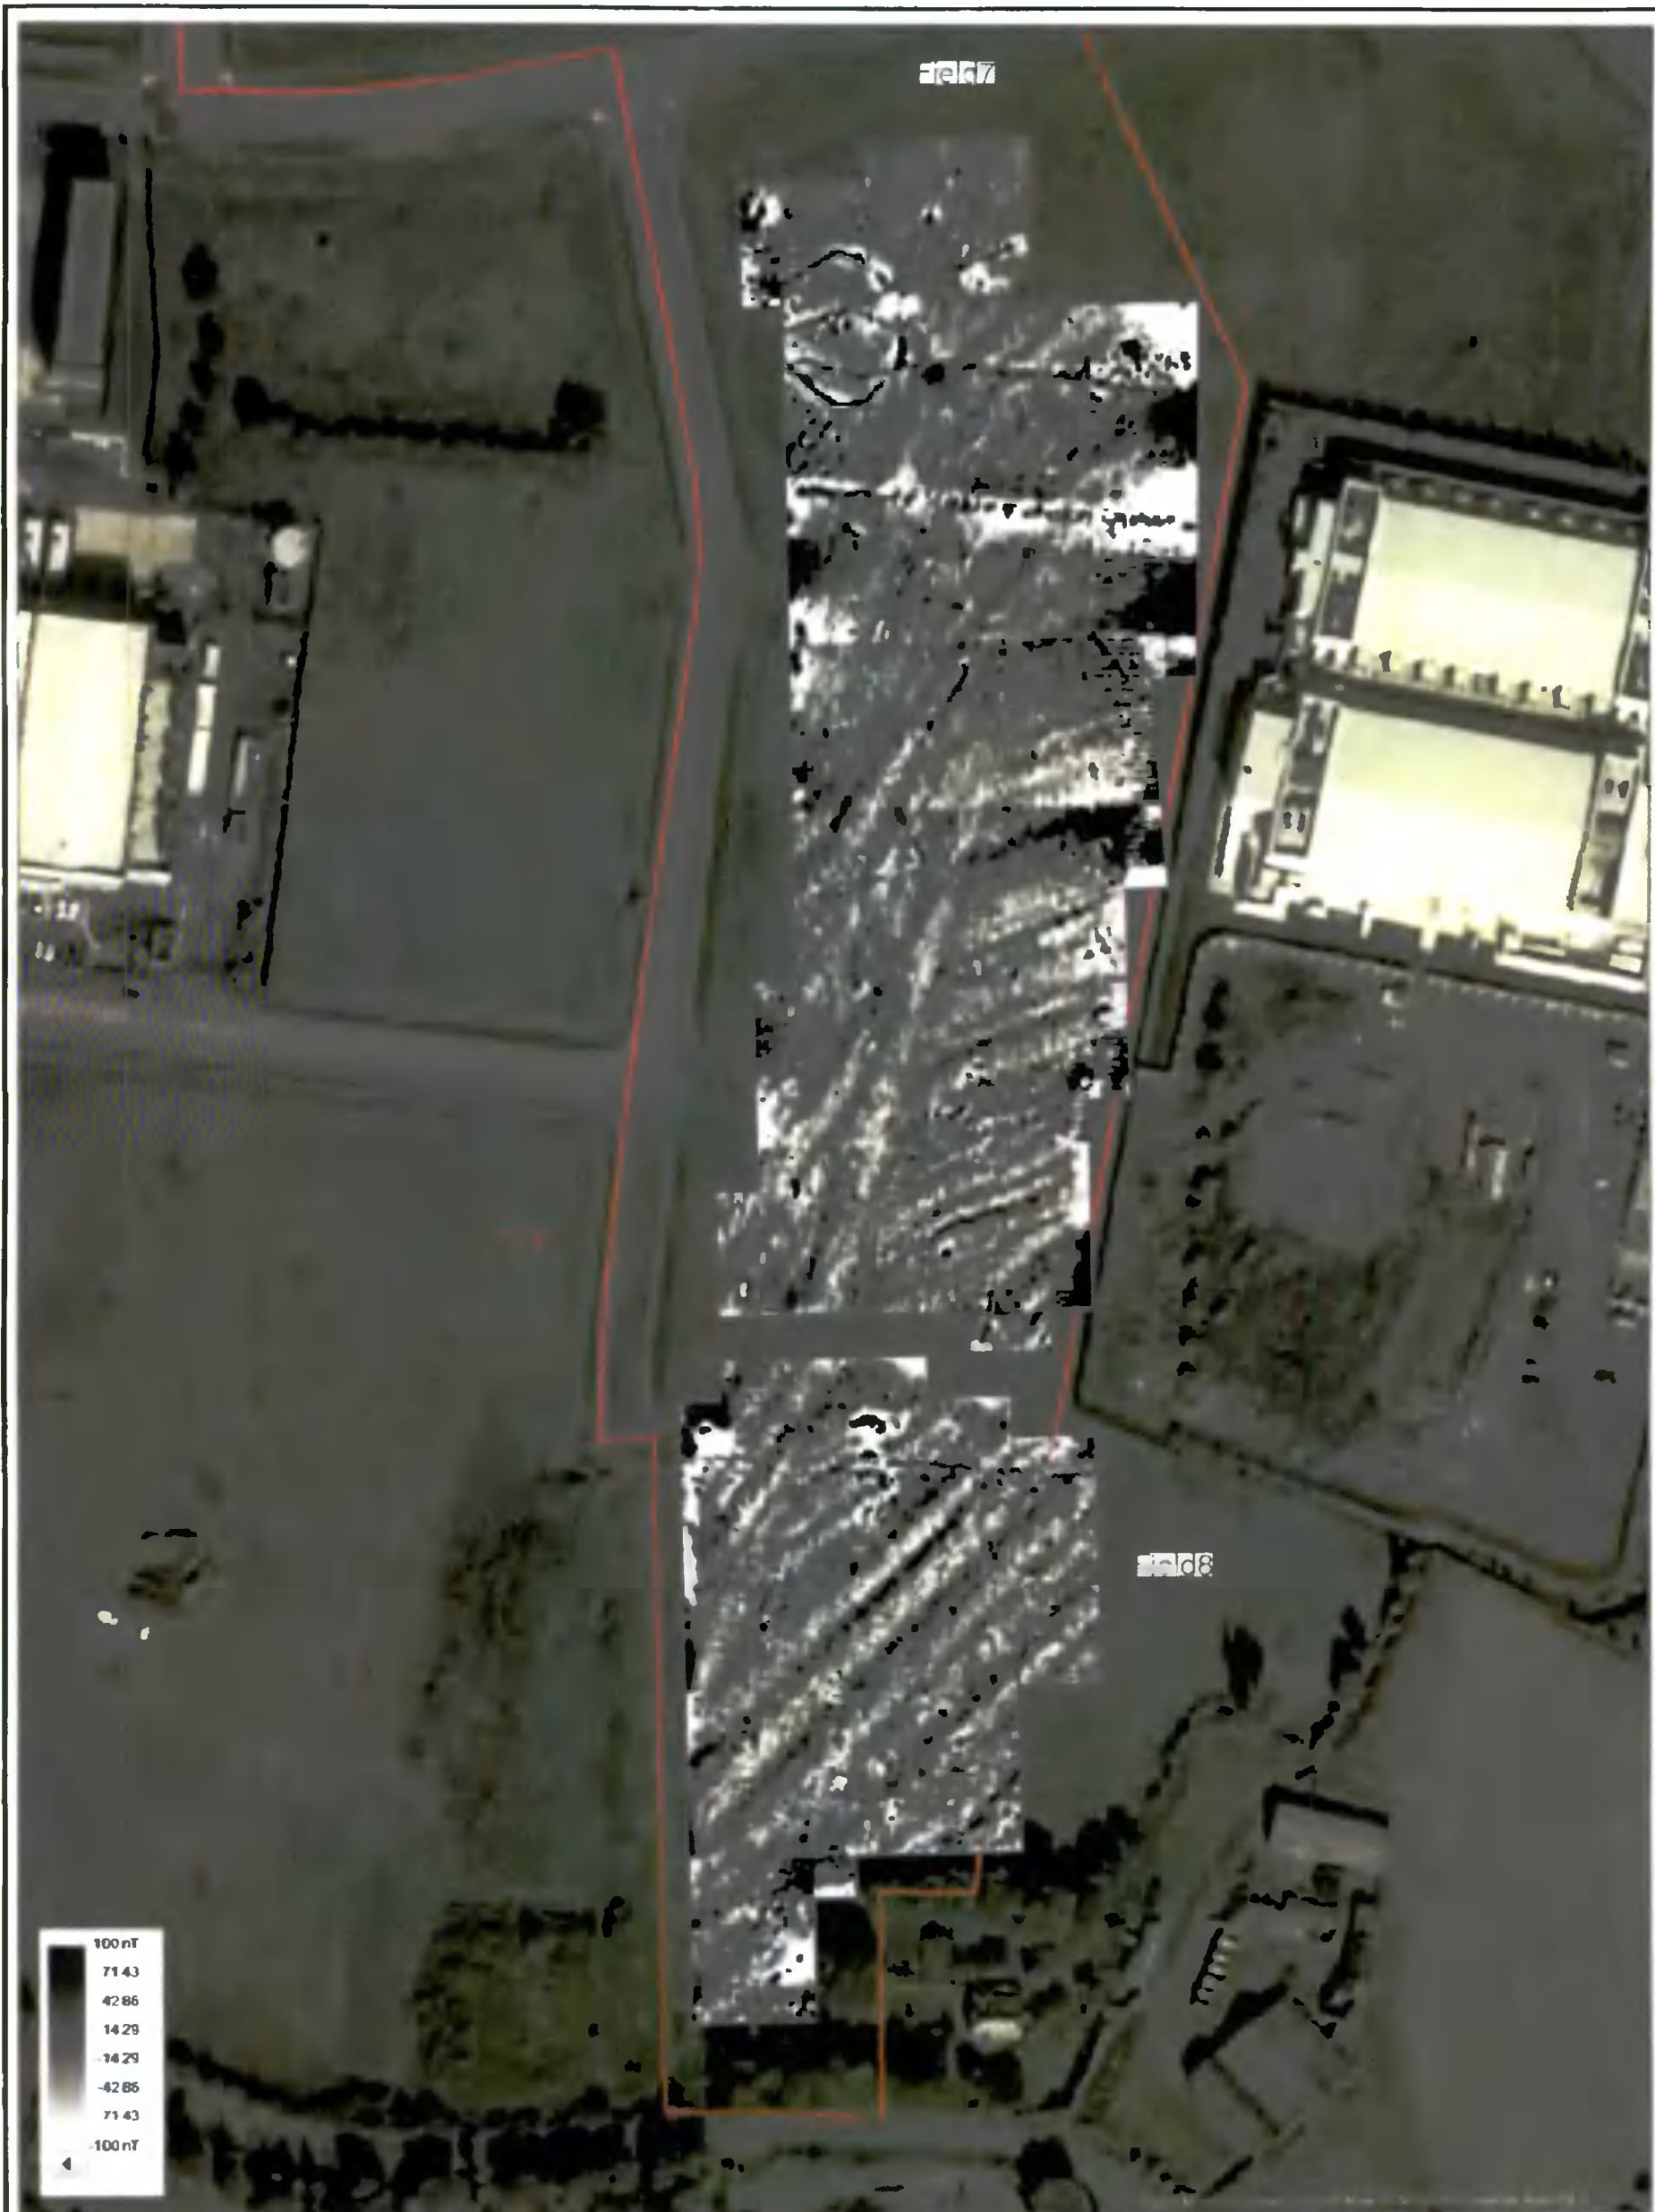
Figure 7: Aerial view of site, showing geophysical survey results (greyscale image) of fields 7 and 8

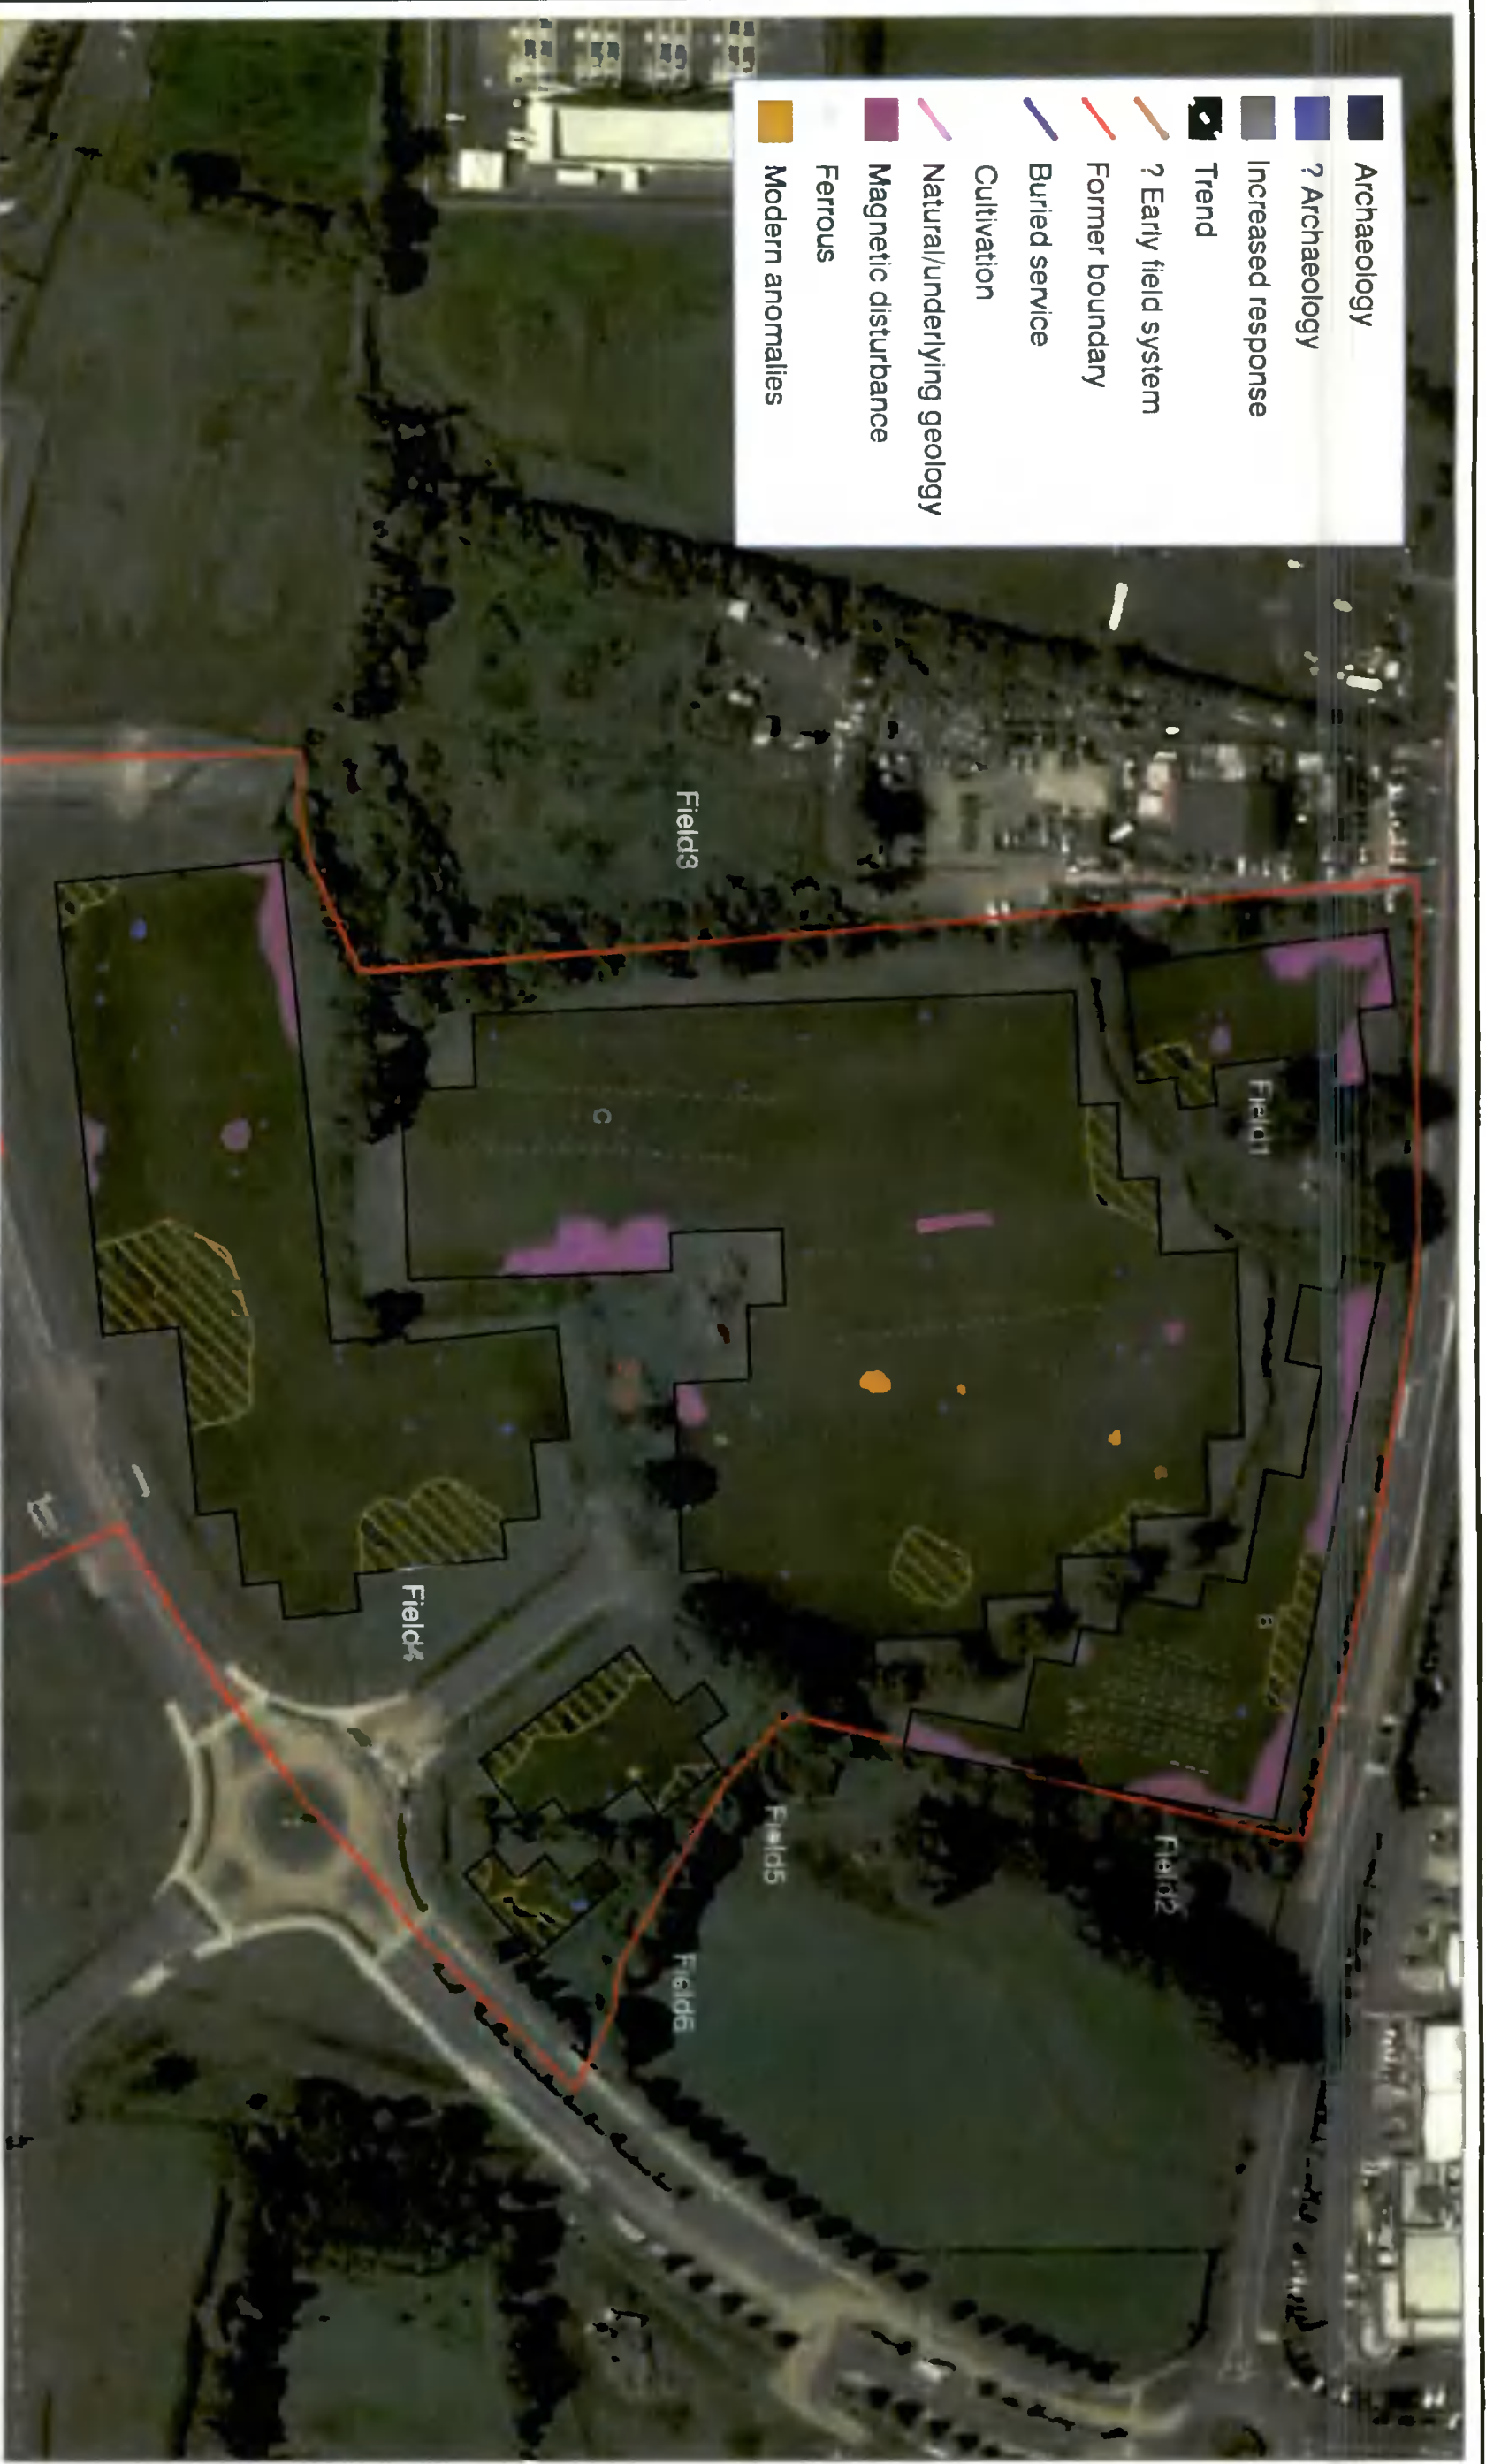
Figure 8: Aerial view of site, showing geophysical survey interpretation of fields 1 to 6

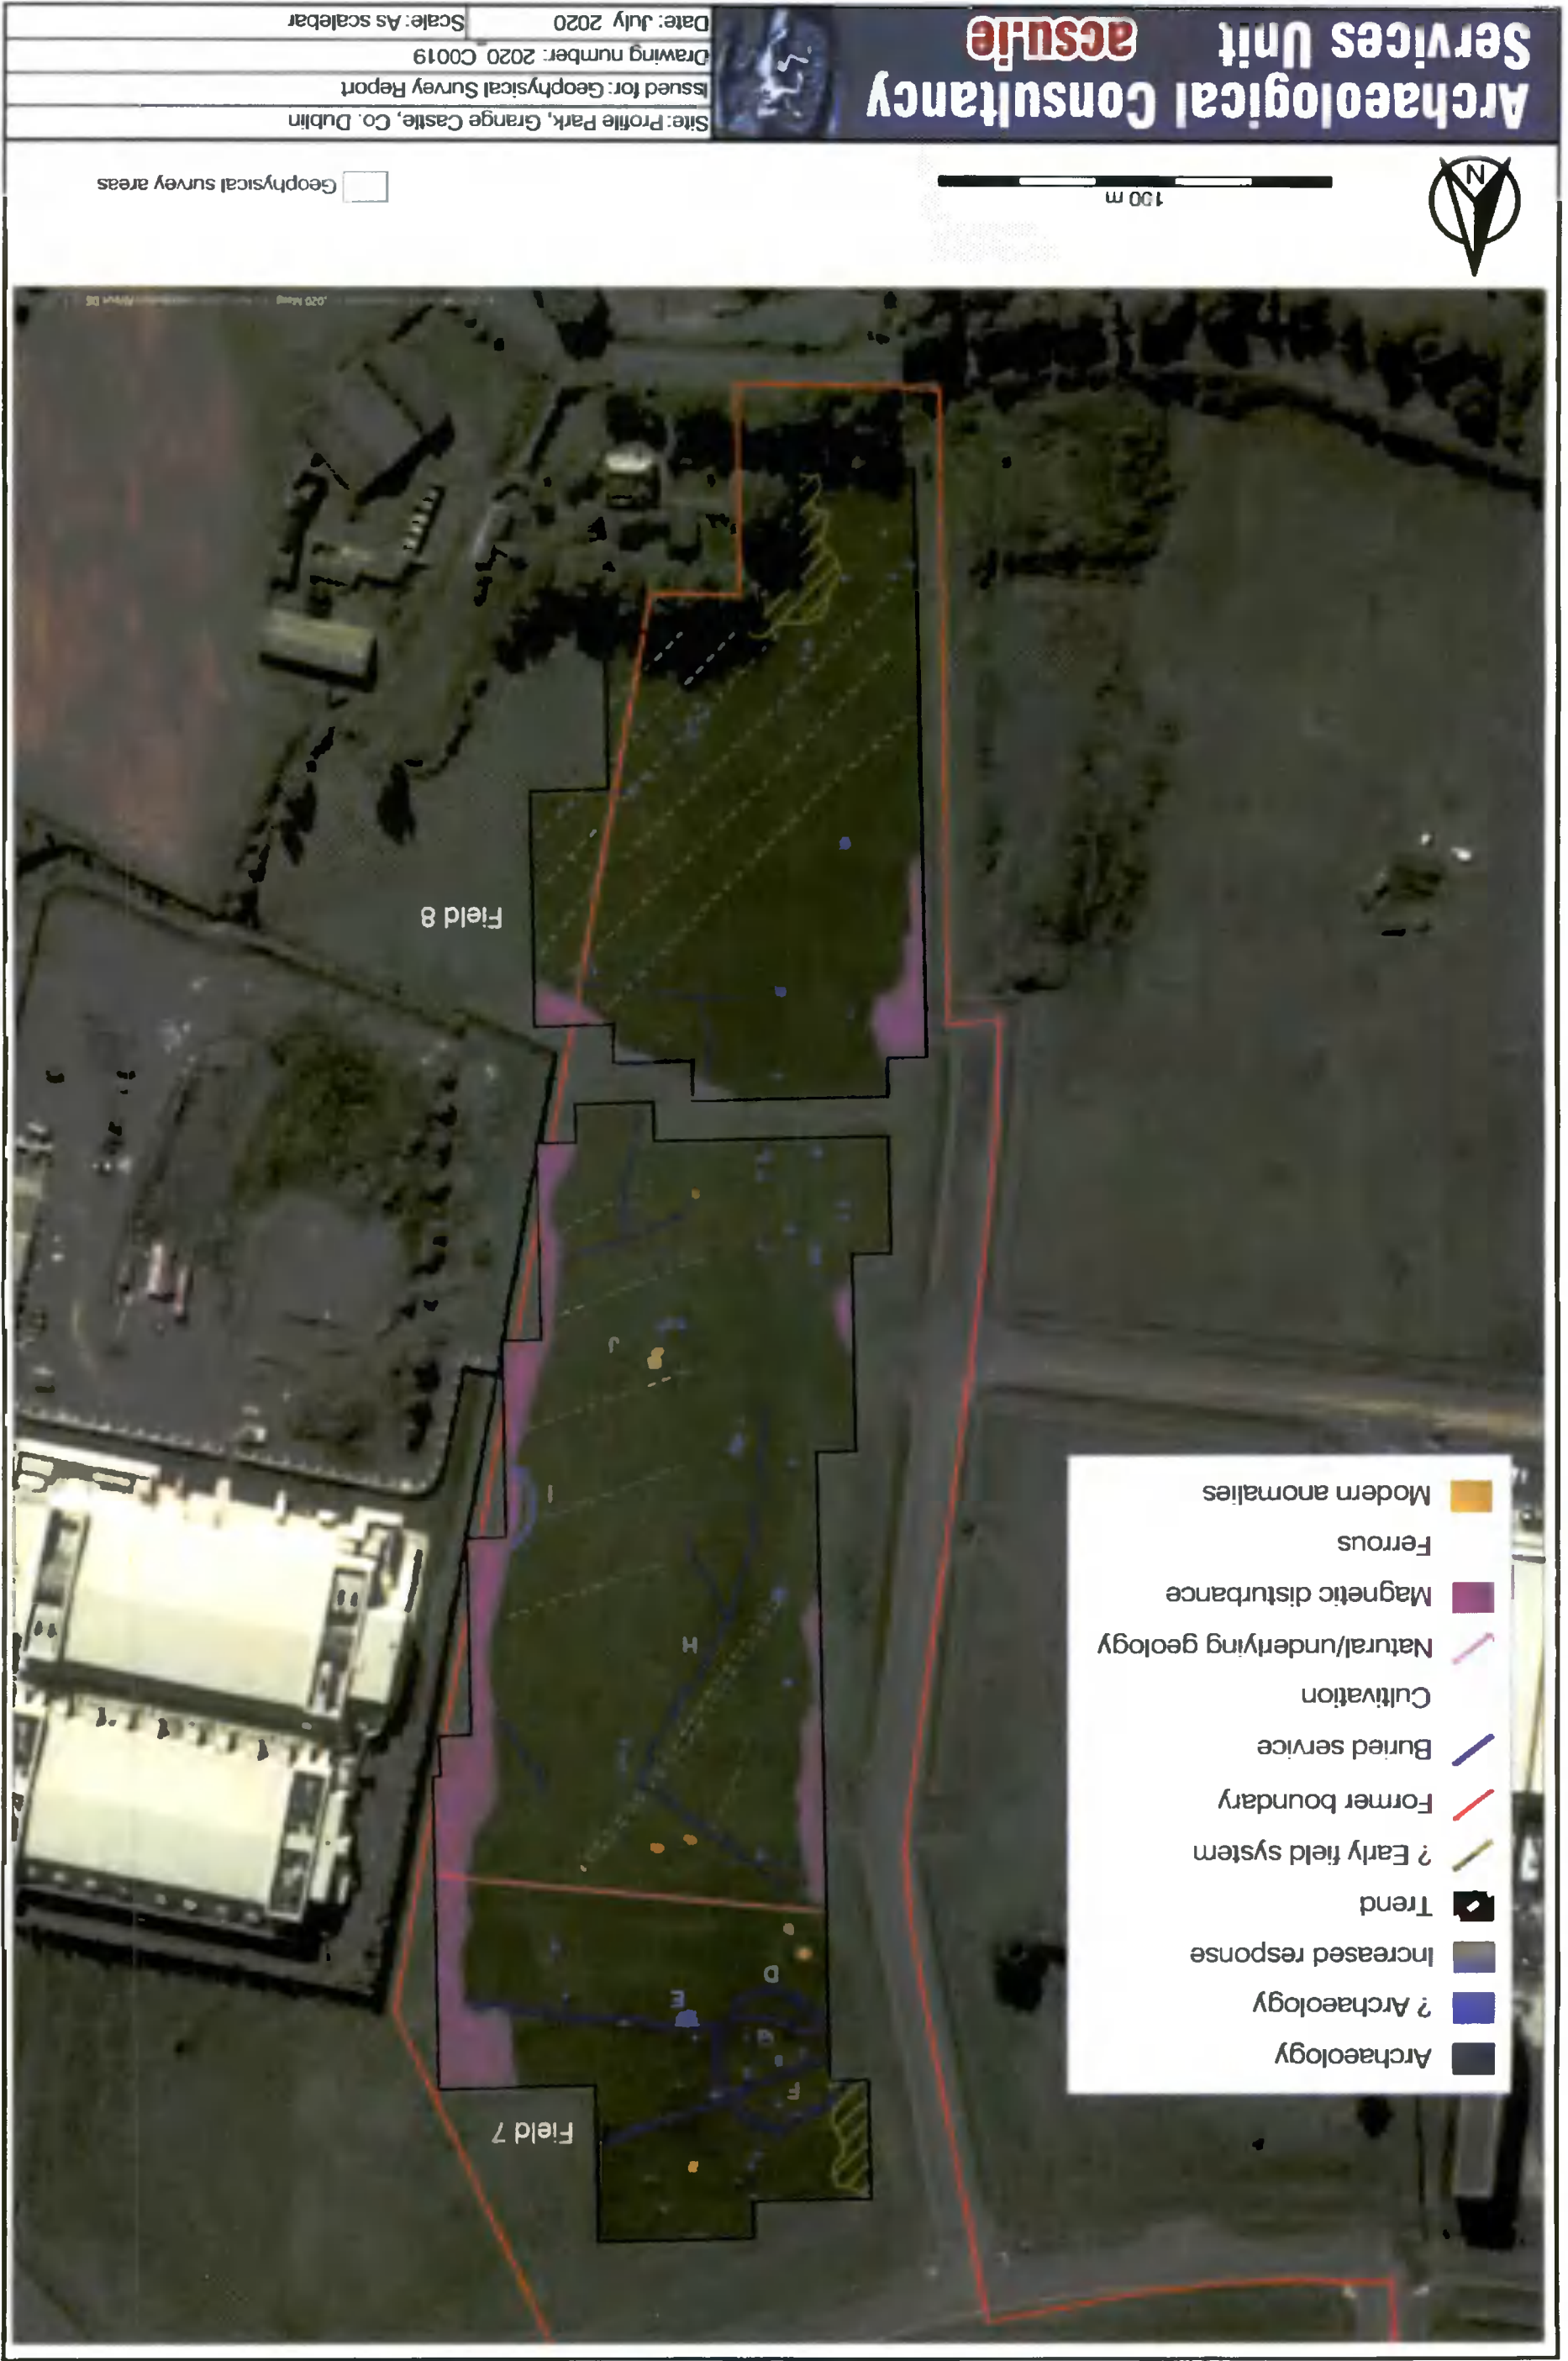
Figure 9: Aerial view of site, showing geophysical survey interpretation of fields 7 and 8

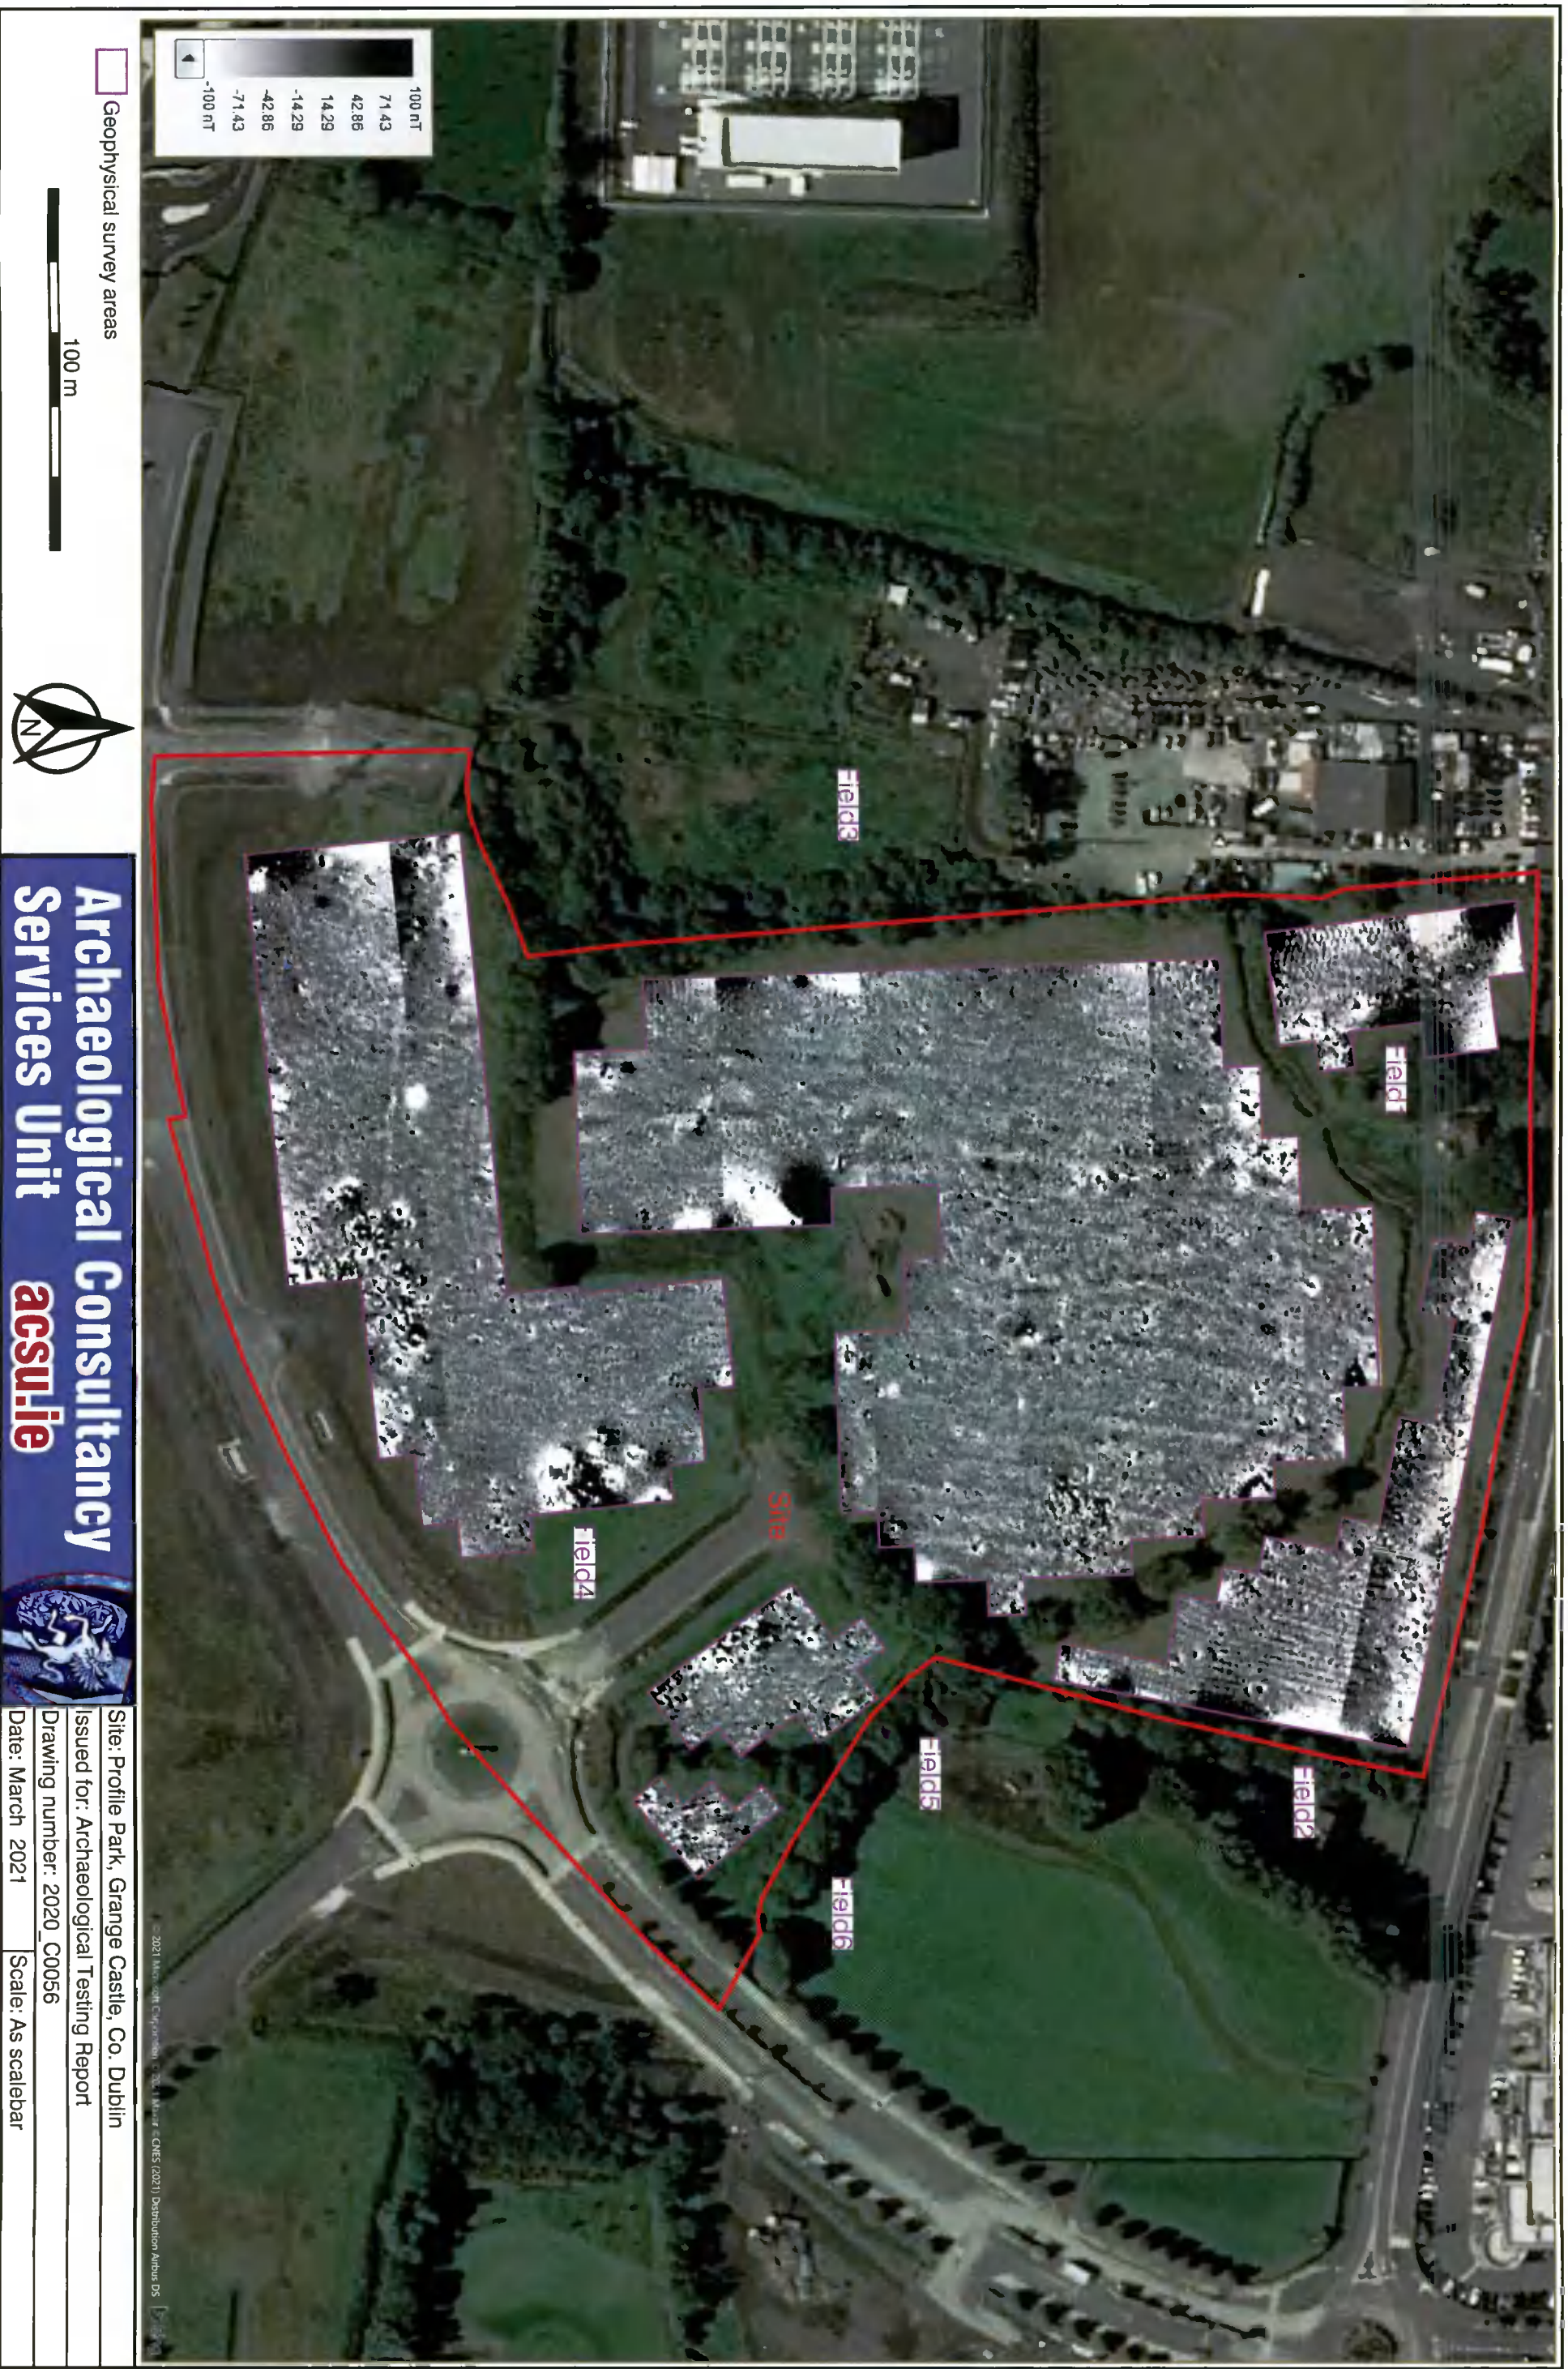
Figure 6: Aerial view of site, showing geophysical survey results (greyscale image)
