Project Name
Dublin data centre

Technical Appendix 2.2: Gazetteers of Archaeology and Architectural Heritage in the 1km study area

**Geophysical Survey of a Site at
Profile Park, Ballybane and Kilbride,
Co. Dublin**

Report on the Archaeological Assessment
(test trenching) at Profile Park,
Ballybane and Kilbride, Dublin,
Co. Dublin.

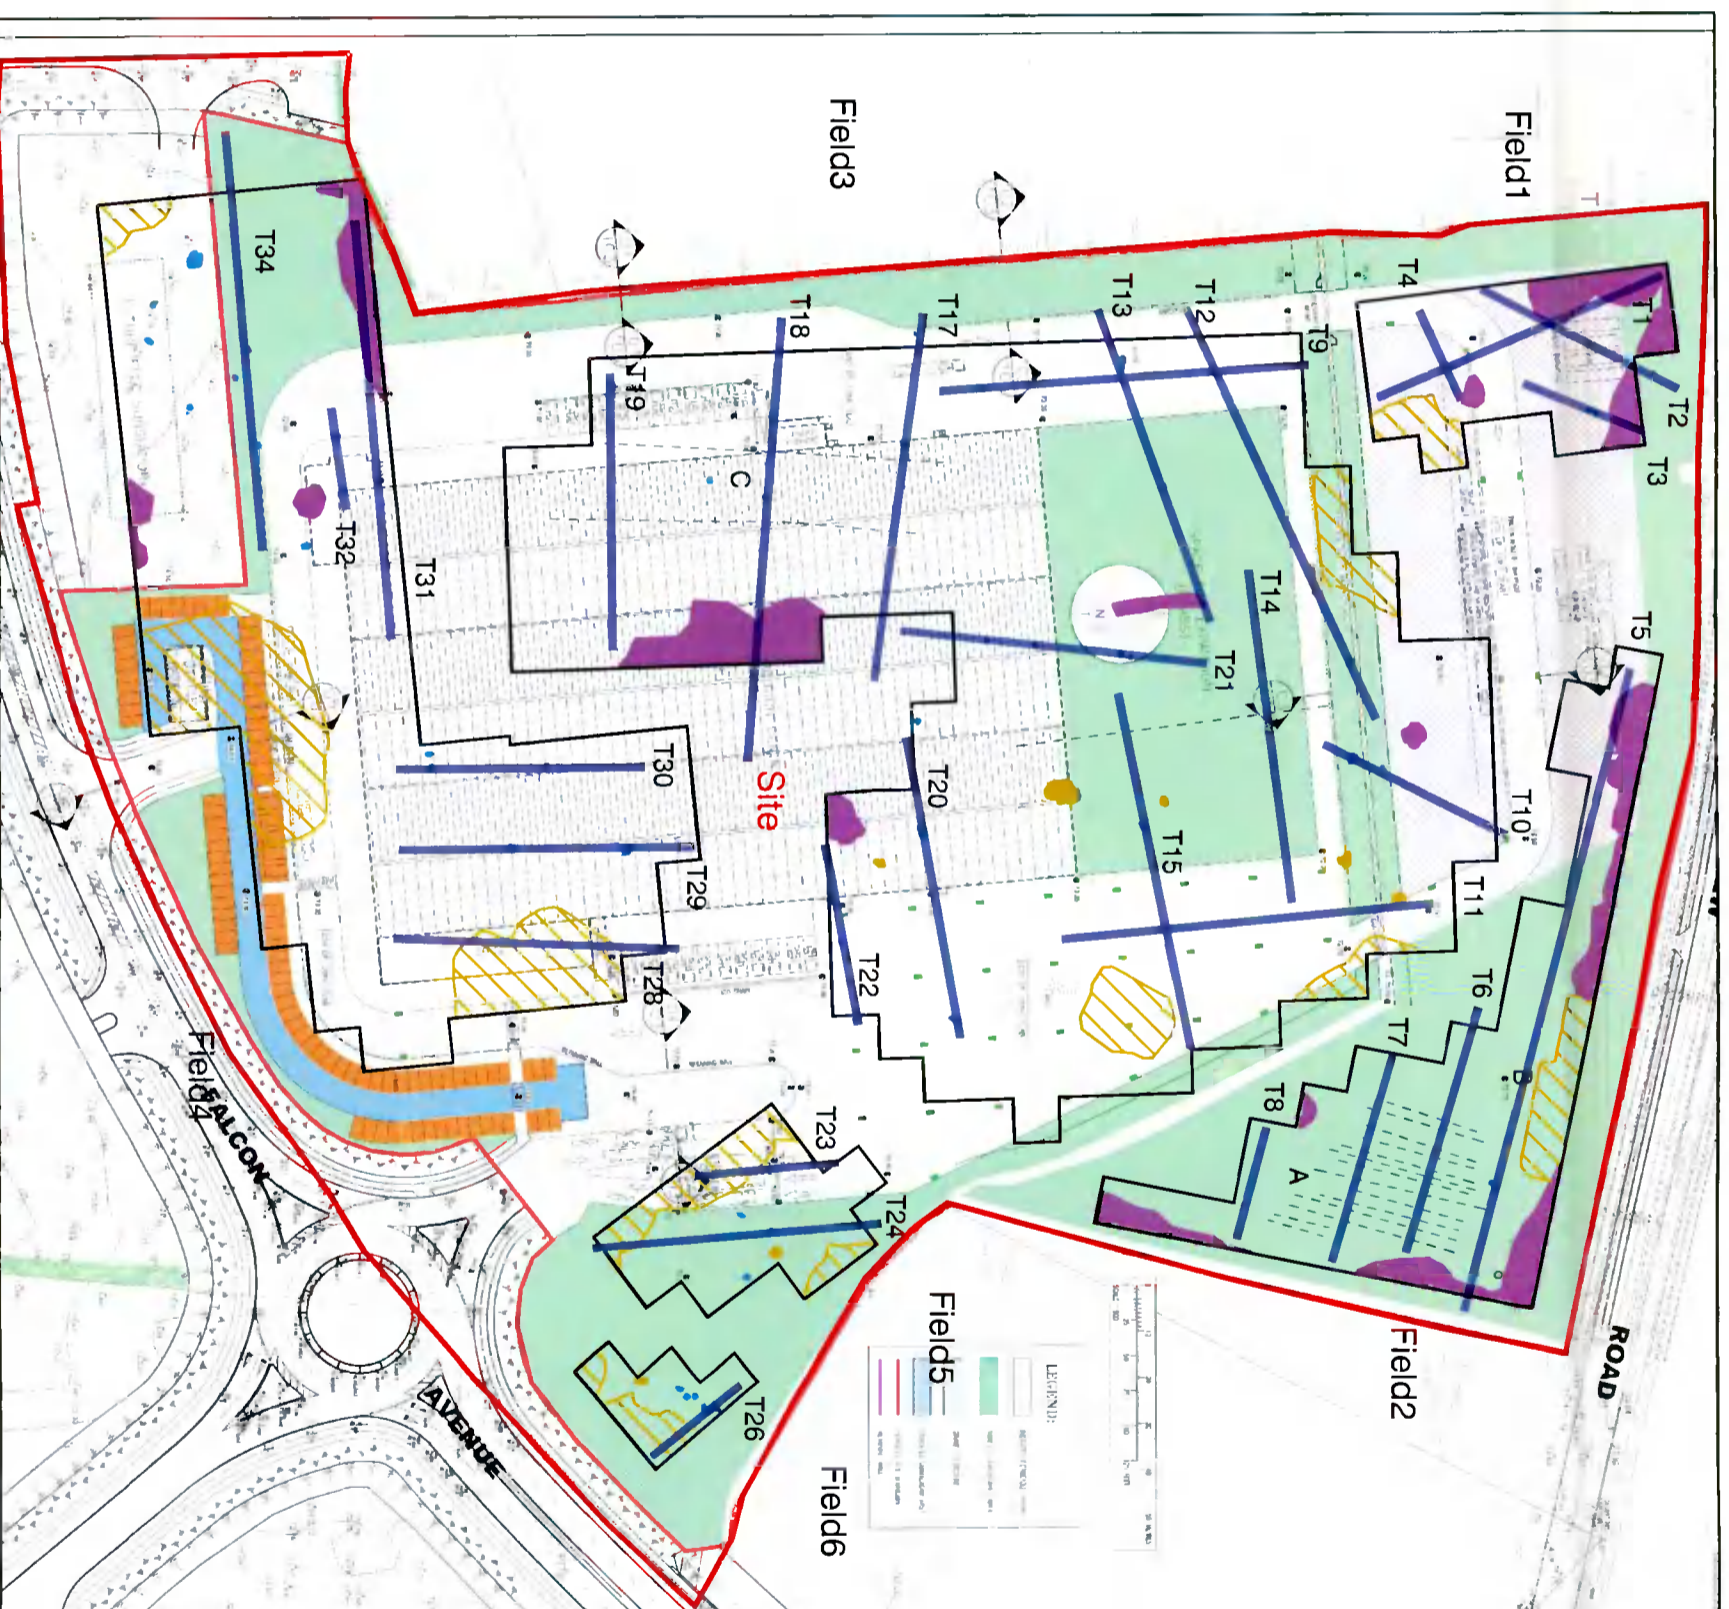
Trench details
(average width=1.9 m)

- T1 = 70 m
 - T2 = 49 m
 - T3 = 28 m
 - T4 = 22 m
 - T5 = 147m
 - T6 = 55 m
 - T7 = 48 m
 - T8 = 26 m
 - T9 = 83 m
 - T10 = 46 m
 - T11 = 83 m
 - T12 = 101 m
 - T13 = 73 m
 - T14 = 75 m
 - T15 = 81 m
 - T16 = null
 - T17 = 83 m
 - T18 = 100 m
 - T19 = 62 m
 - T20 = 68 m
 - T21 = 69 m
 - T22 = 41 m
 - T23 = 32 m
 - T24 = 65 m
 - T25 = null
 - T26 = 25 m
 - T27 = null
 - T28 = 64 m
 - T29 = 66 m
 - T30 = 55 m
 - T31 = 94 m
 - T32 = 23 m
 - T33 = null
 - T34 = 94 m
- Total length = 1,928 m

Figure 8: Detail of site development, showing geophysical survey interpretation and excavated test trenches

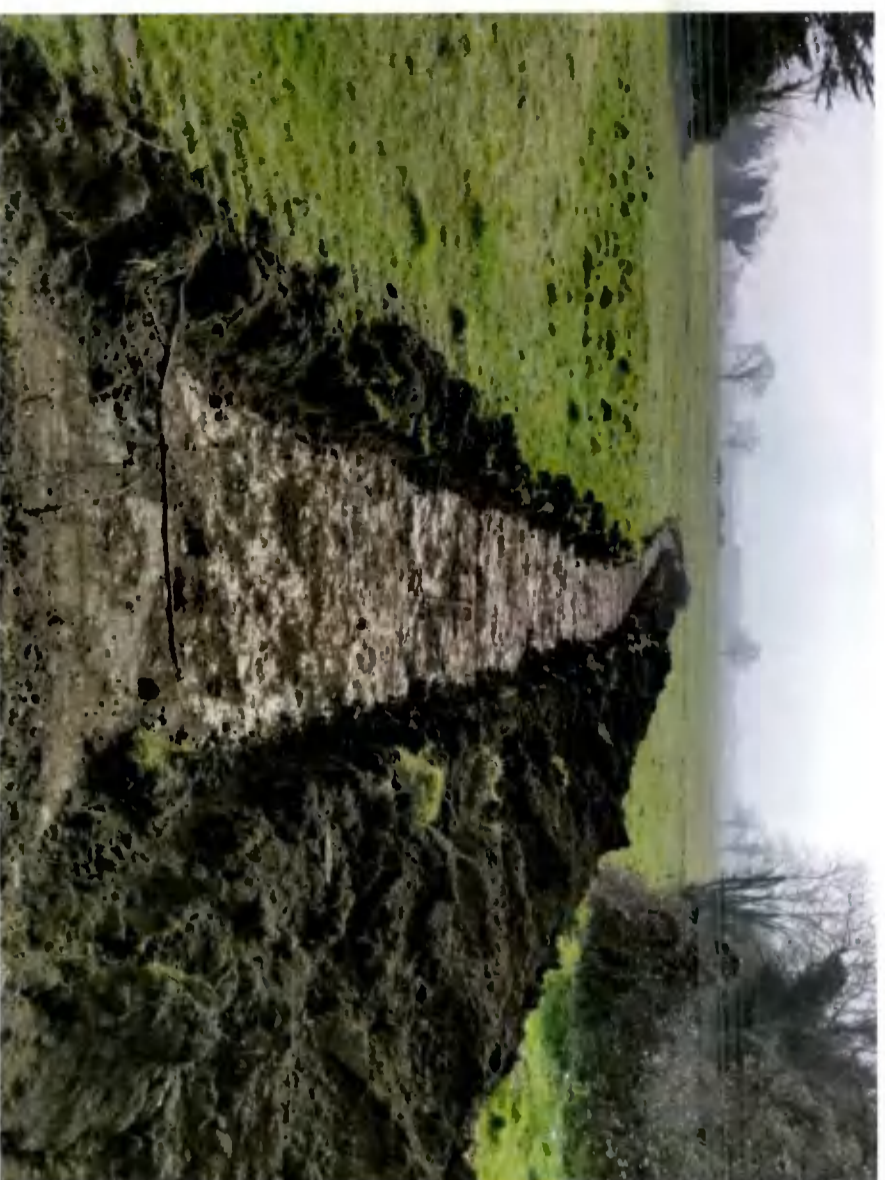
Plate 2: Test Trench 1, facing north-east

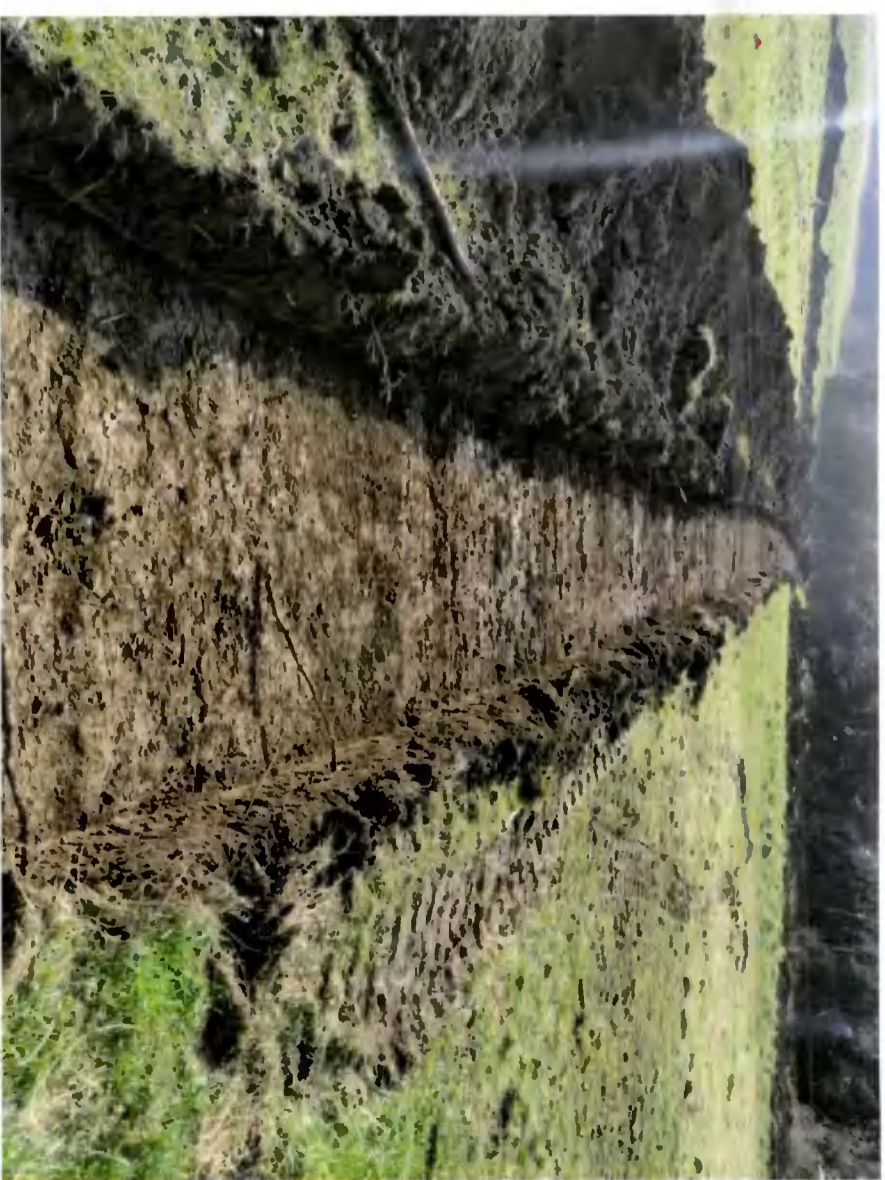
Plate 3: Test Trench 2, facing south-east

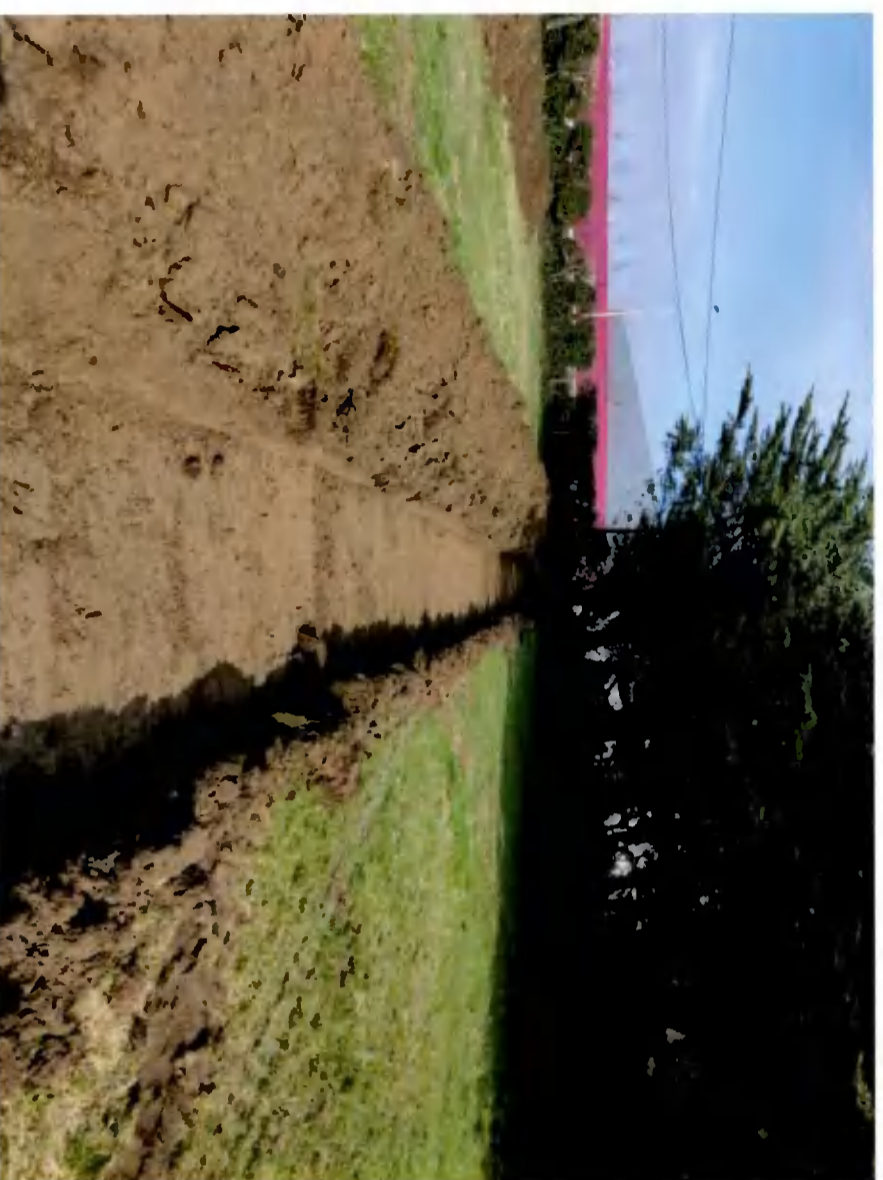
Plate 4: Test Trench 3, facing north-west

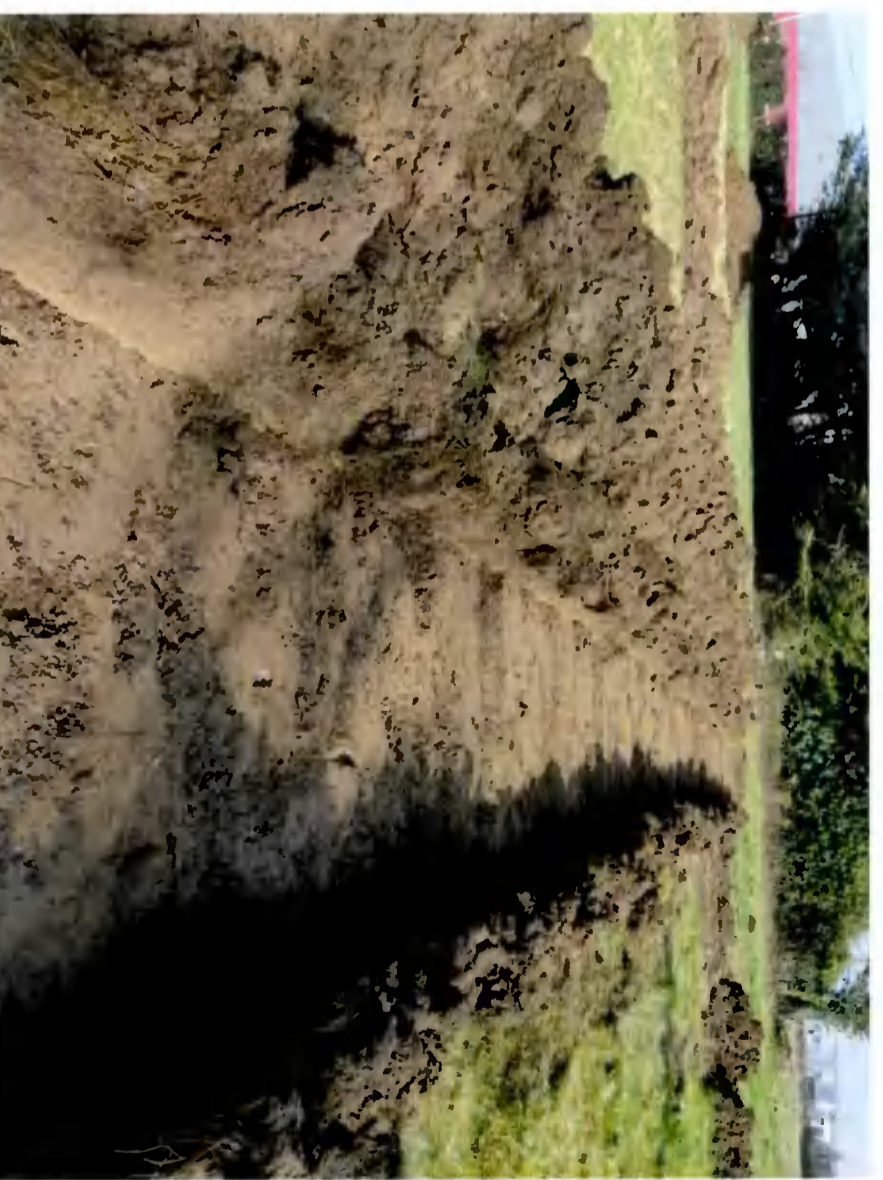
Plate 5: Trench 4, facing north-west

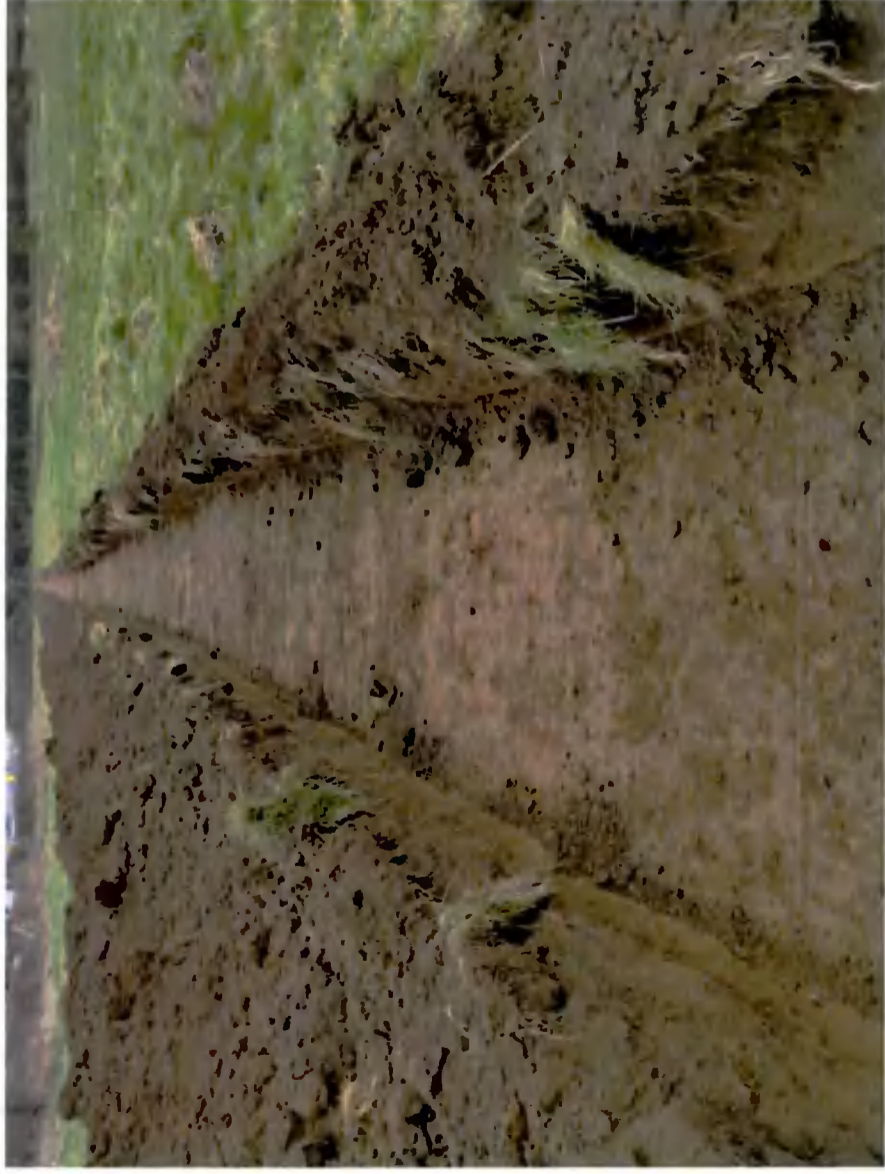
Plate 6: Test Trench 5, facing south-west

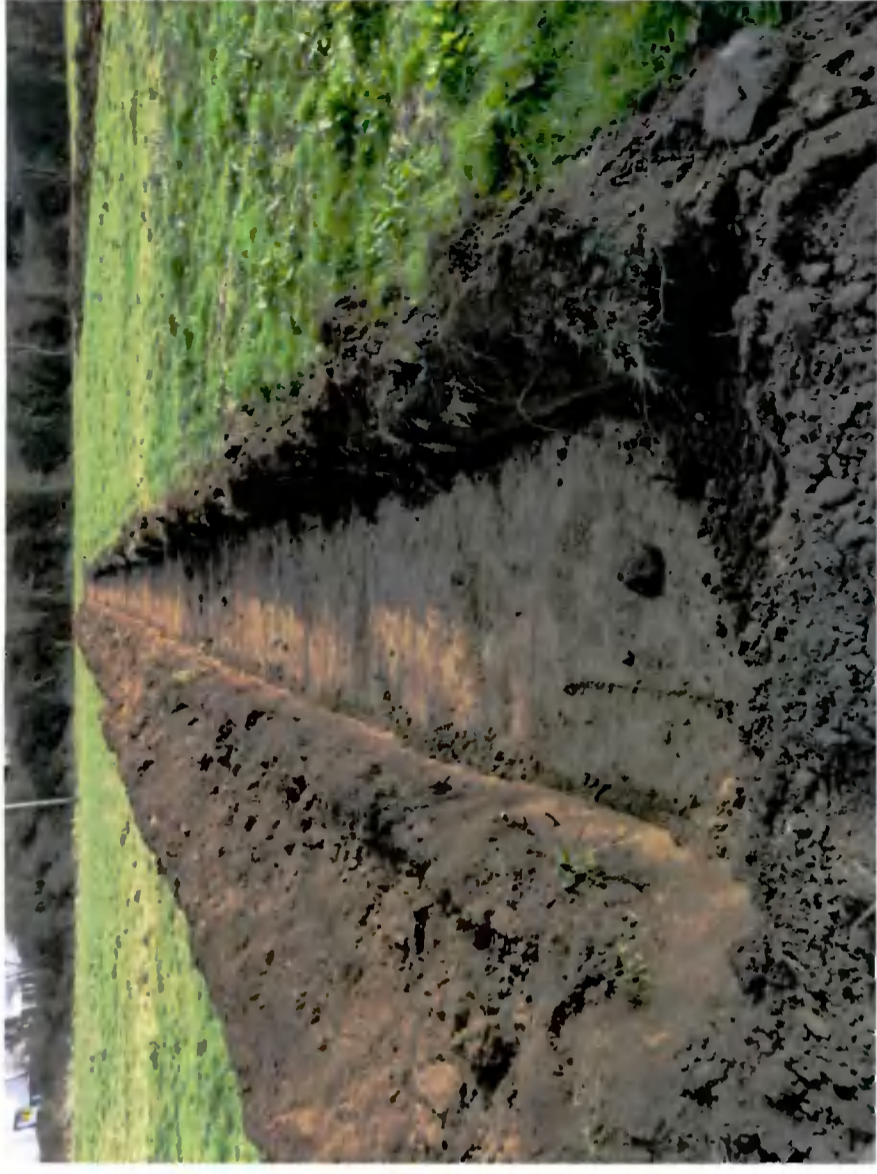
Plate 7: Test Trench 6, facing south-west

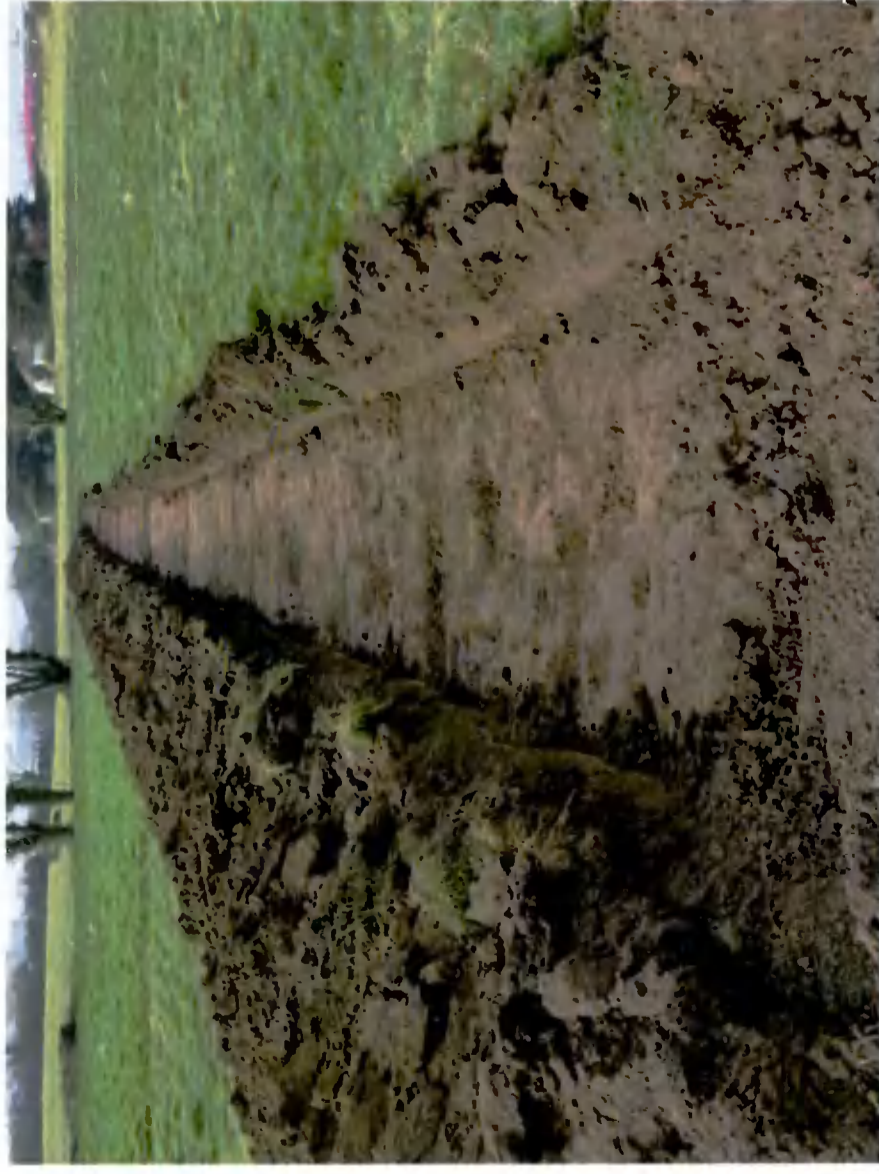
Plate 8: Test Trench 7, facing north-east

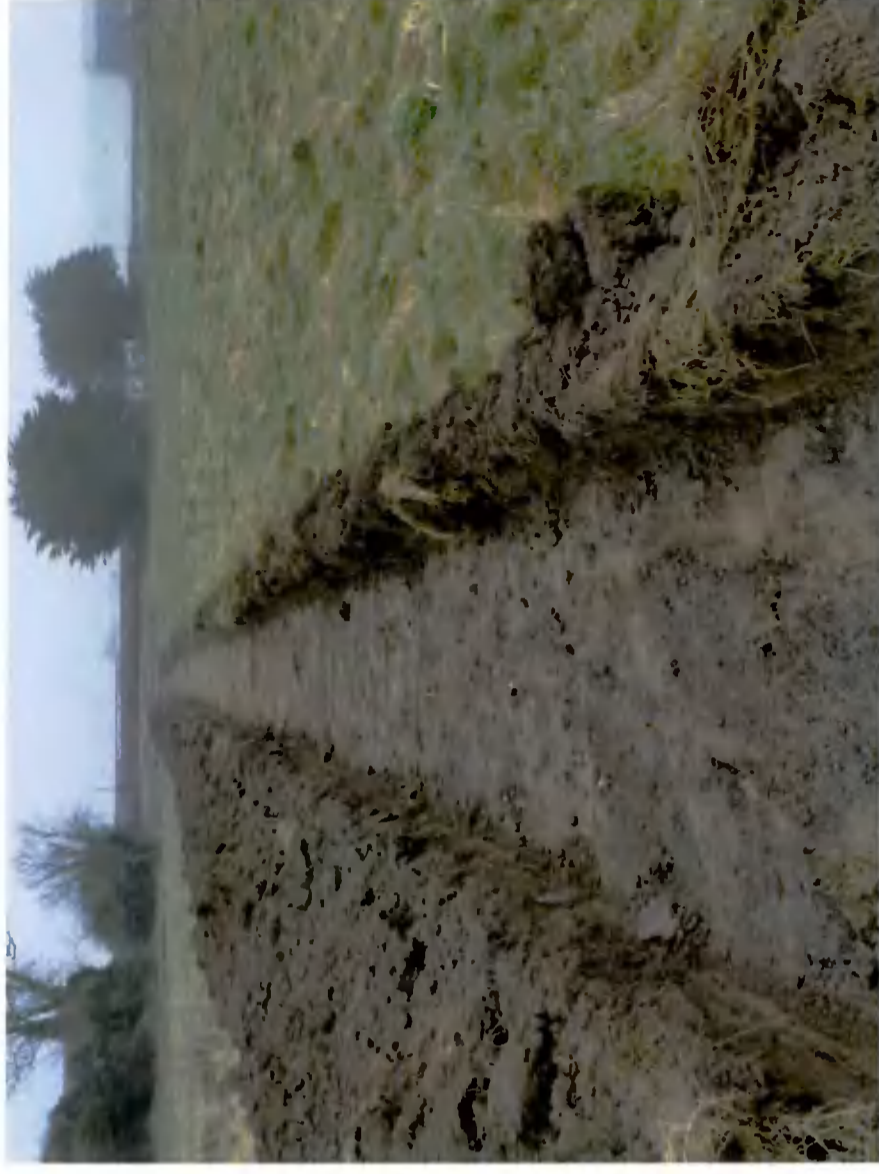
Plate 9: Test Trench 9, facing north

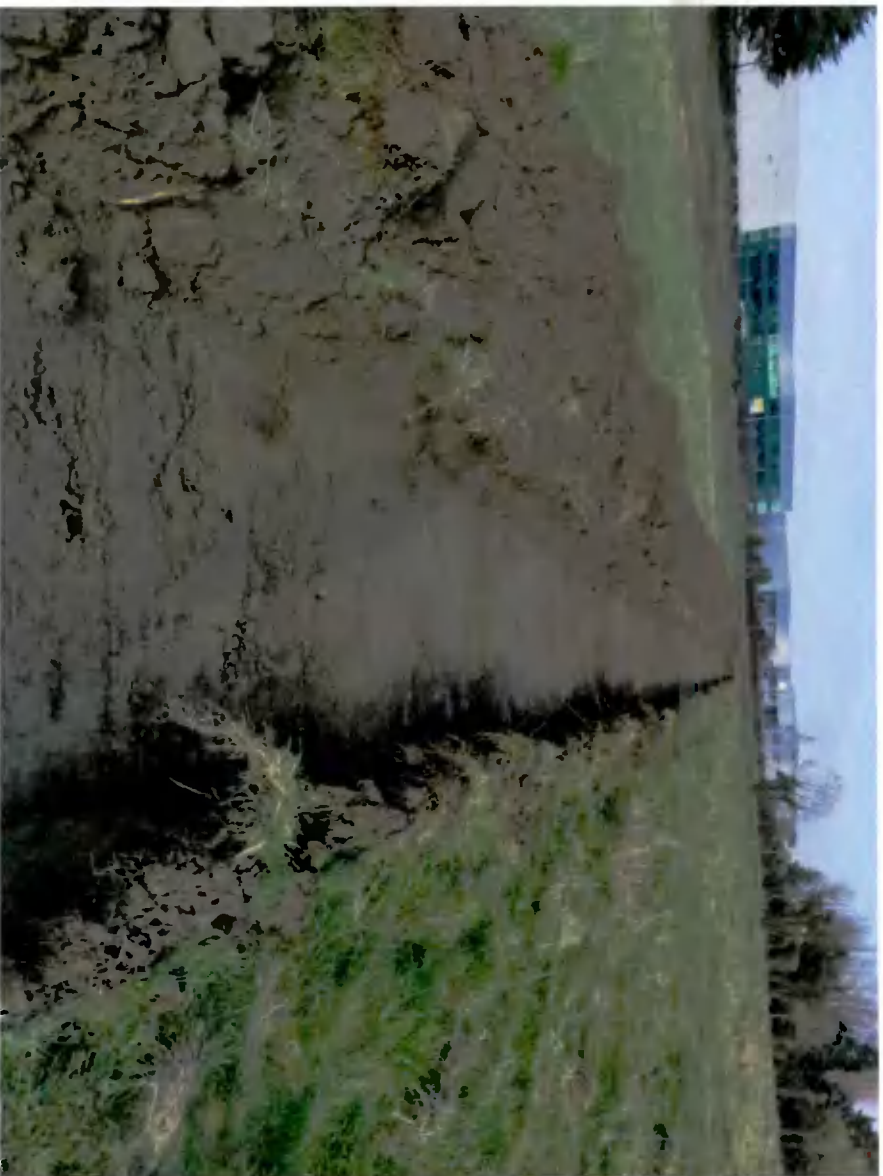
Plate 10: Test Trench 12, facing north-east

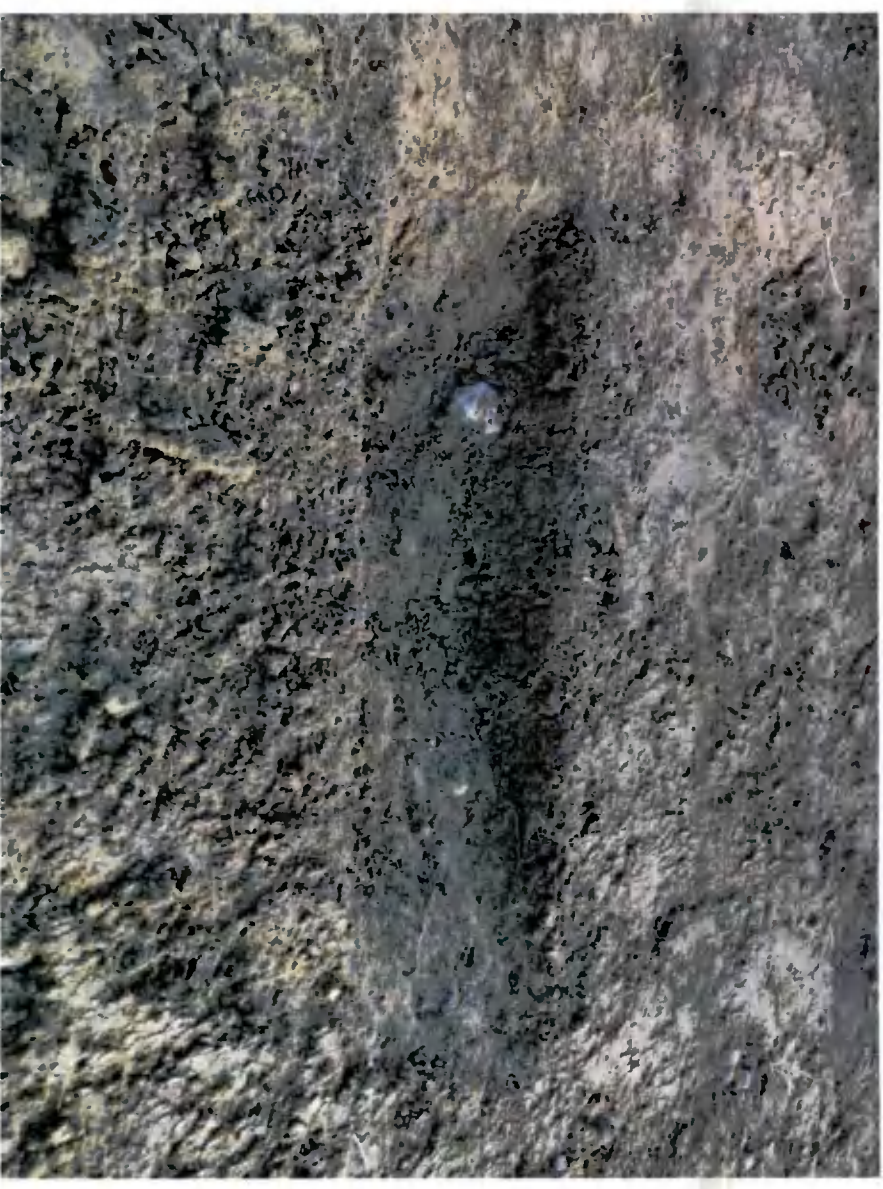
Plate 11: Test Trench 12, furrow, facing south

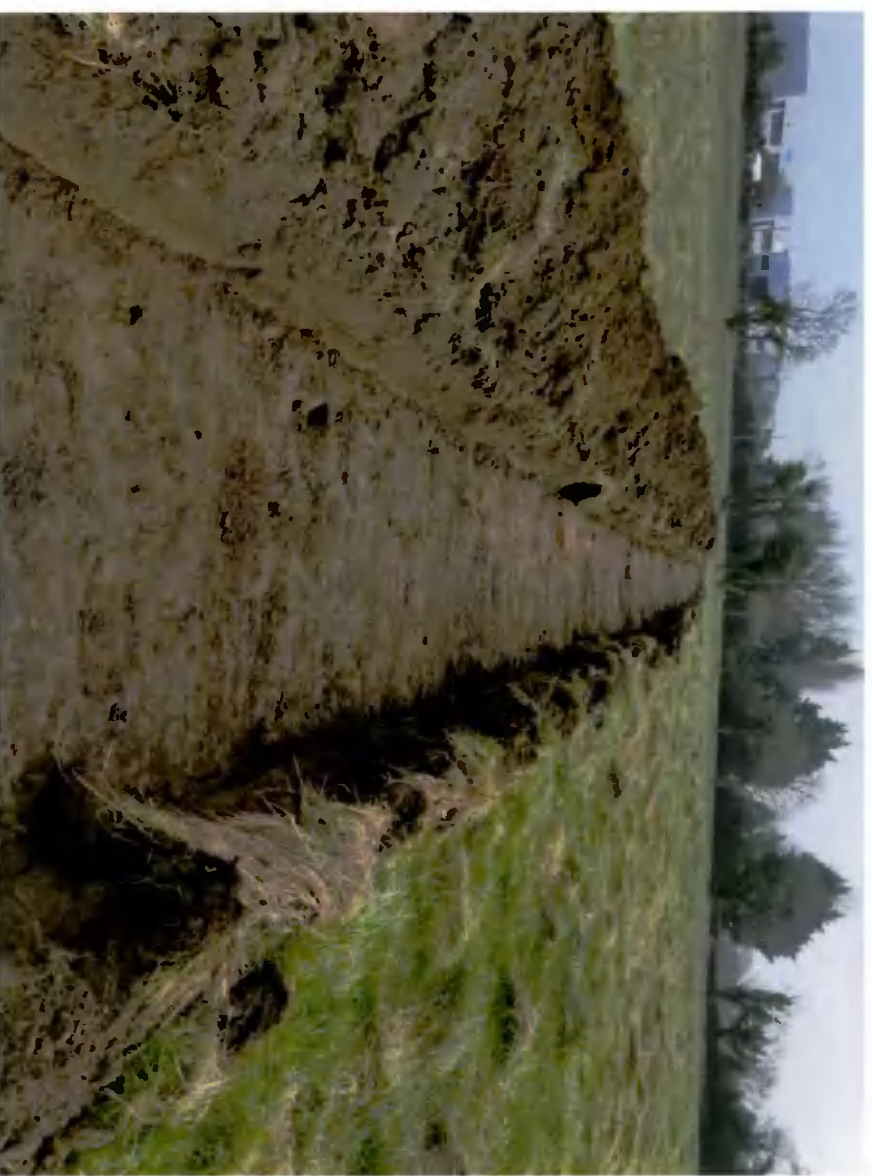
Plate 12: Test Trench 14, facing north-east
