**Residential Development,
Aderrig Phase 2, Adamstown,
Co. Dublin**

Stage 1 Road Safety Audit

Quintain Developments Ireland Ltd

May 2021

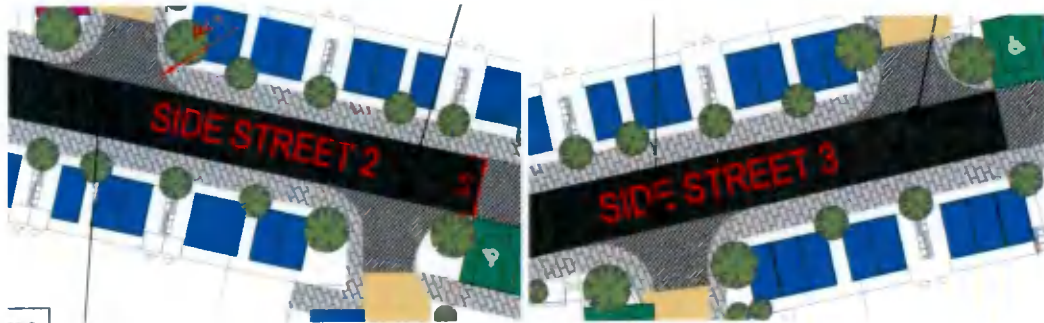
Location: Homezone Streets and Side Streets

2.1. Problem: Tactile paving for visually impaired

The provision of tactile / blister paving at crossing locations is either missing or insufficiently provided across some homezone streets and side streets. Where such surface features are found to be deficient, there is potential for visually impaired pedestrians to inadvertently step out into the adjacent live carriageway resulting in an increased risk of pedestrian-vehicle collisions.

Recommendation

The Design Team should review the design provision / application of tactile paving at all crossing locations across the scheme, taking cognisance of required paving arrangement, colour and extent.

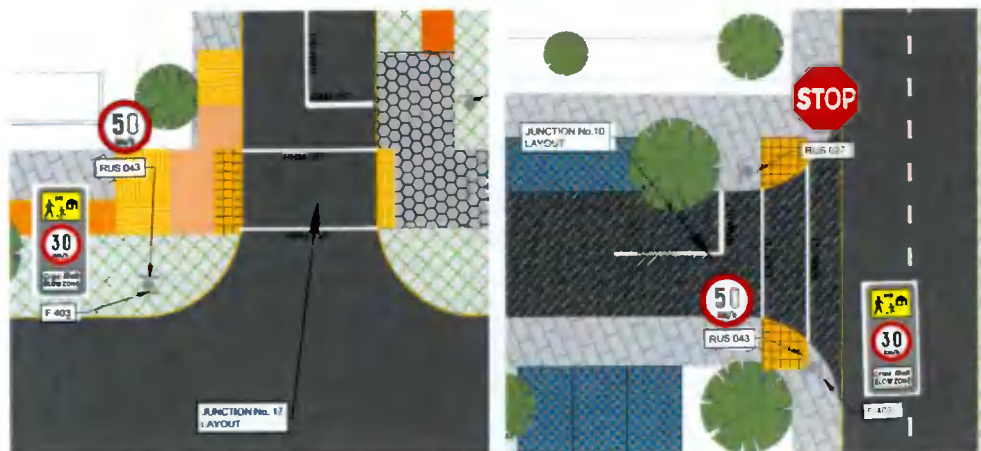
Location: Junction 17 / Linear Park Road

2.2. Problem: Speed Limits

There appears to be an inconsistency in proposed speed limit signage applicable to Linear Park Road. The proposed signage at Junction No 17 suggests 30kph for this road while all other junctions along this road suggest 50kph applies to the same road. Inconsistency in posted speed limits may lead to motorists ignoring the speed limit and/or progressing at speeds inappropriate to the surrounding environment leading to an increased risk of vehicle-vehicle and / or pedestrian-vehicle conflicts.

Recommendation

The Design Team should review the speed limit strategy taking cognisance of possible desire lines across the proposed Linear Park Road, i.e. between the proposed development and the recreational parkland area.

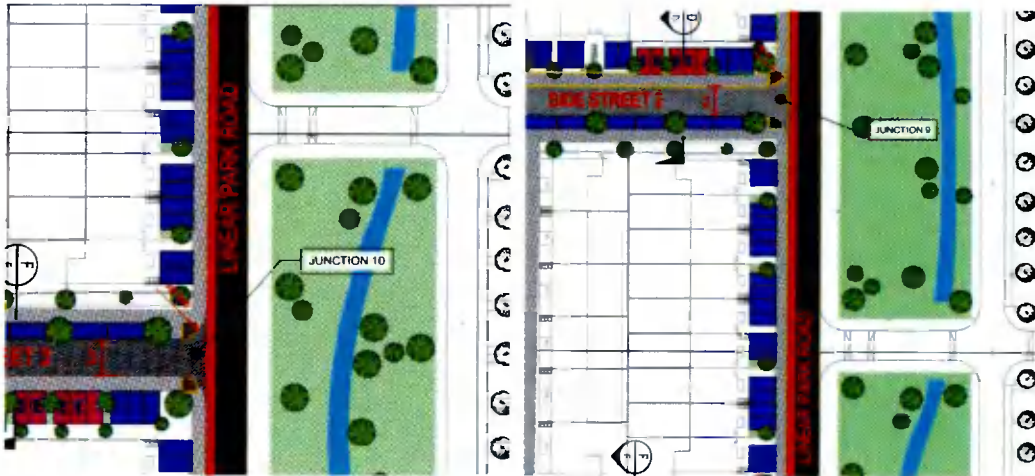
Location: Linear Park Road

2.3. Problem: Formal Crossing Facilities vs Pedestrian Desire Line

Given there is an apparent pedestrian desire line between the proposed development to the west of Linear Park Road and the linear park to the east, the proposed design does not make any provision for formalised crossing facilities to accommodate safe access to the parkland area. Where no formal crossing facilities are provided, pedestrians may attempt to cross the road in an area where it is unsafe to do so leading to an increased risk of pedestrian-vehicle conflicts.

Recommendation

The Design Team should consider provision of formalised crossing points along Linear Park Road. Such provision should be consistent with others provided in the area for similar road type and posted speed limits.

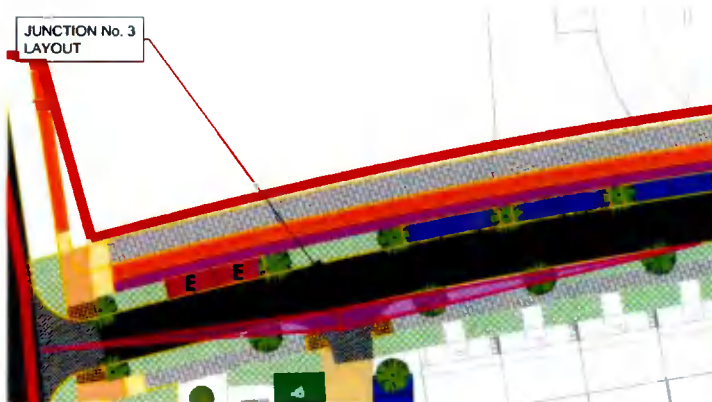
Location: General / All junctions

2.4. Problem: Visibility at Junctions

Where proposed landscaping measures are located in the vicinity of proposed junctions, there is potential for landscape elements (e.g. shrubs, trees, etc) to encroach into visibility envelopes over time. Where visibility at junctions is compromised / reduced, there is increased risk of side swipe type vehicle-vehicle collisions or cycle-vehicle collisions where vehicles emerging from the minor road have inadequate visibility to approaching traffic.

Recommendation

The Design Team should ensure that all landscaping elements are located away from junctions / visibility splays.

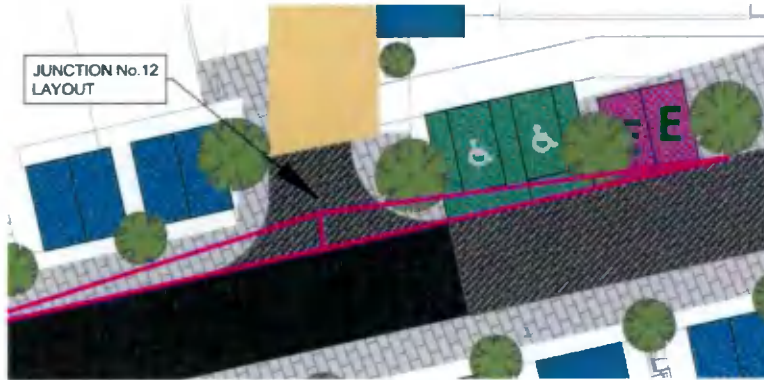
Location: Junction No 12

2.5. Problem: Visibility at Junction

Where a vehicle occupies the proposed accessible parking area or e-parking spaces immediately east of Junction No 12, there is an apparent encroachment into the visibility splay for the junction. This may be further exasperated by the proposed landscaping proposed in the same area (ref Item 2.4 above). Where visibility at junctions is compromised / reduced, there is increased risk of side swipe type vehicle-vehicle collisions or cycle-vehicle collisions where vehicles emerging from the minor road have inadequate visibility to approaching traffic.

Recommendation

The Design Team should ensure the proposed visibility splays will not be compromised by adjacent parking provision.

2.1	Y	Y		
2.2	Y	Y		
2.3	Y	Y		
2.4	Y	Y		
2.5	Y	Y	Parking space locations will be adjusted at detailed design stage to ensure appropriate visibility is achieved.

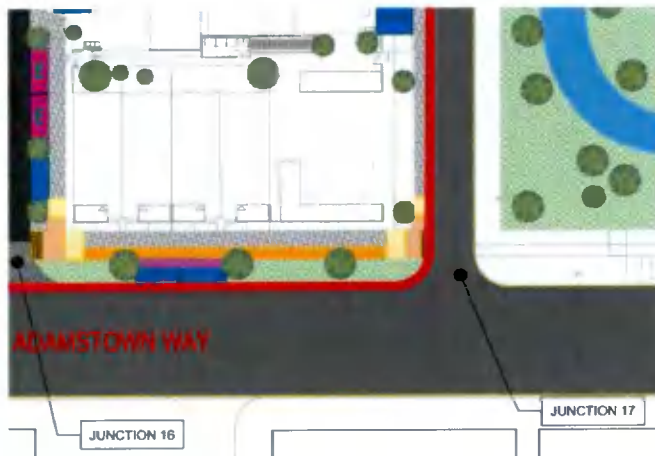
Location: Junction No 16 & Junction No 17

2.6. Problem: Inadequate Parking Provision

The proposed 4 No residential and 1 No Flexible use units located between Junction No 16 and No 17 appear to have 2 No parking spaces between them. Where an insufficient allocation of parking is provided, residents will park outside their properties thereby adversely affecting the visibility splays at these adjacent junctions. Where visibility at junctions is compromised / reduced, there is increased risk of side swipe type vehicle-vehicle collisions or cycle-vehicle collisions where vehicles emerging from the minor road have inadequate visibility to approaching traffic.

Recommendation

The Design Team should consider provision of additional parking allocations in this area, inclusion of parking control measures to ensure the proposed visibility splays (on major road) and junction approaches (on minor road) will not be compromised by potential on-street parking.

2.6	N	N	A total of 378 No. car parking spaces are provided for the 227 dwellings, a ratio of 1.6 spaces per dwelling. The location of these spaces has been carefully designed to ensure car parking is provided as close as reasonably possible to each dwelling. Additional car parking spaces located within 20metres on Side Street 4. The level of car parking is considered sufficient as shown in BKD drawing 6259-P-006 Parking Strategy. Appropriate Traffic Regulation Orders will be used on Adamstown Way to remove risk of inappropriate on-street car parking	Y

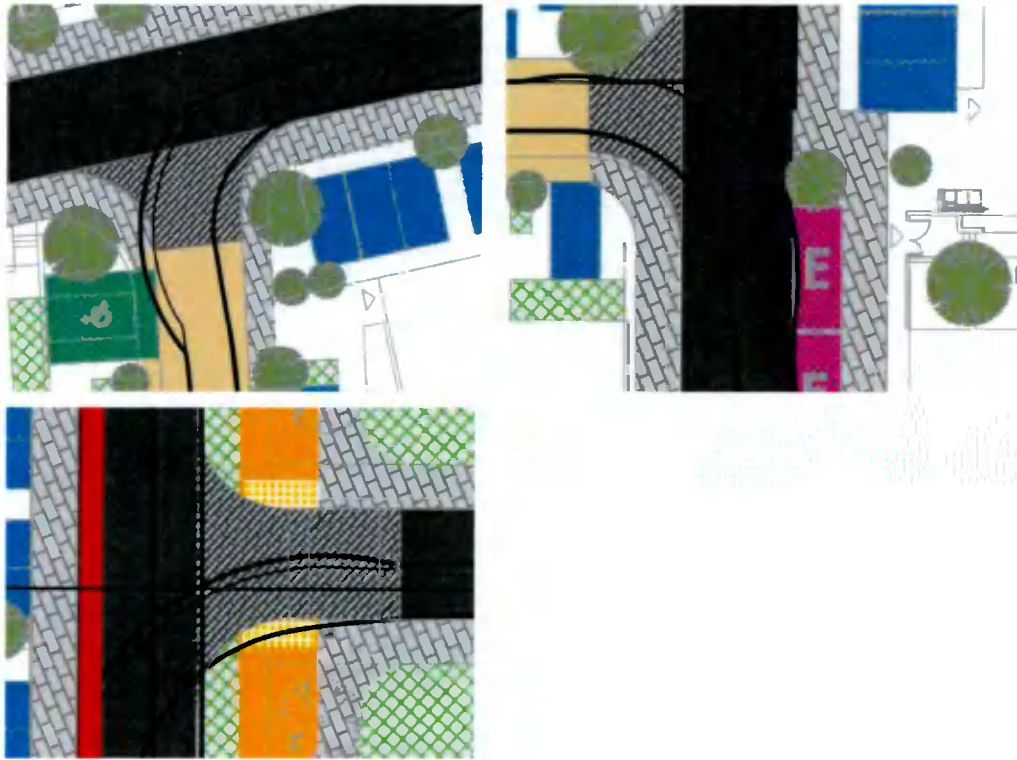
Location: Homezone Streets and Side Streets

2.7. Problem: Access for Larger Vehicles

Where access is required by larger vehicles (e.g. service vehicles [refuse truck] or emergency vehicles) the swept path analyses provided indicate that some turning movements would require the vehicle to mount footpaths when turning into a given street. This may lead to an increased risk of head-on type vehicle-vehicle collisions or larger vehicles being required to traverse pedestrian areas increasing the risk of vehicle-pedestrian collisions.

Recommendation

The Design Team should consider design measures or other alternative measures as appropriate to ensure such vehicles can safely pass through these junctions.

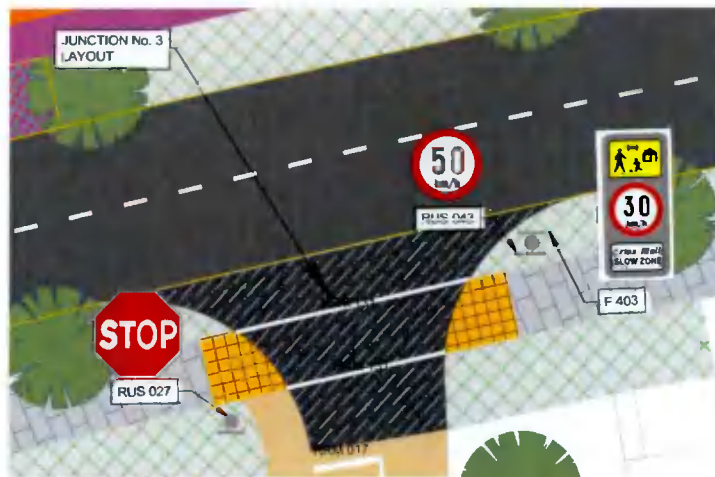
Location: General / All junctions

2.8. Problem: Inappropriate road markings

Pedestrian lines to M 131 of the Traffic Signs Manual are proposed at all uncontrolled pedestrian crossings. Pedestrian lines to M 131 of the TSM are used exclusively at signal controlled junctions. Provision of M 131 pedestrian lines at uncontrolled junctions may lead to pedestrian confusion in relation to crossing priority and cause pedestrians to step onto the carriageway when inappropriate to do so. This may lead to an increased risk of vehicle-pedestrian collisions.

Recommendation

The Design Team should remove the proposed M 131 pedestrian lines at all uncontrolled pedestrian crossings.

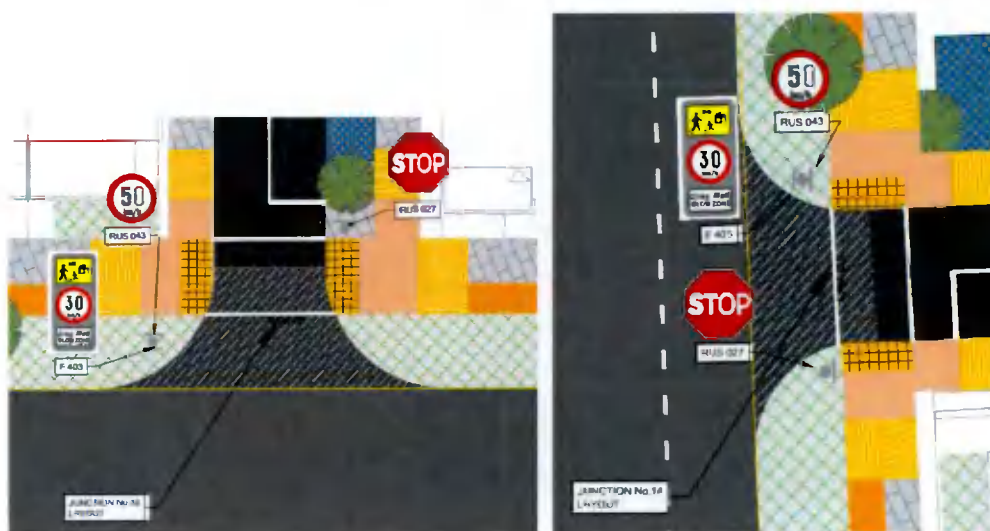
Location: Junction No. 14 & 16

2.9. Problem: Change in levels/materials at crossings

The extent of the proposed raised table ends within the width of the proposed uncontrolled pedestrian crossing. Changes in levels and/or material types within the width of the proposed uncontrolled pedestrian crossings, parallel to the direction of crossing, may pose a trip hazard and could lead to slips, trips and falls.

Recommendation

The Design Team should extend the raised table treatment to ensure consistency in levels and material type across the entire width of the proposed uncontrolled pedestrian crossing.
