Adamstown District Centre Phase 2 Block G Amendment

Stage 1 Road Safety Audit

Quintain Developments Ireland Ltd

October 2021

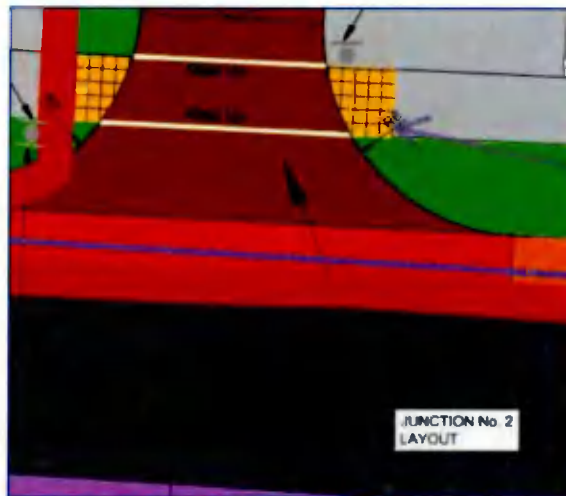
Figure 2-1 – 6m Junction Radii

Location: Junction 1 and Junction 2

The proposed radii of 6m may lead to higher driving speeds. This may increase the risk of conflict with crossing pedestrians, or other road users, where drivers are travelling through the junctions at higher speed.

The Design Team should investigate the provision of smaller radii to encourage slower driving speeds through the junctions.

2.1	Y	N	The concern is noted however the 6m junction radii provided onto external roads is to provide for ease of access for larger vehicles serving the development, refuse and delivery vehicles; these are expected to be higher in magnitude due to the presence of the apartment blocks. This aligns with SDCC Road departments junction radii recommendations. The layout will allow entry and exit of a small and large vehicle at the same time without blocking of the junction which could lead issues between opposing traffic. The provision of the raised table is deemed the key factor in reducing speed and highlight the crossing thereby negating the concern associated with the 6m radius.	Yes

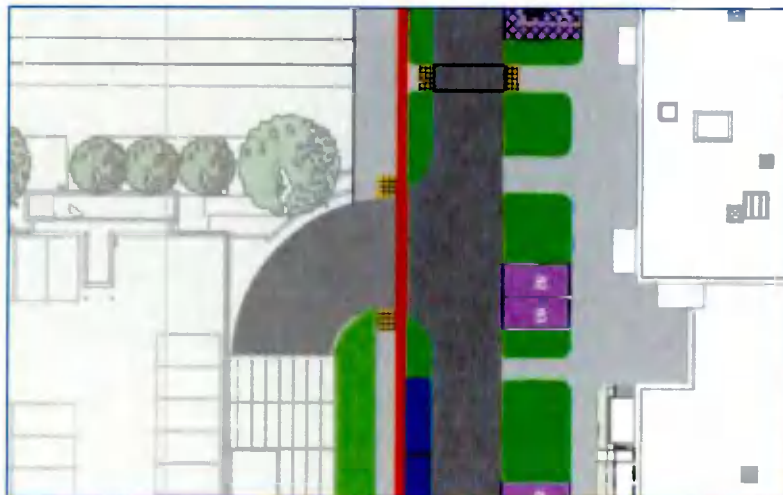
Figure 2-2 – Junction at Centre of Scheme

Location: Centre of Scheme

There is a junction located towards the centre of the scheme that appears to be wide. The width of the junction is in the region of 7-8m which will be challenging for pedestrians to cross safely and may lead to relatively higher vehicle speeds where there may be an increased risk of conflict.

The Design Team should review the proposed layout and introduce measures to reduce the risk of conflict and length of crossing for vulnerable road users. The provision of a raised table across the junction should also be considered.

2.2	Y	Y	The entrance is to a Multi-storey car park. At detailed design stage the introduction of a raised crossing at this location to be investigated to give pedestrian priority.	Yes

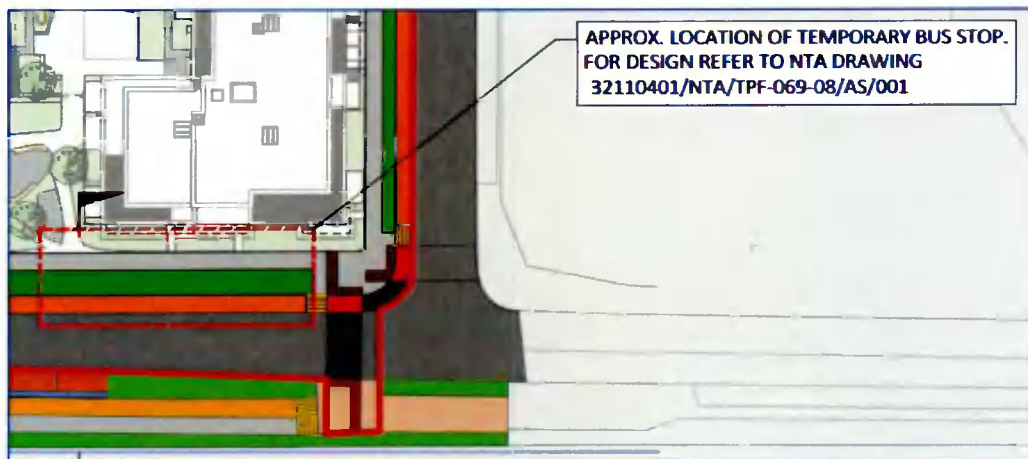
Figure 2-3 - Proposed Temporary Bus Stop

Location: Station Road

The drawings indicate a temporary bus stop may be provided on Station Road, as shown in Figure 2-3. When a bus is stopped here it may block visibility to the pedestrian crossing and/or signals to the east. Vehicles passing/overtaking the stopped bus may fail to see the red light ahead, and could collide with pedestrians crossing or other road users at the junction.

The Design Team should consult with the NTA on the proposed temporary bus stop location and ensure visibility to the pedestrian crossing is not adversely affected.

2.3	Y	Y	Prior to installation and operation of this temporary bus stop the Design Team will consult with the NTA on the proposed temporary bus stop location and ensure visibility to	Yes

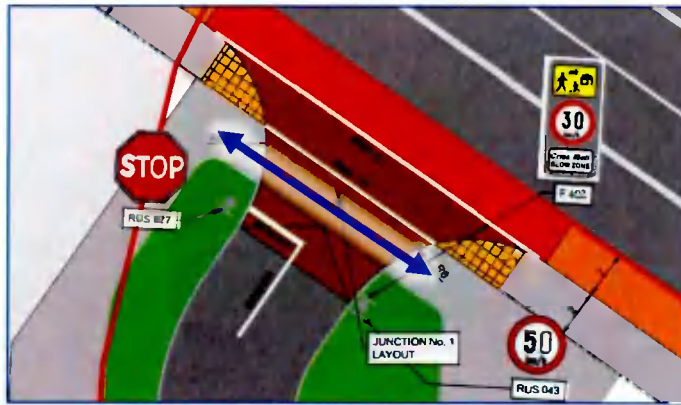
Figure 2-4 - Junction No 1 crossing

Location: Junction 1

The termination of the footways at Junction 1, as highlighted in Figure 2-4, may encourage pedestrians to cross at an undesignated point in the junction. This could lead to trips/falls as the ramp transition will result in a low kerb upstand at this location, which may be unseen by those crossing.

The Design Team should propose means to discourage crossing here, such as extending the grass verge northwards, up to the designated crossing point.

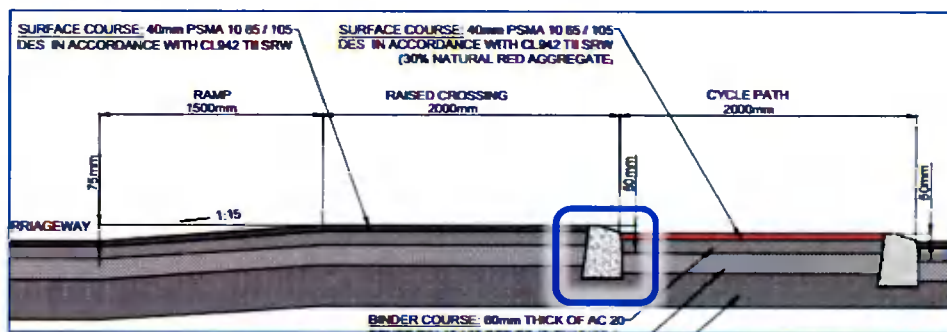
Figure 2-5 - Kerb between raised crossing and cycle path

Location: Junction 1 and 2

The cycle path is proposed to be raised by 50mm across Junction 1 and 2, with a further 50mm vertical difference to the raised crossing; as shown in Figure 2-5. A bevelled 50mm kerb is proposed between the cycle path and raised crossing. Left turning cyclists will be crossing this kerb at an acute angle, as shown in Figure 2-6. This may cause the front wheel of the bicycle to lose traction as it is crossing the face of the concrete kerb, particularly in wet/icy conditions, which could destabilise the cyclist resulting in a fall.

The Design Team should review the proposed raised crossing detail with consideration for left turning cyclists.

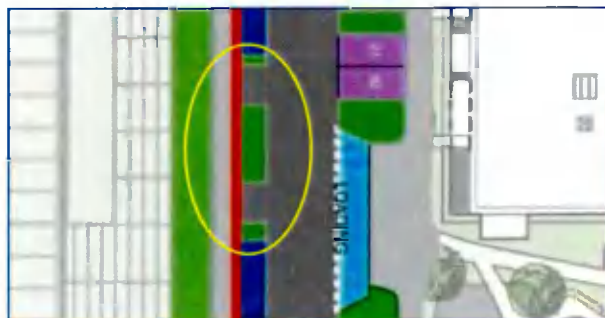
Figure 2-7 – Missing Landscaping

Location: Various Scheme Wide

The landscaping has been discontinued in a number of locations within the scheme along the road edge. These may be seen by some as crossing points and lead to some crossing at undesignated locations and may surprise some drivers and may lead to conflict.

The Design Team should extend the landscaping in these areas to encourage pedestrians to cross at the designated crossing points only.

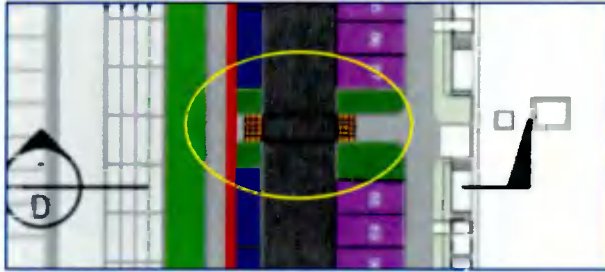
Figure 2-8 – Parking at Crossing Points

Location: Pedestrian Crossing

The presence of parked cars may lead to restricted visibility at the pedestrian crossings; particularly a larger vehicle such a van, truck or jeep. This may lead to drivers conflicting with pedestrians attempting to cross.

The Design Team should ensure adequate visibility is provided at the crossing points only; this may be achieved by setting back the adjacent car parking spaces.
