# Saggart Reservoir - Design and Build Contract

**A mammal assessment undertaken on behalf of Rowan Engineering and Coffey Group for the Irish Water Reservoir at Saggart, County Dublin relating to the area within which earth spoil is proposed for storage**

Brian Keeley BSc (Hons) in Zool. Wildlife Surveys Ireland

February 3<sup>rd</sup> 2021

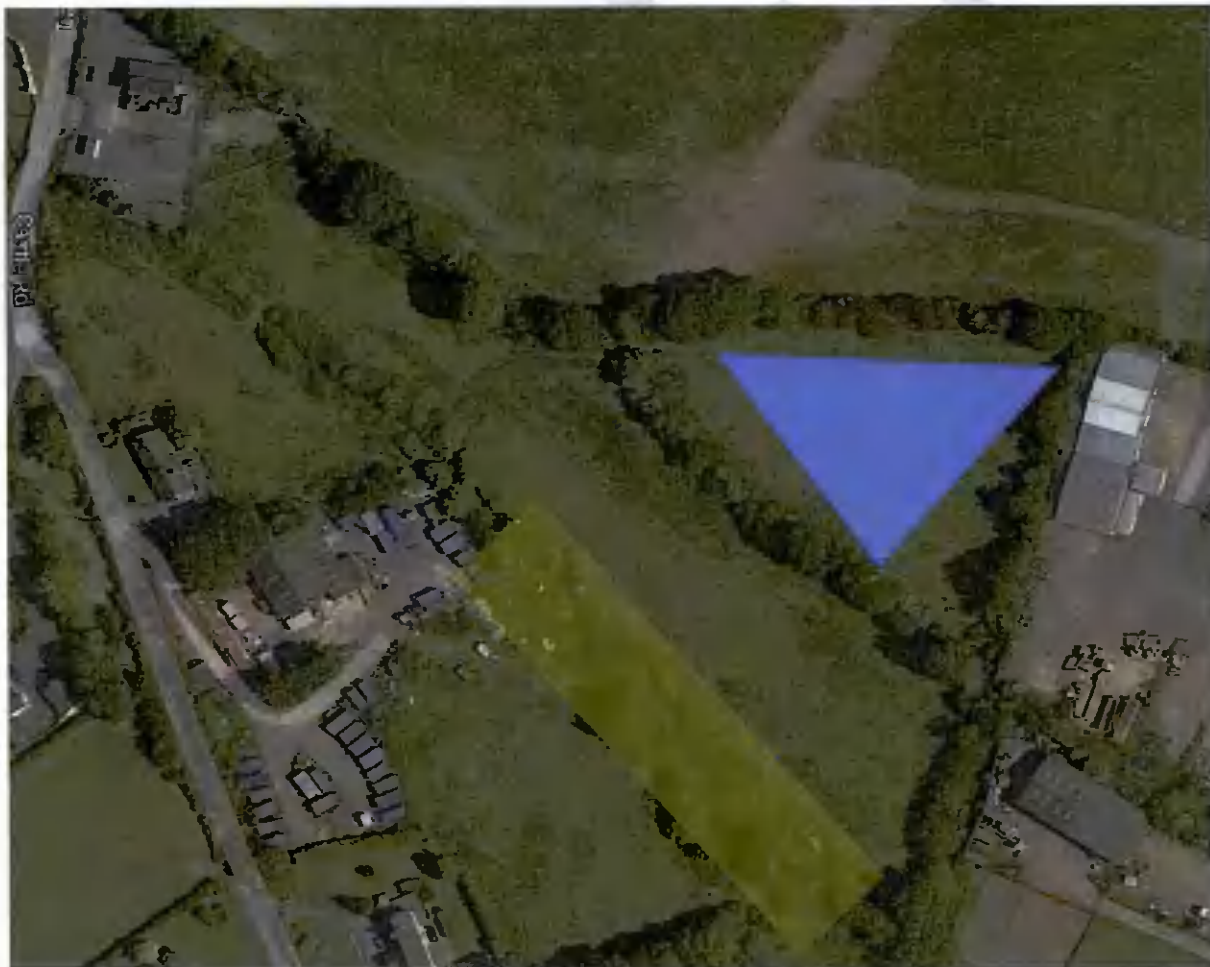
Figure 1: Area proposed for the storage of spoil in lands adjoining the Reservoir. The triangle is indicative of the area under discussion and does not denote the footprint of the spoil heap. The yellow box denotes areas of otter and badger activity noted within the surrounding lands

- Restrict activity to the footprint required for construction of the Works;
- The proposed works area / storage area shall be clearly demarcated with temporary fencing or another suitable method to restrict soil deposition to areas adjacent to the works area;

- Trees and hedgerow located adjoining/adjacent to the construction area shall be protected from root damage by machinery by an exclusion zone/root protection area. This is generally calculated as an area equivalent to a circle with a radius of 12 times the stem diameter at breast height, or more roughly, it should extend to below the edge of the outermost branches of the tree. Such protected trees shall be fenced off by adequate temporary fencing prior to other works commencing;

- NRA guidelines on the protection of trees and hedges prior to and during construction shall be followed (NRA, 2006). No soil, spoil, construction materials or rubbish shall be stored or tipped and no construction plant or vehicles will be parked within the spread of existing trees or hedgerows;

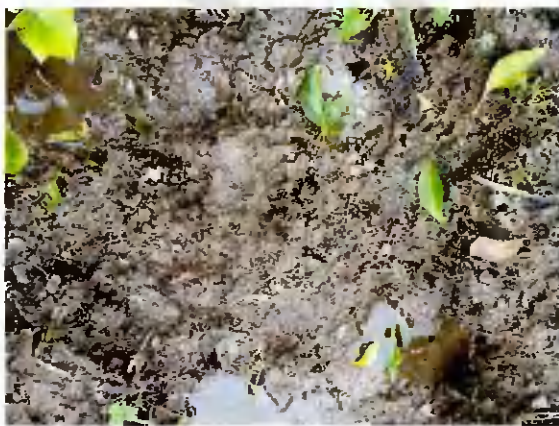
No badger setts were identified within the site proposed for soil storage or in the nearby hedgerow. Badger foraging signs were evident from badger paw prints in the field south of the proposed storage area.

Badger paw prints south of the proposed storage area at the River Camac

- “the Contractor shall maintain a regular watching brief along all topsoil stored on site for potential establishment of badger setts during the construction phase”.

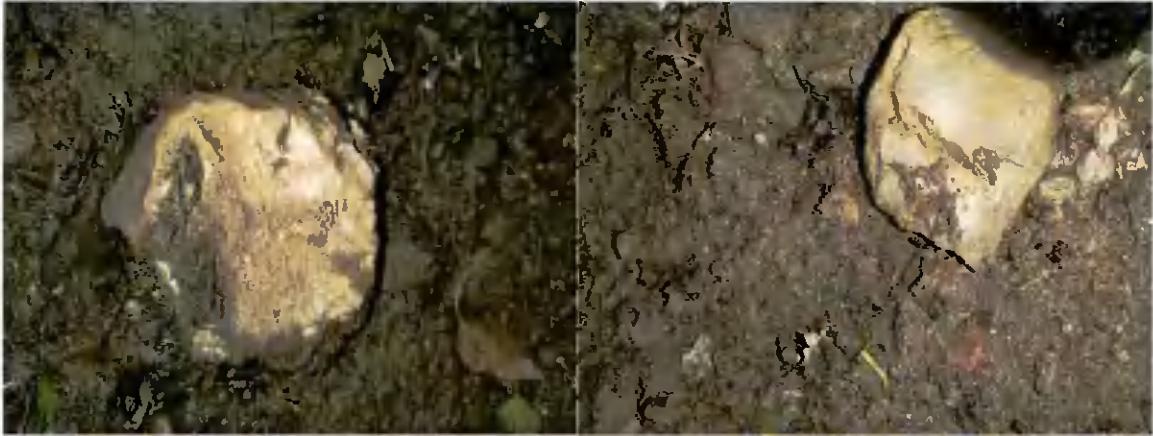
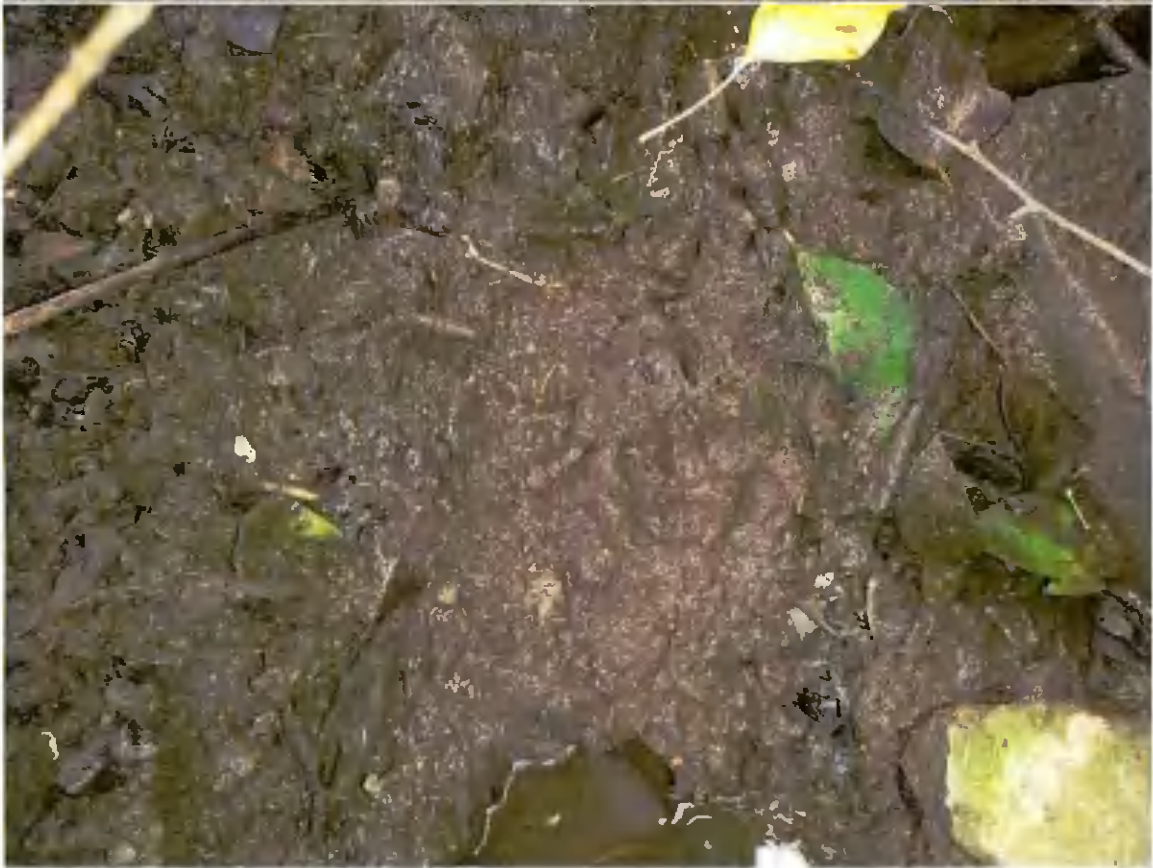
**Otters are present within the Camac and adjoining lands but not within the footprint proposed for spoil storage. The above measures apply:**

Otter spraints and paw print

- **Where otter activity is confirmed onsite, the EnCOW shall engage a suitably qualified Ecologist to advise and or supervise works during construction of the discharge infrastructure.**
- **The Contractor shall maintain a ten metre riparian zone alongside all watercourses within the site boundary or lands for which the contractor may require as a working corridor for the construction of the discharge pipes. A narrow working corridor, clearly delineated shall be put in place alongside the Camac River during the construction period.**
- **No works or storage of materials outside of the working corridor shall be permitted. Works in the area shall be scheduled to coincide with dates that will be approved by IFI and/or NPWS and shall be completed in a timely manner to reduce all unnecessary environmental impacts/disturbance to otter.**
