Cherry Orchard Apartments – Site Investigation

Client: Dublin City Council

Report Date: 24th August 2021

Report No.: OCB20-070

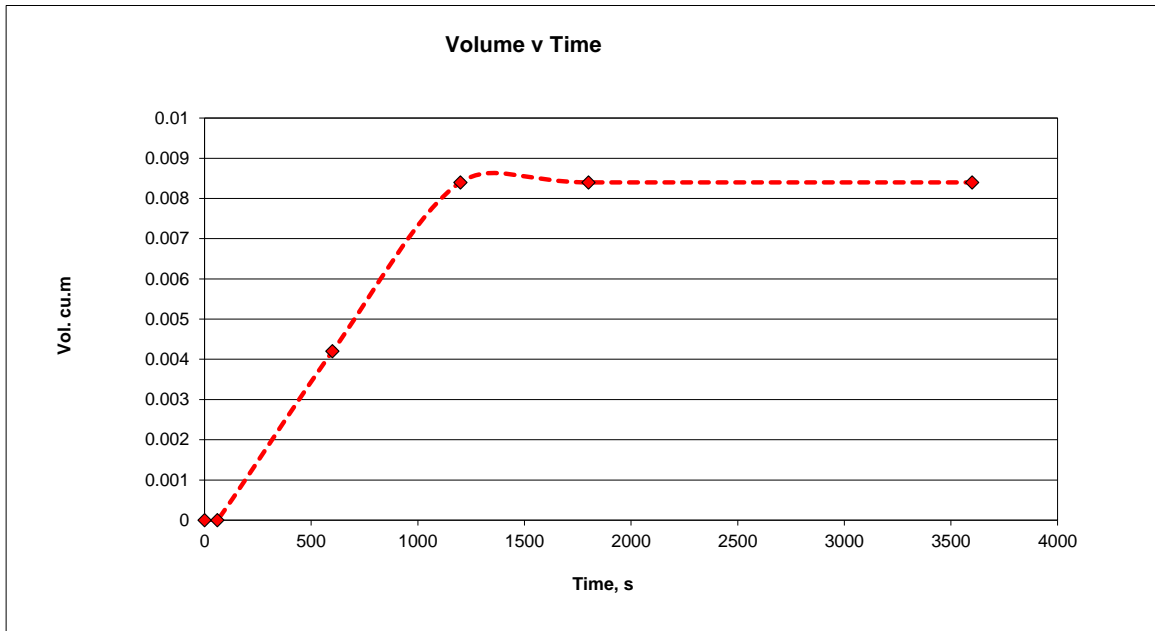
Time (min)	Measure (m)	Time (s)	Depth (m)	Fall (m)	Volume (m ³)
Start	0	0.500	0	1	0	0
	1	0.500	60	1	0	0
	10	0.510	600	0.990	0.01	0.0042
	20	0.520	1200	0.980	0.02	0.0084
	30	0.520	1800	0.980	0.02	0.0084
	60	0.52	3600	0.98	0.02	0.0084

NOTES:
 The water level did not fall sufficiently in order to calculate an Infiltration Coefficient

Appendix F presents the results and analysis of the infiltration test. The absence of the outflow from the pit precluded calculation of infiltration coefficients.
