Phase 3 Tubber Lane Adamstown
Stage 1 Road Safety Audit

Stage 1 Road Safety Audit

This report describes the findings of a Stage 1 Road Safety Audit associated with the Phase 3 Tubber Lane Adamstown project.

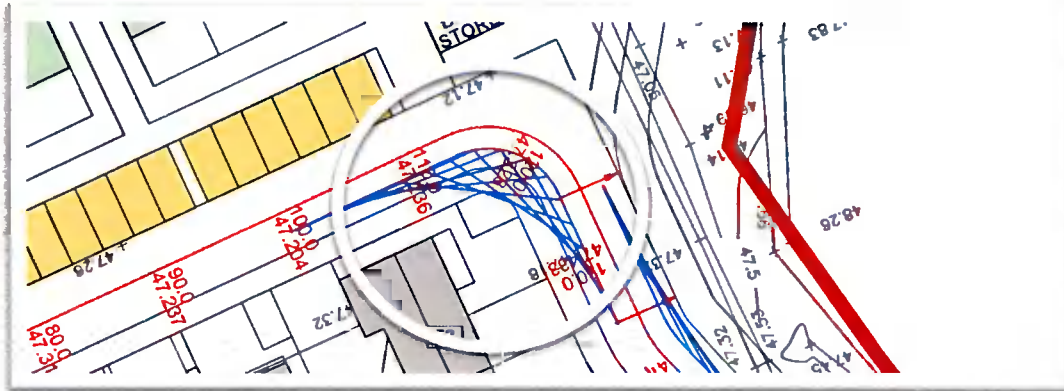
Figure 2.1 – Examples Where Boundary Treatment Could Compromise Forward Visibility

2.1 Problem: Forward Visibility Around Low Radius Corners

Location: Low Radius Horizontal Curves – Development Wide

Boundary treatments may block forward visibility around some low radius corners within the development roads. This could lead to rear end shunt type collisions.

Recommendation

Appropriate forward visibility should be provided around low radius corners within the development.

2.1	Yes	Yes	Wall/Garden railing will be adjusted inwards and footpath widened locally to allow for forward sight visibility around low radius corners.	<i>Noted with thanks.</i>

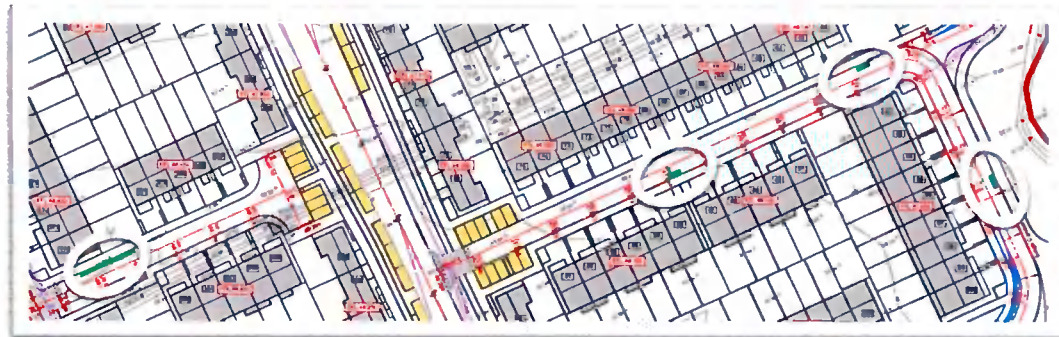
Figure 2.2 – Examples Where In Lane Tree Pits Form Obstructions to Opposing Vehicles

2.2 Problem: Vehicle Strikes on In-Lane Tree Pits

Location: Development Wide

The tree pits which have been placed in lane may restrict the ability of two opposing vehicles to pass without conflict.

Recommendation

The road alignment should be adjusted locally to the tree pits to allow two opposing vehicles to pass without conflict.

2.2	Yes	No	<p>The tree pit build outs have been located in the carriageway to provide an element of traffic calming and SuDS. The design intent is the chicane created by the build out will force the traffic from one direction yield to the other, similar to a parked car would provide. Section 4.4.8 of DMRUS "Changes to kerb lines can also be used to slow drivers at critical points by changing the alignment of the carriageway to create pinch-points, build-outs and horizontal deflections.</p> <p>I In addition, the build outs are located on straight section of road which are easily visible with adequate stopping sight distance. We also propose located a lighting column directly across from the build-out so they are easily visible at night.</p>	<i>Yes</i>

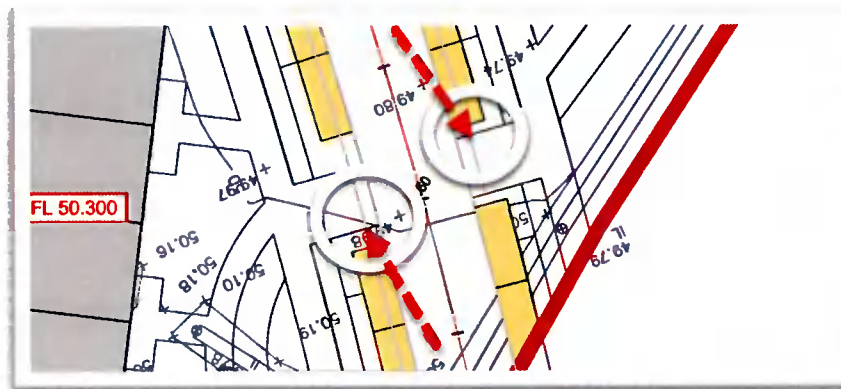
Figure 2.3 – Parking Obscuring the Presence of Pedestrian Waiting to Cross

2.3 Problem: Parking Obscuring Visibility to Pedestrians

Location: Pedestrian Crossing on Drawing 20065 / 103

The close proximity of the parallel parking may obscure the presence of a pedestrian waiting to cross from an approaching driver's vision. This could lead to conflicts between vulnerable road users and vehicles.

Recommendation

The parking should be re-positioned to improve forward visibility to a pedestrian waiting to cross the road.

2.3	Yes	Yes	Car parking to be repositioned to improve forward visibility to the pedestrian crossing.	<i>Noted with thanks.</i>
