Intended for  
**Vantage Data Centers DUB11 Limited**

Date  
**February 2022**

# **KILCARBERY SUBSTATION AND TRANSMISSION LINES**

## **VOLUME 2: LANDSCAPE, VISUAL AND HERITAGE IMPACT ASSESSMENT**

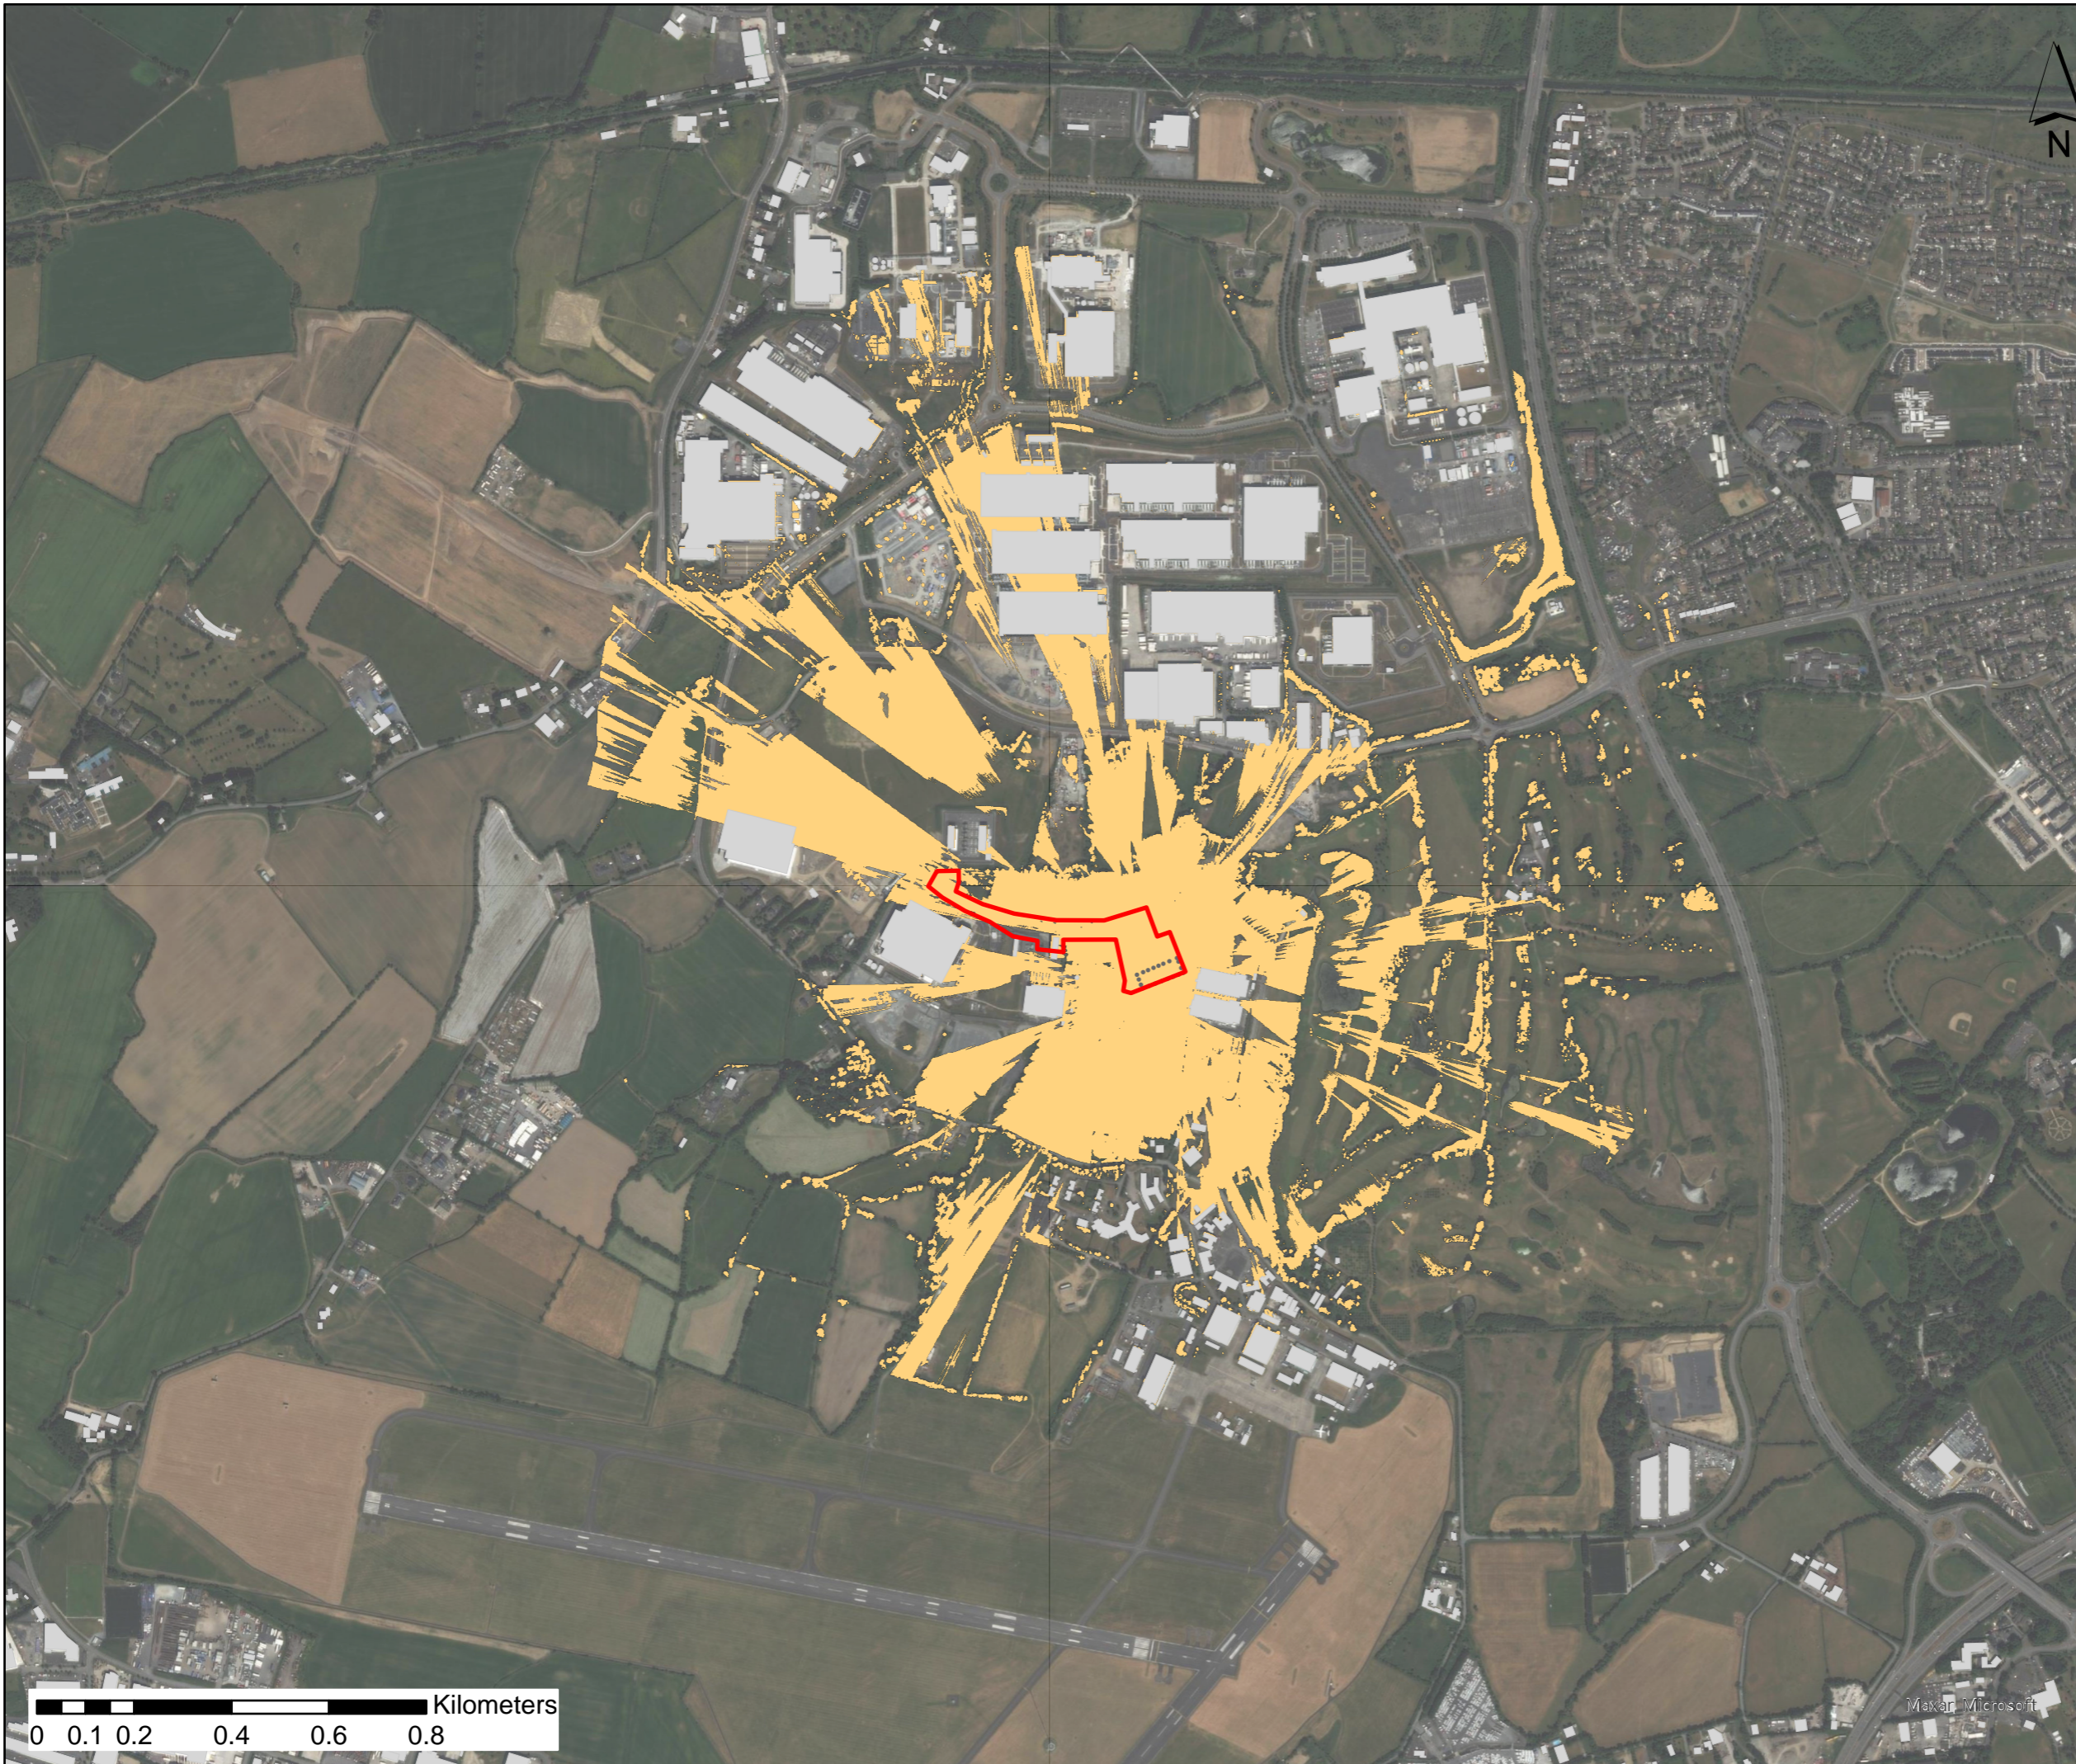
Proposed Development Visibility

Notes: Visibility is calculated at heights above a Digital Surface Model that places observers on buildings and vegetation. Building areas have been overlaid to account for this effect.

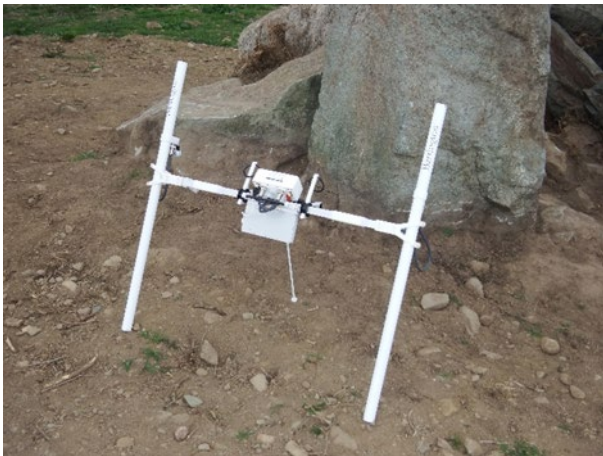
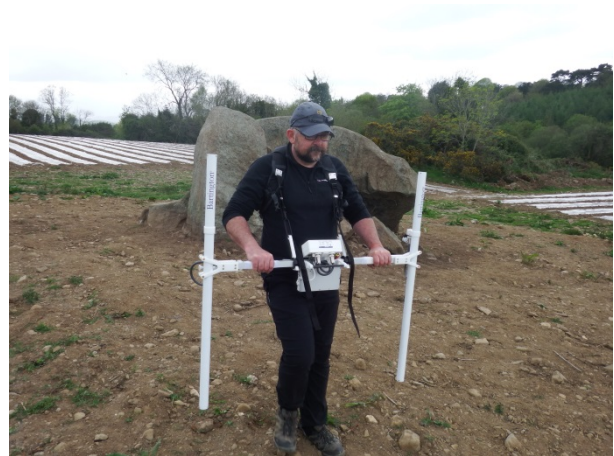
**Fluxgate Gradiometer Survey:** Surveys are undertaken using the Bartington Grad 601-2 survey instrument which was specifically designed for archaeological prospection. It includes sensors that are highly stable, minimizing requirements for excess data processing. The instrument has a vertical 1 m sensor separation permitting finite resolution of buried archaeological features. Surveys can be undertaken in scan or detailed (zig-zag traverse) modes for reconnaissance or high-density mapping. The fluxgate enables reliable flexibility during fieldwork. Frequent realignment of the instruments and zero drift correction ensure a constant high quality of data. Extremely sensitive, these instruments can detect variations in soil magnetism to 0.1nT, affording diverse application throughout a variety of archaeological, soil morphological and geological conditions. The instrument can be employed in both commercial and research-based investigations allowing for completion of projects within short timescales. Regular grid sample densities from standard 1600 readings to 12800 readings per 20m by 20m grid are permitted. A constant high quality of data is assured by experienced field staff operating in accordance with English Heritage Research & Professional Guidelines No. 1, *Geophysical Survey In Archaeological Field Evaluation* (David 1995).

Bartington Grad 601-single axis dual sensor gradiometer.

The Bartington GRAD 601-2 instrument is a specifically designed gradiometer for use in archaeological prospection. Extremely sensitive, these instruments can detect variations in soil magnetism to 0.01nT, affording diverse application throughout a variety of archaeological, soil morphological and geological conditions. The survey is geo-referenced with a Trimble Geo 7X unit accurate to within 1cm. Interpretation of the results was made by examination of the raw data as greyscale images, XY trace, relief and data plots. Archived raw data is presented in Figures 6 and 7 and an interpretation is presented in Figures 8 and 9.

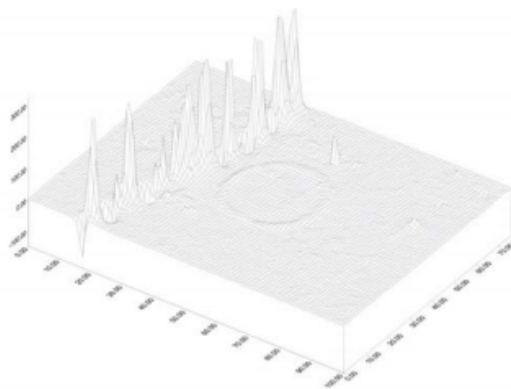
**XY Trace:** The data are presented as a series of linear traces, enabling a semi-profile display of the respective anomalies along the X and Y axes. This display option is essential for distinguishing between modern ferrous materials (buried metal debris) and potential archaeological responses. The XY trace plot provides a linear display of the magnitude of the response within a given data set.

XY Trace of enclosure site

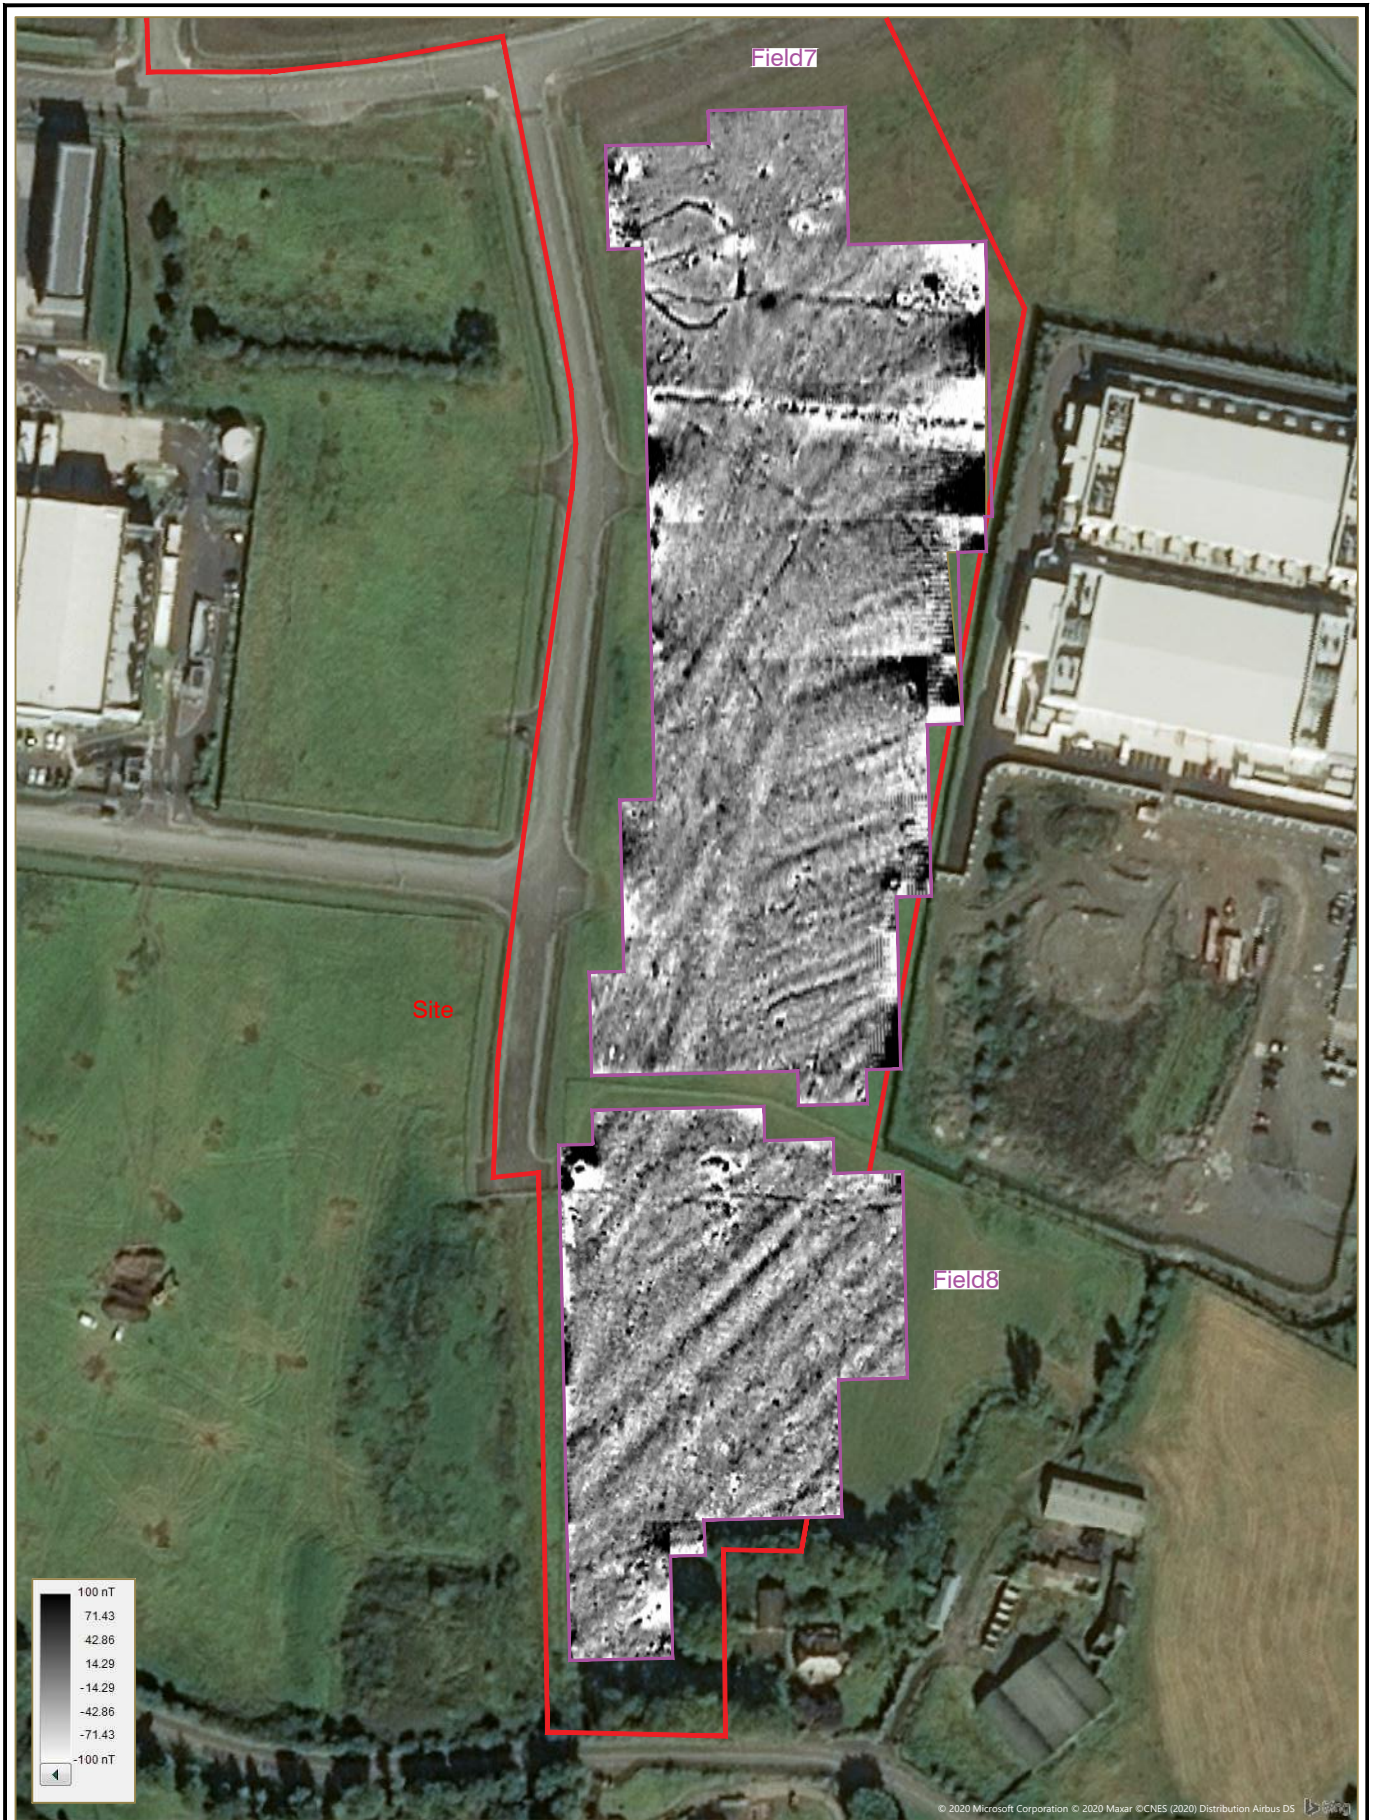
Figure 7: Aerial view of site, showing geophysical survey results (greyscale image) of fields 7 and 8

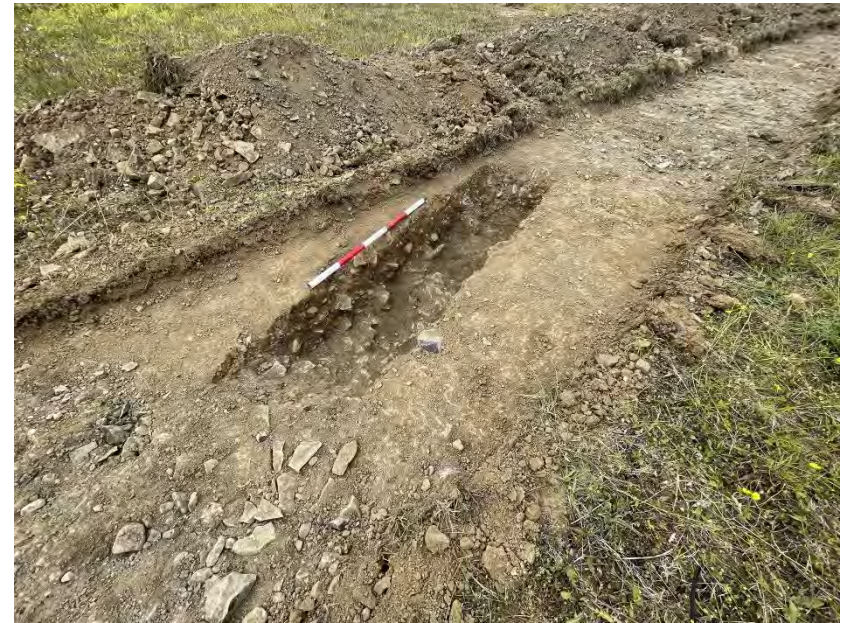
Plate 6: Test Trench 1, enclosure ditch C3, facing north-west.

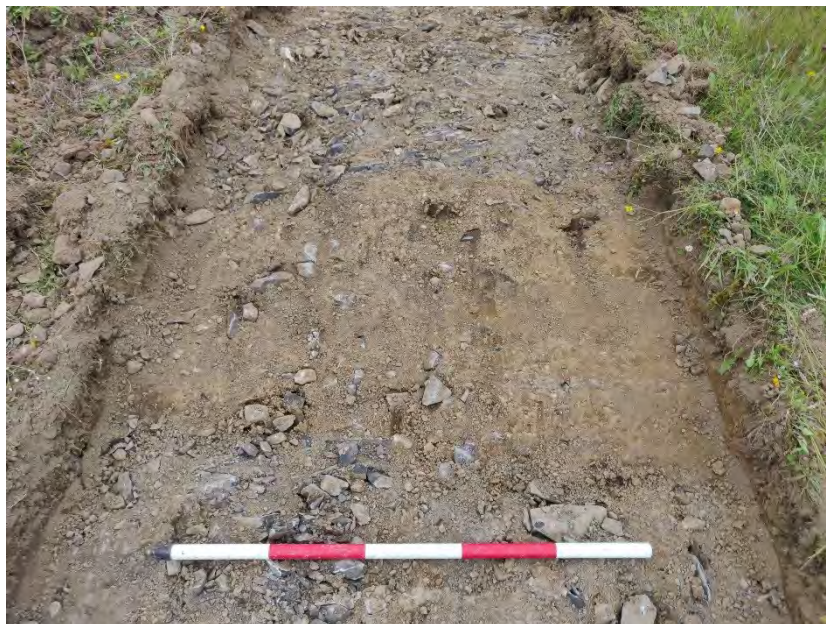
Plate 7: Test Trench 1, ditch C5, facing north.

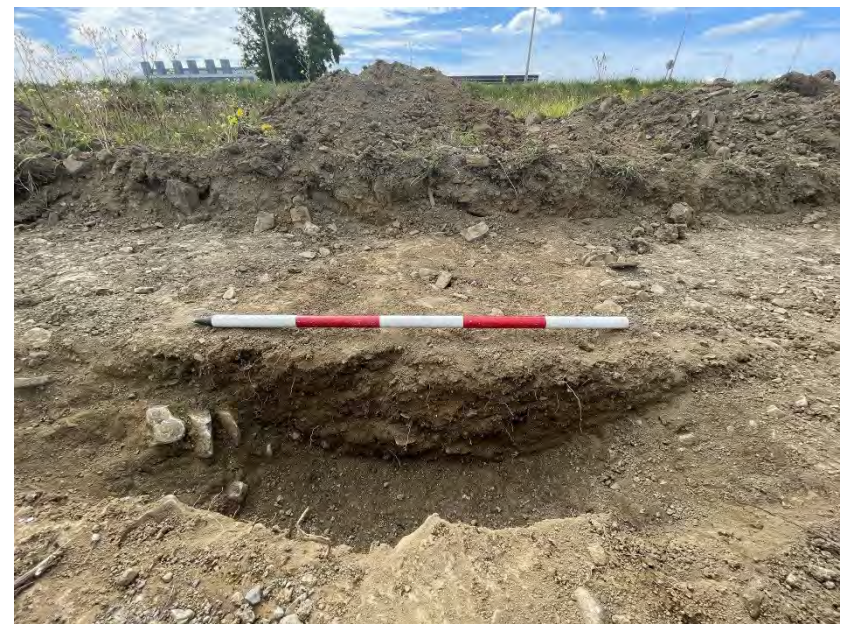
Plate 8: Test Trench 1, section through ditch C5, facing west.

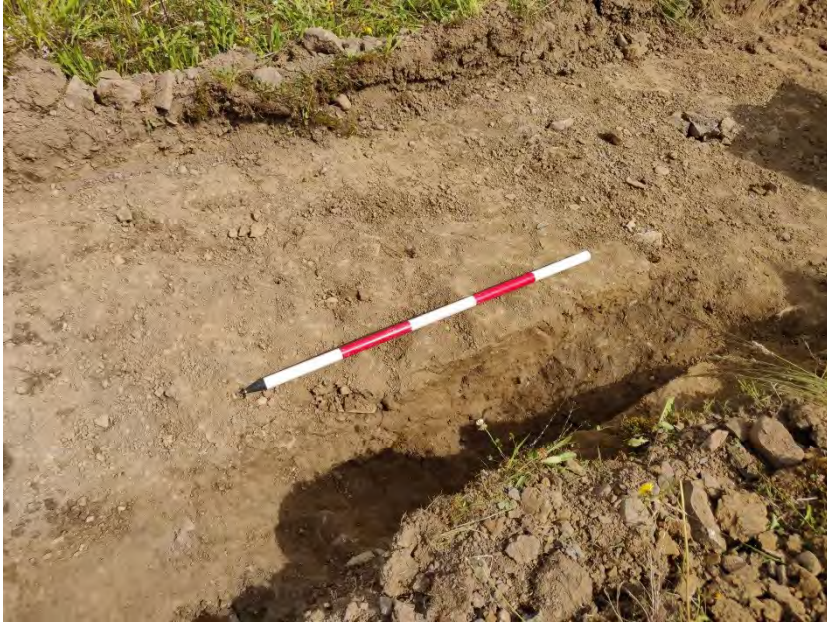
Plate 9: Test Trench 1, ditch C7, facing southeast

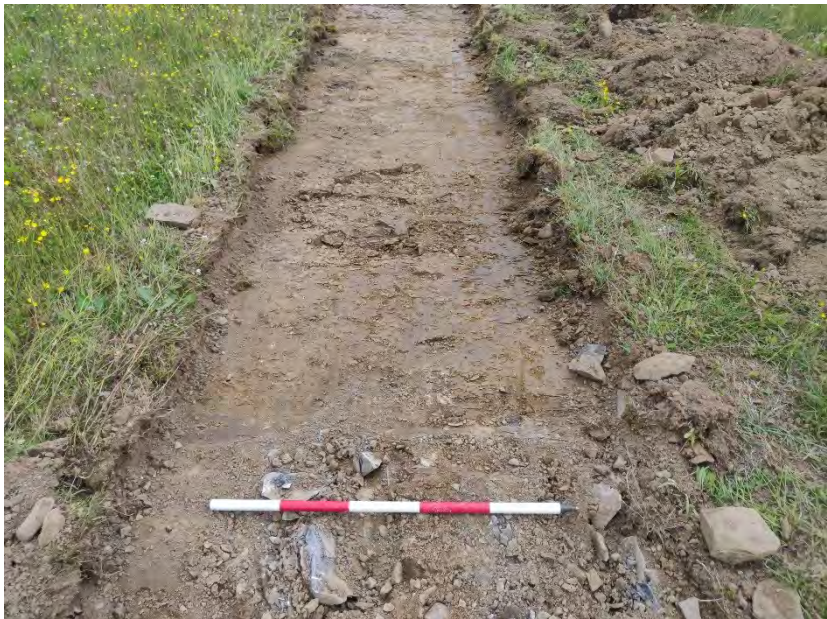
Plate 11: Test Trench 2, enclosure ditch C3, facing east.

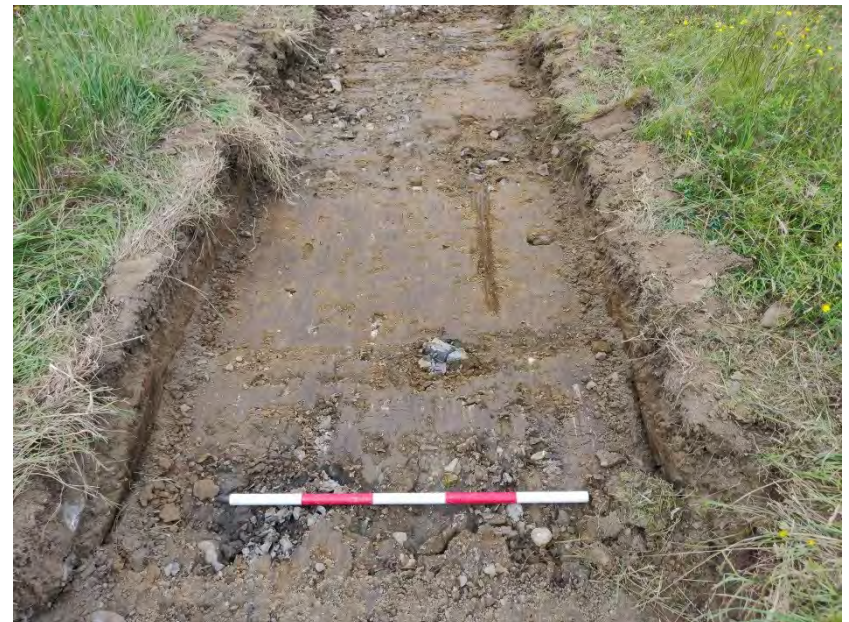
Plate 16: Test Trench 6, enclosure ditch C3, facing north.

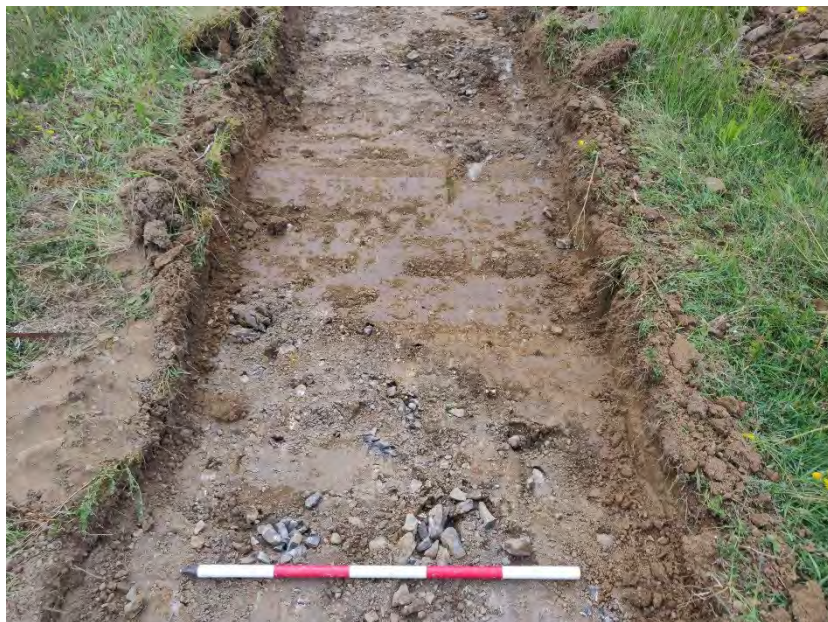
Plate 19: Test Trench 8, enclosure ditch C3, facing southwest.
