**Archaeological Test Excavation of a site at Main Street,
Newcastle, County Dublin**

For Pavement Homes

**Licence 18E0558
Planning ref: SD18A/0363**

**Claire Walsh
April 2019**

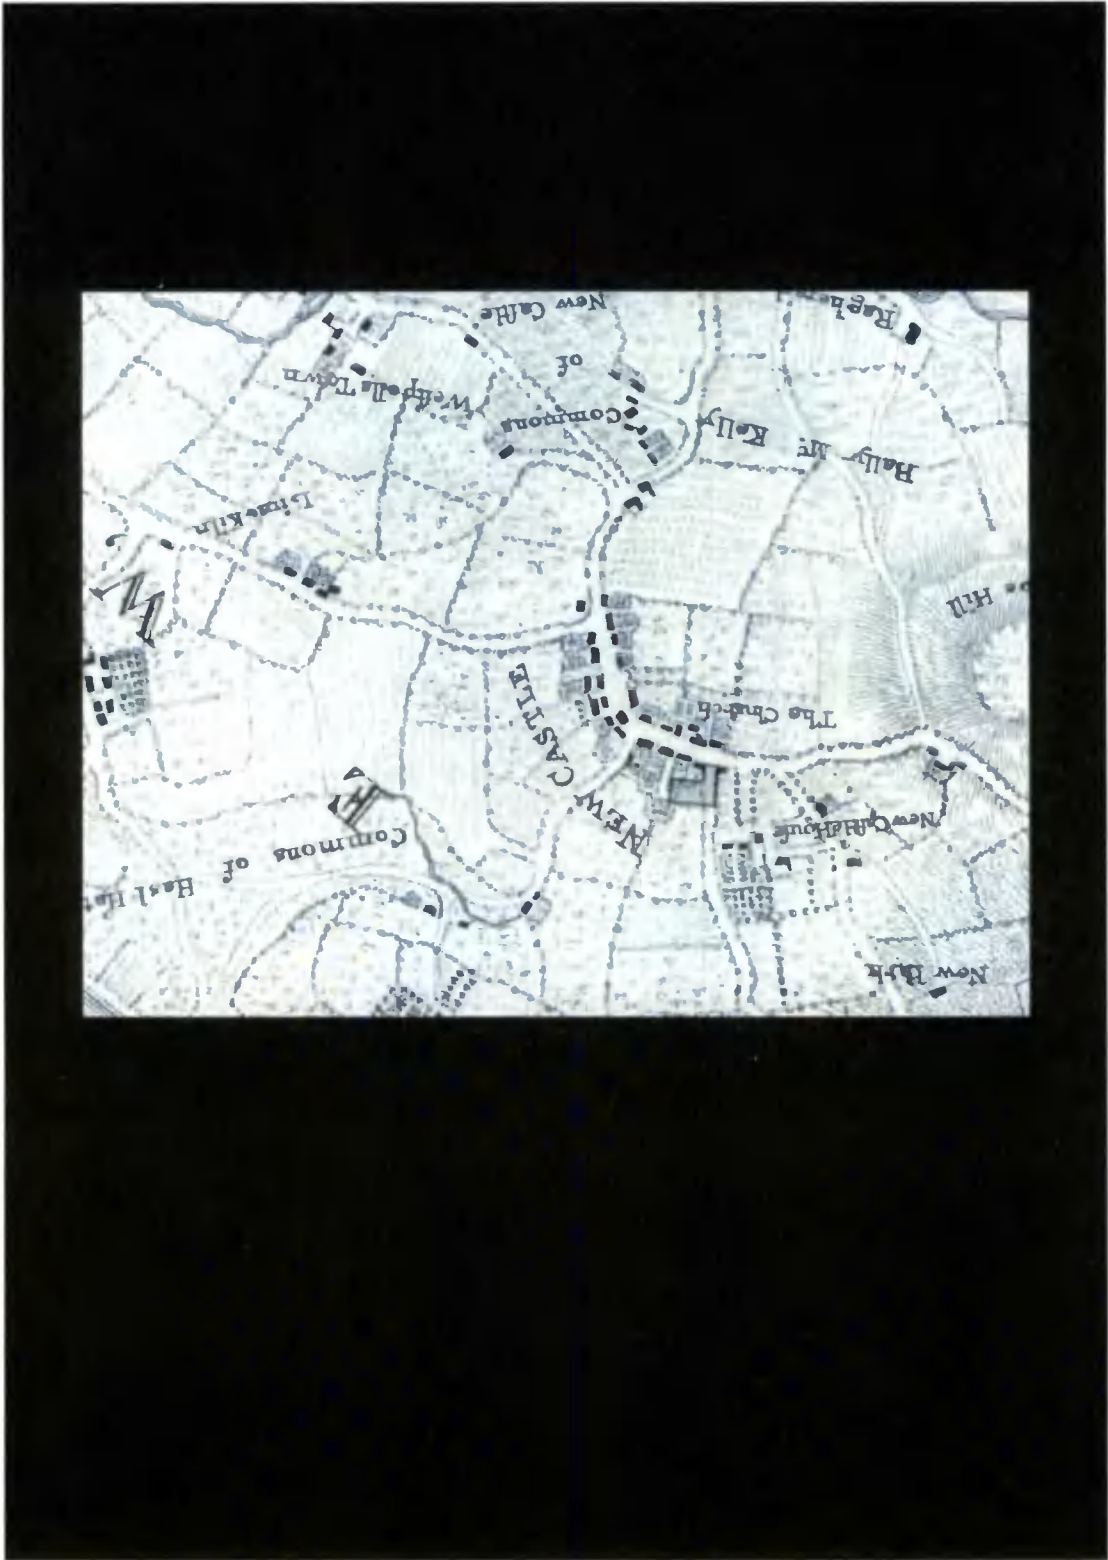
Figure 3. Newcastle on Rocque's 1760 map.

Rocque's map of 1760 indicates a linear settlement around a curving street (Swan's potential ecclesiastic enclosure) with laneways leading off to all directions. Buildings are located to the street, and the remains of the burgage plots extend from these. One of these laneways appears to be on the present site, where the proposed access from Main Street will be located. There was no building on the street front in the mid- 18th century. Parts of field boundaries extend along the margins of the site on Rocque's map.

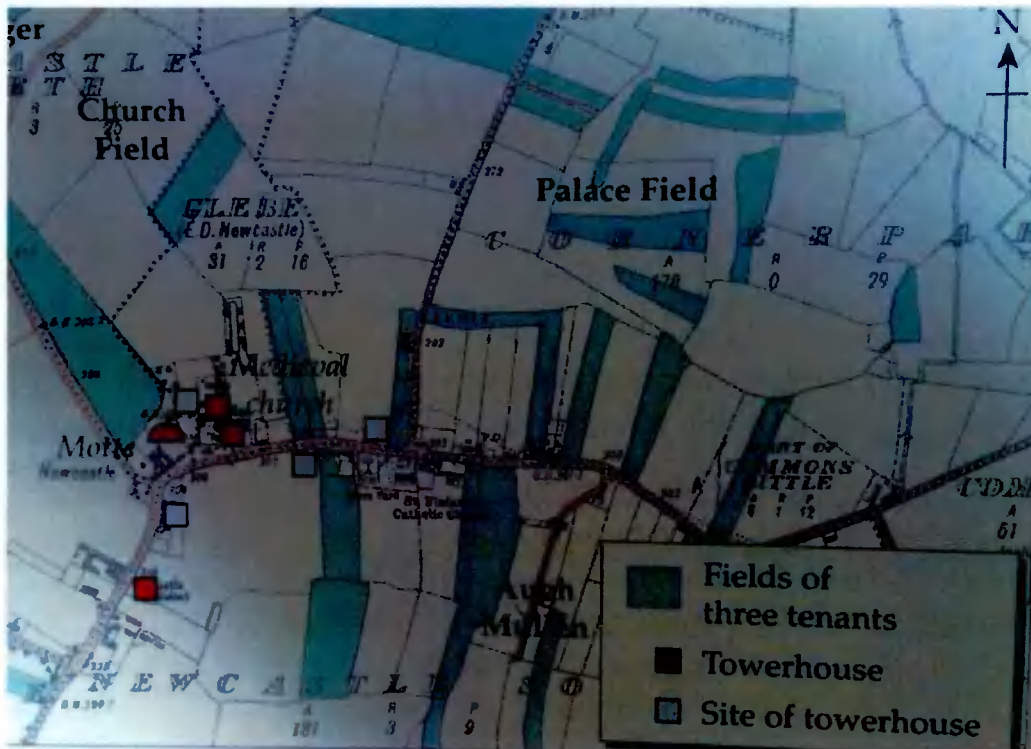
Figure 4. Aylmer's 1722 map, after Simms, showing medieval structures.

A composite map derived from George Aylmer's estate map of 1722, after Simms, shows the layout of a three- field system, with scattered ownership of long strip fields, and commonage. No strip fields are indicated on the subject site.

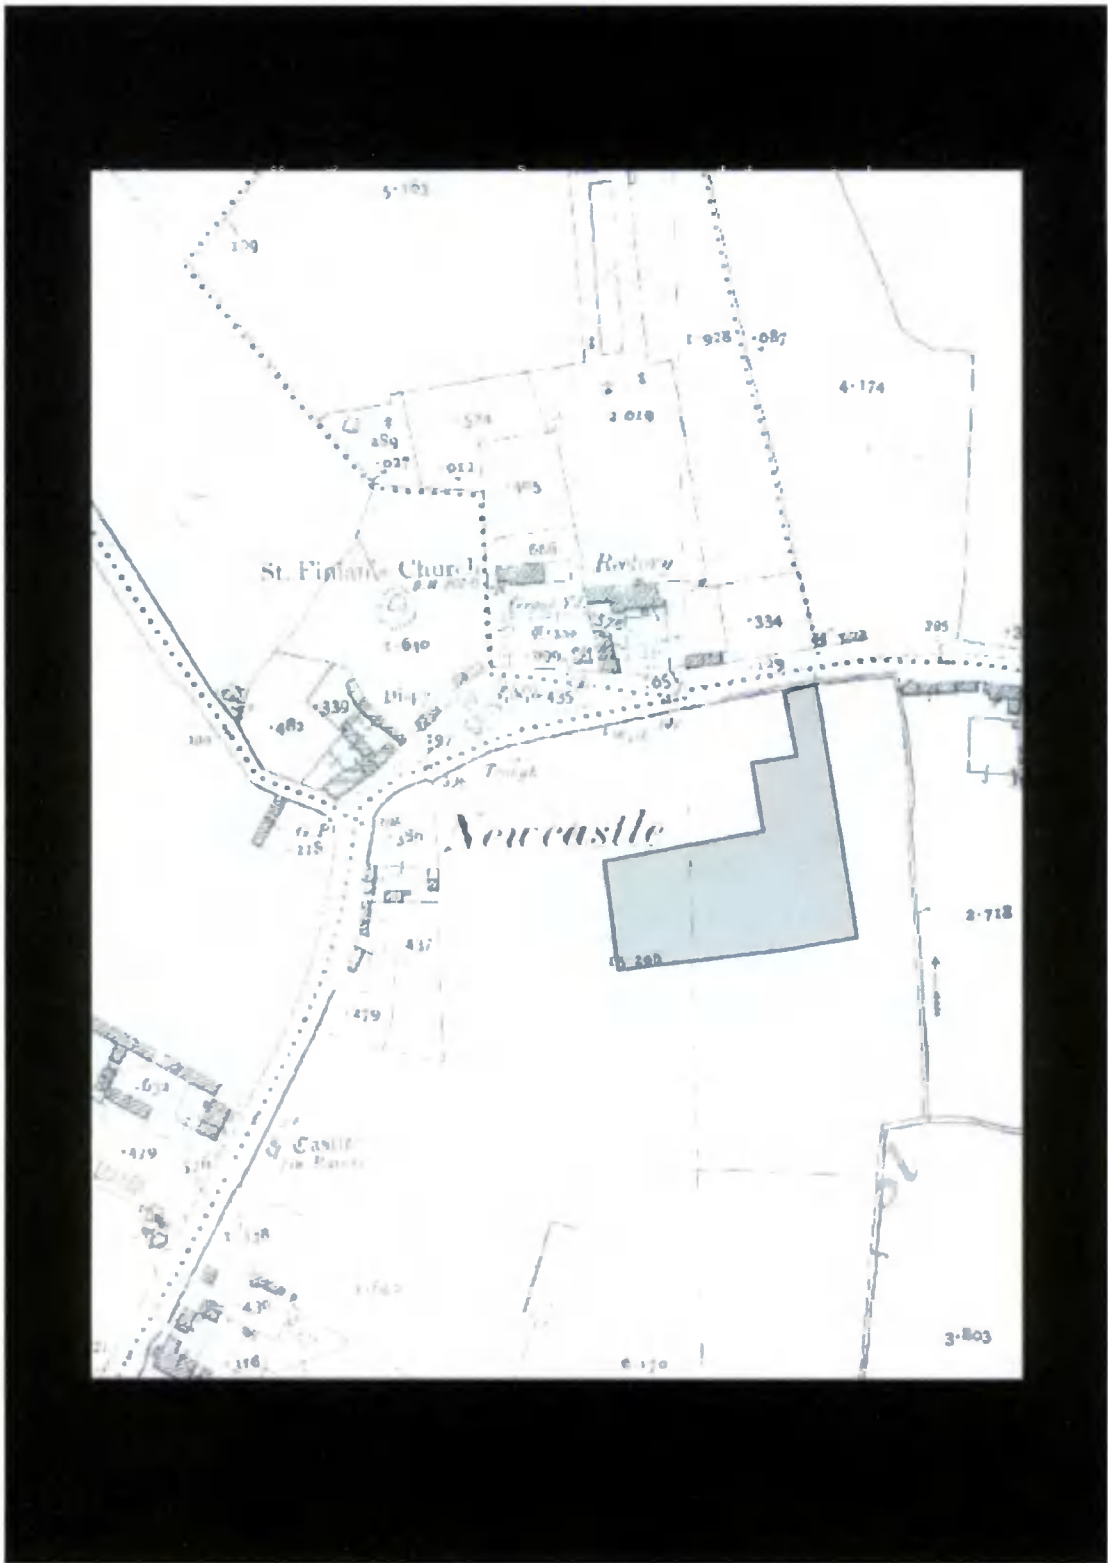
Figure 5. Newcastle on Ordnance Survey First Edition, 1847.

The 6in (first edition) map shows no features on the subject site, nor on the 25 inch, dating from c. 1880-1913. There are no structures on the site indicated on the mid- 20th century Cassini series of maps.

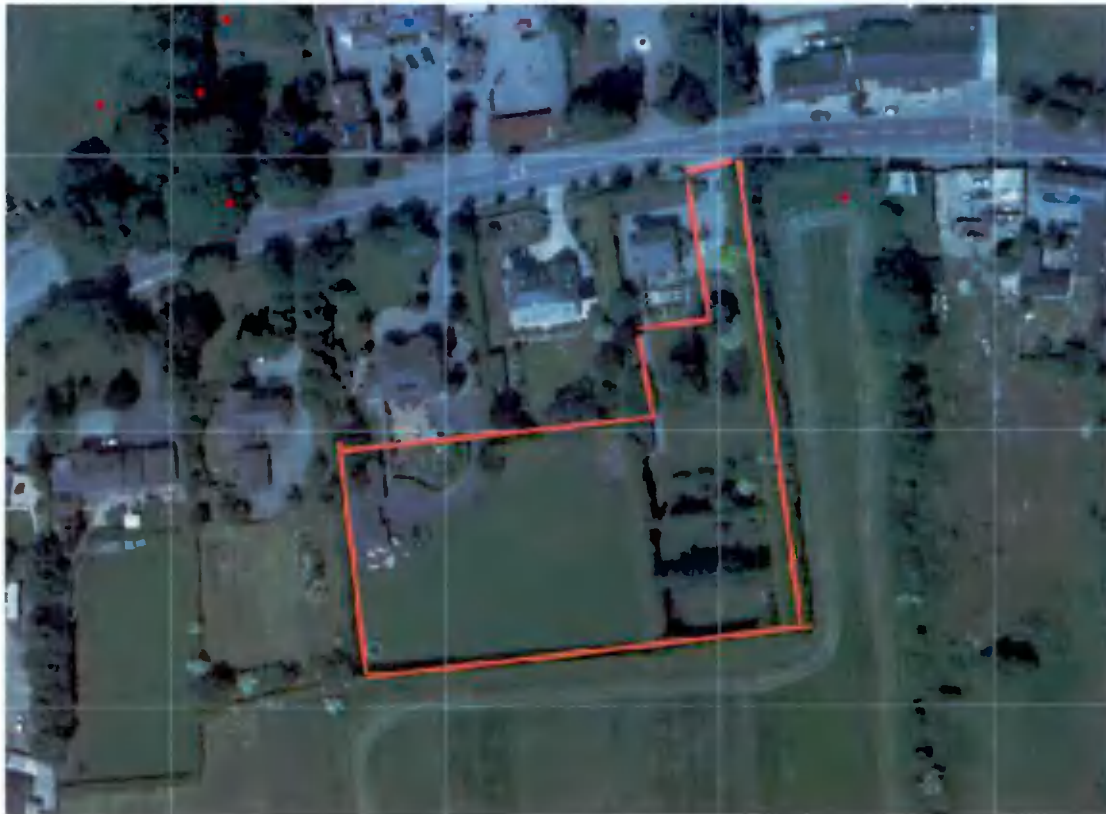
Figure 6. Digital globe shot showing suburban gardens presently forming site.

The Digital Globe aerial photograph shows that the site has been used as gardens for some time. A concrete surface and shed extends into the northern part of the site, and further hedged boundaries have been planted on the eastern part. These areas are likely to have been subjected to heavy land drains, disturbing any earlier deposits.

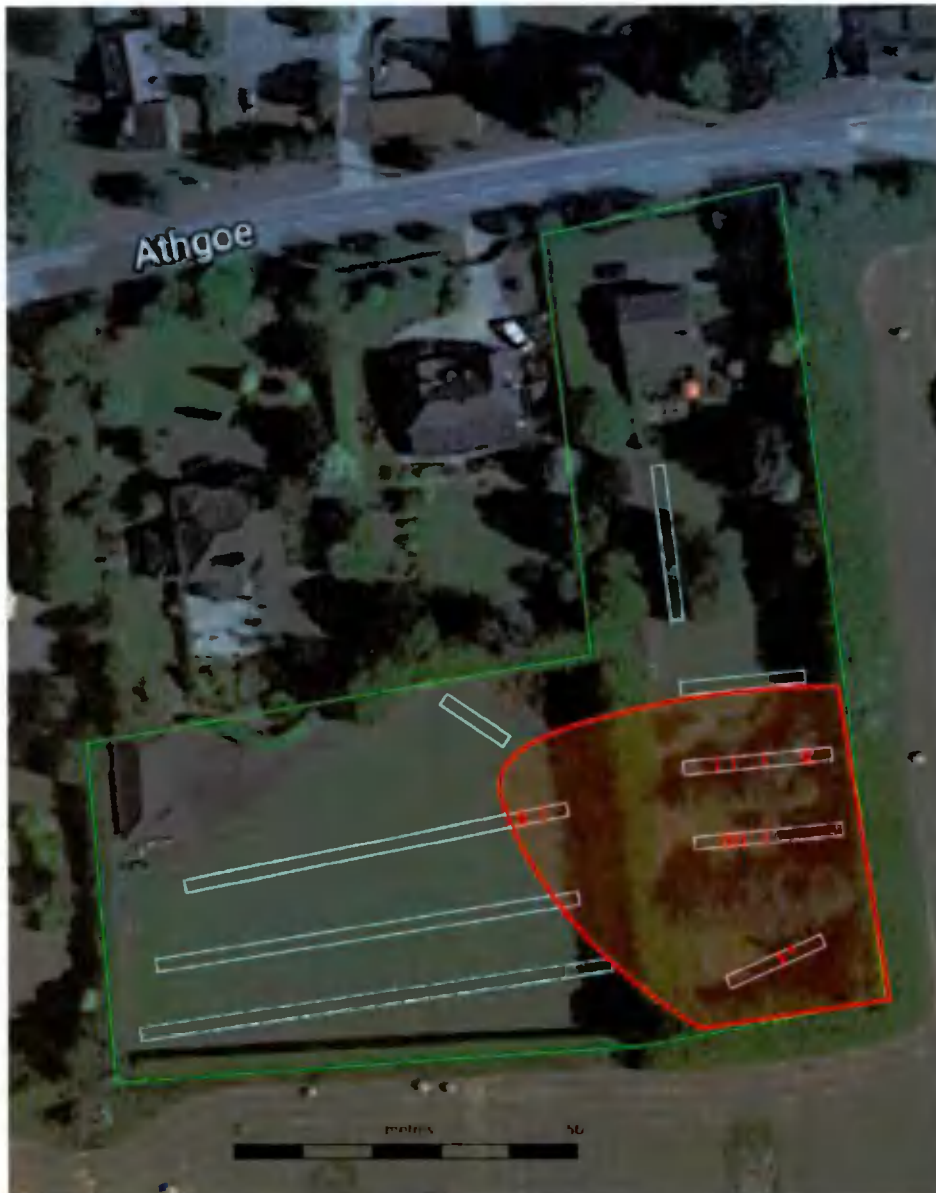
Nine trenches (totalling 281 linear metres / 562 square metres) were opened on the site under archaeological supervision on the 04^h and 05th April 2019, using a 14-tonne, tracked 360-excavator equipped with a 2m-wide toothless grading bucket (figs. 7-8). All trenches measured 2m in width.

Fig. 8. Location of Trenches and features uncovered overlaid on satellite photograph of the site.

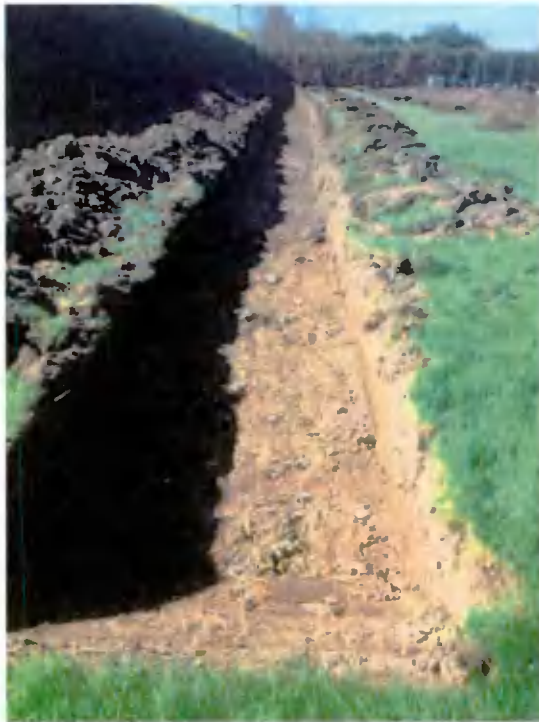
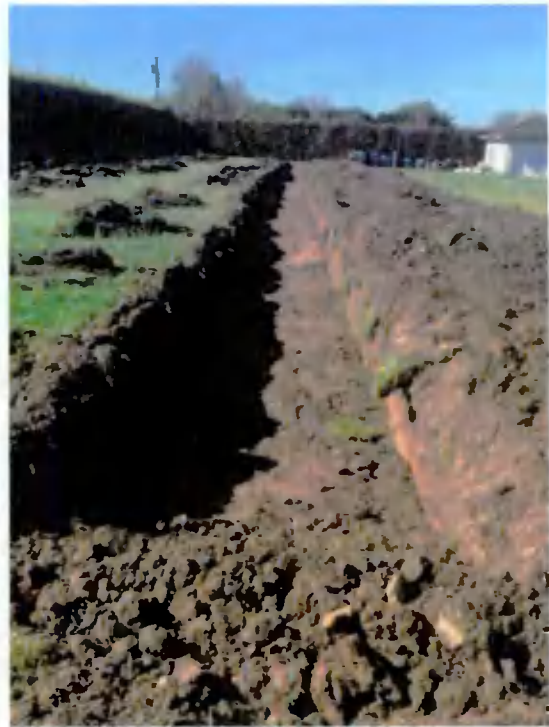
No features of archaeological interest were revealed. Both the ploughzone and topsoil were remarkably 'clean' and apart from a modern rubbish pit towards the west end of the trench and a few modern plastic objects no finds were uncovered.

Fig. 10. Trench 1, looking west.

Fig. 11. Trench 1, looking west.

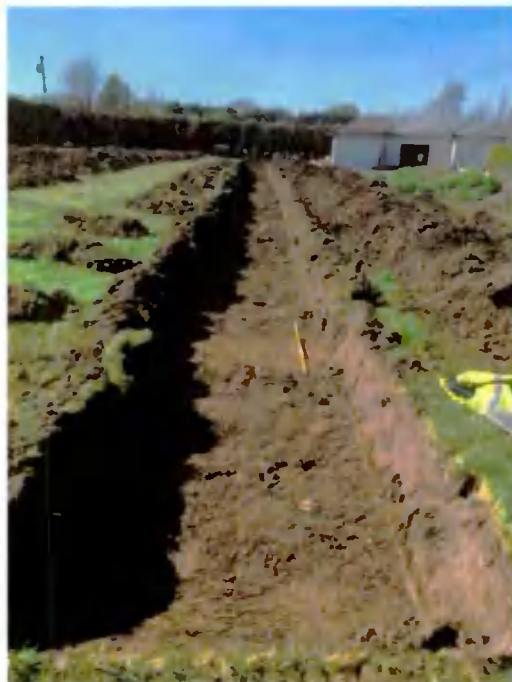
Two features (F1 & F2) of archaeological interest were revealed at the east end of the trench below the ploughzone at 400mm below modern ground level; over the remainder of the trench the only features revealed were modern rubbish pits.

Fig. 12. Trench 3, looking west.

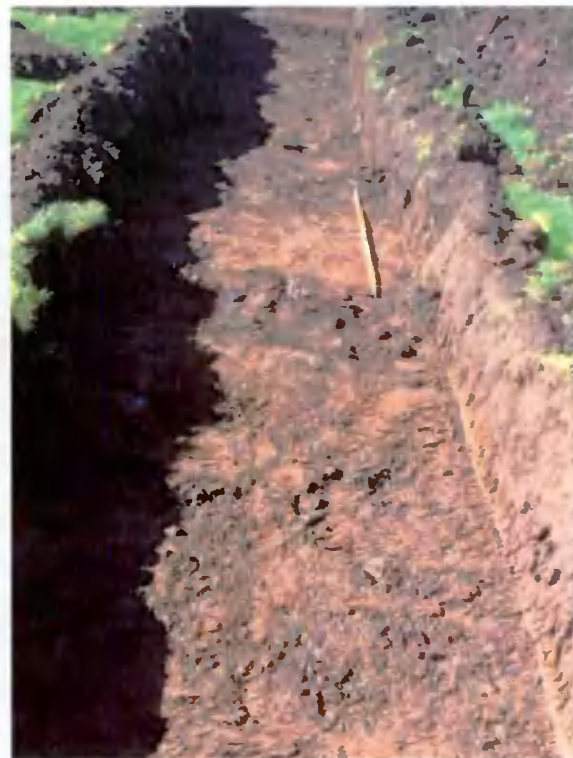
(F1) 3m from the east end of the trench a 600mm wide north-south aligned linear gully filled with silty grey loam crossed the trench. Sherds of medieval pottery were present in its upper fill and it was not further excavated.

(F2) 5m from the east end of the trench a 2200mm wide north-south aligned linear gully filled with silty grey loam crossed the trench. Sherds of medieval pottery were present in its upper fill and it was not further excavated.

Fig. 13. Trench 3, F1 & F1 at ends of ranging rod.

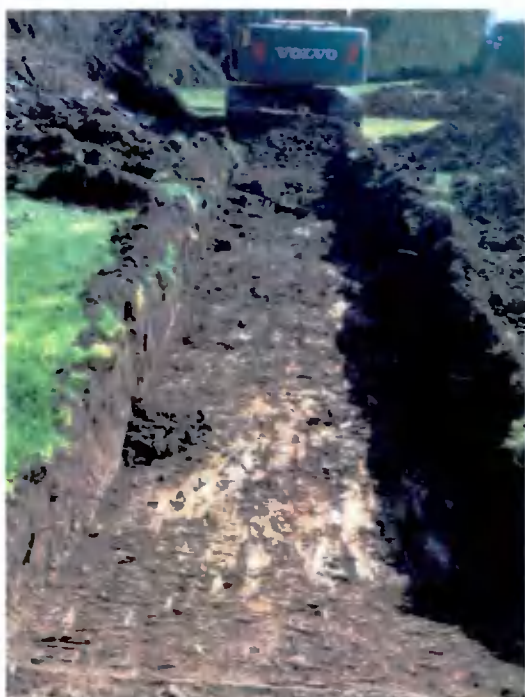
Modern rubbish pits cut into subsoil (which was shallower -350mm below modern ground level- and harder here than elsewhere) occupied the full length of the trench and no features of archaeological interest were uncovered. The shallow depth of subsoil here suggests that this area may have been scarped in recent times to level the field.

Fig. 14. Trench 4, looking southeast.

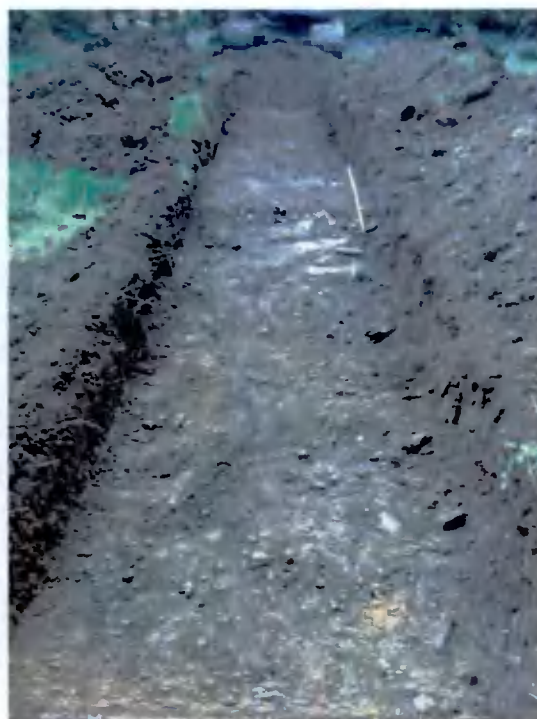
(F3) A 600mm wide, north-south aligned, lime-mortar bonded, limestone masonry wall or footing, was revealed at the north side of the trench at 400mm below modern ground level. The white lime mortar in the structure did not include coal or red brick fragments, suggesting it possibly dated to before the eighteenth century.

(F4) The large and 600-700mm wide, limestone capstones of a substantial north-south aligned drain crossed the trench 1.3m west of (F3). The top of the capstones lay 300mm below modern ground level.

The presence of the mortared stone structure (F3) and the flagstone-capped drain (F4) in Trench 5 suggest the presence of a building or buildings in the vicinity. These type of features are not generally found in a medieval agricultural context. The drain (F5) and burnt spread (F6) and other features in Trenches 6 and 7 and the discovery of many sherds of medieval and post-medieval pottery from Trenches 5-7, suggest the building/s and associated features date from the medieval to post-medieval period and were surrounded by an area of cultivation evidenced in Trenches 3, and 5-7.

Fig. 15. Trench 5, ranging rod beside F3 & F4

Fig. 16. Trench 5, looking north, (F3) on left, (F4) on right.

Should substantial masonry structural remains survive, the National Monuments Service may require *in situ* preservation, which may affect the layout or extent of the proposed development.

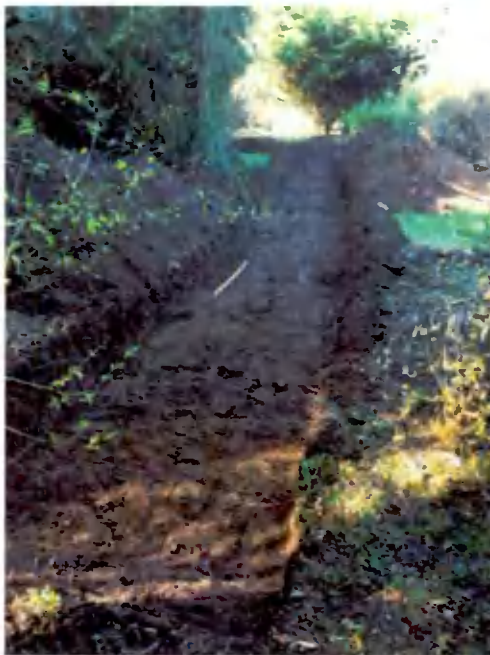
Close to the east end of the trench, a 1.3m-wide, north-south aligned gully (F13), filled with grey silt crossed the trench. To its west the 3m-wide former field boundary ditch (F14) crossed the trench. Further west again there were three silt-filled, north-south aligned cultivation furrows (F15-17), some of which contained medieval pottery. The top of these features lay at 500-550mm below modern ground level.

Fig. 19. Trench 7, looking west.

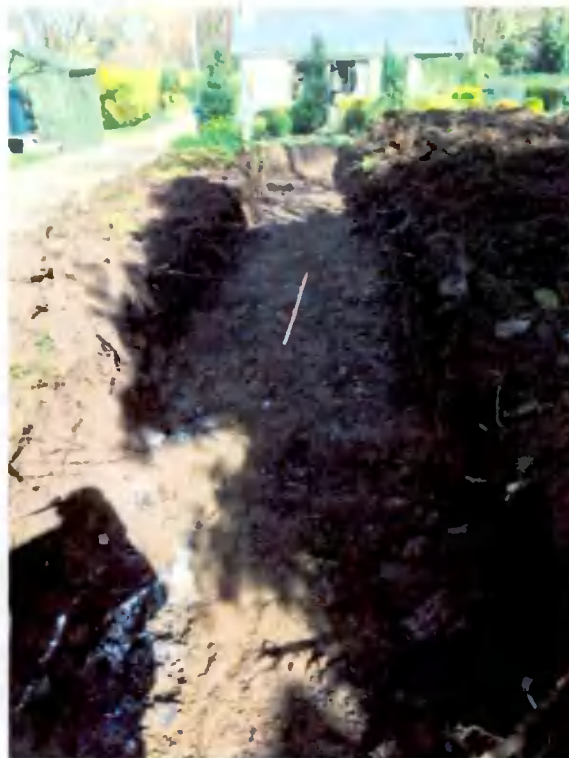
A north-south aligned, 3.5m-wide ditch (F18) filled with silty loam crossed the trench 5.5m from its east end. The top of the ditch lay 450mm below modern ground level and this feature is likely to be the same field boundary ditch noted in Trenches 6 and 7.

Fig. 20. Trench 8, looking west.

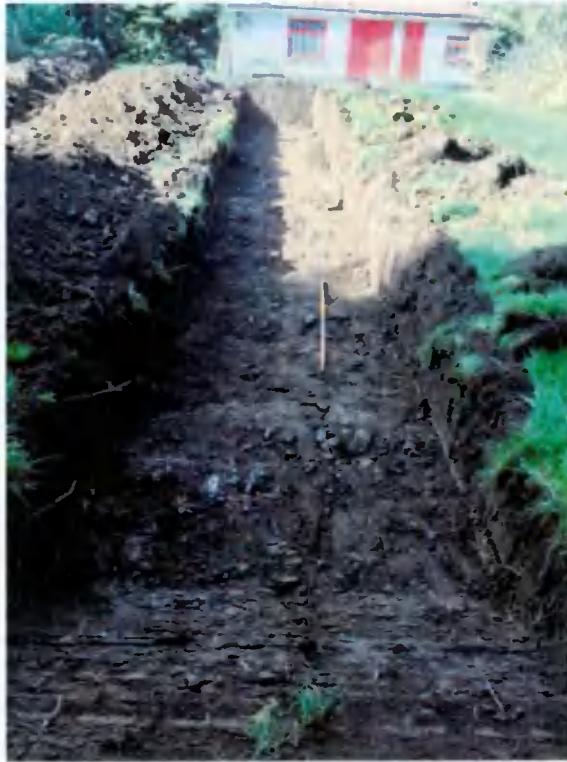
No features of archaeological interest were noted in this trench. Subsoil here was particularly stony and not conducive to the survival of cut features.

Fig. 21. Trench 9, looking north
