# Rowan

## River Camac Surface Water Monitoring 2021 Report 2021

**Hinch Site, Saggart, Co. Dublin**

**Coffey Constructions Ltd**

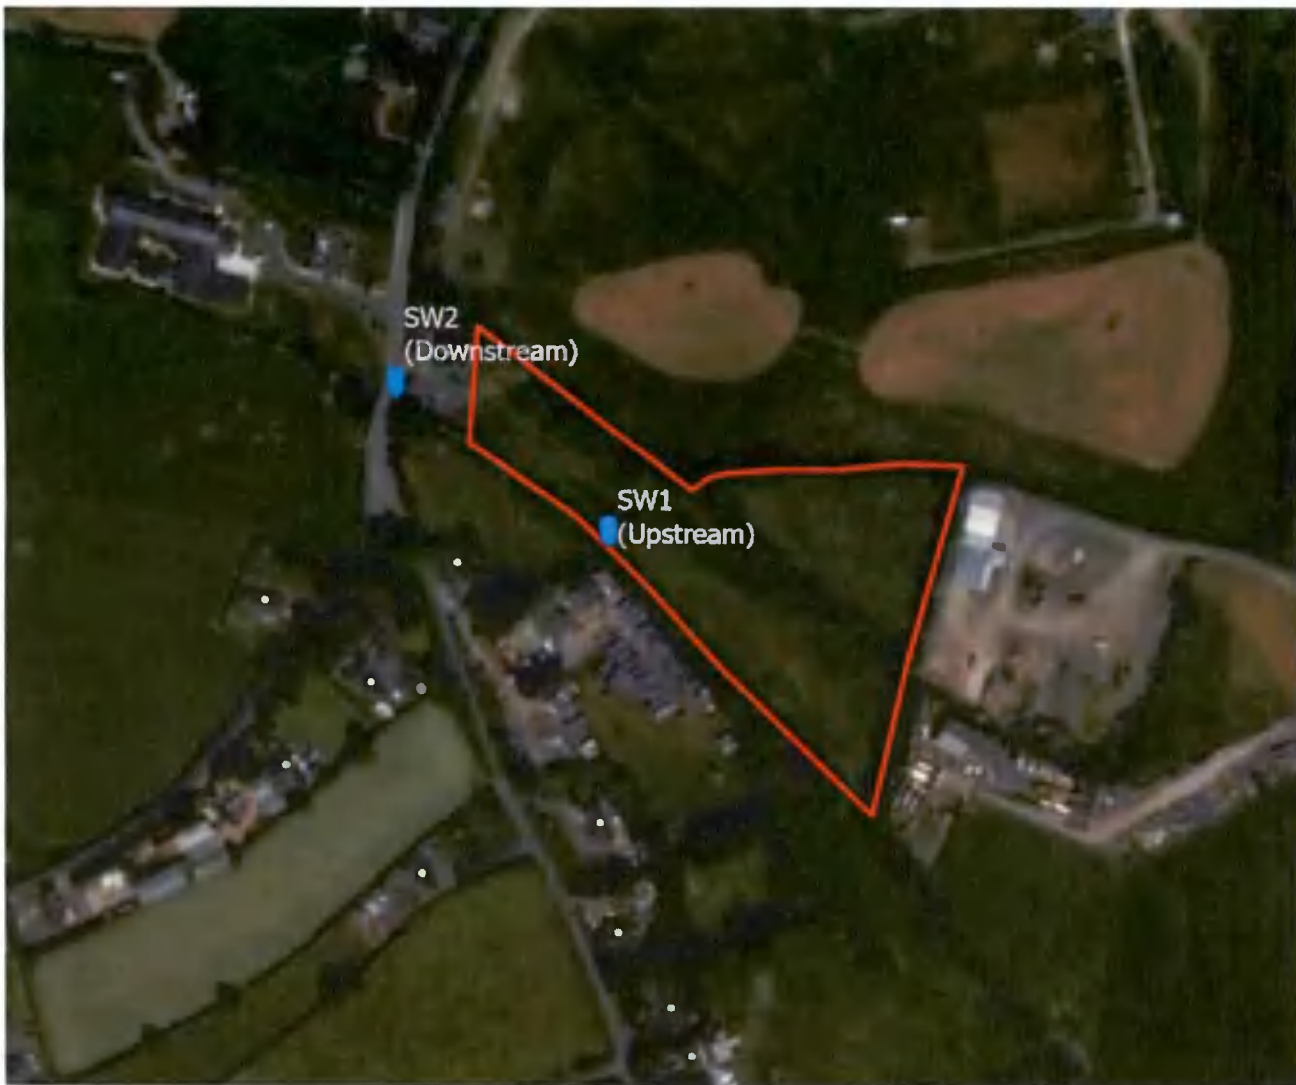
Figure 2: Site Sampling Locations

Table 1: River Camac sample locations

Sample No.	Description	Location (ITM)
SW1	Upstream	X703457 Y726019
SW2	Downstream	X703356 Y726089

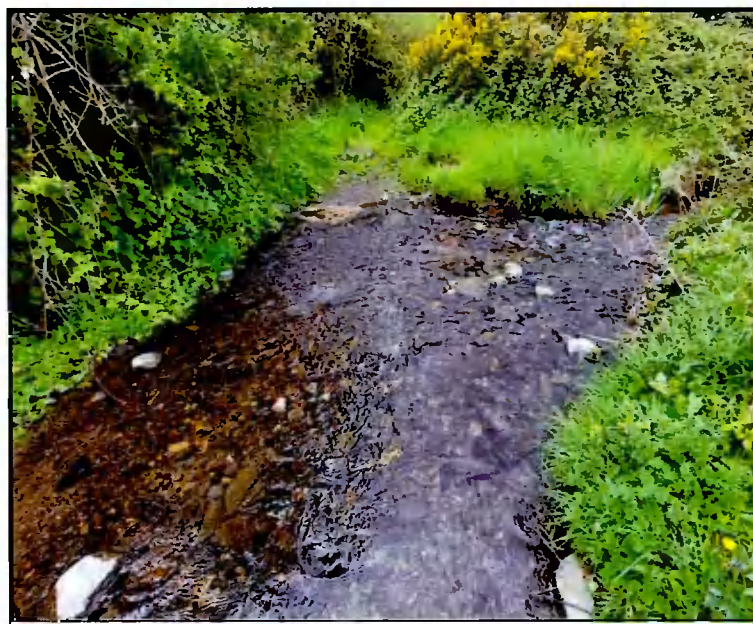
Photograph 1: SW1 (Upstream) Sampling Location

Surface water sampling was carried out by Mr. Ian Douglas and Ms. Eimear O'Brien of Rowan on 18<sup>th</sup> of May 2021 at monitoring locations SW1 and SW2. Monitoring locations are shown in Photographs 1&2 below and in Appendix A.

Monitoring Location	Visual Inspection 18 <sup>th</sup> May 2021	Other Comments
SW1	<ul style="list-style-type: none"> <li>• Clear sample</li> <li>• No odour</li> </ul>	Dry weather.
SW2	<ul style="list-style-type: none"> <li>• Clear sample</li> <li>• No odour</li> </ul>	Dry weather.
