## **Appendix 11 – Mammal Assessment Report**

## Saggart Reservoir - Design and Build Contract

A mammal assessment undertaken on behalf of Rowan Engineering and Coffey Group for the Irish Water Reservoir at Saggart, County Dublin relating to the area within which earth spoil is proposed for storage

February 3<sup>rd</sup> 2021

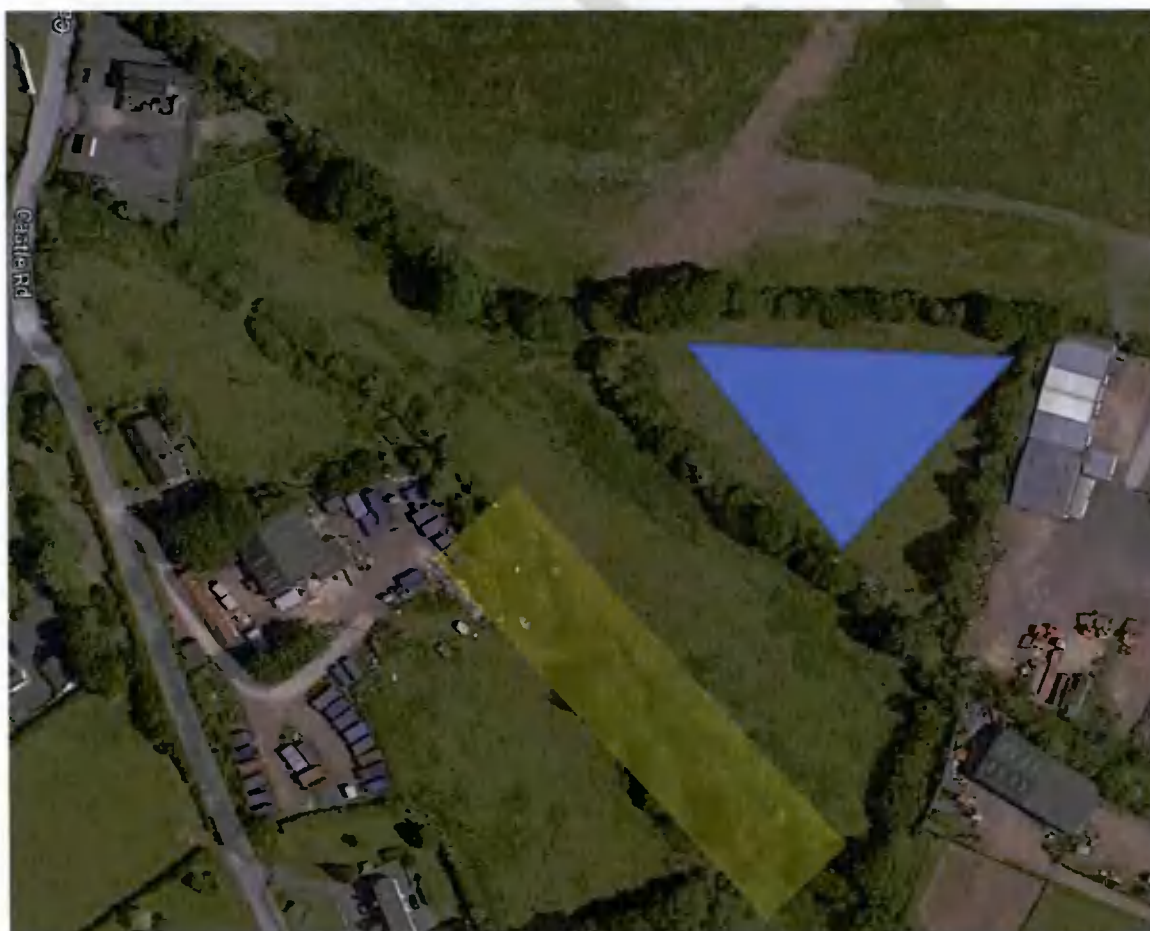
Figure 1: Area proposed for the storage of spoil in lands adjoining the Reservoir. The triangle is indicative of the area under discussion and does not denote the footprint of the spoil heap. The yellow box denotes areas of otter and badger activity noted within the surrounding lands

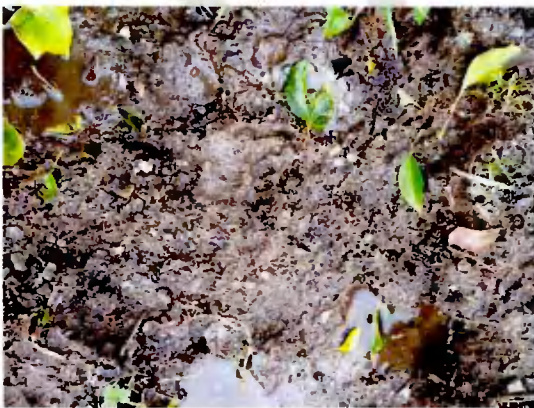
No badger setts were identified within the site proposed for soil storage or in the nearby hedgerow. Badger foraging signs were evident from badger paw prints in the field south of the proposed storage area.

Badger paw prints south of the proposed storage area at the River Camac

- “the Contractor shall maintain a regular watching brief along all topsoil stored on site for potential establishment of badger setts during the construction phase”.

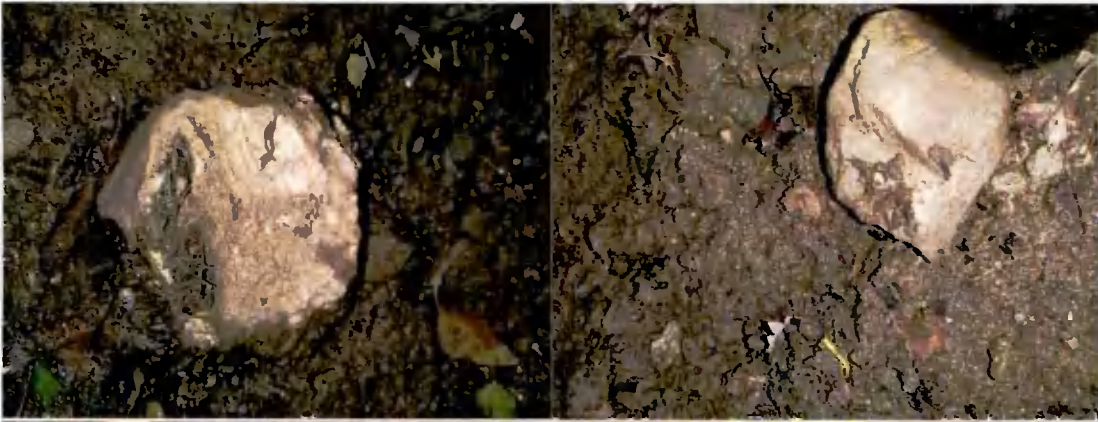
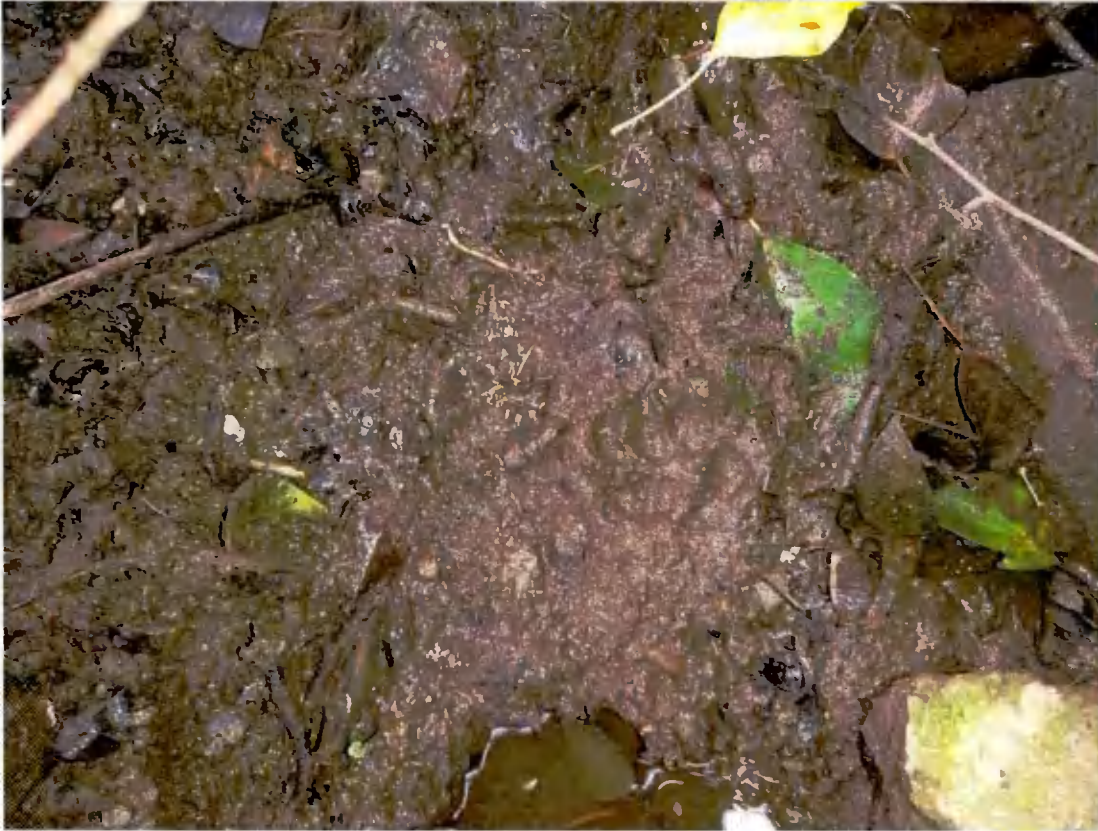
**Otters are present within the Camac and adjoining lands but not within the footprint proposed for spoil storage. The above measures apply:**

Otter spraints and paw print

- **Where otter activity is confirmed onsite, the EnCOW shall engage a suitably qualified Ecologist to advise and or supervise works during construction of the discharge infrastructure.**
- **The Contractor shall maintain a ten metre riparian zone alongside all watercourses within the site boundary or lands for which the contractor may require as a working corridor for the construction of the discharge pipes. A narrow working corridor, clearly delineated shall be put in place alongside the Camac River during the construction period.**
- **No works or storage of materials outside of the working corridor shall be permitted. Works in the area shall be scheduled to coincide with dates that will be approved by IFI and/or NPWS and shall be completed in a timely manner to reduce all unnecessary environmental impacts/disturbance to otter.**
