Technical Appendix 11.3: Biodiversity Management Plan

Biodiversity Management Plan

Profile Park Data Centre

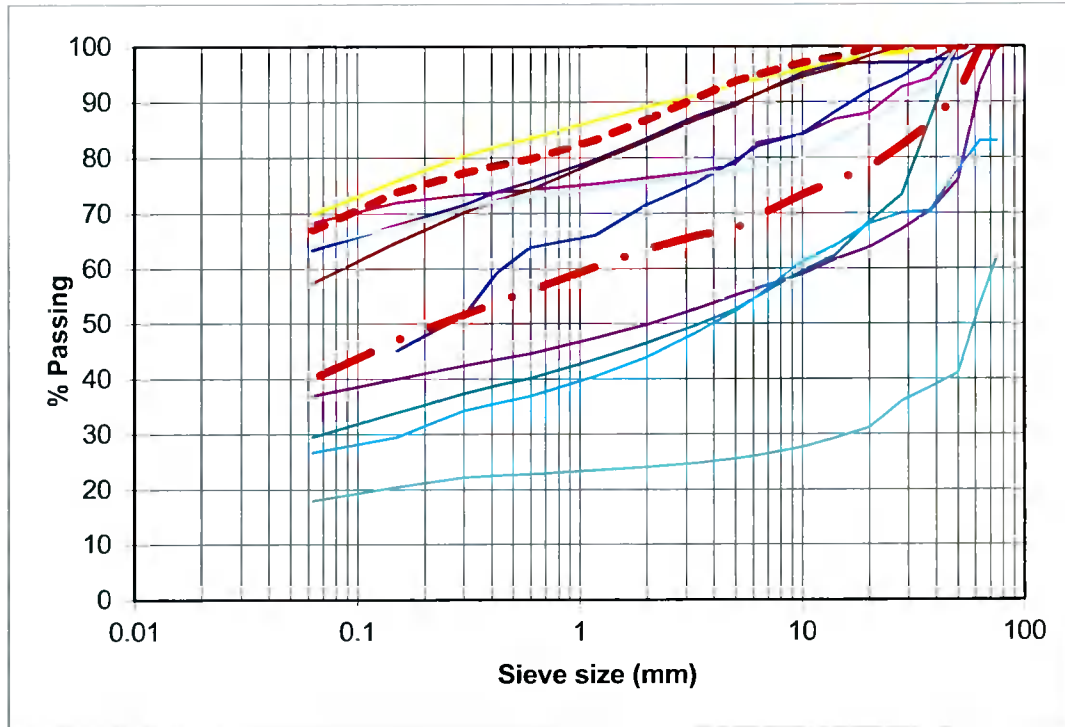
Figure 4 - Particle Size Distribution Envelope

A series of index or classification tests were carried out on the trial pit samples and results are presented in Appendix 8. Moisture contents are quite variable with the majority in the 10 to 19% envelope. The particle size distributions show the glacial soils to be well graded with typical 'straight-line' type profiles (refer to Figure 4). Fines contents (<425micron) are largely between 52 and 70%. The Atterberg Limits show the glacial till deposits to be a mixture of low plasticity (CL) and intermediate (CI) CLAY. Plasticity Indices range from 10 to 22% (refer to Figure 3).

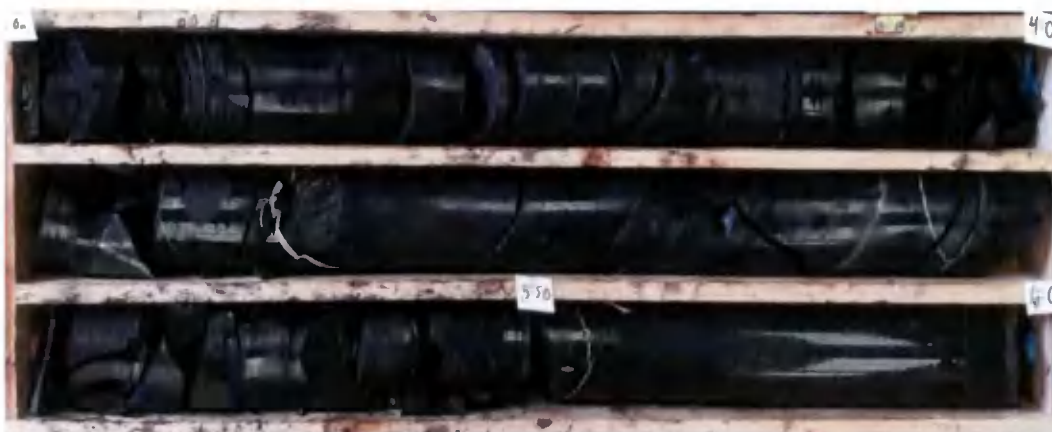
RC03 (3.0 to 6.0m)

The rotary drillholes show that bedrock typically consists of dark grey to black, strong fine grained predominantly argillaceous or muddy LIMESTONE with partings or thin interbeds of shale or mudstone (core specimens illustrated in Figure 7). Rotary coring proved bedrock or 'rockhead' at depths between 2.60m and 3.0m bgl. This correlates well with refusal depths in the cable percussive boreholes which mainly terminated at depths of 2.3 to 2.9m. The mechanical indices show that total core recovery (TCR) was excellent (100% in all instances) while rock quality designation (RQD) values mostly range from 50 to 70% though RQD values in RC03 are noticeably lower reflecting a more closely fractured or jointed cores. This is not uncommon in the Calp formation in West Dublin where rapid changes occur in both composition and fracture state.

Discontinuity spacings in the cores generally range from closely spaced (60 to 200mm) to medium spaced (200 to 600mm) with dips ranging from sub-horizontal, to 45°. The discontinuity surfaces are typically smooth to rough, planar to curvilinear and locally exhibit clay smearing in tight to moderately open apertures. Local iron oxide staining was also remarked during logging and calcite veining was apparent throughout.
