Electric Vehicle Charging Hub & Coffee Drive Through, Applegreen Rathcoole

Stage 1 Road Safety Audit

Petrogas Group Ltd

February 2021

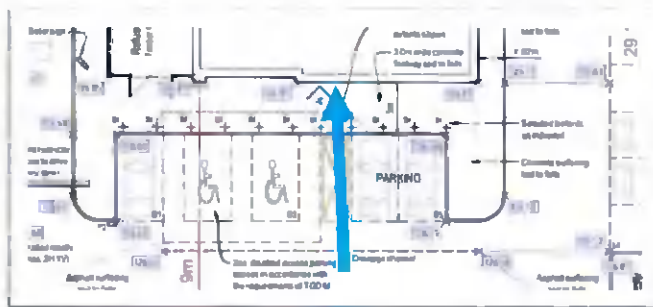
Figure 2.1 – Desire Line to Building Entrance

2.3 Problem: Building Access Blocked

Location: Drive Through Coffee Building

Careless parking practice could lead to the main access of the building entrance being blocked, resulting in progression issues for the visually impaired, ambulant disabled or parents pushing prams.

Recommendation

The yellow box should be replaced with a kerbed build-out. The buildout should be aligned centrally with the main access door and should also provide for universal access.
