Title: **STAGE 1&2 ROAD SAFETY AUDIT**

Proposed Residential Development, Kingswood, Co. Dublin

Report reference: **1417R01**

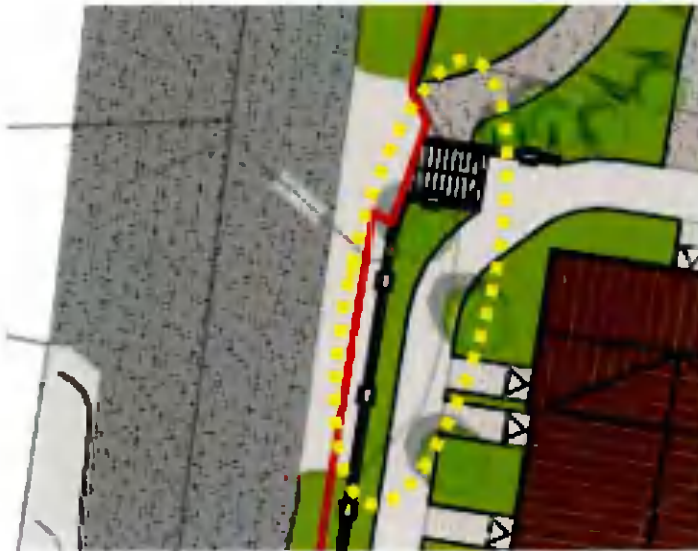
3.1 Problem

Drawing P210514-PIN-XX-DR-D-0001-SI P05, General Layout.

It is proposed to provide a set-back footpath along the development boundary with Old Naas Road and the existing stone wall is to be retained. There is a risk that this private footpath (noted that it is planned to be taken in charge – Drawing 21003-TJOC-ZZ-ZZDR-C-0079 Rev C01) may not be accessible to all members of the public walking from the Cheeverstown Road roundabout to a destination west of the site. It appears that steps are proposed. A lack of pedestrian facilities accessible to all would lead to pedestrians travelling on the carriageway where they would be at high risk of being struck by a passing vehicle.

It is recommended that a footpath be provided along the entire site boundary with access for all including the mobility impaired.

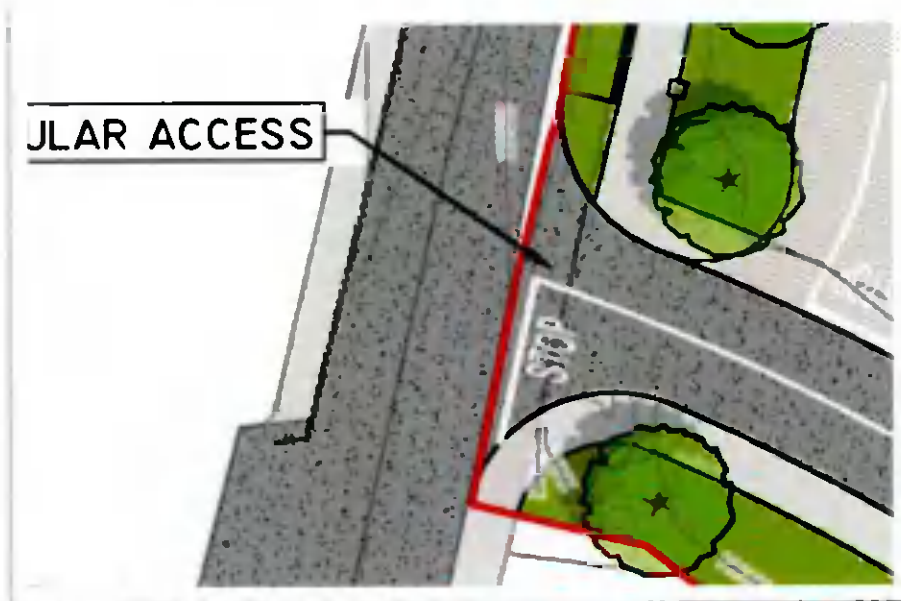
3.2 Problem

Drawing P210514-PIN-XX-DR-D-0001-SI P05, General Layout.

There is no facility for crossing the Old Naas Road for pedestrians if they wish to access the proposed development from the footpath on the opposite side of the carriageway. This could lead to trips and falls at the kerbs or inaccessibility for the mobility impaired.

It is recommended that an uncontrolled pedestrian crossing be provided at a suitable location to cater for future desire lines and with suitable visibility.
