**Tandy's Lane Development Phase 2**  
Stage 1 Road Safety Audit

Quintain Developments Ireland Ltd

March 2022

## Stage 1 Road Safety Audit

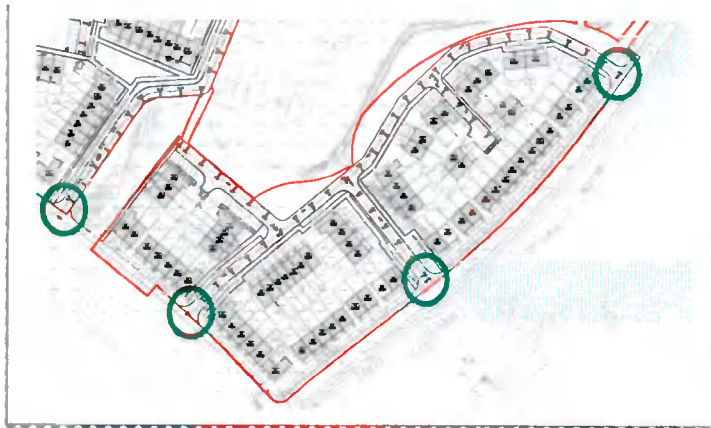
**Figure 2.1 – Example Junctions Where Priority Should be Afforded to Pedestrians and Cyclists**

**Location:** Junctions with Adamstown Dr., Adamstown Pk., Tandy's Ln. & The Boulevard

Failing to afford priority to pedestrians and cyclists at junctions formed between development streets and the surrounding Link Streets could result in conflicts between vulnerable road users and general traffic.

Appropriate crossing facilities should be provided for pedestrians and cyclists at junctions formed between development streets and the surrounding Link Streets.

2.1	Yes	Yes	Crossing points added to the junctions	<i>Noted with thanks.</i>
2.2	Yes	Yes	All junctions have been checked for visibility. For the junctions onto main roads car parking is excluded from the visibility splays however on internal roads, partial encroachment into the visibility splay is considered acceptable as it is both in line with other developments in the SDZ and will encourage reduced traffic speeds in these built up residential areas.	<i>Noted with thanks.</i>

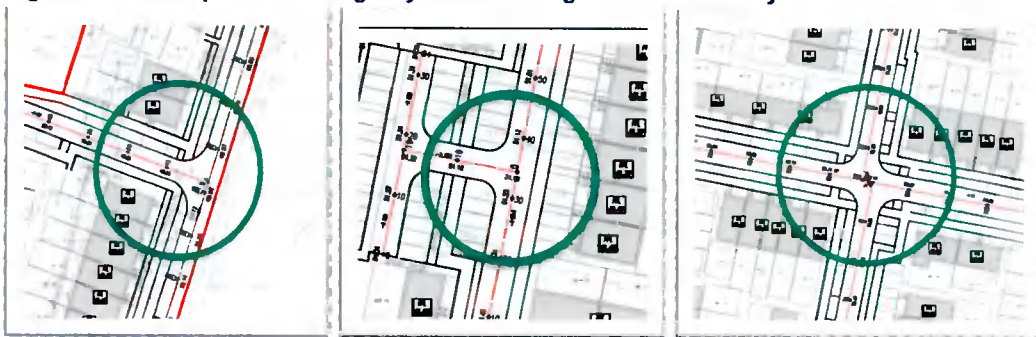
**Figure 2.2 – Examples of Parking May Be Obscuring Junction Visibility**

**Location:** Internal Development Streets

Car parking spaces placed near internal junctions are likely to block the envelope of visibility, leading to an increased risk of collision at the junctions.

The internal junctions should be checked to ensure that parking is not obscuring junction visibility.

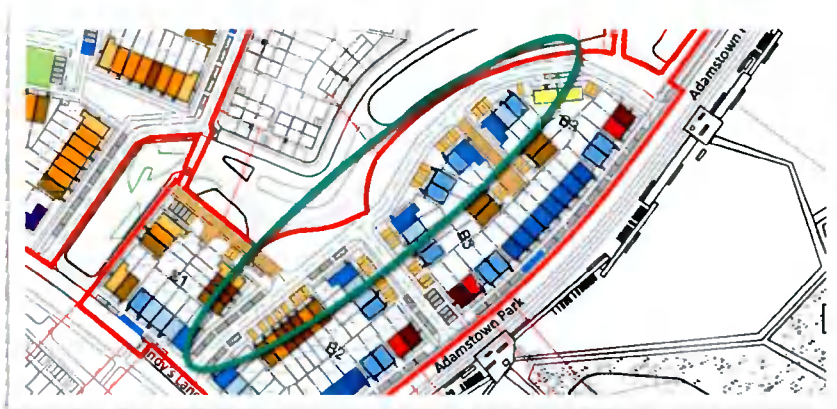
**Figure 2.3 – Sudden Changes in Direction within Local Street**

**Location:** Local Street to North of Blocks B2 & B3

The sudden changes in direction within the street could lead to opposition type vehicle conflicts or kerb strikes.

The sudden changes in direction should be replaced with smooth tangential curves.

2.3	Yes	Yes	The street has been realigned to provide smooth tangential curves.	<i>Noted with thanks.</i>
2.4	Yes	Yes	Crossing points will be provided at all desire lines through the site at detailed design stage.	<i>Noted with thanks.</i>

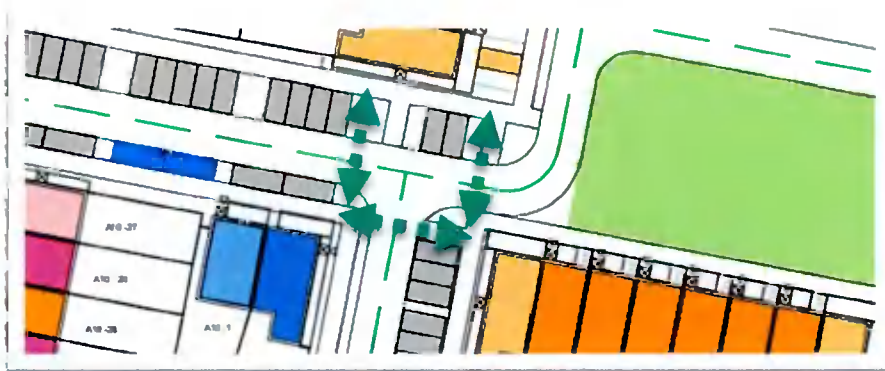
**Figure 2.4 – Key Pedestrian Desire Lines on Internal Street Junction**

**Location:** Junctions on Internal Development Streets

Failing to provide formal crossing facilities at local street junctions could result in pedestrians crossing the streets at unsafe locations and progression issues for the mobility impaired.

Crossing facilities which afford advantage to vulnerable road users should be provided on local street junctions serving all key pedestrian desire lines.
