PROJECT: EDMONSTOWN SHD, KILMASHOGUE, DUBLIN 16		JOB NO. TEDM001	
DRAWING: Tree Survey & Constraints	DATE: 28-10-21	SCALE: 1:500 @ A1	DRAWING NO. 101
DRAWN BY: Cianus Kilduff	CK INITIALS	REVISION:	
STATUS: Planning

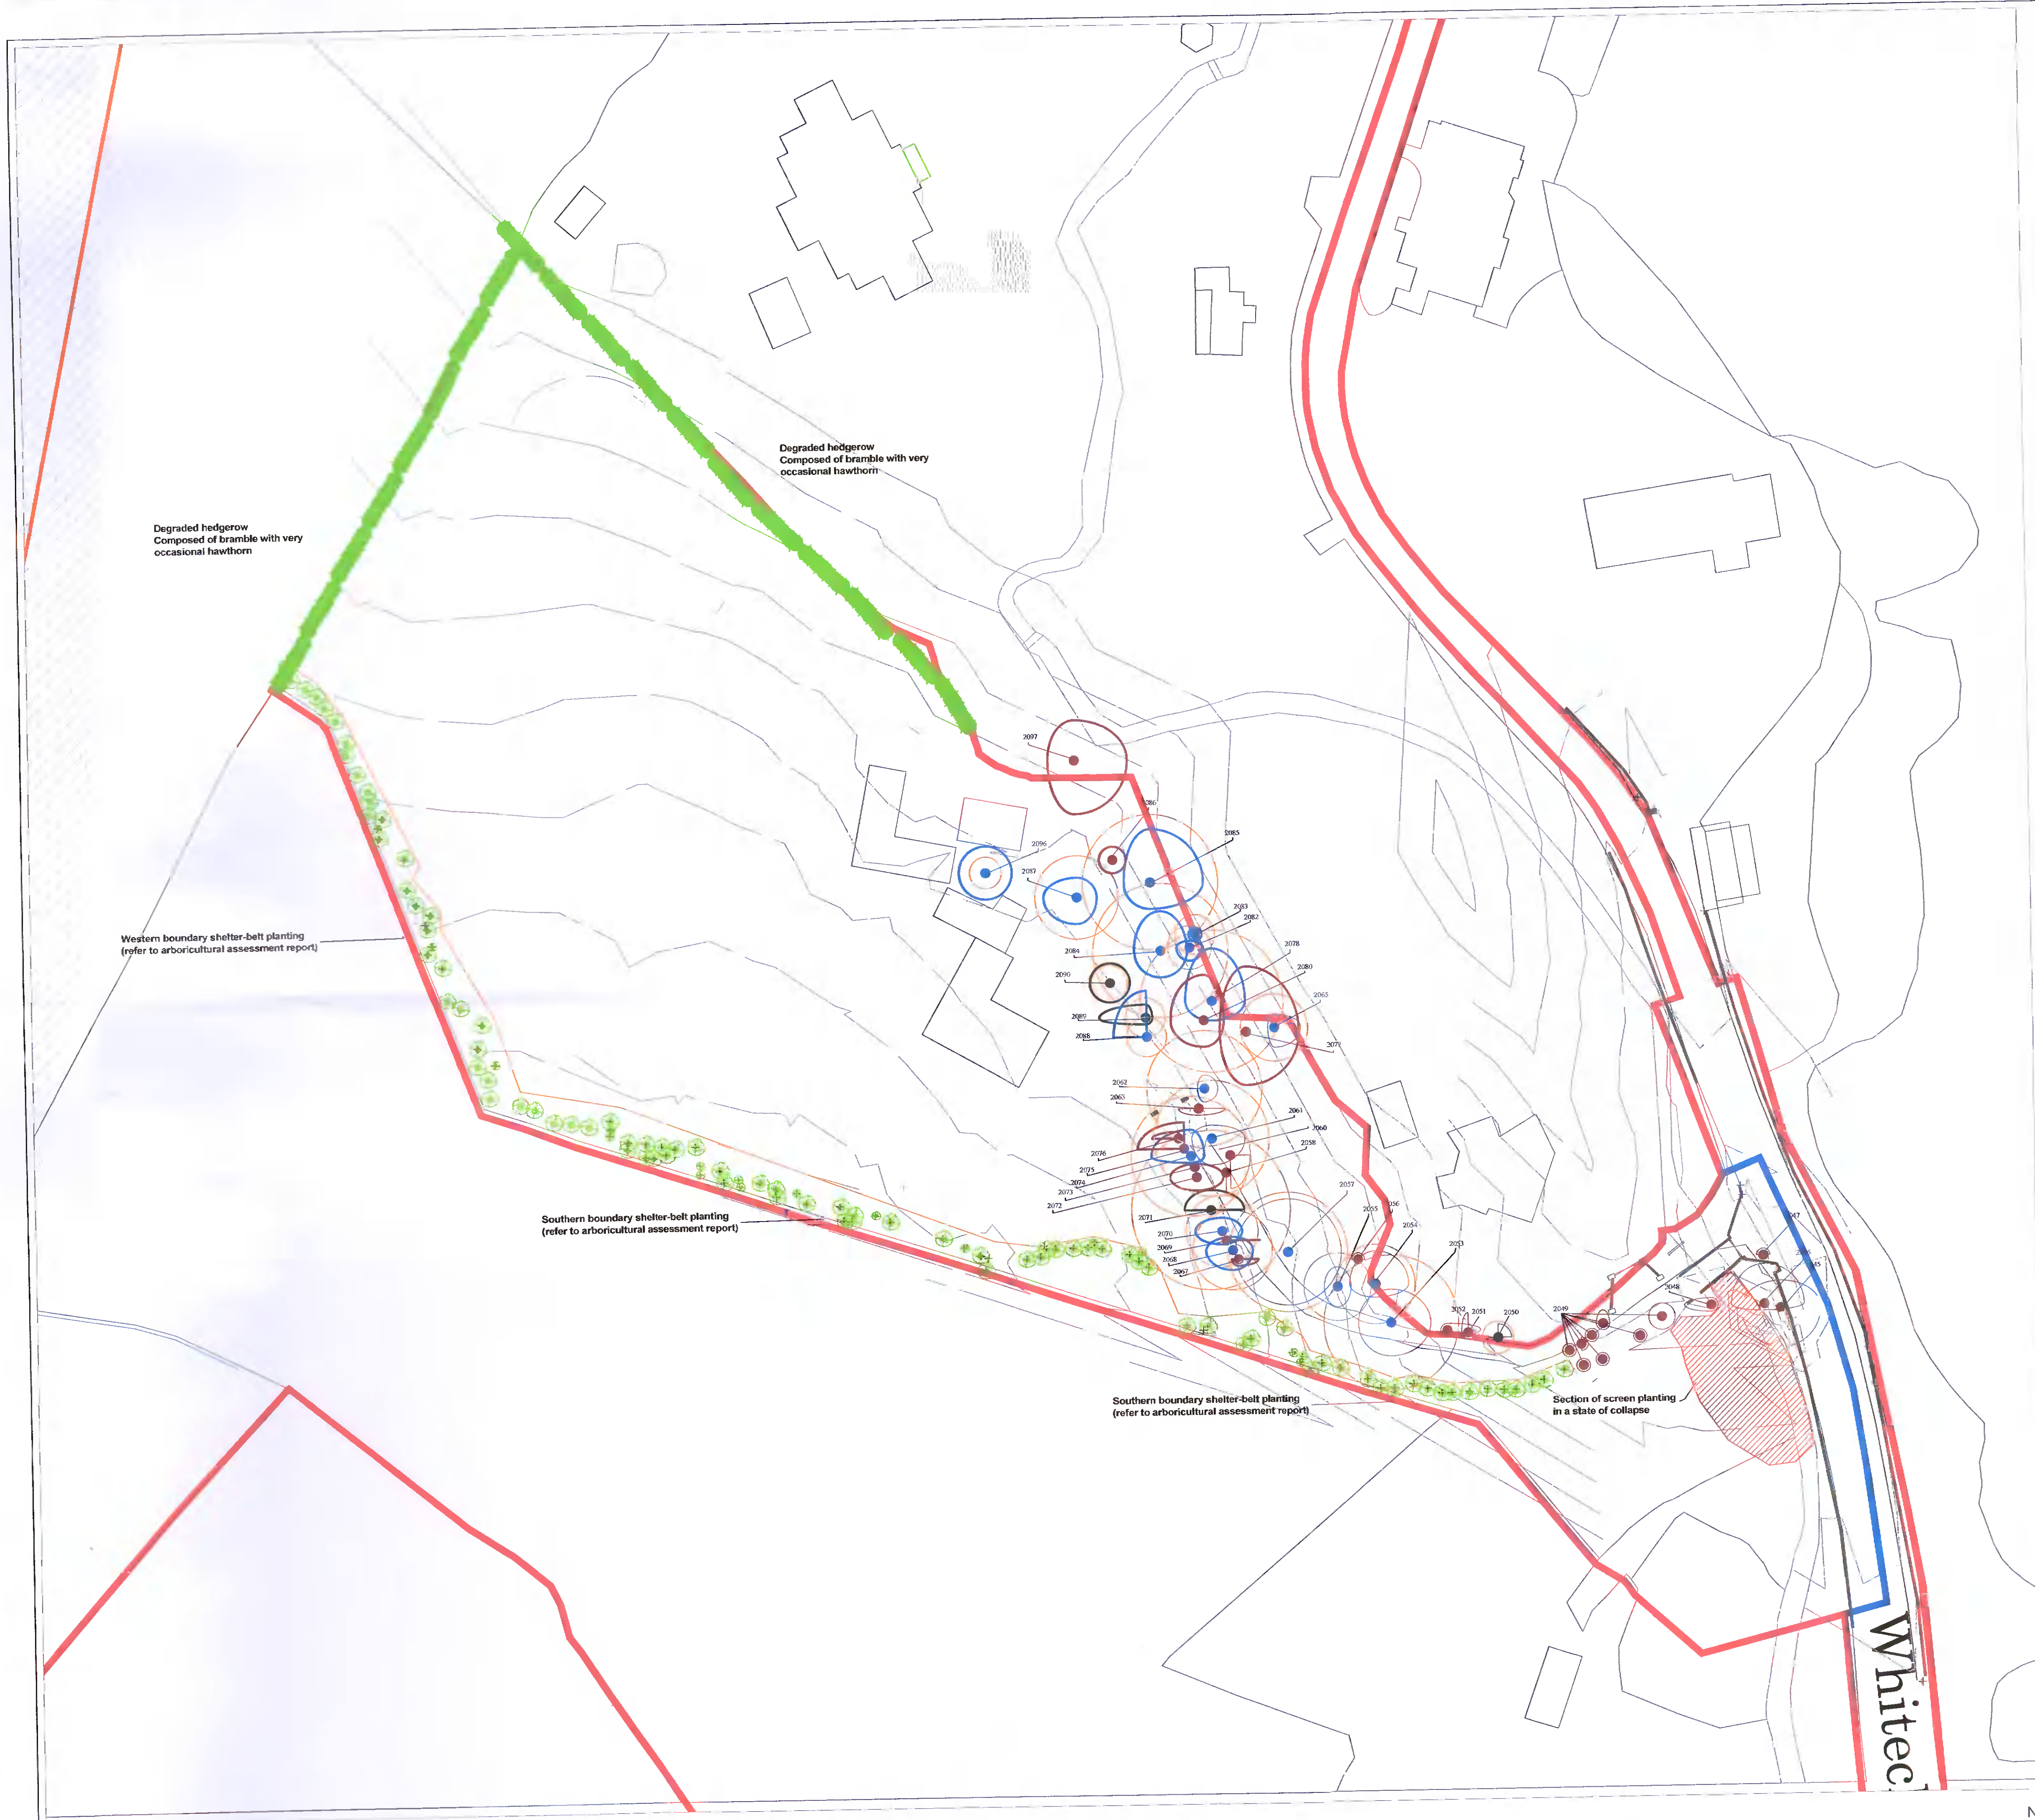
Degraded hedgerow  
Composed of bramble with very occasional hawthorn

Western boundary shelter-belt planting  
(refer to arboricultural assessment report)

Southern boundary shelter-belt planting  
(refer to arboricultural assessment report)

Section of screen planting  
in a state of collapse

Drawing to be interpreted with reference to Tree Survey document

Tree constraints shown are calculated from guidelines contained within BS5837 (2012) with dimensions contained within Section 8 of the Tree Survey document. This outline should not be interpreted as the exact extent of root spread however it is considered the optimal area to be retained free of developmental impacts. Natural and/or man-made barriers such as waterlogged soil or buildings may restrict the spread of tree roots. Crown spreads may also prove to be a constraint particularly where crown reduction may not be possible. The constraints lines shown on this drawing are therefore a guide only. An on-site assessment should be undertaken in the event of any developments being planned within the areas shown for retained trees.
