Bat survey of No. 2 Firhouse Road and the former 'Morton's The Firhouse Inn', Firhouse Road, Dublin 24

May 2022

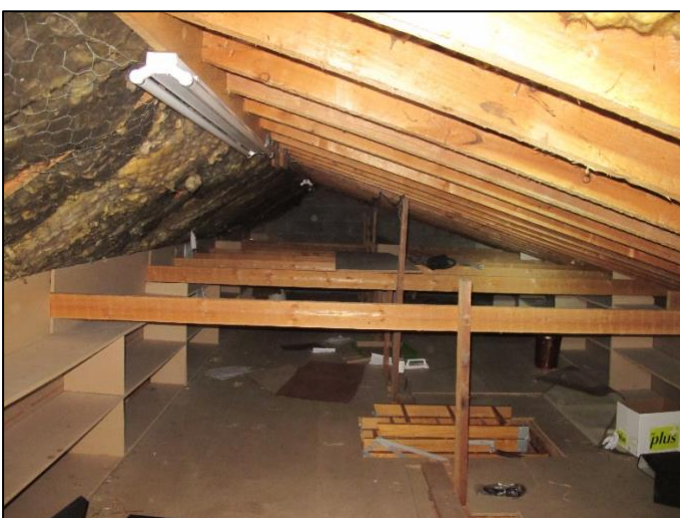
The Firhouse Inn attic has an approximate ridge height of 2 m high and water ingress through the slate roof is evident with frequent water staining on the rafters. One hole in the slates near the ridge could potentially enable bats to access, however, heavy cover of cobwebs rules out bats using it as an entry point. An extension was added to the original building and the attic is extended to run continuously from east to west with returns facing north at both ends. The older attic space, to the east, has a moderate level of cobwebbing throughout the roof space suggesting bats had not been flying around recently and no staining visible on the timbers other than water staining from rainwater ingress. A

single moth wing was noted indicating brown long-eared bat feeding, but no other sign of insects was observed. The newer attic space to the west was extensively used as file storage by the previous occupants and cobwebbing is not a feature. The water storage tank is uncovered but contains no bat corpses. The attic floor is covered in mouse droppings but no bat droppings were observed.

Plate 4 . Firhouse Inn attic showing return at western end

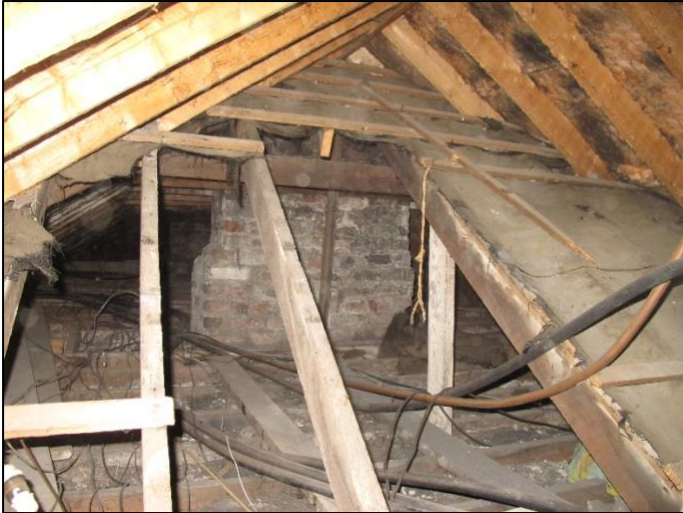
Plate 5. Firhouse Inn attic showing middle attic

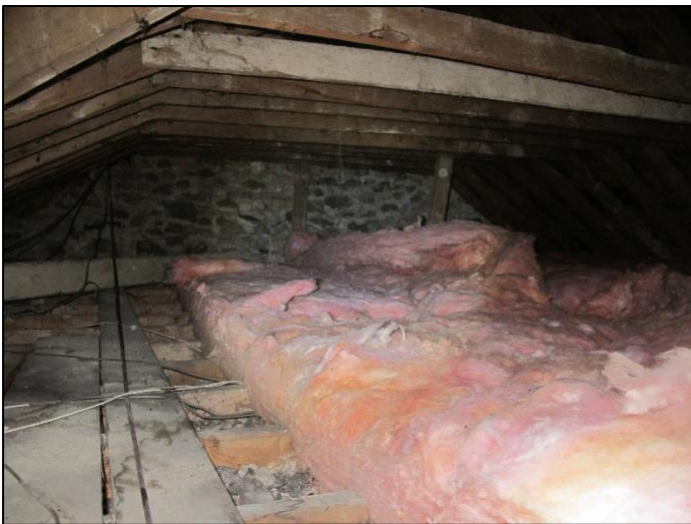
Plate 6. Firhouse Inn attic, showing return at eastern end

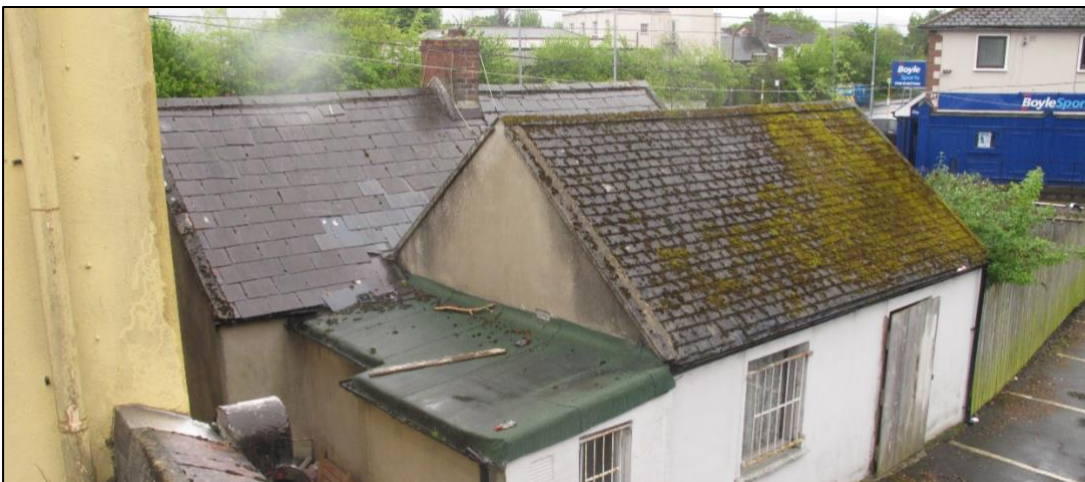
The soffits and fascia on the north facing gable ends of the Firhouse Inn are in poor condition with numerous holes suitable for entry by bats. The front attic of the cottage has two missing slates and mortar on the ridge tiles missing, allowing potential roost entry points for bats. The two story building is relatively modern and well maintained and offers no discernible roost features.

Plate 7. Cottage showing roof with valley between two attic spaces. Rear attic (right) is tiled. Front attic (left) is inaccessible and has several slates dislodged allowing possible entry of bats

Prior to works commencing, emergence (dusk) and re-entry (dawn) watches should be undertaken to ensure no bats are present. These should be carried out during the appropriate season, May to September. If bats are not confirmed exiting or entering the buildings, a further internal survey is required before demolition works involving roofs can commence, under the supervision of an ecologist. During the period October to April inclusive, a pre-works internal survey is required, and demolition works involving the roofs supervised by an ecologist.

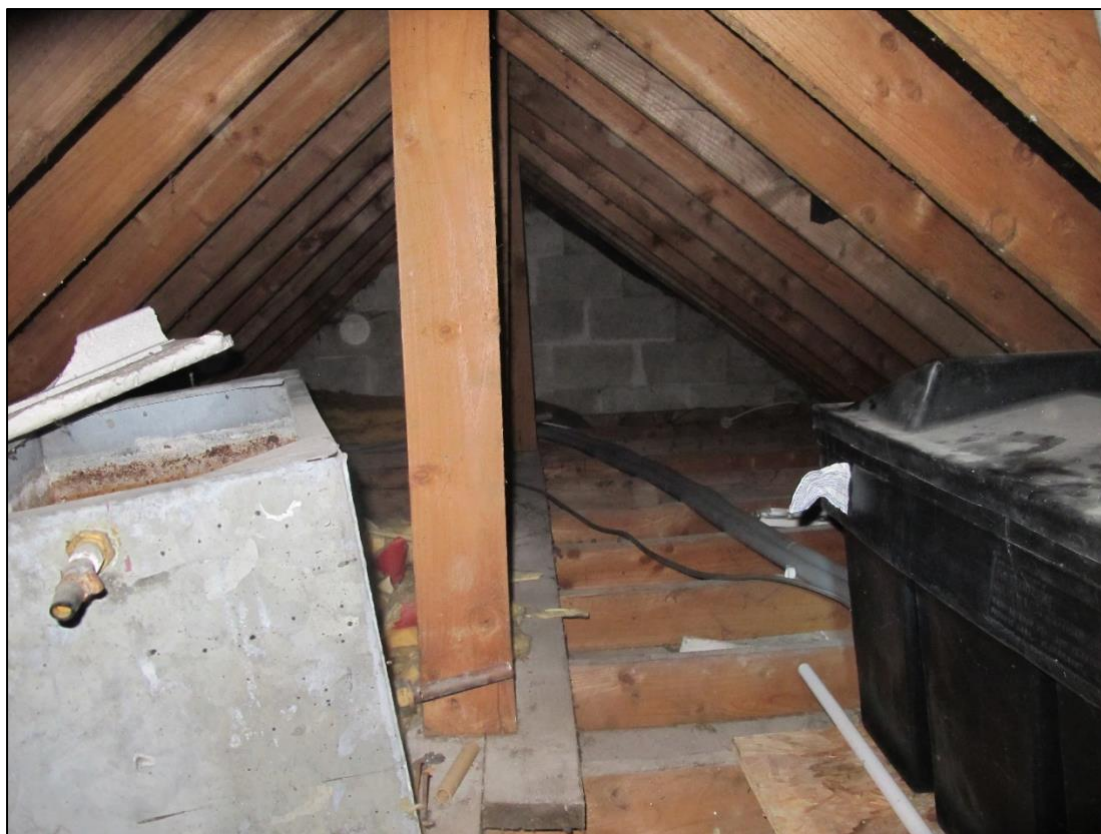
The cottage has two attics with a valley between the two roof spaces. Only one attic is accessible which is to the rear of the cottage. It has an approximate ridge height of 1.7 m high. The attic tank is covered and no holes were apparent in the tiled roof. It is moderately cobwebbed and there are no signs of bats.

Plate 8. Interior attic of cottage (rear attic)

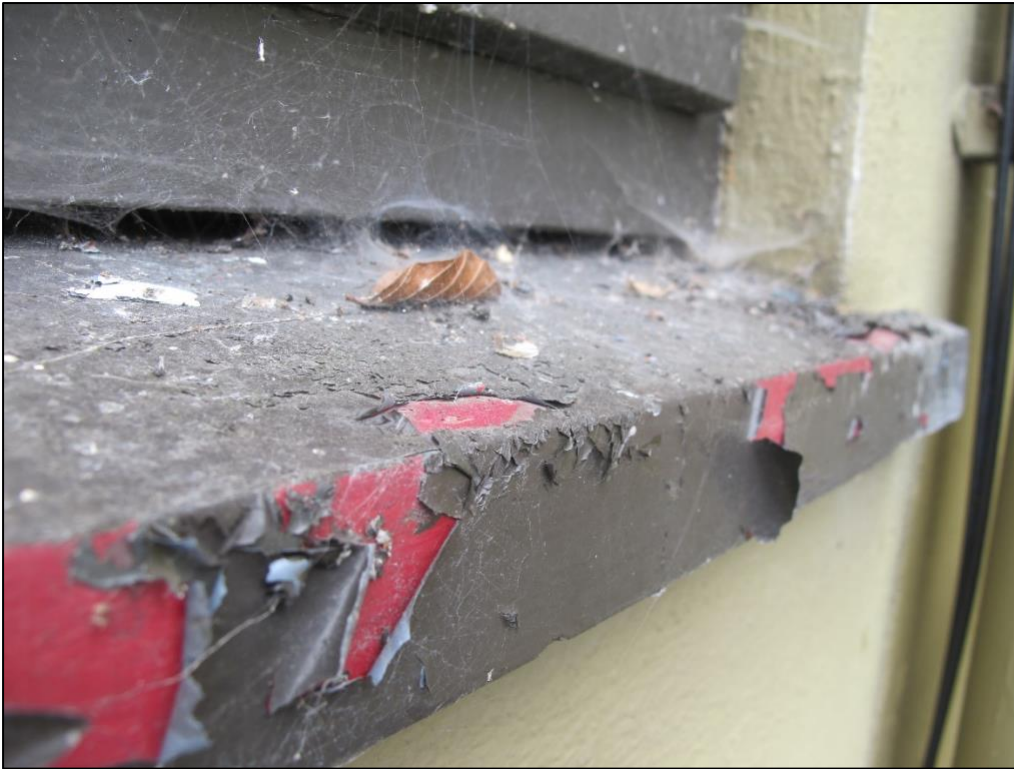
The external features of all buildings were also examined for signs of bat droppings or staining around windowsills and exposed features around windows and walls. None were found.

Plate 9. Exterior wall and windowsills were examined for bat droppings.

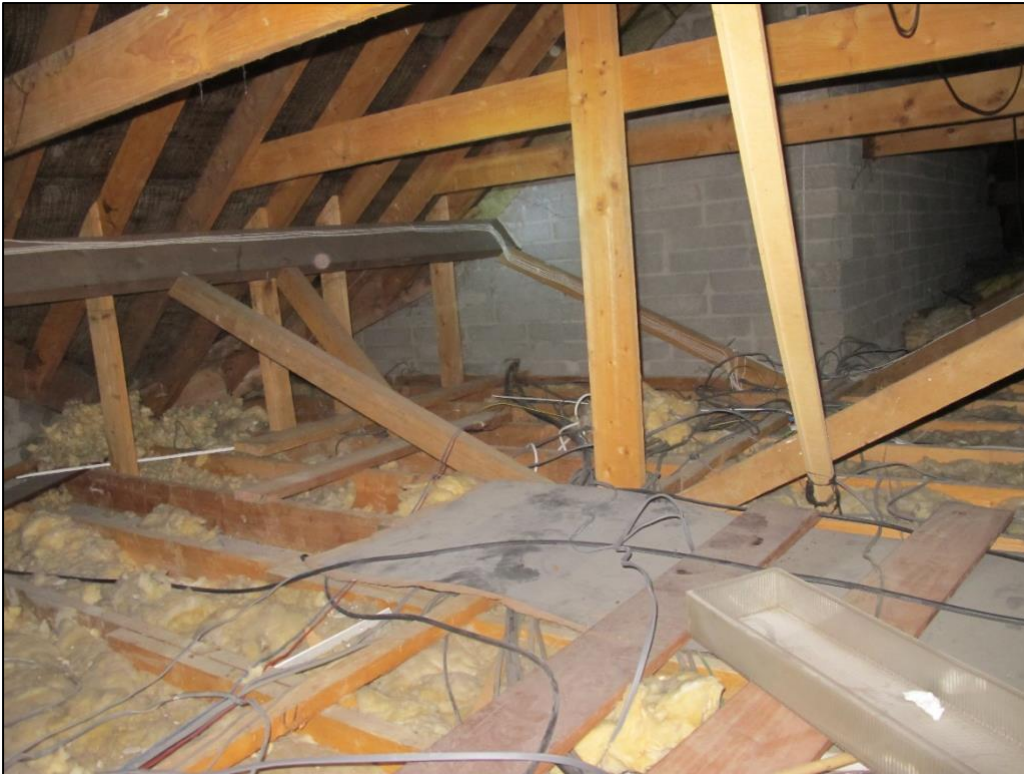
The two story building to the west of the site has two separate attics; a large L-shaped attic to the front and a smaller attic to the rear on the east side. Neither attic showed any sign of bats.

Plate 11. Front attic of two story modern building.

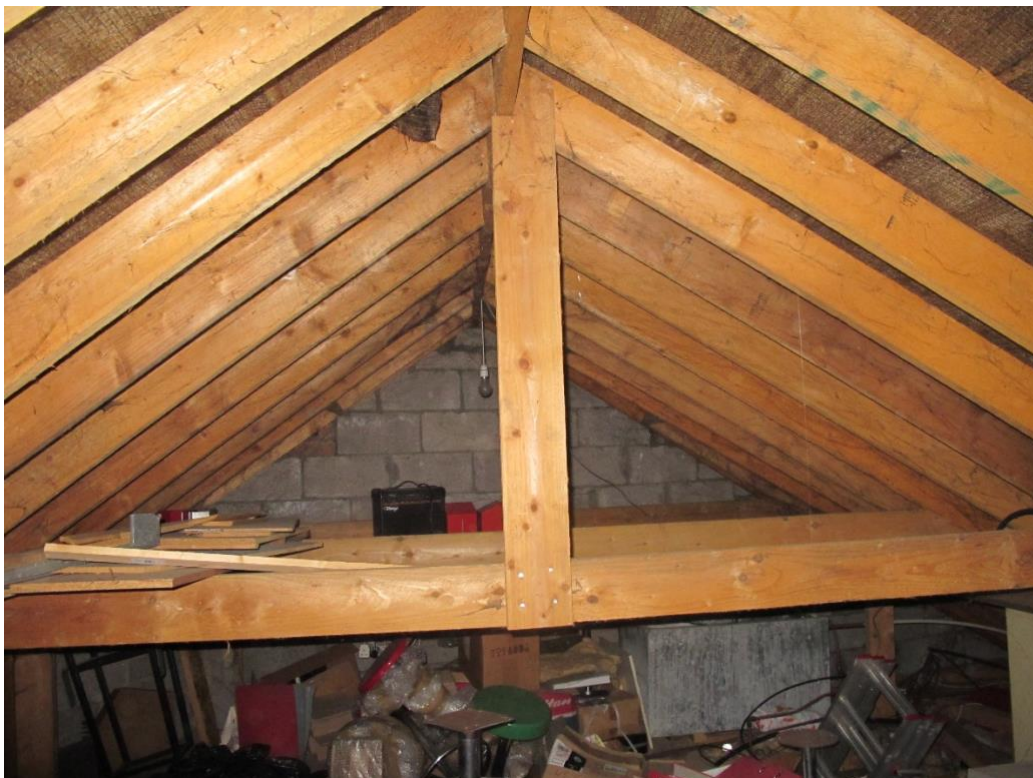
Plate 12. Rear attic of two story modern building.
