Proposed Primary School,
Kishoge, Lucan, Co. Dublin

Stage 1 Road Safety Audit

Document Ref: P22-066-PSW4-RP-001

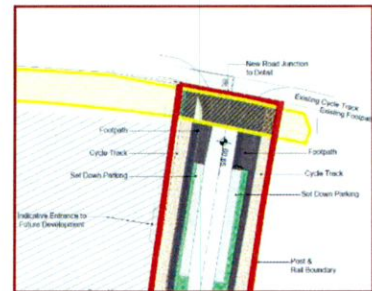
Location: Thomas Omer Way

Summary: No amendments proposed to the existing road layout/lane configuration on Thomas Omer Way to reflect the proposed new priority junction with the westbound carriageway.

It is proposed to construct a new priority-controlled junction onto the westbound carriageway of Thomas Omer Way to facilitate vehicular access to the school development. No amendments to the existing road layout or lane configuration are proposed on Thomas Omer Way, which currently consists of a single general-traffic lane on the offside, and a bus lane on the nearside, of the westbound carriageway.

In addition, there is an existing off-road cycle track and adjacent footpath running along the southern side of Thomas Omer Way.

In the absence of changes to the existing road layout/lane configuration, the introduction of a new junction could result in driver uncertainty/hesitation on the approach to, or departure from, the new junction leading to possible unsafe manoeuvres resulting in collisions. For example, should a driver turn into the new access from the general-traffic lane while another driver chooses to enter the bus lane in order to undertake the same manoeuvre, this could result in shunt or side-on collisions.

Appropriate amendments should be implemented on the Thomas Omer Way westbound carriageway to safely cater for the vehicle manoeuvres arising from the introduction of the proposed new junction.

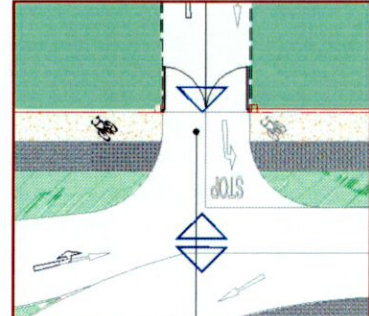
Location: School Access Road

Summary: Discontinuous footpath and cycle track at school car park entrance.

The footpath and cycle track along the northern side of the road immediately south of the proposed school development is indicated as being discontinuous across the entrance to the school car park.

This arrangement prioritises vehicles entering/exiting the car park above non-motorised road users. In addition, inter-visibility between exiting drivers and pedestrians or cyclists approaching the access may be restricted by the boundary wall/fence, possibly resulting in exiting drivers failing to see an approaching pedestrian or cyclist leading to vehicular/NMU collisions.

The footpath and the cycle track should be continuous across the entrance to the school.

The gate to the school, and boundary on either side of the gate, should be set back a sufficient distance to afford adequate inter-visibility between exiting drivers and pedestrians/cyclists approaching along the external footpath/cycle track (e.g. bell-mouth arrangement).

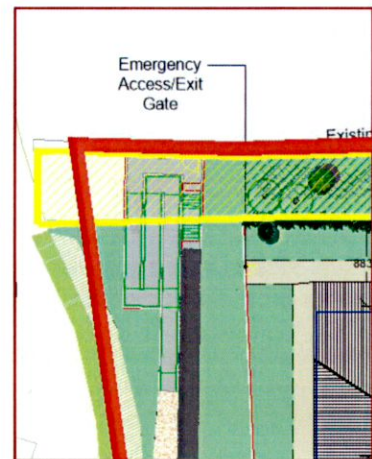
Location: NMU Entrance from Thomas Omer Way (north-western corner of development site)

Summary: Unclear if gradients along proposed non-motorised road user ramps will be appropriate for mobility impaired pedestrians.

At this early stage in the design development, it is unclear what gradients are proposed on the proposed non-motorised road user (NMU) ramp to/from the proposed school and Thomas Omer Way, in the north-western corner of the proposed development.

Steep gradients can create difficulties for wheelchair users and pedestrians, particularly the mobility impaired and the elderly, to safely and comfortably navigate the ramps, possibly resulting in slips, trips and falls.

In addition, it is unclear if cyclists travelling along the proposed ramp are intended to dismount and walk along the ramp, or if the ramp is of sufficient width to accommodate cyclists, pedestrians & wheelchair users without cyclists having to dismount.

The gradients & width of the ramps, and the frequency & dimensions of landing areas, should cater for the needs of the mobility impaired (e.g. wheelchair users), as recommended by the National Disability Authority.

In addition, the width of the ramp should be adequate to cater for the expected volumes of pedestrians, cyclists & wheelchair users during peak times.

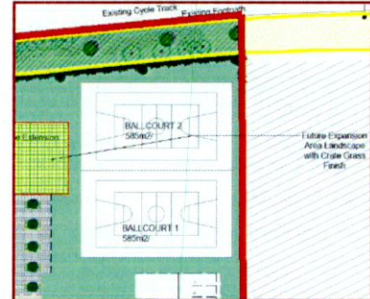
Location: Thomas Omer Way

Summary: Floodlighting may create glare for drivers on Thomas Omer Way.

Two "Ball Courts" have been indicated within the proposed development adjacent to Thomas Omer Way. It is unclear from the information provided if it is intended to provide lighting to these courts. If lighting is to be provided care will be required in order to ensure that the lighting does not shine towards, and dazzle, drivers on the adjacent road.

Poorly oriented lighting may create glare for drivers on Thomas Omer Way resulting in drivers being distracted, disoriented or momentarily blinded leading to a temporary inability to see a hazard in the upcoming road, resulting in a failure to stop.

During the design development the proposed lighting provision for the "Ball Courts" should be designed such that it will not result in the dazzling of drivers on the adjacent roads.

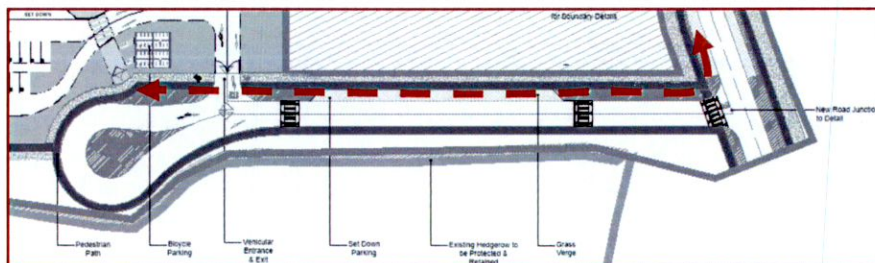
Location: School Access Road (to the south of the proposed development)

Summary: Unclear if proposed cycle facilities or sufficient width for two-way cycle traffic.

A cycle track is proposed along the northern side of the school access roads, which will presumably cater for both inbound & outbound cyclists.

It is unclear if the proposed width of the cycle track is adequate to cater for the expected volumes of two-way cyclists, possibly resulting in some cyclists entering the adjacent footpath in order to pass oncoming cyclists resulting in increased risk of collisions with pedestrians on the footpath.

The width of the two-way cycle track should be adequate to cater for the expected volumes of cyclists in accordance with guidance provided in the National Cycle Manual.

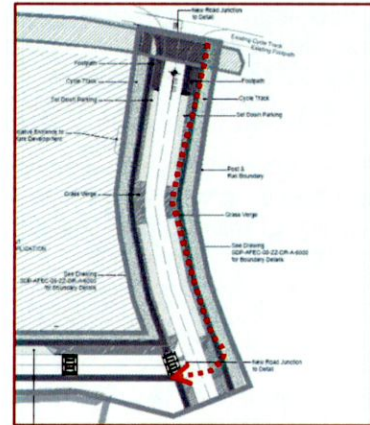
Location: School Access Road (to the east of the proposed development)

Summary: No crossing facilities for southbound cyclists or students dropped off on the eastern side of the north-south school access road wishing to travel to the proposed school.

No crossing facilities have been indicated of the north-south running School Access Road to the east of the proposed development. The absence of a crossings may result students dropped off on the eastern side of the road within the proposed set-down areas and/or southbound cyclists crossing at unsafe locations. In the case of cyclists, some may choose to travel southbound within the northbound cycle lane, increasing the risk of collisions with other cyclists.

Crossings should be provided to cater for students travelling to/from the set-down & pick-up areas along the eastern side of the proposed new road to the east of the proposed development.

In addition, a two-way cycle track of appropriate width could be provided along the western side of the school access road to the east of the proposed development, and along the northern side of the school access road to the south of the proposed development, which could permit the omission of the cycle track on the eastern side of the access road to the east of the proposed development if it is not required for other reasons.

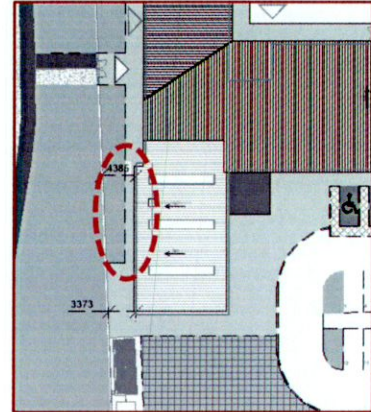
Location: School campus

Summary: The footpath along the western side of the school building is narrow and may not sufficiently accommodate the expected volume of pedestrians & cyclists during peak times.

The width of the footpath along the western side of the school building appears to be relatively narrow in places.

This route is the most likely route for cyclists who enter the campus from the north-west wishing to access the bicycle parking locations.

This could lead to pedestrians and cyclists travelling in opposite directions being unable to pass each other within the footpath, resulting in them stepping into the adjacent verge where there is an increased risk of slips and falls, in particular during wet or icy weather.

The footpath at this location, and throughout the proposed development, should be of adequate width to cater for the likely/expected volumes of pedestrians and cyclists during peak times.

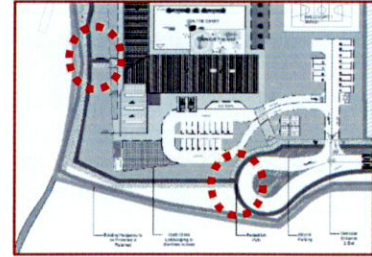
- 4.1 Potential conflict points have been indicated between the proposed footpaths & cycle tracks, in particular on the western side of the proposed development and at the southern entrance into the proposed development.

At these locations cyclists would be required to cross the path of pedestrians, with a resulting potential for conflicts. If possible, during the design development conflict points should be eliminated or reduced.

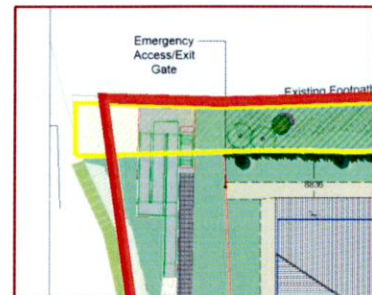
- 4.2 It is proposed to provide an "Emergency Access/Exit Gate" at the north western corner of the school campus, however, the footpath on the school side of the boundary fence at this location appears to terminate at the gate.

No path has been indicated extending from this emergency gate to the nearby footpath. This is assumed to be CAD error. The drawings should be updated to indicate a footpath linking the gate and the footpath to the west.

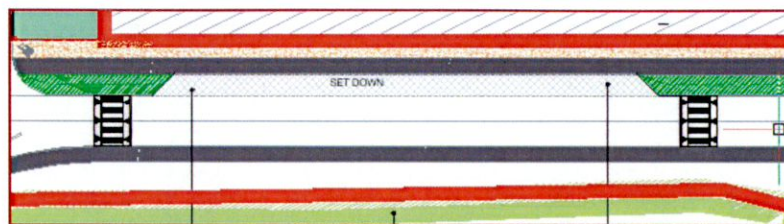
- 4.3 Raised tables have been indicated along the school access road to the south of the proposed development with zebra-crossing markings, however no Belisha beacons have been indicated at these locations and the raised-tables terminate on the northern side at a grass verge.

It is unclear if these raised-tables are intended to be crossings or if their purpose is purely for traffic. Regardless, the zebra-crossing markings should be omitted unless it is intended to provide Belisha beacons, and the other measures required at zebra crossings.

Should there be no crossing desire line at these locations the omission of the markings should be sufficient along with vertical separation between the footpath and the top of the raised-table.

However should a crossing desire exist at these locations the footpath on the northern side should be extended to meet the raised-tables, the top of the raised tables should be flush with the footpath levels on either side and tactile paving provided to warn visually impaired pedestrians of the carriageway risk.
