**Road Safety Audit
Stage 1
for
APARTMENT DEVELOPMENT
AT
SCHOLARSTOWN RD, RATHFARNHAM, DUBLIN 16**

Date: October 2022

Report produced by: Road Safety Matters Ltd

Reference: RSM/MOB/170822/SCHOLARSTOWN-RSA1 OCT22

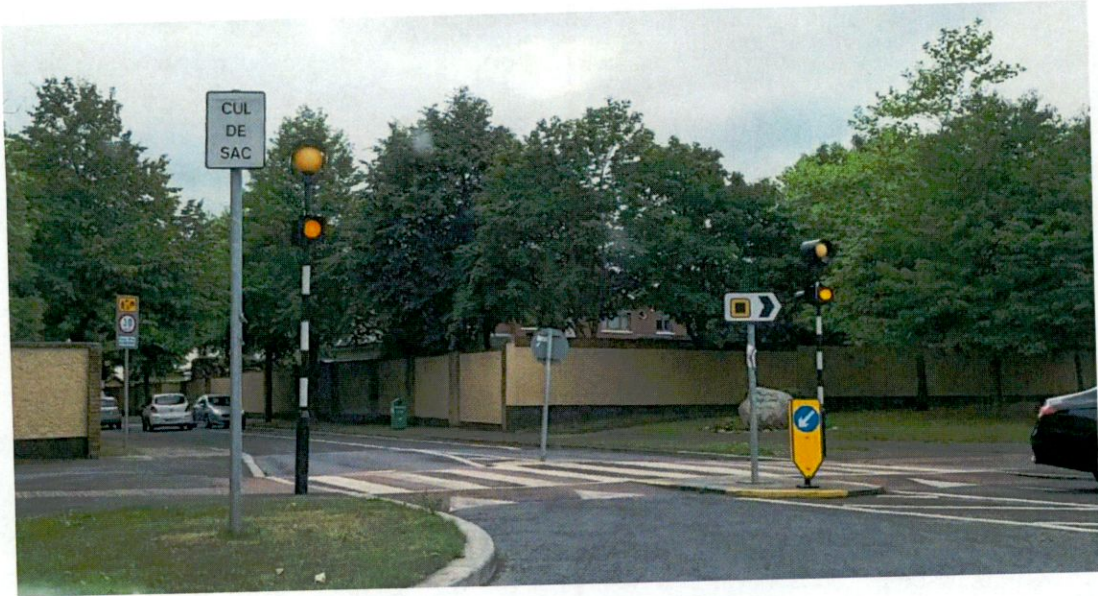
The posted speed limit on Orlagh Grove adjacent to the site is 30 km/hr. There was no 85th percentile speed survey data provided for the link, however on-site observation demonstrated that most vehicles appeared to be travelling close to the posted speed limit. Reduced DMURS visibility splays have been noted on the design plans, and visibility to the left and right at the new

Figure 3: 30 km/hr posted urban speed limit on Orlagh Grove on exit from Roundabout

1. Visibility at the site access junction should be clear and unobstructed at all times in accordance with traffic speeds, with visibility splay requirements to be determined on the basis of prevalent 85th percentile speeds on the adjacent link, and adjusted where necessary to take into account the likely waiting position of vehicles at a significant offset from the channel line.
2. Low internal site speeds should also be encouraged, with provision for additional vertical or horizontal traffic calming measures where necessary on the internal access road to maintain low vehicle speeds.

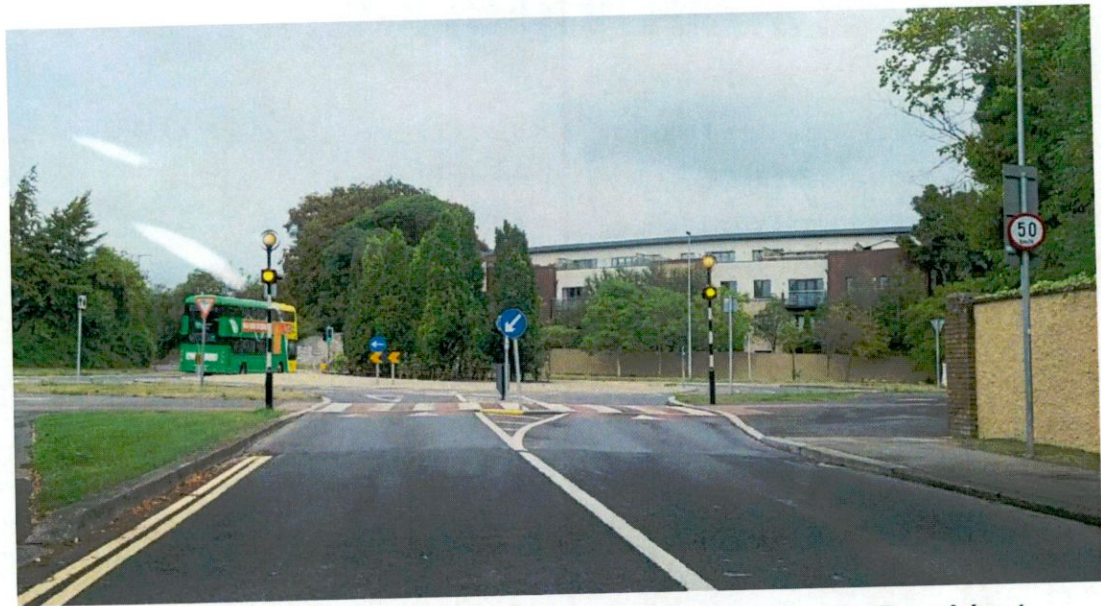
There is formal traffic calming provided on entry to the Orlagh Grove in the form of vertical deflection at a raised zebra crossing to the north of the proposed site access, which is shown in figure 3, and which appears to be effective in reducing vehicle speeds on entry to the link. The site is also posted with 30 km/hr slow zone speed limit signage on the nearside on entry to the residential area. Existing vertical deflection measures are also provided on the link further south of the proposed access point, as shown in figure 7. The design for the proposed development site also includes for vertical deflection in the form of a raised pedestrian crossing point across the mouth of the access junction, which should assist in maintaining low speeds on entry to the site. It was noted that sightlines illustrated on the design plan have been taken from a distance of 2.4m back from the channel line of the major road, which is the x-distance applicable for lightly trafficked junctions, however it was noted that vehicles egressing from the development site will be stopped at a significant offset from the channel line due to the proposals for a raised crossing at the junction mouth, which is intended to prioritise the movement of pedestrians. For the reduced visibility x-distance to be achievable, motorists will need to stop closer to the stop line, which will block the pedestrian crossing.

Figure 4: Raised Zebra Crossing on approach to Scholarstown Rd Roundabout

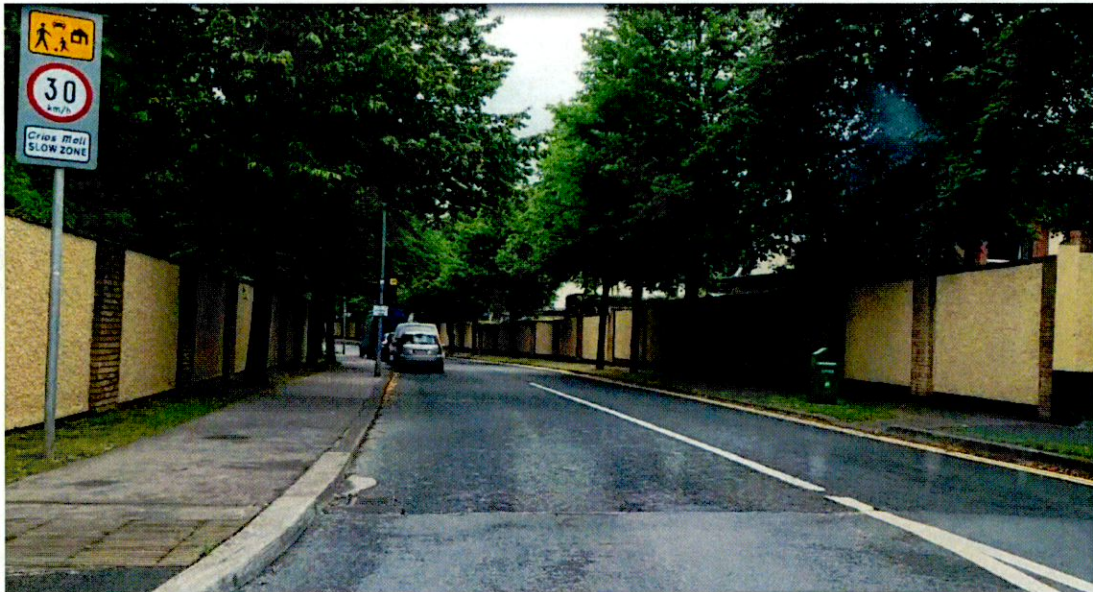
Figure 5: 30 km/hr Slow Zone speed limit north of Site Access

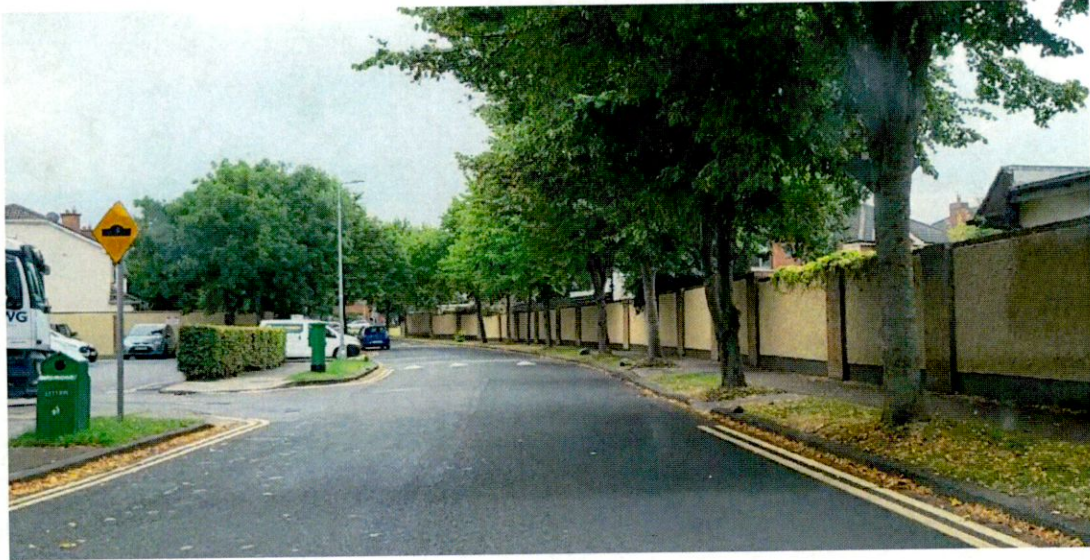
Figure 7: Existing Vertical Deflection and Traffic Calming South of Site Access

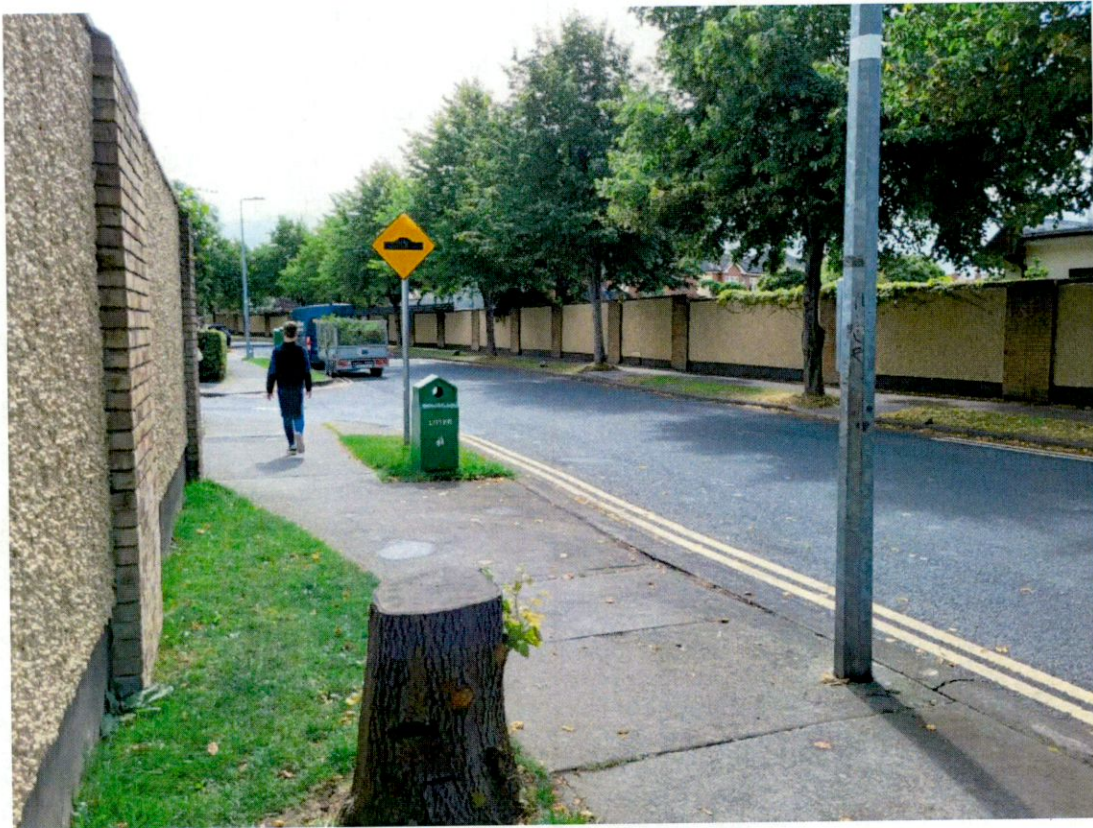
There were no details provided on proposed boundary treatment or landscaping for the site or for any of the internal areas of the site, and no provision for site clearance, with a significant number of mature trees noted within the site, with mature overhanging trees also located within the verges on both sides of Orlagh Avenue leading to fallen leaves and slippy conditions underneath and likely contributing to darker conditions and interference with street lighting during the hours of darkness. Within the site, inappropriately located boundaries or landscaping which exceeds 1.05m in height can reduce forward visibility and intervisibility between pedestrians and motorists, and may lead to an increased risk of conflict with oncoming vehicles and VRUs. Inappropriate boundary treatment or landscaping at or on approaches to the proposed site access can also present an obstruction in the visibility splay at a junction, leading to an increased risk of pulling

out type incidents and right-angled collisions. There are also a number of large utility cabinets located in close proximity to the proposed site access point, which can obstruct pedestrian movement and can also obstruct clear visibility to and from oncoming traffic.

Figure 8: Visibility to left from proposed Site Access showing existing high wall and street furniture

1. Detailed design should include provision for site clearance to indicate treatment of all existing features on the site, with provision for reinstatement of all features displaced by the works where necessary, at a safe location which does not present a hazard to road users.
2. Landscaping [proposals to be clarified at detailed design stage, with all trees and landscaping to be located away from positions which could increase the risk of conflict or have a negative impact on intervisibility at Vulnerable Road User (VRU) desire lines.
3. Any potential intervisibility obstructions arising from boundary treatment, internal walls, landscaping, utilities, or street furniture should be removed or relocated or provided at a height less than 1.05m, and all trees, hedges and landscaping should be located away

from positions which could increase the risk of conflict for road users, including pedestrians, with pedestrians to be clearly visible from a point 2m back from each crossing and desire line or conflict point.

4. Trees, boundaries and landscaping should be offset a safe distance from the carriageway edges and ideally away from footways or areas where shedding leaves and tree roots may cause slip/trip hazards, or where street lighting luminescence may be compromised.
5. All features and street furniture including fencing, gate posts/pillars, sign faces, landscaping and lighting columns should be at a minimum recommended 450mm offset from the kerb in an urban environment. Solid continuous hazards such as walls should be a minimum 600mm offset from the kerb edges.

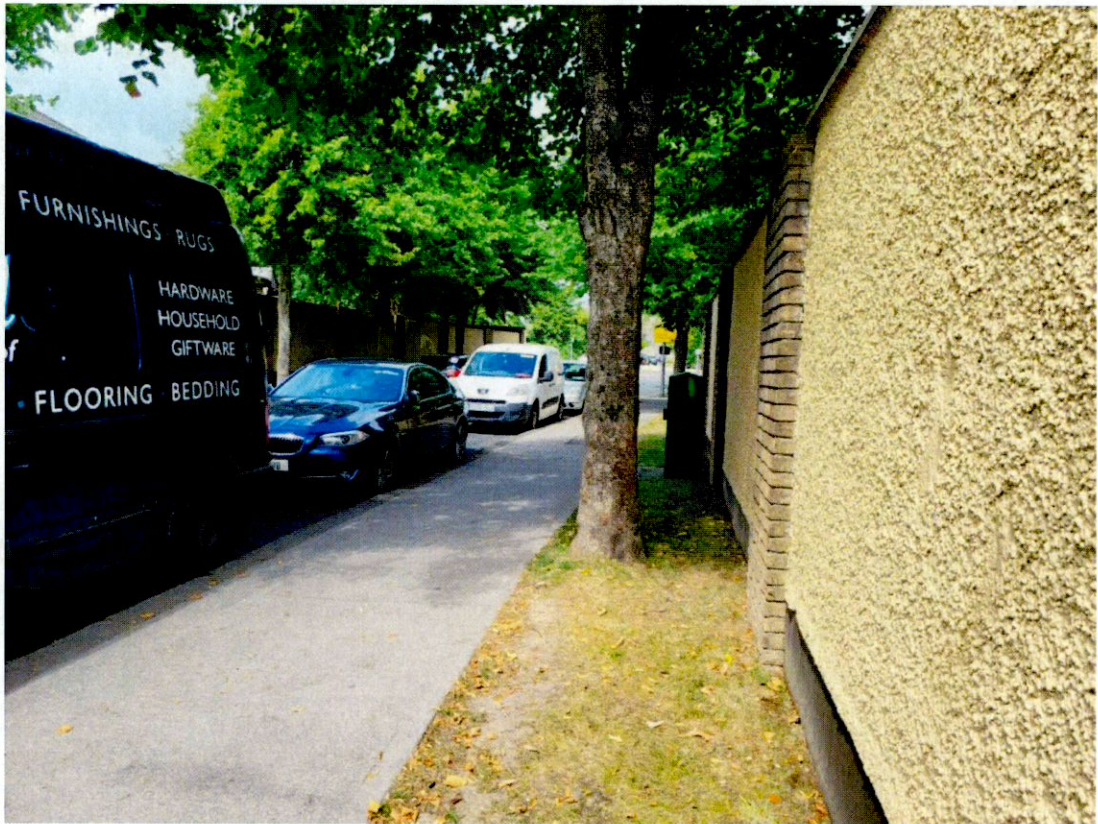
Figure 9: Visibility to Right from proposed Site Access showing existing high wall Trees and utility cabinet

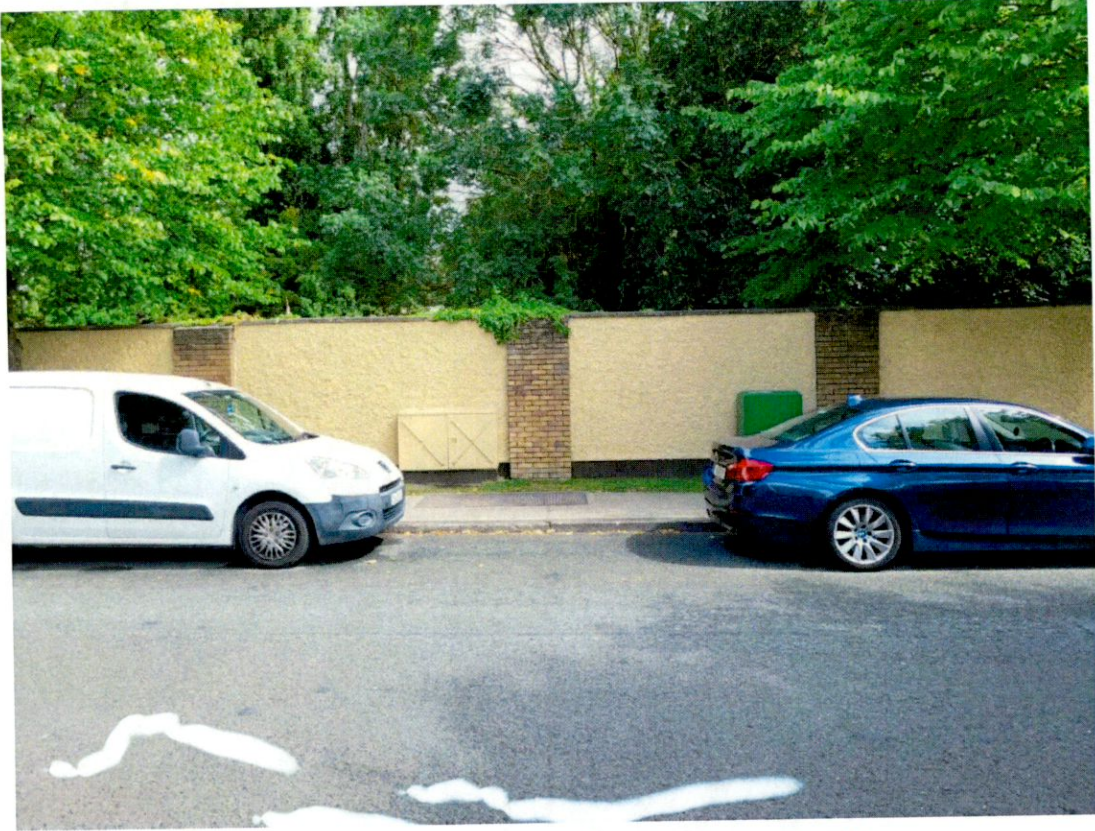
Figure 10: View towards site showing trees within site and utility cabinets/high wall along site boundary

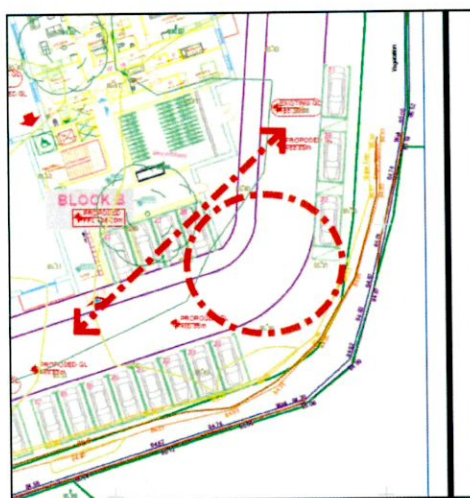
There was no swept path analysis provided to demonstrate that the proposed geometry of the site access and internal road will safely accommodate the swept paths and turning movements of all anticipated vehicle sizes. A relatively sharp internal curve was noted with no provision for widening on the bend. Low radii values are not advisable on single carriageway roads due to the potential for side swipe and head on collision risk with oncoming vehicles. The nearside boundary treatment and parked vehicles may also restrict sightlines on the inside of the bend at this location, as highlighted in figure 11.

Figure 11: sharp internal bend with nearside sightline restrictions for northeast bound vehicles

1. The geometry of the site access and internal road should be subject to swept path analysis for the worst-case scenario anticipated vehicle sizes, as well as more frequent vehicle types, to demonstrate that the proposed layout will safely accommodate the swept paths and turning movements of all anticipated vehicle sizes with adequate margins of safety, and that two-way movement will be possible on the proposed layout without encroachment into the VRU zone.
2. All internal radii should safely accommodate two-way movement without presenting a head on or side swipe collision risk, and forward visibility around bends should not be compromised by boundary treatment, building lines or the location of parking bays.

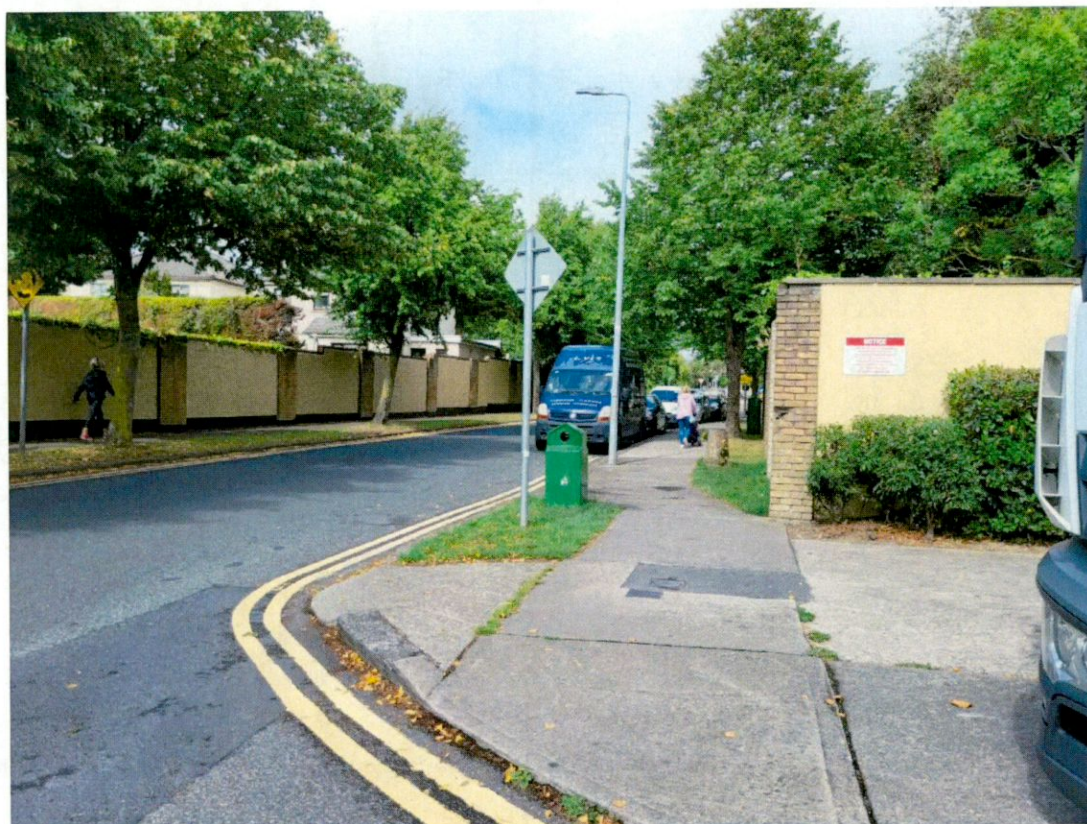
The proposed site access is located in very close proximity to the adjacent access to the Spar Supermarket and associated surface car park, and visibility splays will overlap, as highlighted in figure 13. The demand for use of this access point is unknown, however the Audit Team considered there is likely to be a relatively frequent level of usage at this location, as access and egress to and from food retail developments typically have high trip rates. Overlapping visibility splays represent a departure from standard on single carriageway roads, as vehicles waiting to pull out from either access point simultaneously will restrict visibility to and from oncoming vehicles, resulting in an increased risk of right-angled collisions and pulling out type incidents.

Figure 12: Visibility to right from adjacent access to Spar showing proximity to site

1. The proposed access should not impact on the safe operation of any other existing junctions or access points in close proximity. Closely spaced access points should be avoided, and ideally combined where feasible to form one access point and to limit the number and frequency of conflicting turning movements occurring in close proximity on the link.
2. Where access points cannot be combined and where visibility plays overlap, associated risks should be mitigated where feasible, with egress from the Spar car park to be permitted from the southernmost access point only, and with suitable low boundary treatment to be

provided between the two sites to ensure enhanced intervisibility can be achieved between the two overlapping access points.

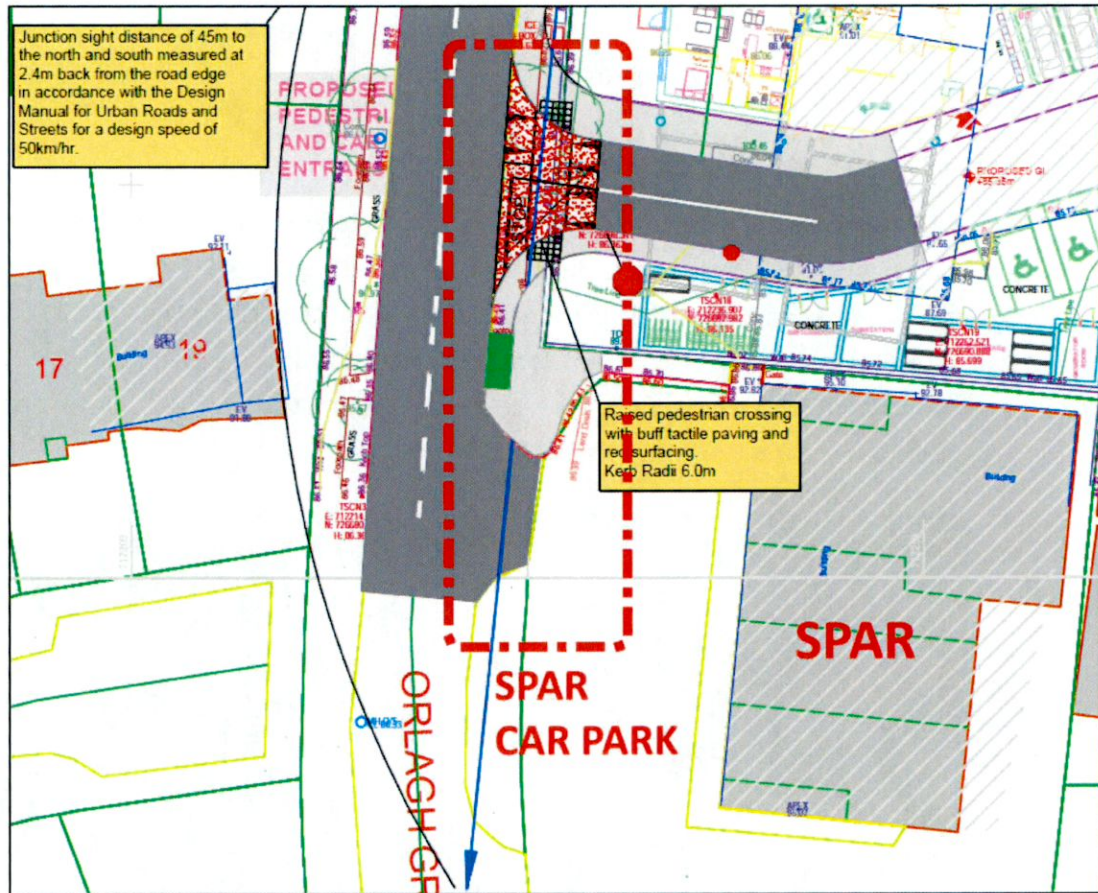
Figure 13: Overlapping visibility plays at closely spaced access points

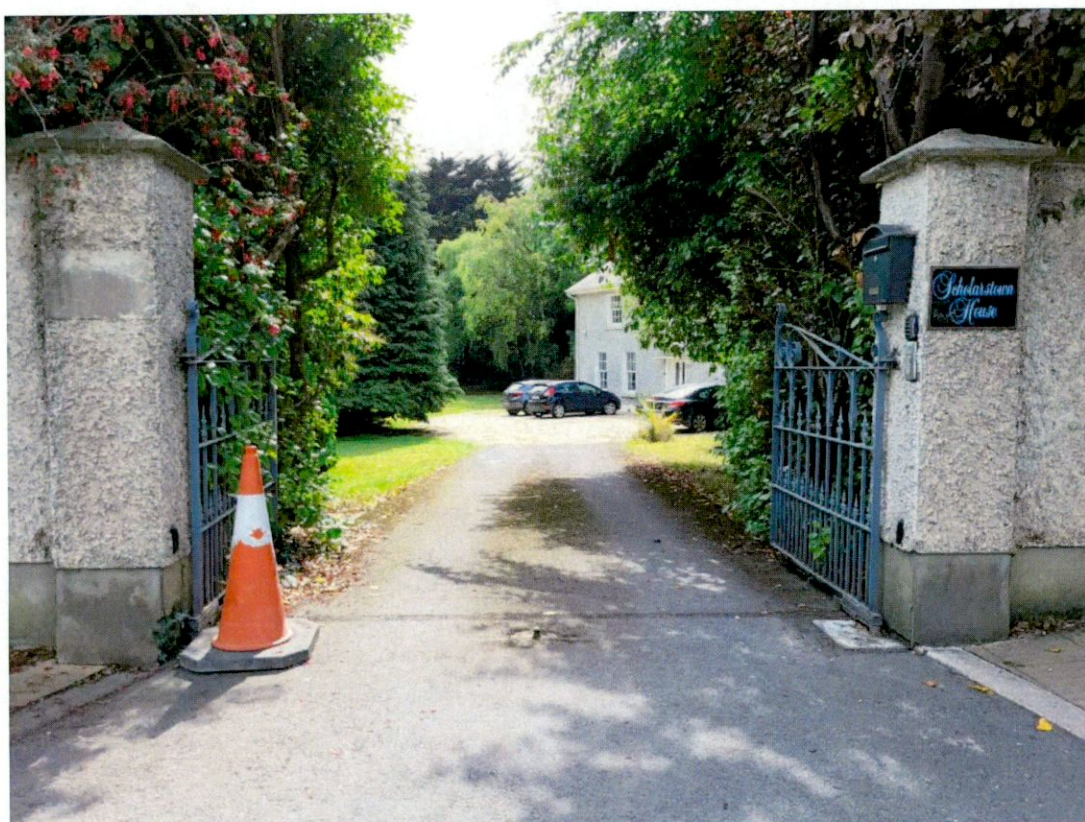
There are a number of existing access points on the site which are shown in figures 14-16, and the provision for retention or closure of these access points has not been shown on the preliminary design layout. One of the access points has been configured for VRU accessibility, however there is no provision for VRUs at the western gated access point, and poor intervisibility was noted at this location due to the height of the existing boundary wall, as outlined further in section 2.3 of this Stage 1 RSA report.

Figure 14: Access into the Site Directly off Scholarstown Rd

1. A full Audit of all existing access points to and from the site was outside the scope of this Stage 1 report, as there are no proposed design changes at these locations, however consistent treatment of each access point to and from the site should be provided as the site design progresses, to include suitable clearance from gate pillars and improved intervisibility and accessibility for VRUs.
2. The final internal site layout should ensure that no increased demand arises for turning to and from the existing access points as a result of the proposed site development, and that vehicles waiting to turn in at these points do not obstruct the carriageway or footway areas.

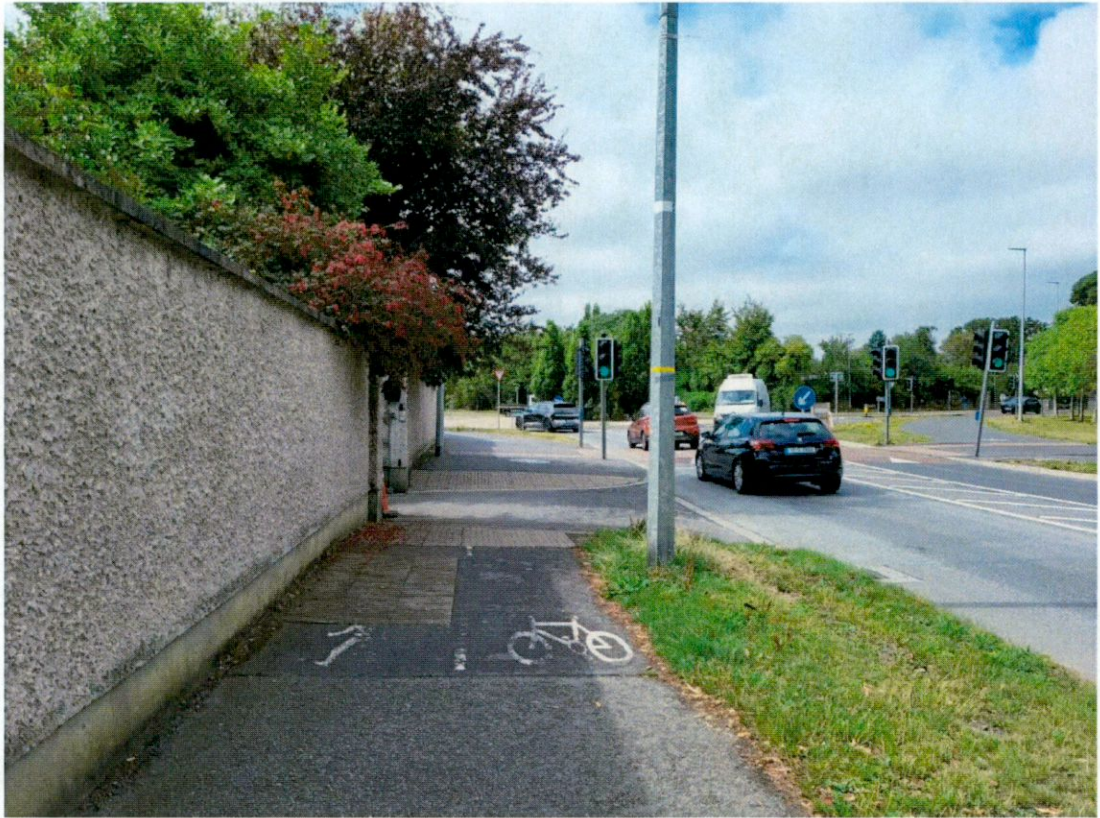
Figure 15: Approach to Access into the Site Directly off Scholarstown Rd

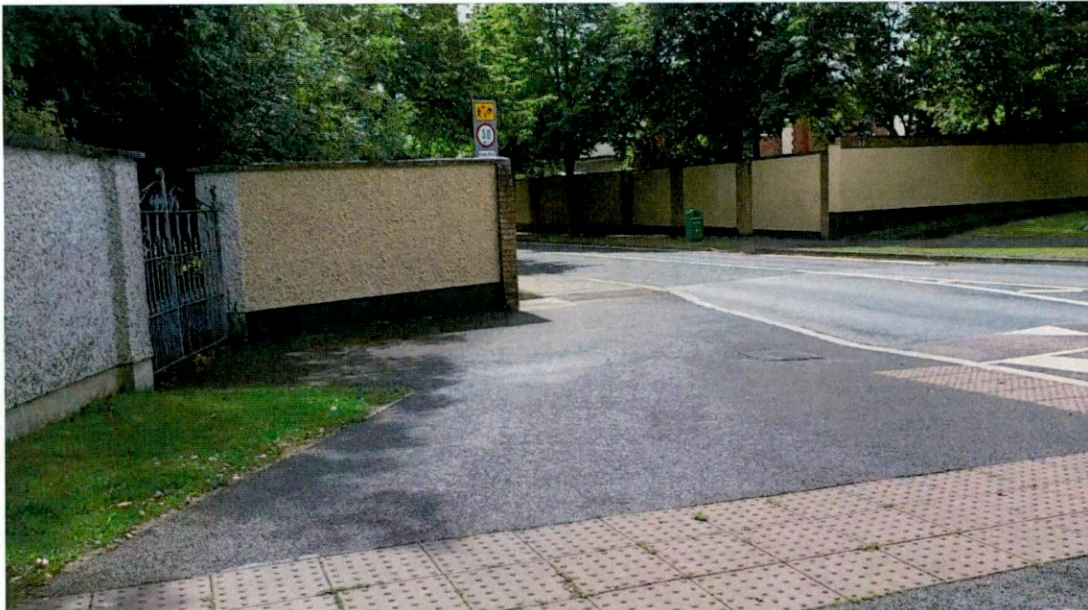
Figure 16: Additional Site Access off Orlagh Grove

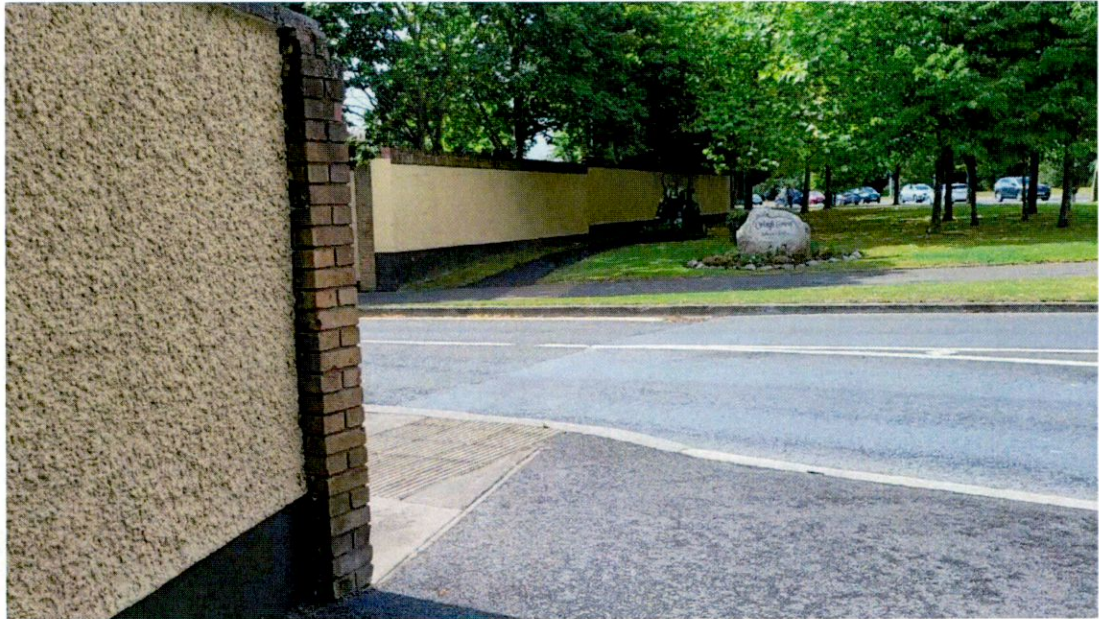
- Scholarstown Rd is currently configured with segregated off road footways and cycleways, with the cycling facilities terminating on entry to Orlagh Grove, and there is no provision for connectivity between the site and the existing cycling infrastructure on Scholarstown Rd.
- Bicycle parking has been shown within the site, however the provision for safe cyclist accessibility to and from these spaces has not been shown, as proposed footway widths are narrow, and insufficiently wide for shared use. Pedestrians and cyclists using the restricted space will be vulnerable to conflict.

Figure 18: High wall reducing intervisibility at existing access point to site

1. Pedestrian activity, desire lines and demands at the site should be considered as necessary in the final design layout, with due regard for all neighbouring land uses and all likely VRU desire lines, and facilities should not terminate abruptly or transition to narrow substandard facilities where obstructions arise, including obstructions from parked vehicles.
2. Intervisibility between pedestrians and motorists should not be compromised by any vegetation or boundary treatment. Pedestrians should be clearly visible from a point 2m

back from both sides of each crossing point across the path of motorised traffic, on all approaches.

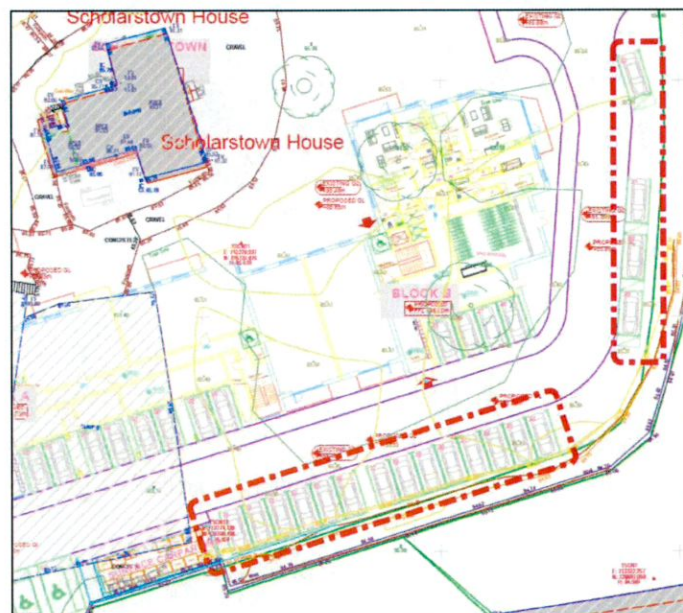
- There is no provision for footways to the rear of the parking spaces highlighted in figure 19, to minimise the risk of conflict with passing and turning vehicles.

Figure 19: No provision for footways adjacent to parking areas

10. Parking areas should be clearly distinguishable from pedestrian circulation areas for the benefit of visually impaired pedestrians as outlined previously, and footways should ideally be provided to the rear of parking spaces to minimise the risk of conflict and to prevent pedestrians have to walk within the area where vehicles will be passing, turning and reversing from perpendicular parking bays.

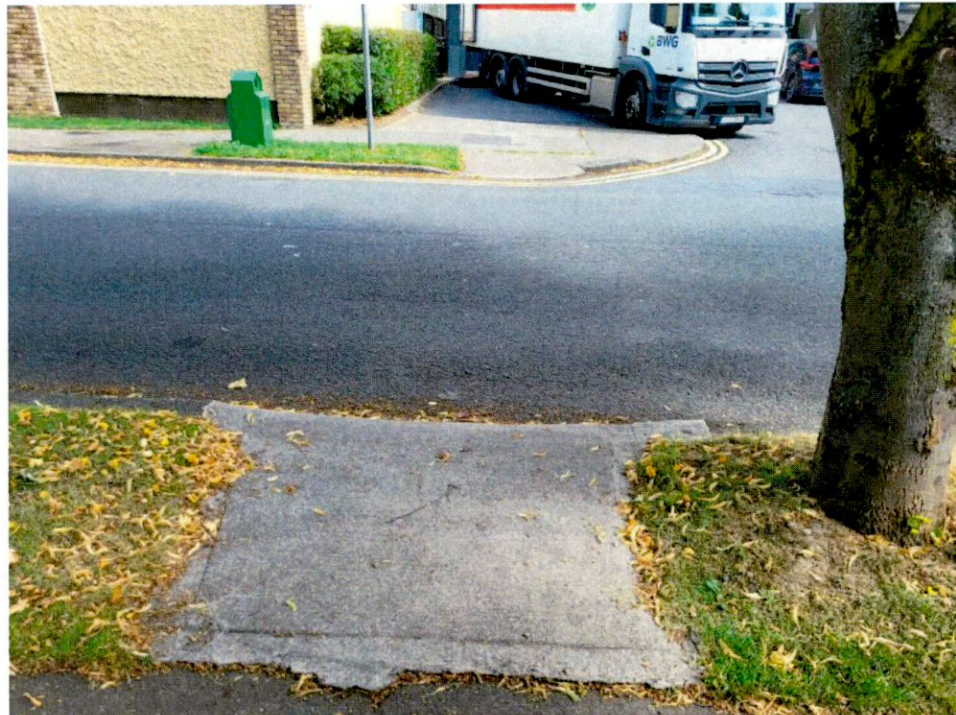
- There is no provision for safe crossing of the Orlagh Grove carriageway to the south of the proposed site access, with non-standard crossing points shown adjacent to the Spar Access, which is narrow with insufficient dropped kerb and tactile paving provision, as shown in figure 19, and reduced intervisibility also noted due to the location of mature tree trunks within the verges adjacent, as well as the high wall on the eastern side of the crossing. Intervisibility obstructions increases the risk of pedestrian/vehicular conflict.

Figure 20: Narrow Crossing Point with Poor Intervisibility

3. The demand for crossing the carriageway of Orlagh Grove to the south of the site access point should be assessed, with provision for safe crossing facilities where necessary.

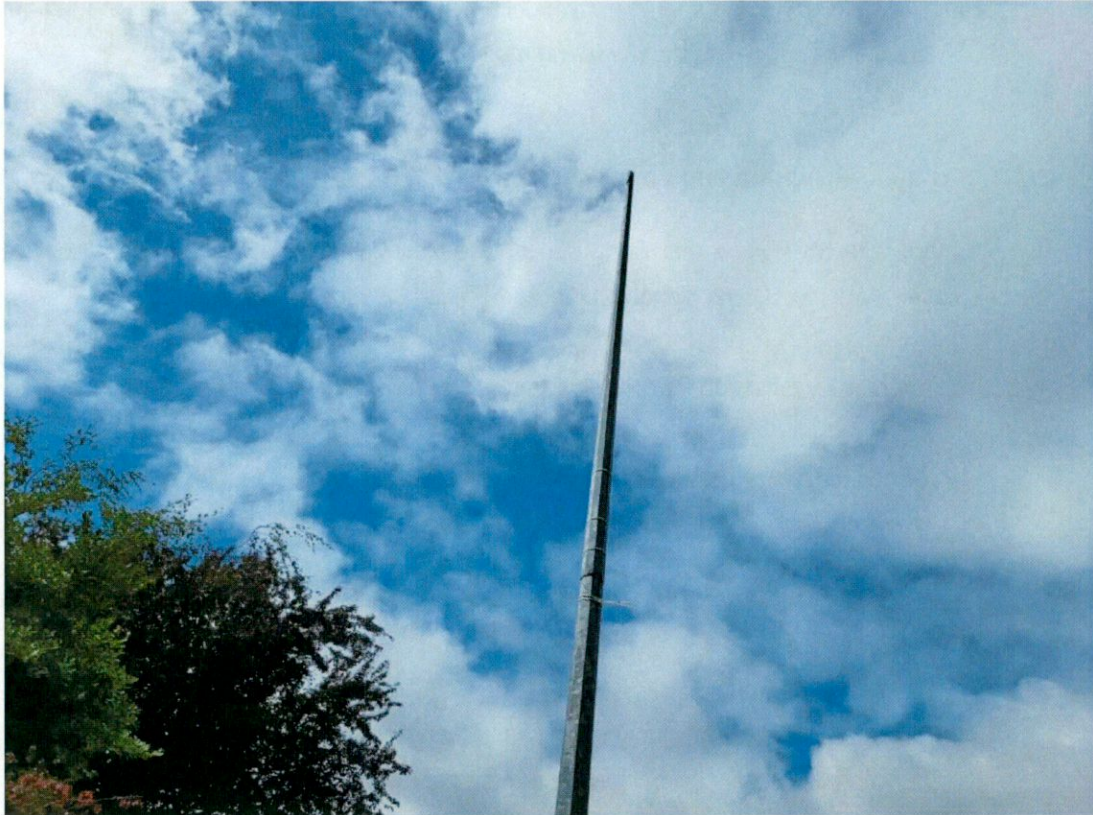
New lighting columns have been shown within the site, however they appear to be located in close proximity to the kerb edges where vehicles will be turning and reversing, presenting an increased risk that the columns may be struck. Column locations may also obstruct the movement of pedestrians and cyclists on the narrow internal footways. A full review of existing lighting provision was not possible at the time of the site visit, however it was noted that existing lighting on Scholarstown Rd adjacent to the site appears dated, and a lamp was also missing from one of the columns, as shown in figure 21. The dense tree foliage within verges on both

sides of Orlagh Grove are also likely to reduce the effectiveness of street lighting. Insufficient lighting within or surrounding the site may lead to an increased risk of road user conflict during the hours of darkness.

Figure 21: Missing Lighting Lamp on Column at site boundary

1. Existing Lighting Provision surrounding the site should be reviewed and enhanced where necessary to ensure the boundary of the site and all site approaches are well lit in the hours of darkness.
2. All new lighting columns should be provided at a sufficient offset from the carriageway edge to minimise the risk of being struck by passing and turning vehicles, with a minimum recommended 450mm to be provided in urban environments. Where columns cannot be moved, provision should be made for suitable protection to prevent vehicle strike.

3. Lighting columns should ideally be located to the rear of footways in a location which does not obstruct the movement of VRUs.
4. Internal site lighting should not interfere with lighting on the external public road network, and should not cause dazzle to passing motorists.

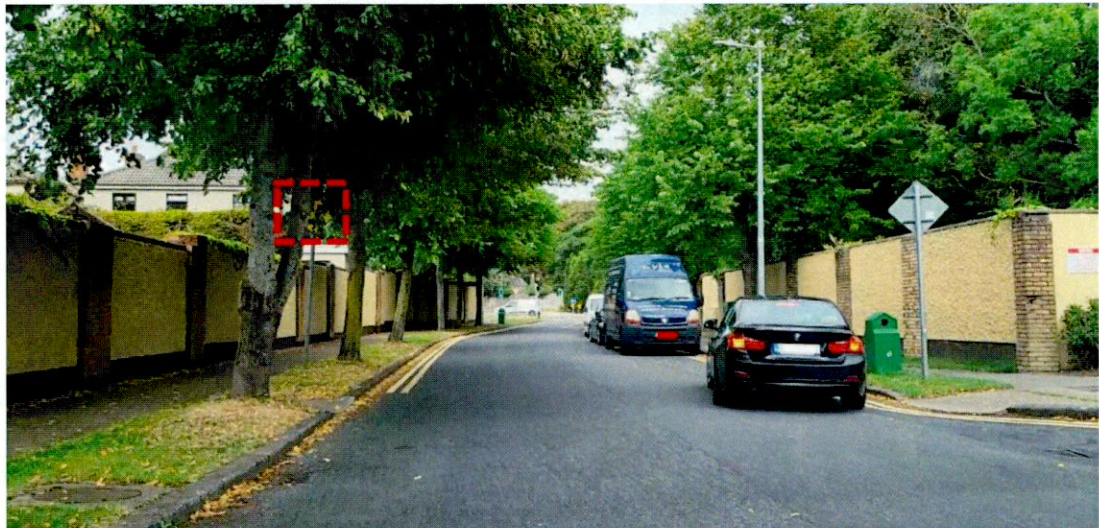
- Existing signs are obscured by trees and overhanging vegetation within the verges, as shown in figure 22.

Figure 22: Existing Warning Sign for roundabout ahead is Obstructed

1. The layout should be finalised at detailed design stage, taking into account all issues raised in this Stage 1 RSA report, with provision for suitable warning at an appropriate location in advance of the junction.
2. Any new signs should be placed in a location which is clearly visible to approaching motorists in accordance with traffic speeds, and at a suitable mounting height to minimise overhead hazards for pedestrians and cyclists.
3. All signs should be placed at a sufficient offset from the carriageway edge, minimum 450mm from the edge of the sign face to the kerb, to minimise the risk of being struck by passing or turning vehicles.
4. All new road markings and signage to be installed in accordance with the requirements of the Traffic Signs Manual, to include highly reflective material to ensure visibility during the hours of darkness.
