Architectural Heritage Impact Assessment

Scholarstown House, Scholarstown Road, Dublin 16

October 2022

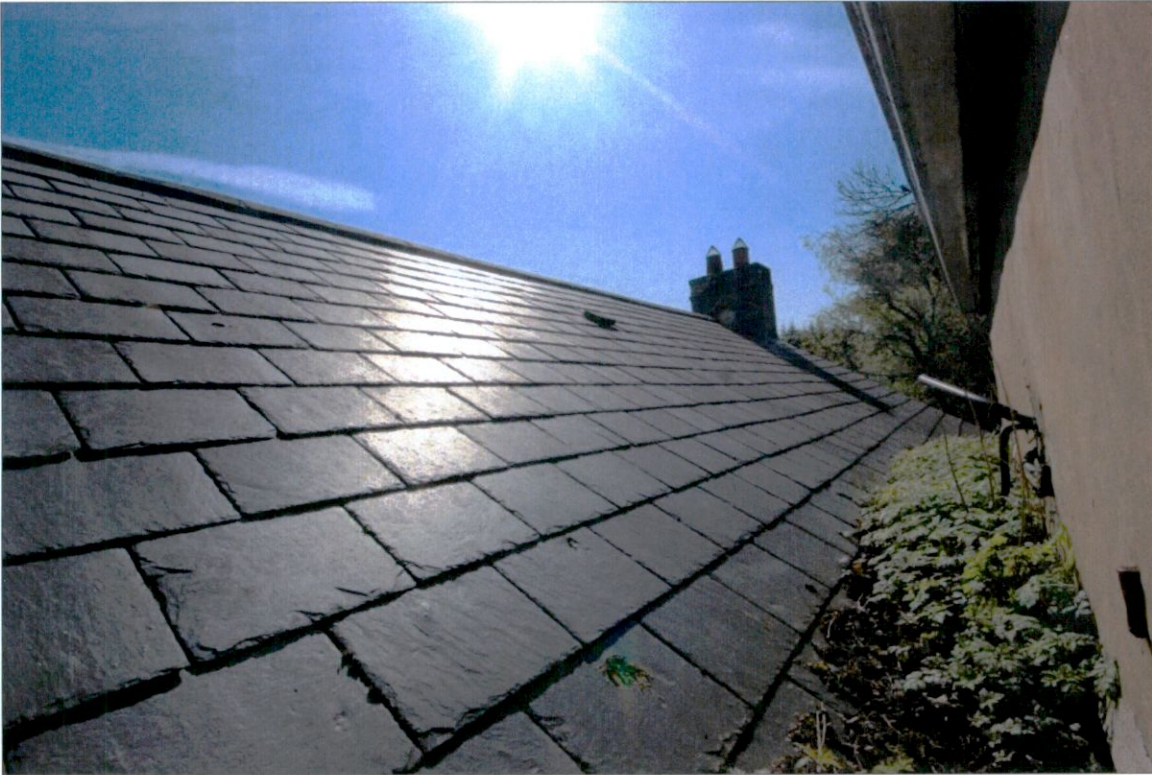
Plate 16: Valley between main roof and return

- The gutter in the valley between the main house and the return is blocked with vegetation and requires clearing and ongoing maintenance to reduce the likelihood of water ingress causing damage to the interior. It is recommended that access should be provided to enable regular inspection and maintenance of this vulnerable part of the protected structure.

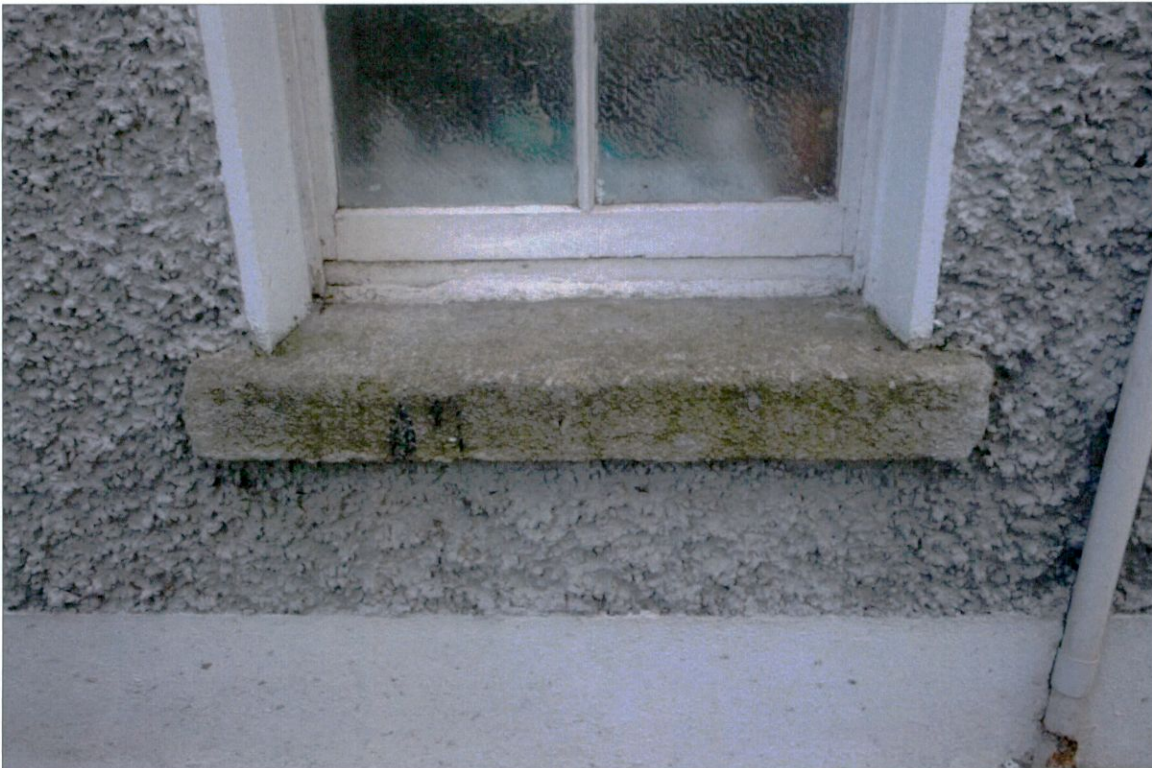
Plate 17: Granite sill to ground floor window to rear return

It is important to examine and ensure the integrity of stone windowsills on the site. These should be free of vertical cracks which could result in moisture ingress into the masonry wall fabric beneath. Cracked window sills should be replaced with new stone sills to match if they cannot be effectively repaired using resin-bedded stainless-steel dowels and crack sealant or weathered beneath with a suitable lead damp-proof course. It is important that there is an effective upstand on sills which prevents water being blown under window frames and into the masonry structure. If necessary, an upstand can be installed on a retained stone sill or damage to existing upstands can be repaired using an appropriate epoxy resin-based filler. A gap should be left beneath timber window frames to enable sufficient ventilation around the window that restricts moisture damage. The gap beneath the sides of any windows should be pointed with a lime mortar which will physically restrict water ingress to this vulnerable part of the opening by soaking up any water in this area from the sill and allowing it to dry out again, preventing it being trapped within the masonry or held for an extended time against the base of the window frame. The use of silicone or other sealing mastics around the exterior of timber window frames is **not** recommended.

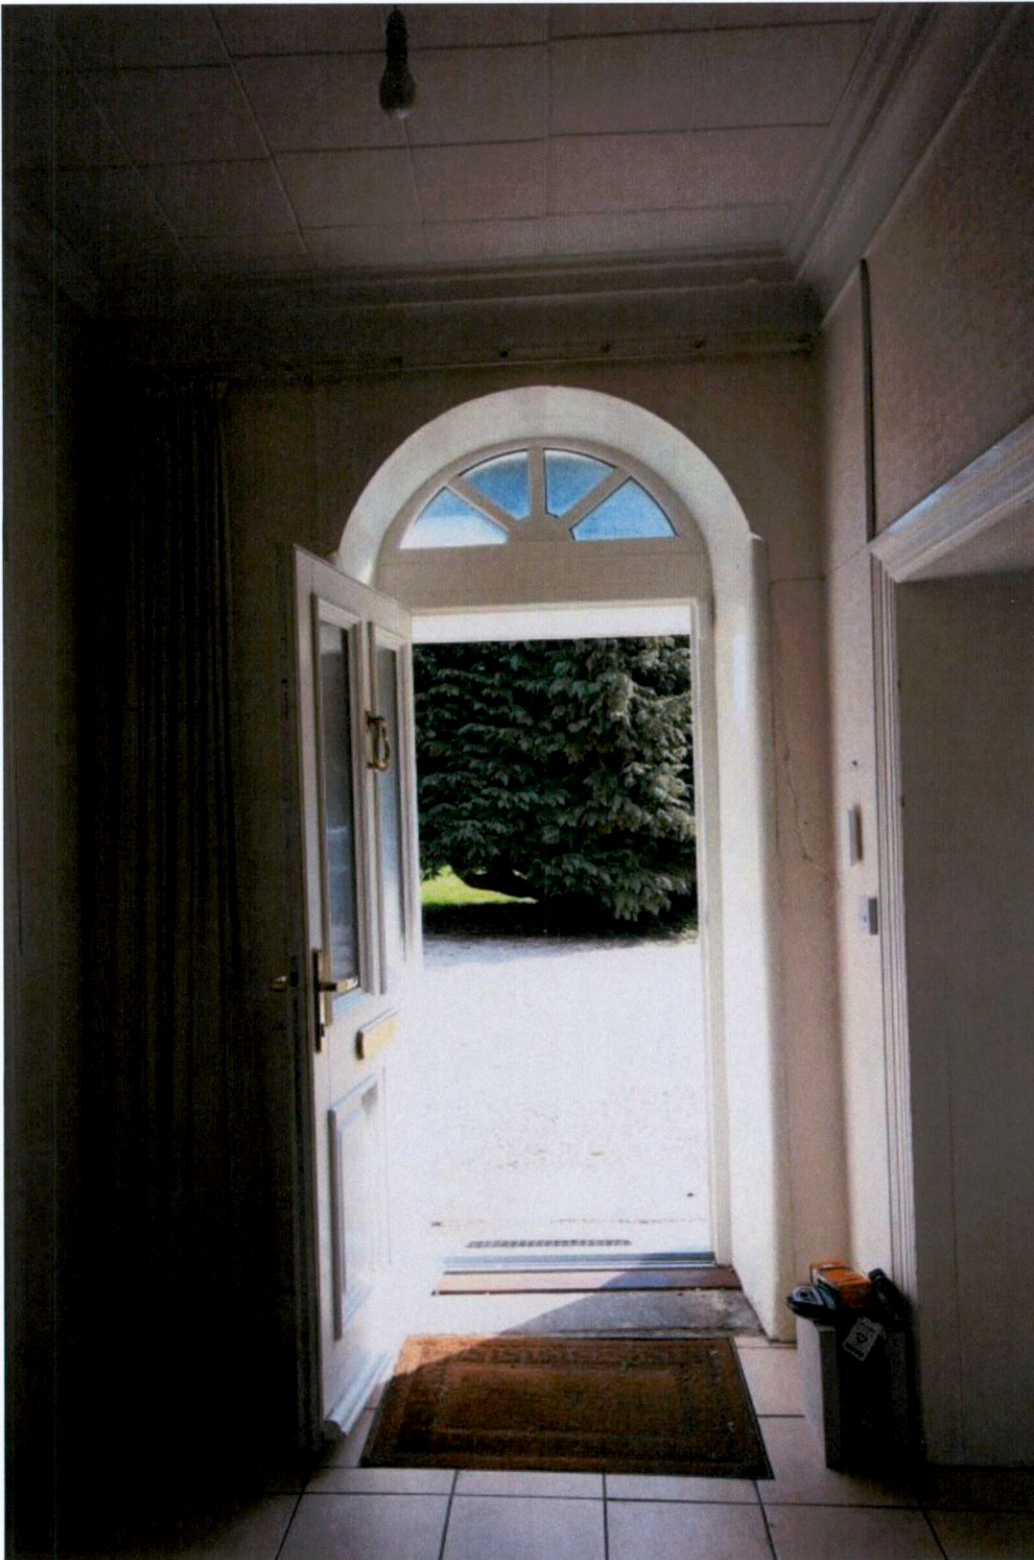
Plate 19: Entrance hallway looking to front door – note modern door and crude fanlight detail

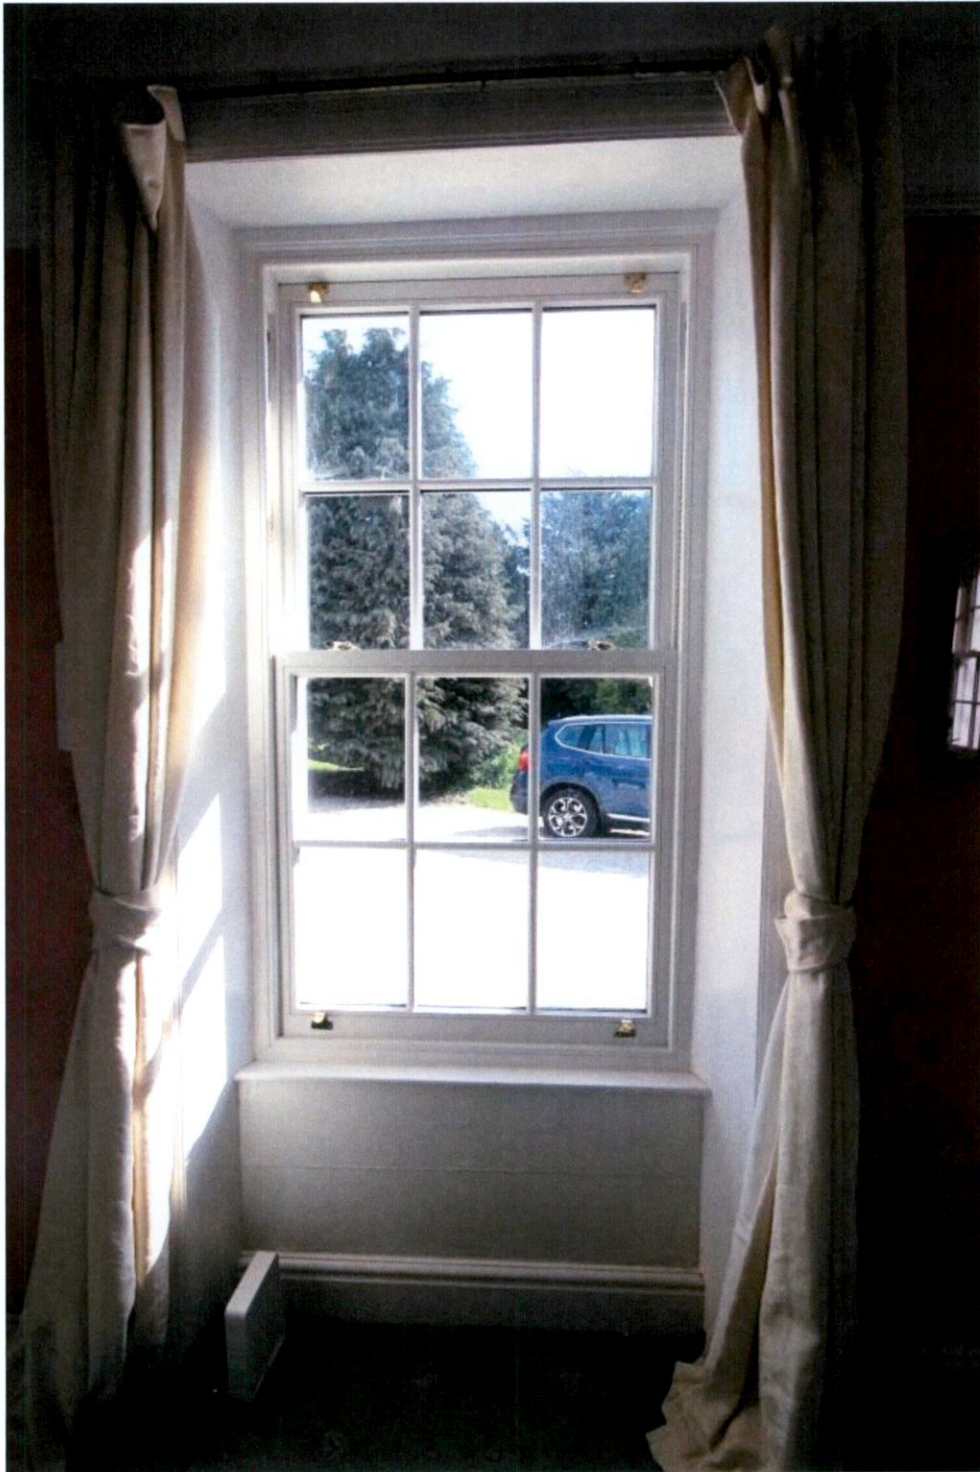
Plate 22: Typical replacement sash window to front elevation

A specialist conservation joiner will be engaged to remove sashes from boxes, strip back built-up thick or loose layers of paint, carry out necessary localised timber repairs to the frames (in approved hardwood) and re-glaze panes where necessary (retaining all re-usable historic glass particularly crown or cylinder glass) before an approved system of protective paint is applied.

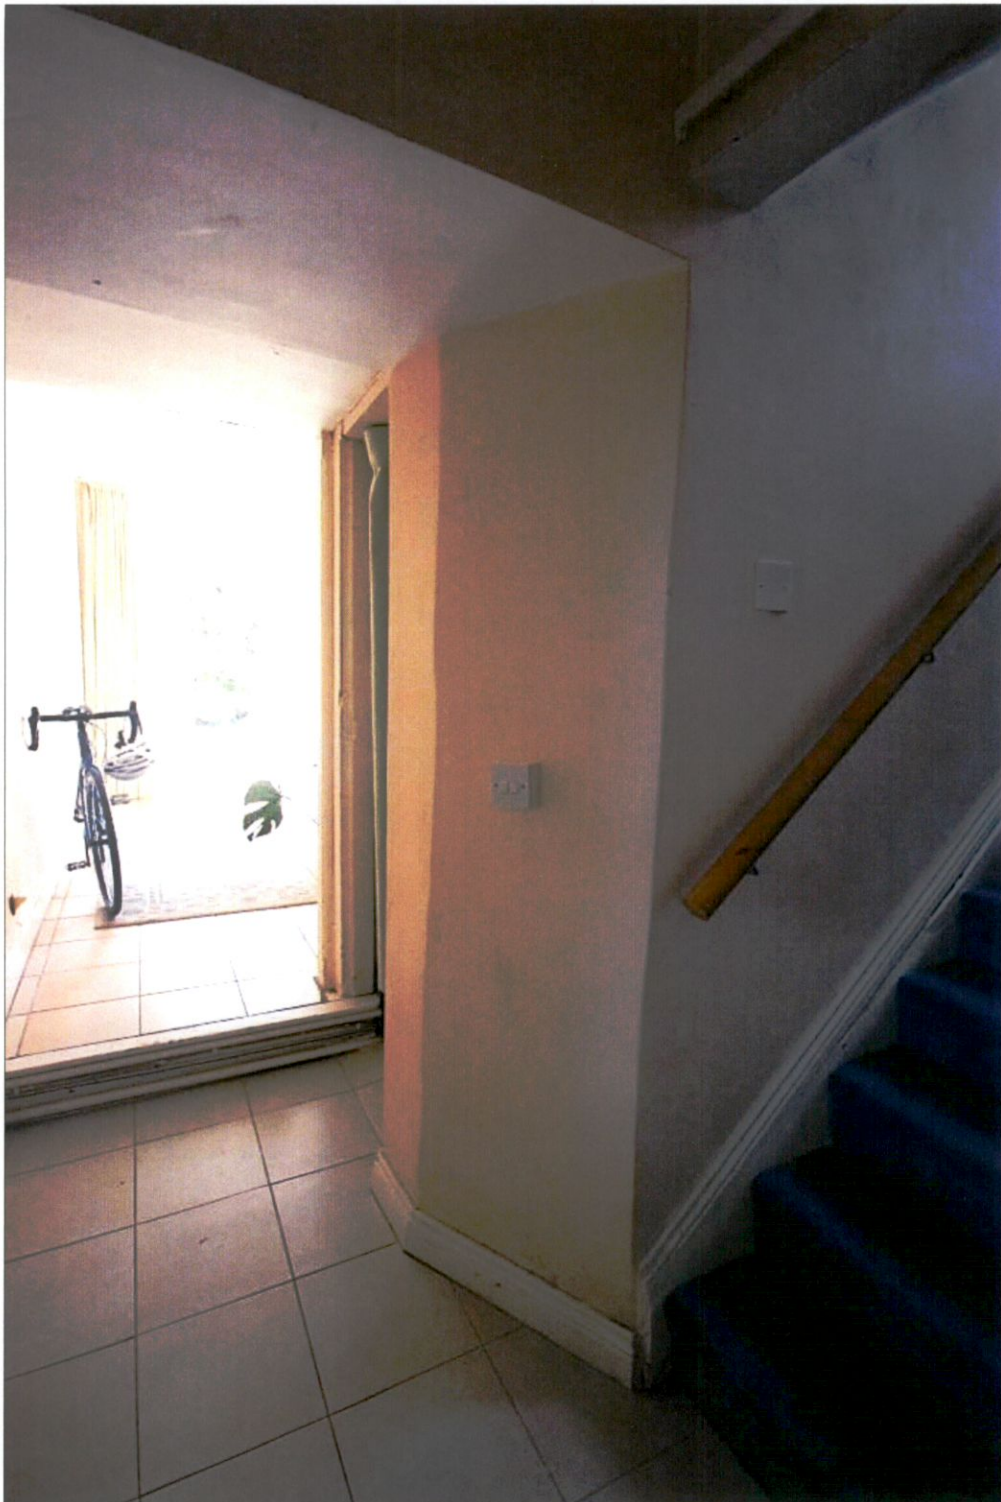
Plate 28: View from rear hallway GF04 to entrance hallway GF01. Note original rear wall of main block of original house.

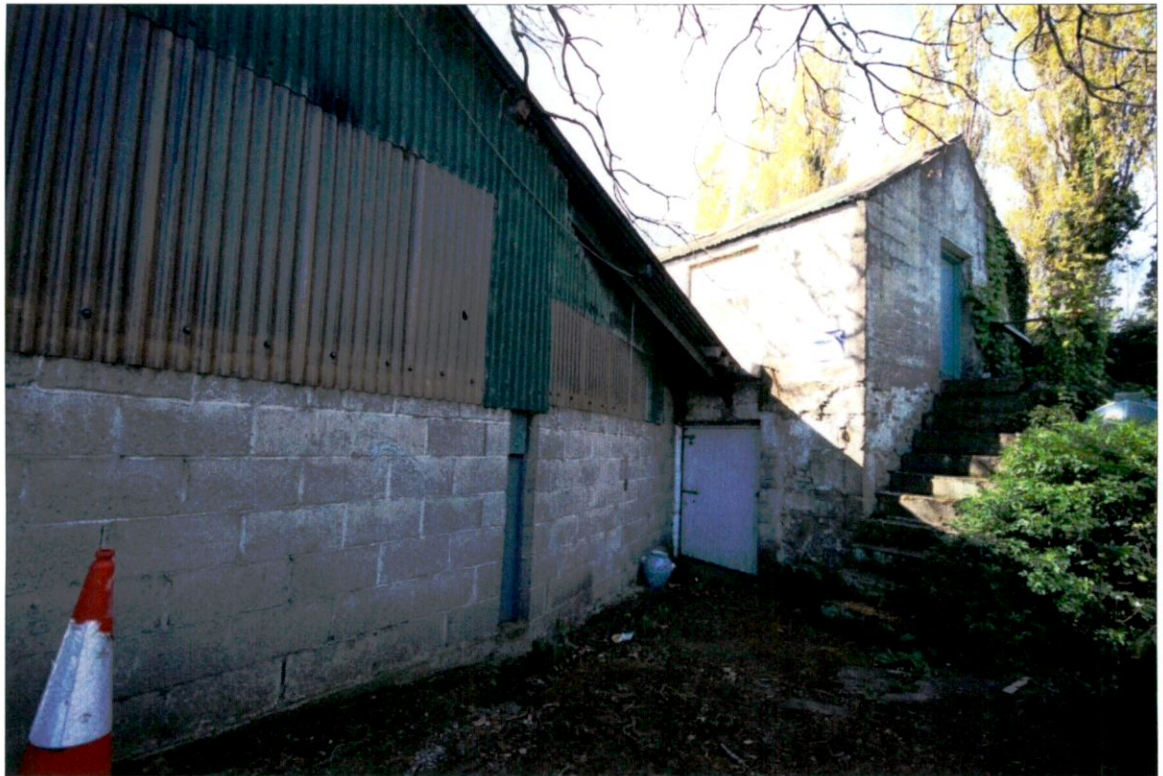
Plate 41: Northern elevations of outbuildings. Note rubble stone masonry walls to lower portion of building D2 with cast-concrete upper floor-level and steps.

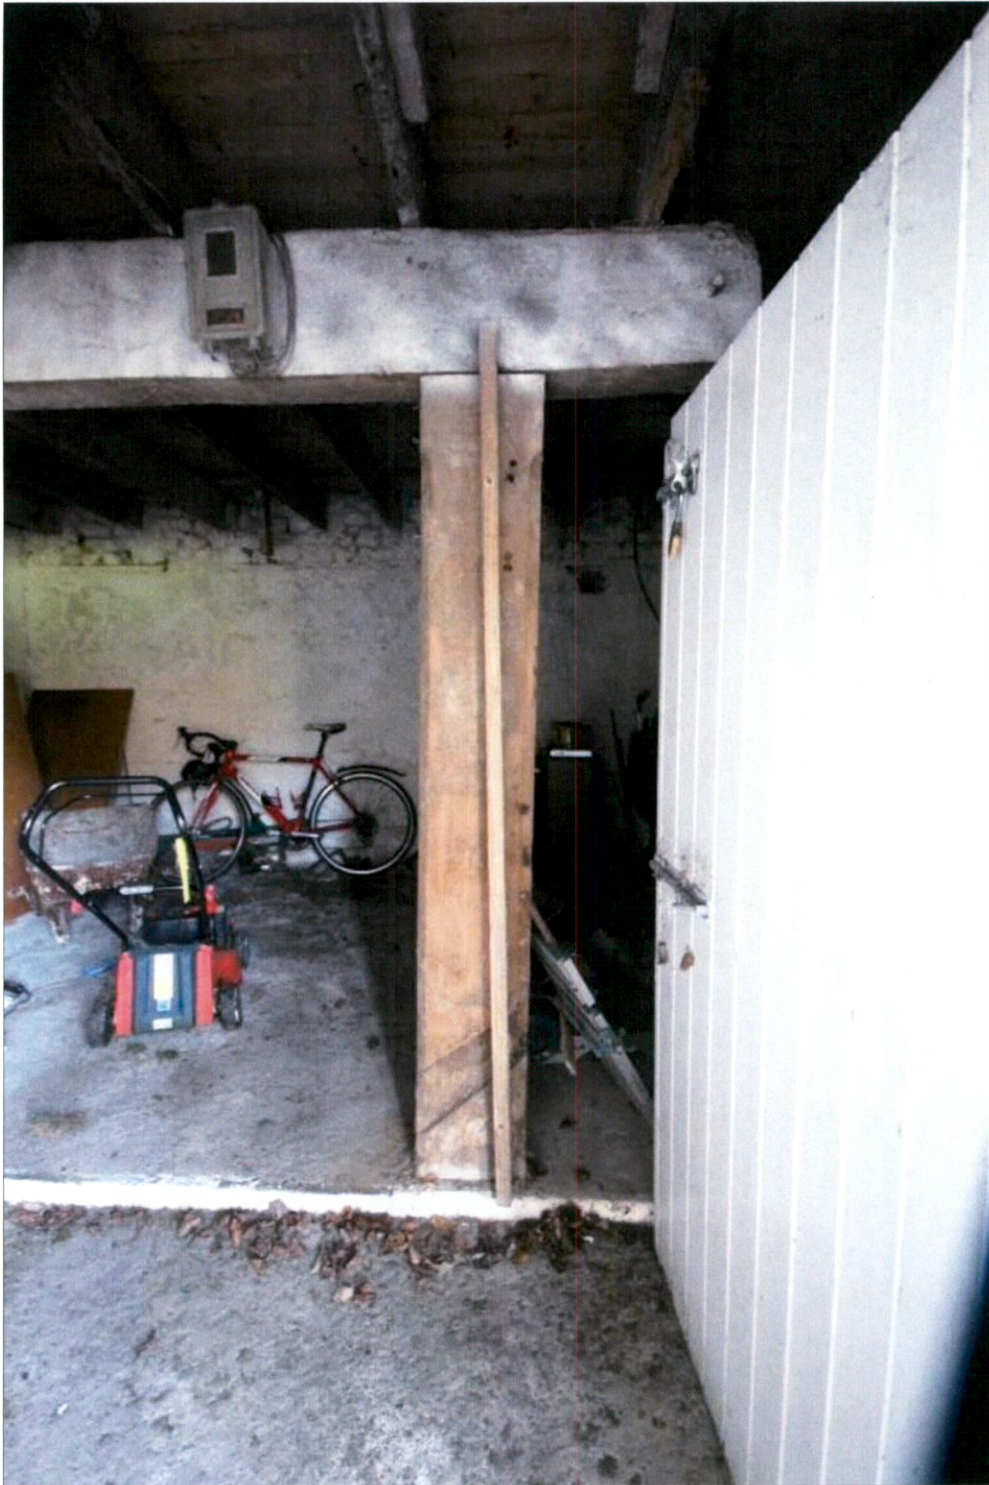
Plate 55: Oak beams in Building D2

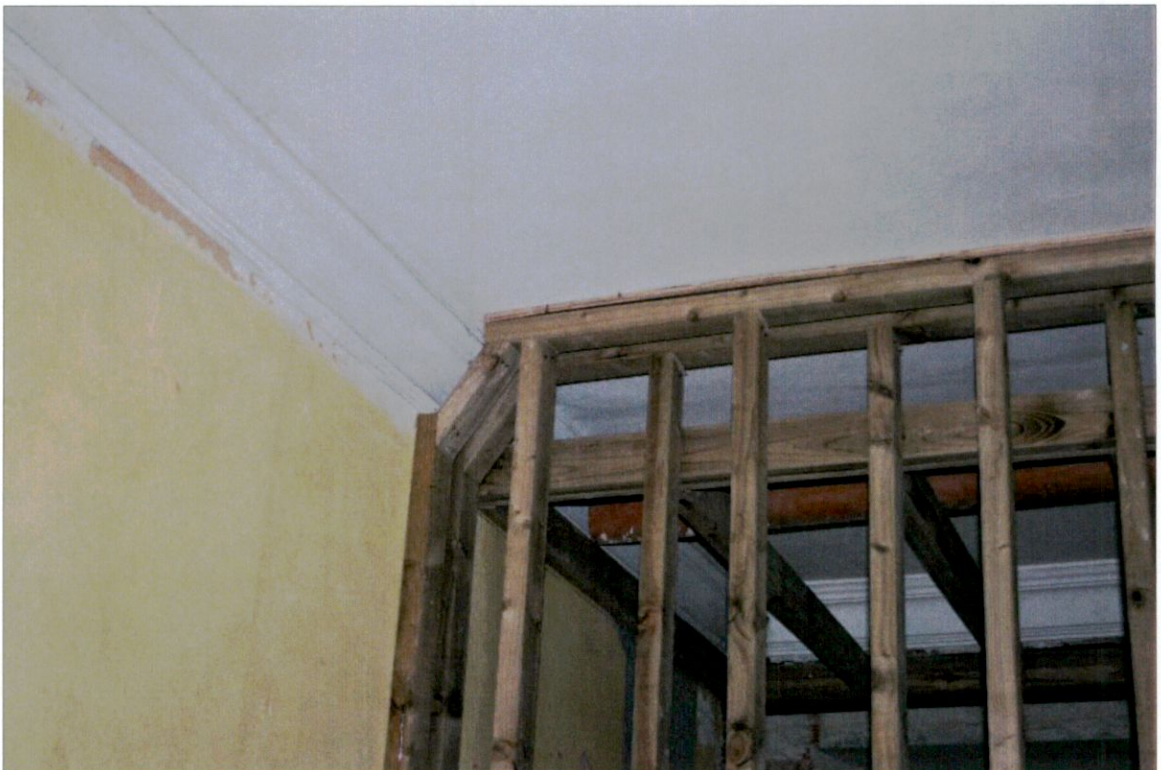
Timber-framed partition wall inserted within larger room avoiding irreversible interference with continuous moulded plaster ceiling decoration. Where possible, new proposed services should be concentrated within inserted partition walls in order to minimise chasing of original walls.

The replacement of existing inserted stud wall partitions with new stud walls to facilitate the proposed layout of the rear annex will follow consist of high-quality inserted material which causes minimal intervention to the existing structural envelope. Where possible services will be incorporated within new stud wall partitions rather than chasing original masonry walls.

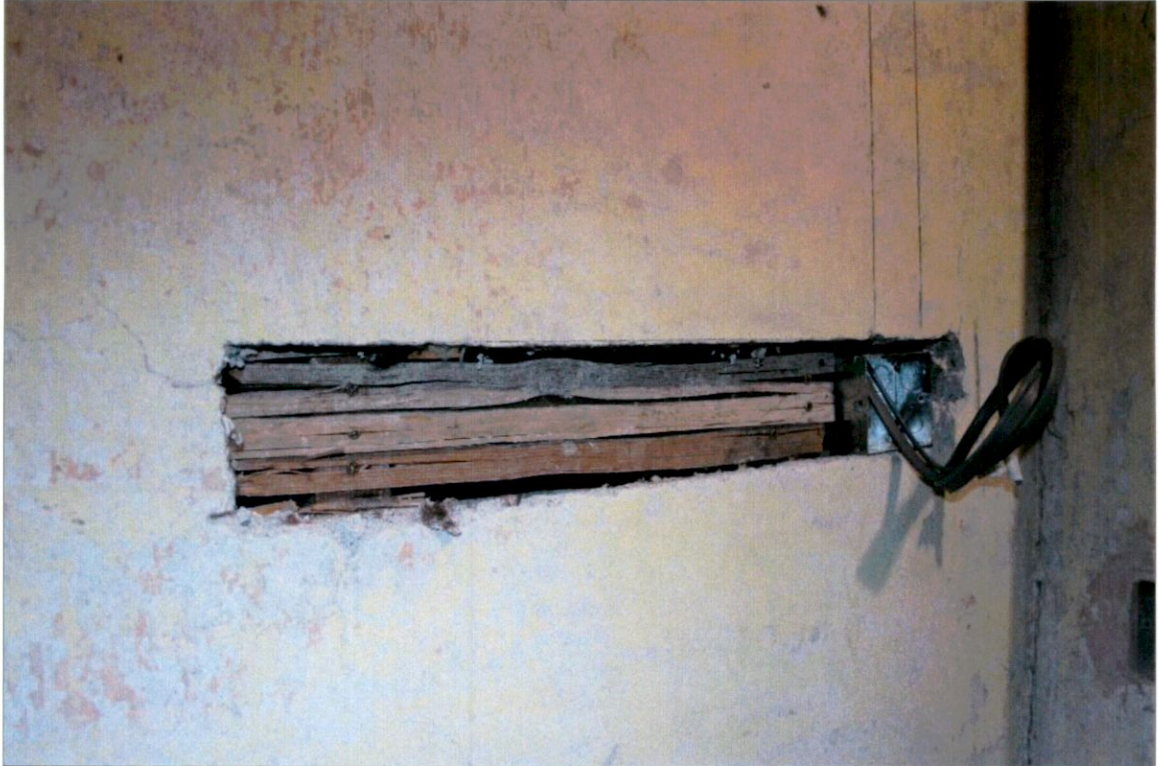
*Timber ground inserted between studs on historic lath-and-plaster partition to provide adequate support for installed socket, wiring for which was fished down behind lath-and-plaster surface causing minimal interference to historic fabric which will be made good with laths and lime plaster. Unlike in the above example, **all** timber should be pilot-holed before it is screw-fixed.*

minimum making use of existing chases or conduits where possible. Removal of limited sections of lath-and-plaster stud wall surfaces in order to 'fish' wiring through to the required outlet point will be preferable to chasing of same. The removal of limited sections of lath-and-plaster to insert timber grounds between existing timber studs for proposed sockets will be permitted with any resulting holes in wall surfaces made good using riven laths and appropriate lime plaster when initial electrical installation is complete.

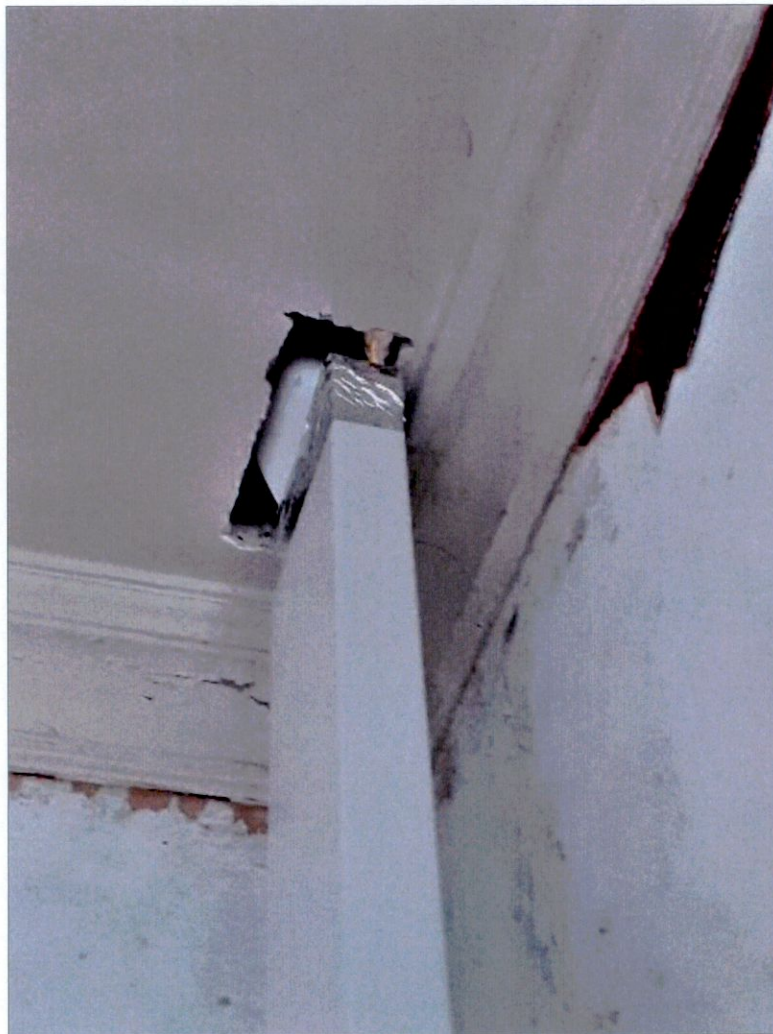
Mechanical ventilation duct converted from round to rectangular profile in order to divert around moulded plaster ceiling cornice. This duct can later be boxed-in, but no irreversible interference will be caused to significant historic plaster detail.
