## Determination of Particle Size Distribution

Project: Clondalkin

PROPOSED DEVELOPMENT SITE, OLD NANGOR ROAD, DUBLIN 22

EXISTING CULVERT HYDRAULIC ASSESSMENT REPORT

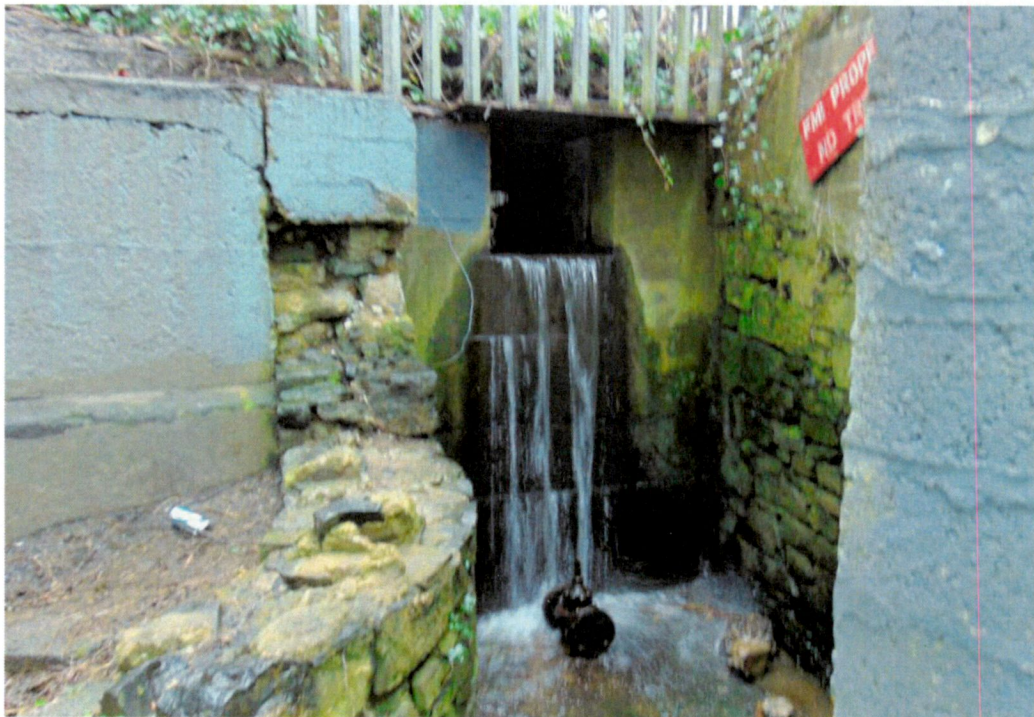
*Figure 2 – Concrete Tank Outlet*

The culvert was originally constructed as part of a paper mill, which is no longer in existence. It does however provide a hydraulic conveyance function to allow waters that spill into the Mill Pond from the Camac River to flow back into the river downstream. The rate of discharge from the pond is limited by an opening in the side of the concrete tank located upstream of the culvert inlet as shown in *Figure 2* below.

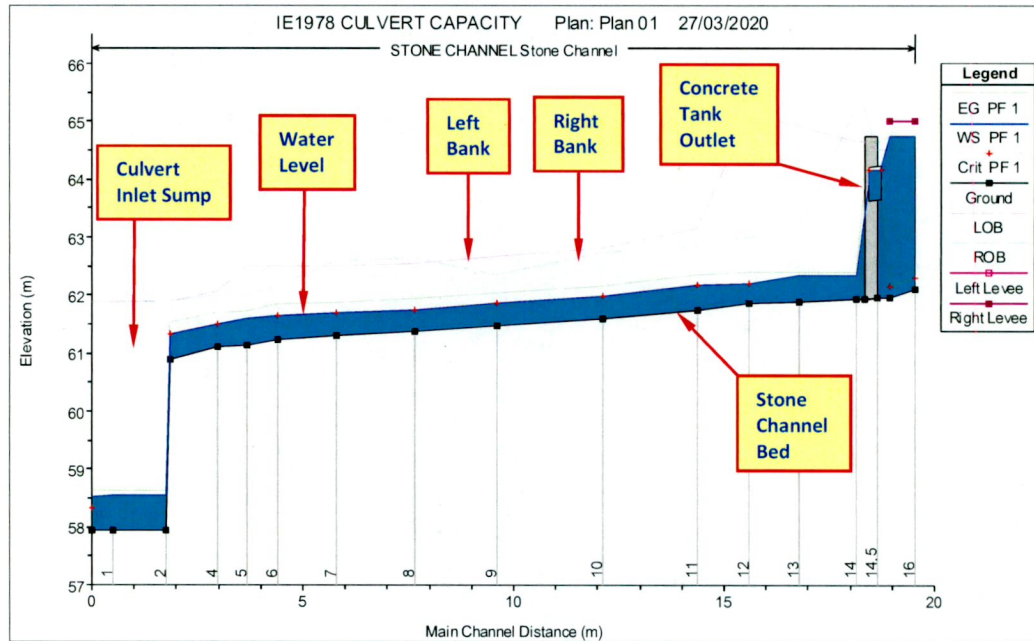
Figure 4 – Model Longitudinal Profile

The model simulation is represented by a longitudinal profile through the modelled reach as shown in *Figure 4* below.

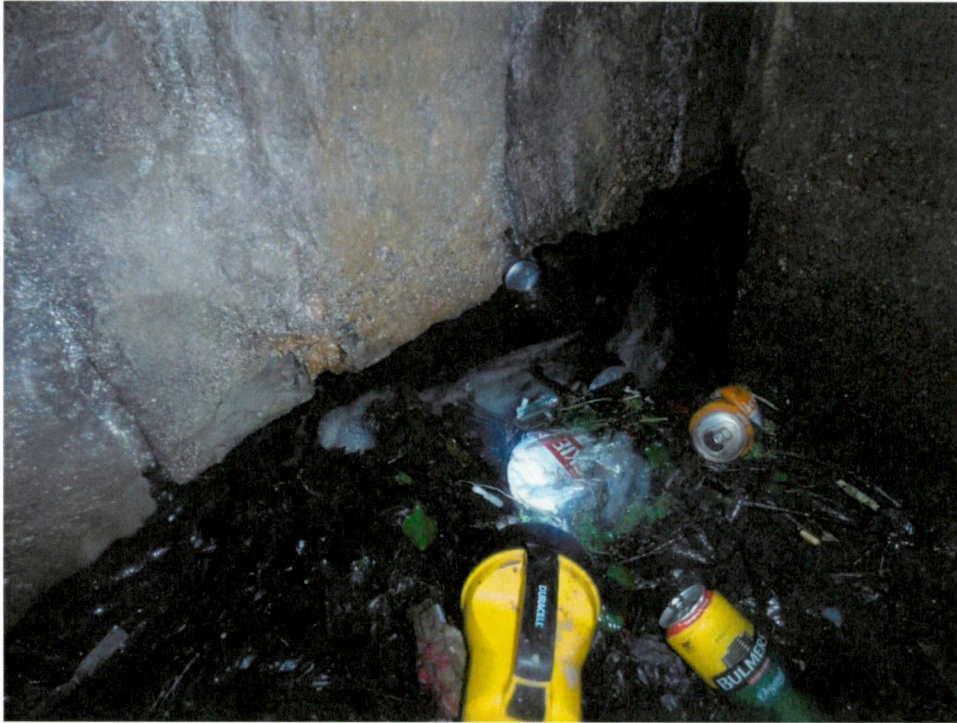
**Photograph No. 1** Upstream end. Old bridge fascia.

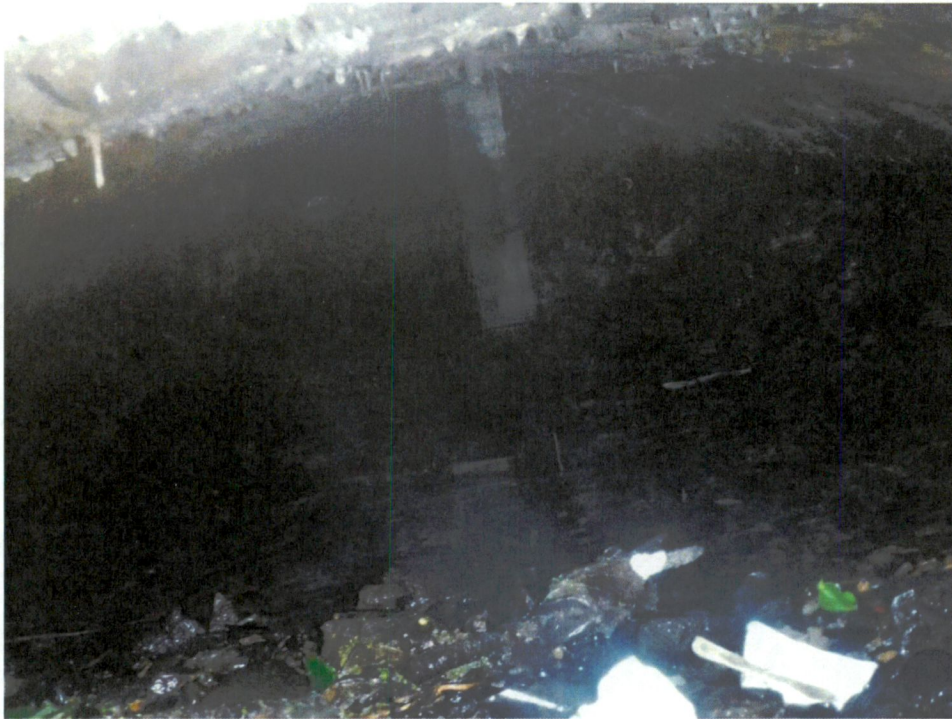
**Photograph No. 2** Upstream End @ 2 m. Blockage in Arch Barrel

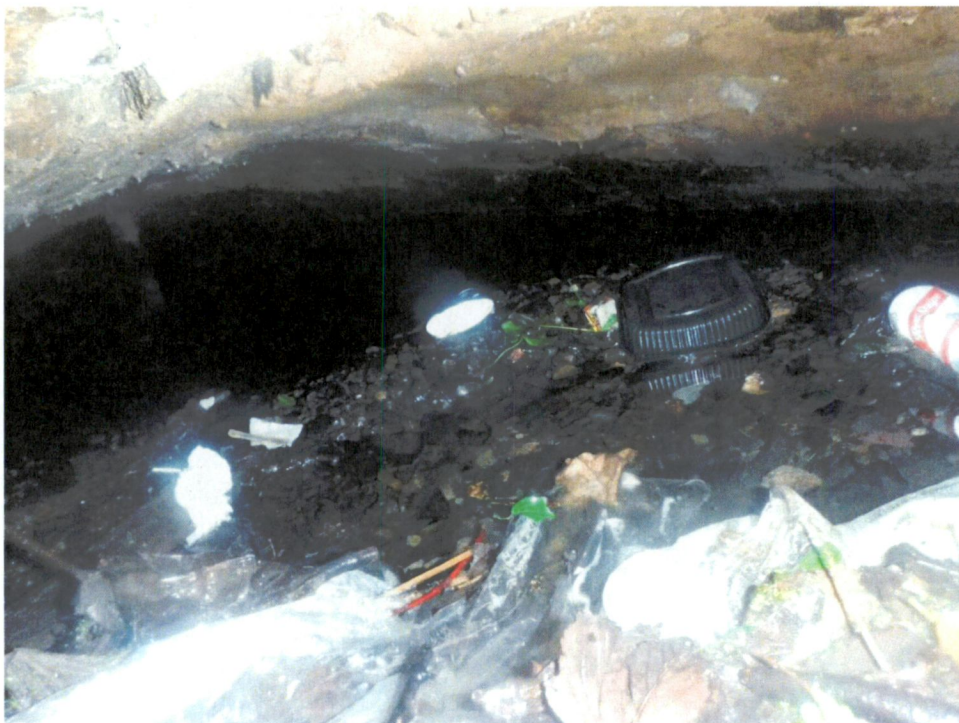
Photograph No. 3 Upstream End @ 2 m. Arch Barrel
