Title: **QUALITY AUDIT**

**Road Safety Audit Stage 1-2, Access Audit, Cycle Audit and  
Walking Audit.**

**Proposed Clonburriss SDZ Site for Kelland Homes Ltd.**

Report reference: **1470R01**

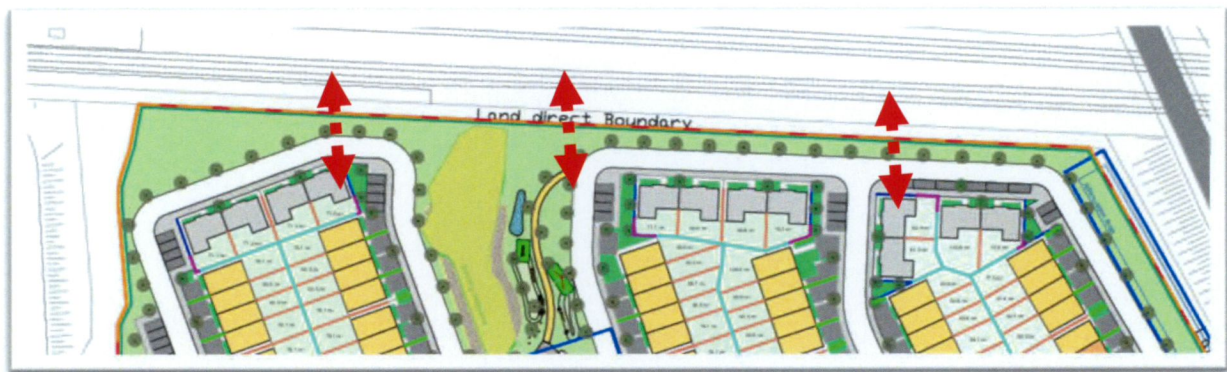
There are no proposed pedestrian or cyclist links to the path at the northern boundary of the site leading to the train station. This lack of permeability may lead to unofficial routes without hard standing which could lead to trip/slips and falls.

*Red arrows are indicative only to illustrate the issue*

It is recommended that a number of pedestrian and cycle links be provided to the existing shared use path.

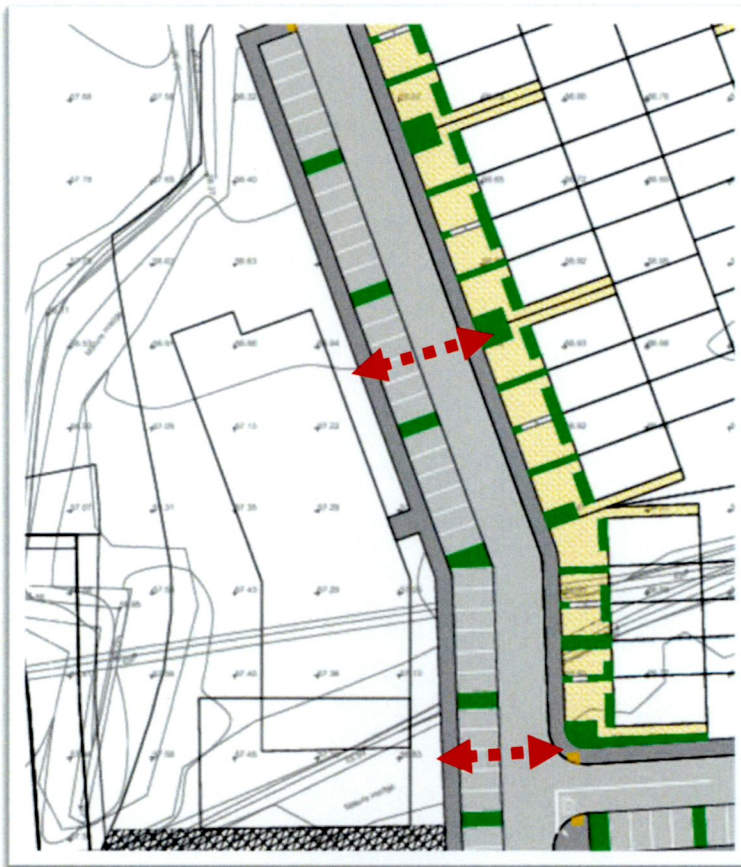
There is perpendicular parking along Road 1 with intermittent landscaped areas between parking bays. There are no other access points for pedestrians, particularly the mobility impaired including those pushing buggies or in wheelchairs to access the apartment block except at the extreme ends of the parking which may be a long way from the desire line.

*Red arrows are indicative only to illustrate the issue*

It is recommended that intermittent access points for pedestrians be provided.

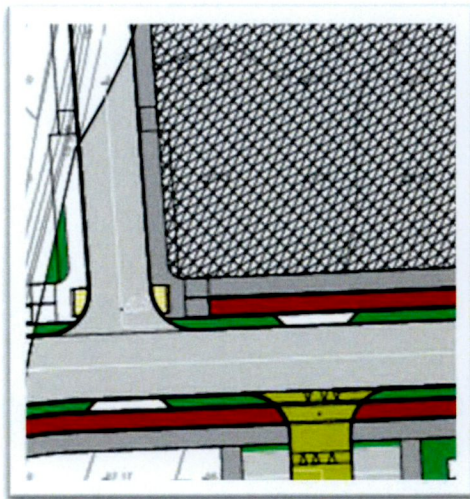
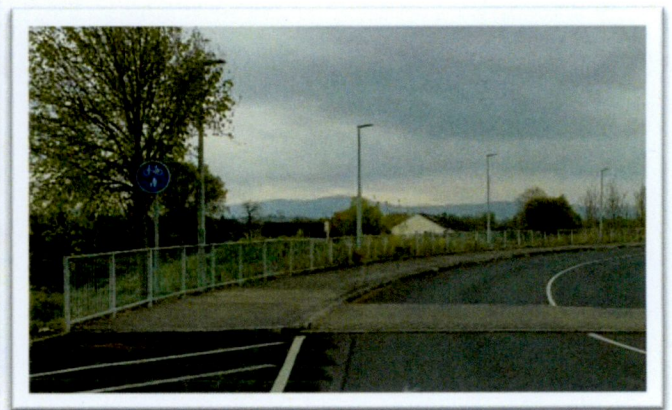
It is proposed to realign the access to the Clondalkin & Fonthill Train Station Park and Ride. It is proposed to provide a footpath only along the access road. There is an existing shared use footway/cycle track to the facility.

It is recommended that facilities be provided for cyclists along the access road.

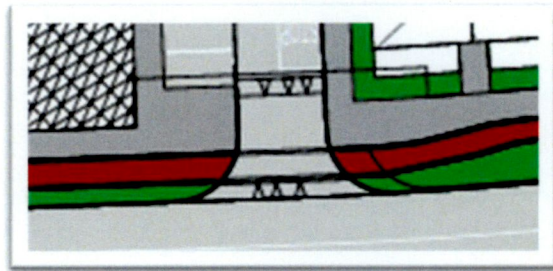
It is unclear if the cycle tracks along the distributor road will be coloured at the various accesses throughout the development. A lack of colour contrast may not alert drivers of the possibility of crossing cyclists.

*Example only*

It is recommended that coloured surfacing be used on the cycle tracks as they cross the accesses.
