Stage 1/2 Road Safety Audit

Proposed Residential Development, Knocklyon Road, Dublin.

| Document No: | 211090-ORS-XX-XX-RP-TR-13g-001 |

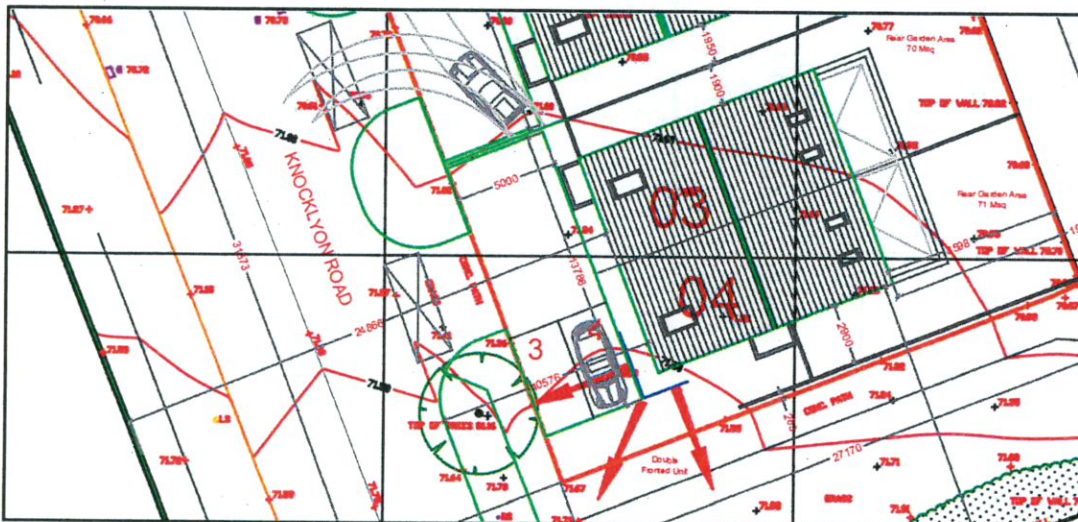
Problem No.1: Sightlines

Location: Site Entrance/Exit

The audit team note from the design drawings that there are insufficient details provided in relation to sightlines, including the impact of proposed landscaping and existing vegetation at the entrances/exits. There is a potential safety risk to users of the development if trees, shrubs, or signage obstruct sightlines, potentially leading to side impact vehicle collisions.

The design team should ensure that landscaping does not impact on sightlines and visibility of pedestrians or vehicles within the site or at the accesses.

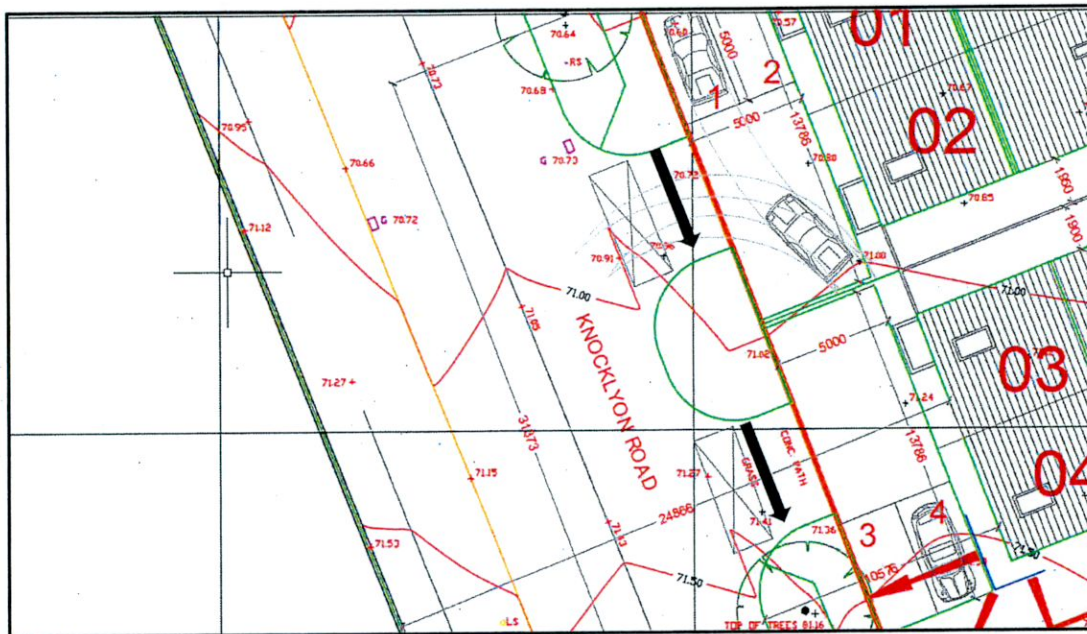
Problem No.2: Pedestrian Path Treatment

Location: Across Site Entrance/Exit

The audit team note from the drawings provided that it is unclear how the pedestrian concrete path will continue across the entrances of the development. It is unclear how pedestrian priority will be maintained at the driveway locations. Drivers may become confused as to priority of movement which could potentially result in vehicle-pedestrian conflict or an injury.

The design team should specify that footpaths continue across the entrances locations to clearly indicate pedestrian priority at these locations.
