Transitional Care Facility

Stage 1 & 2 Road Safety Audit

Bartra Property Cookstown Limited

February 2023

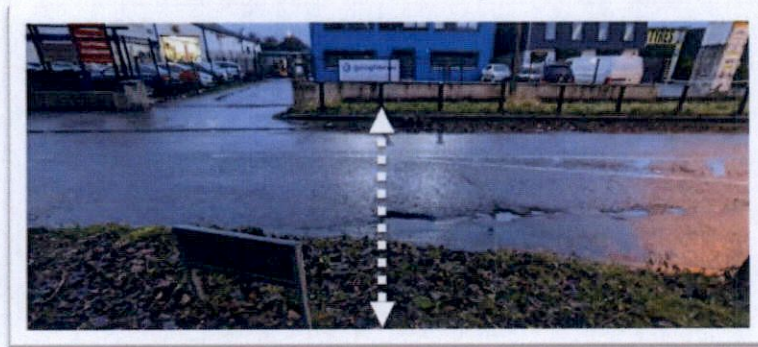
Figure 2.1 – Example Pedestrian Crossing Location with High Containment Kerbs

The existing high containment kerbs create a difference in level between the footpaths and the road pavement which could lead to steep gradients and pedestrian progression issues at the site accesses and various pedestrian crossing points.

Appropriate footpath gradients should be provided at the site access points and pedestrian crossing locations.

2.1	Yes	Yes	Appropriate transition kerbs have been added and suitable gradients will be maintained as part of any design.	<i>Noted</i>
2.2	Yes	Yes	The kerbing along the development boundary is to be replaced with standard height kerbs.	<i>Noted</i>

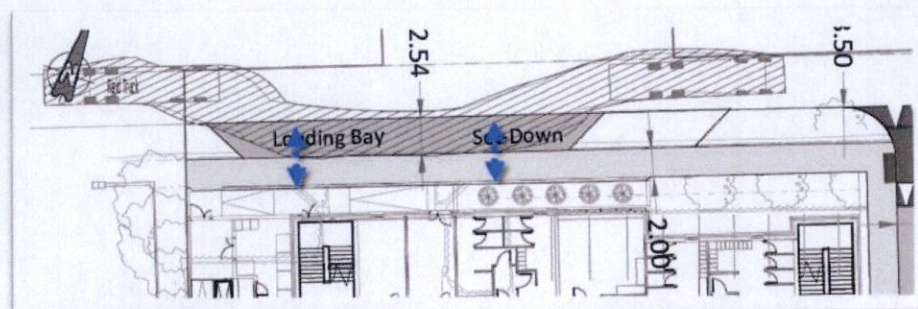
Figure 2.2 – Example Pedestrian Connection Points Between Vehicles & Footpath

The existing high containment kerbs could create a difference in level between the footpath and the loading bays which could lead to steep gradients and progression issues for pedestrians moving between the vehicles and the adjacent footpath.

The loading bays should be designed to facilitate ease of movement and universal access between vehicles in the loading bay and the adjacent footpath.

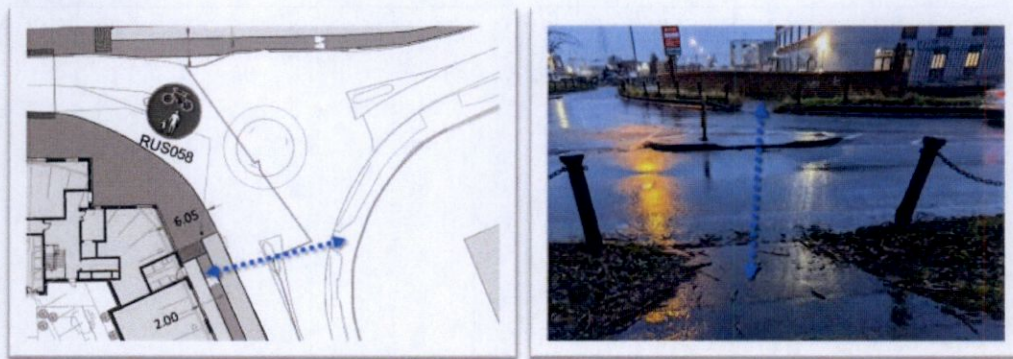
Figure 2.3 – Existing Crossing to be Facilitated

Failing to facilitate the existing courtesy pedestrian crossing at this location could lead to walkers crossing at places where it is less safe to do so.

Provision should be made to facilitate the existing pedestrian crossing.

2.3	Yes	Yes	The proposed layout has been amended to maintain and incorporate this crossing	<i>Noted</i>
2.4	Yes	Yes	The proposed layout has been amended to include appropriate kerbing at this location to close off the parking bay.	<i>Noted</i>

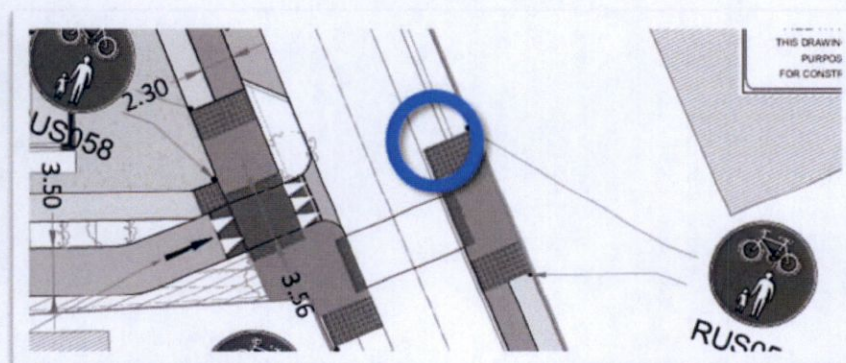
Figure 2.4 – Area Where Vehicles Could Enter Shared Surface Whilst Parking

Without containment, vehicles manoeuvring into or out of the parallel parking spaces could roll into the shared surface, placing pedestrians at risk of conflict.

Appropriate containment measures should be set in place to mitigate the risk of vehicles rolling into the shared surface.

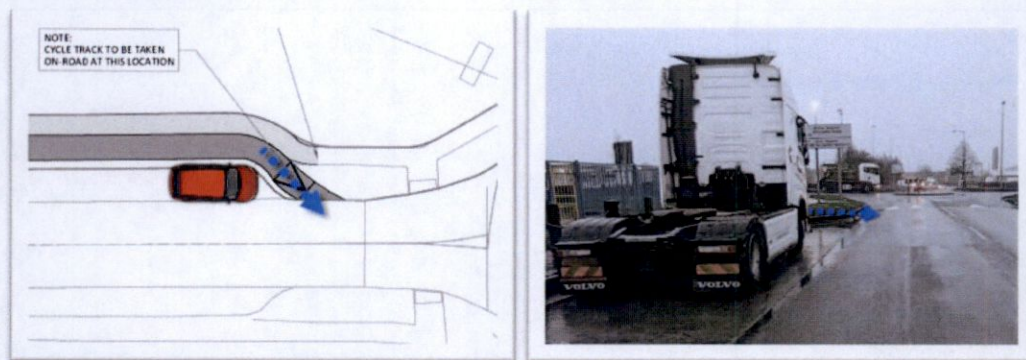
Figure 2.5 – Visibility for Cyclists Obscured by Parked Vehicles

Vehicles occupying the parallel parking zone are likely to block visibility for cyclists attempting to re-join the adjacent traffic lane. This could lead to conflicts between cyclists and general traffic.

The design should be amended to ensure that cyclists are afforded appropriate visibility to oncoming vehicles at the point where they will be encouraged to re-join the traffic lane.

2.5	Yes	Yes	The connection point to the road has been set further back from the car parking to ensure visibility.	<i>Noted</i>
2.6	Yes	Yes	The layout has been updated to show proposed connectivity to other planned road upgrade works at this location.	<i>Noted</i>

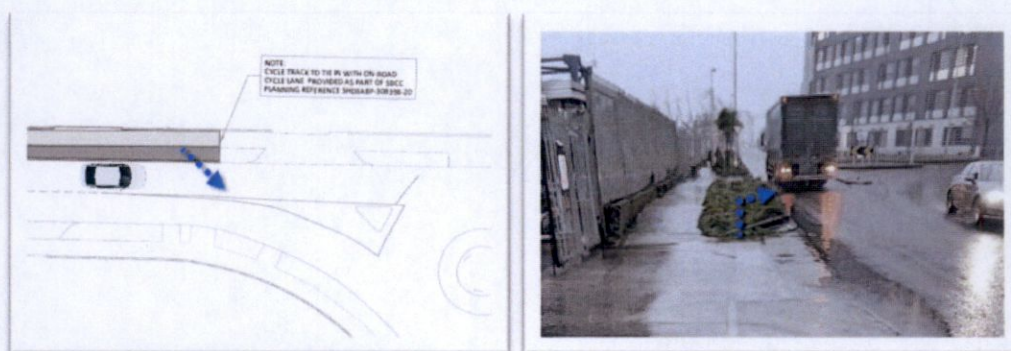
Figure 2.6 – Cycle Track Termination in Verge / Beside High Containment Kerb

Terminating the cycle track in the verge with no direct access to the adjacent traffic lane could lead to loss of control type collisions for cyclists.

An appropriate cycle track termination should be provided in advance of the adjacent industrial access point to the south.

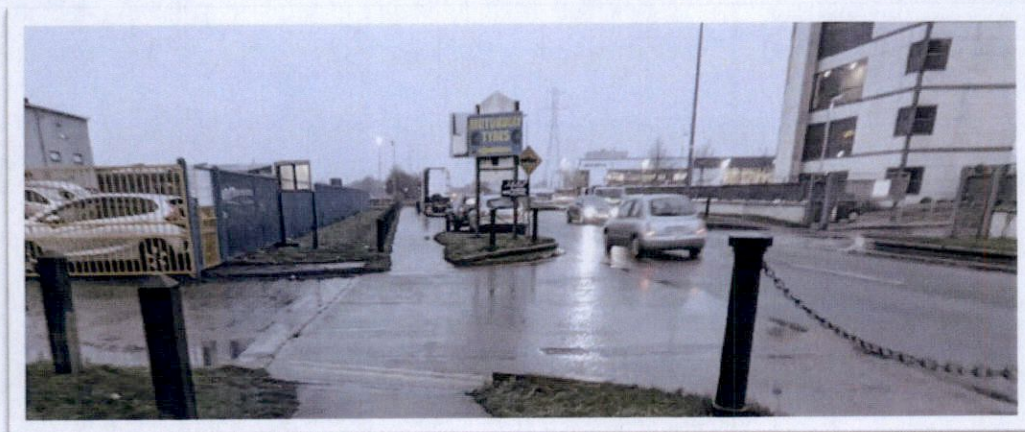
Figure 2.7 – Example Street Furniture i.e. Railings, Bollards, Lighting Columns and Signage

Existing street furniture could create hazards and pinch points within the footpaths and cycle tracks which are likely to lead to progression issues and conflicts for vulnerable road users.

The street furniture should be rationalised to facilitate the safe and comfortable progression of pedestrians and cyclists.

2.7	Yes	Yes	All street furniture will be relocated to an appropriate setting at the back of footpath. Private signage will be relocated subject to agreement with the relevant parties or the alignment amended slightly to avoid conflict through agreement with South Dublin County Council.	<i>Noted</i>
