Request for Further Information - Engineering Response (South Dublin County Council Register Reference SDZ22A/0014)

Phase 3 Proposed Development at Aderrig, Adamstown, Co. Dublin

March 2023

Waterman Moylan Consulting Engineers Limited

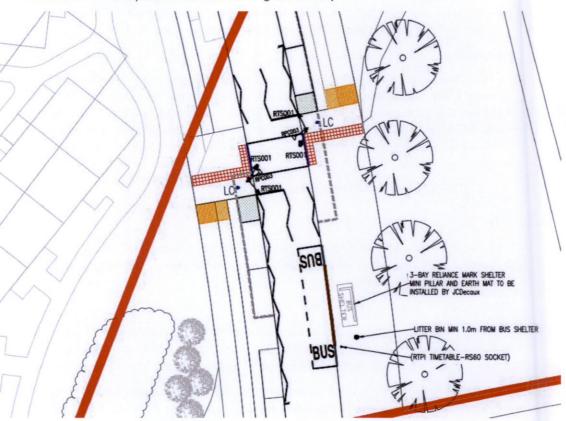
Figure 1: Proposed toucan crossing

It is proposed that, in addition to the signalized crossing at the junction of Adamstown Way and Celbridge Link Road, there will be a toucan crossing to the north of the Aderrig Phase 3 development, where pedestrians and cyclists will cross the Celbridge Link Road, refer to Figure 1.

The design of the toucan crossing has been discussed with the NTA and SDCC Roads Department and all comments implemented into the design. A road safety audit has been undertaken for the proposed bus stop and toucan crossing on Celbridge Link Road and the items raised have been satisfactorily addressed. A copy of this road safety audit is included as part of this further information response, refer to Appendix B.

22-023- T111 - Proposed Toucan Crossing & Bus Stop

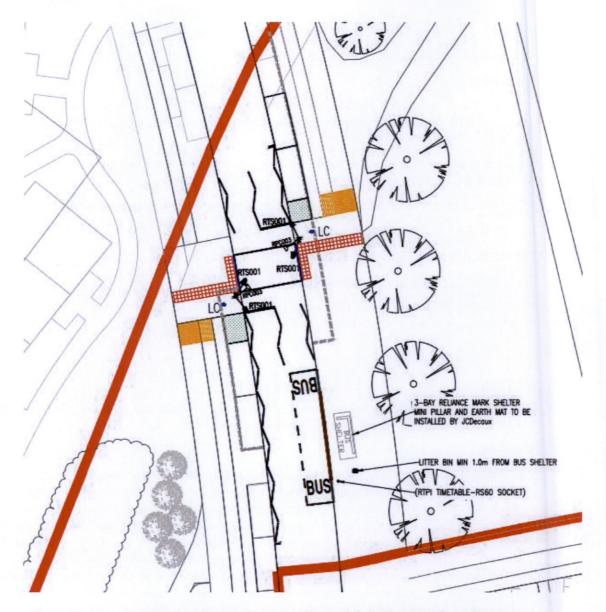
Figure 2: Proposed northern toucan crossing and Celbridge Link Road Bus stop

The National Transport Authority (NTA) requested a preliminary design for an additional bus stop on the Celbridge Road C2 bus route adjacent to the proposed Aderrig Phase 3 development in Adamstown. The proposed design features a single bus stop on the southbound lane adjacent to the proposed toucan crossing, which provides pedestrians and cyclists safe passage across the Celbridge Link Road. Following consultation with Goodrock Project Management, the NTA and Waterman-Moylan on the proposed bus stop locations, it was determined that the preferred location of the northbound bus stop would straddle two separate land ownerships and therefore be excluded from this application. Celbridge Link Road will ultimately be taken in charge therefore the final design of the northbound bus stop can be undertaken by the relevant authority for statutory undertaking. The indicative location of which can be seen on Waterman-Moylan Drawing No. 22-023- SK099 – Masterplan.

The design criteria specified by the NTA has also been applied to the bus stops to the bus south of the Aderrig phase 3 site, which was previously proposed under the Adamstown Boulevard planning application (reference number SDZ22A/0007). The indicative southern bus stop locations are to be agreed upon with the SDCC and NTA via Condition No. 10 of the Boulevard Planning Application (Reg. Ref. SDZ22A/0007) (refer to Drawing number 22-023-T112 for indicative locations).

An RSA has been undertaken on the bus stop design on Celbridge Link Road and the items raised have been satisfactorily addressed.

The final submission of the NTA bus stop design is included as part of this further information response. Refer to Waterman-Moylan Drawings, for details of same;

- 22-023-T111 Proposed Toucan Crossing & Bus Stop
- 22-023- T112 Proposed Uncontrolled Crossing & Bus Stops
- 22-023- SK099 Masterplan

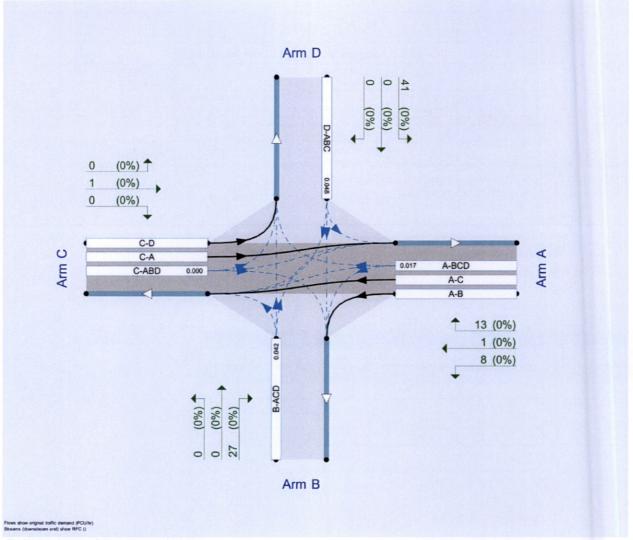
The junction diagram reflects the last run of Junctions.

Junction	Name	Junction type	Major road direction	Use circulating lanes	Junction Delay (s)	Junction LOS
1	untitled	Crossroads	Two-way		6.06	Α

Arm	Width of carriageway (m)	Has kerbed central reserve	Has right turn bay	Visibility for right turn (m)	Blocks?	Blocking queue (PCU)
	A	6.00			30.0	~	0.00
Г	С	6.00			100.0	1	0.00

Arm	Minor arm type	Lane width (m)	Visibility to left (m)	Visibility to right (m)
В	One lane	3.00	23	23
D	One lane	3.00	23	23

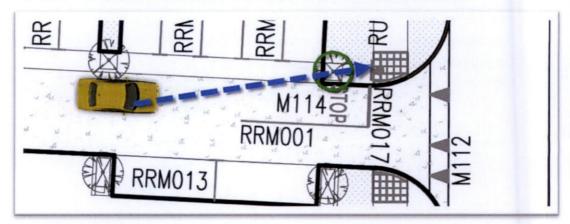
Figure 2.1 – Junction Where a Tree Could Obscure Forward Visibility to a Stop Sign

A tree obscuring a driver's forward visibility to the stop sign could increase the risk of late braking and conflicts with pedestrians attempting to cross the road.

Tree positions on all internal priority-controlled junctions should be checked to ensure that appropriate forward visibility is maintained to road signage (especially when the trees have reached maturity).

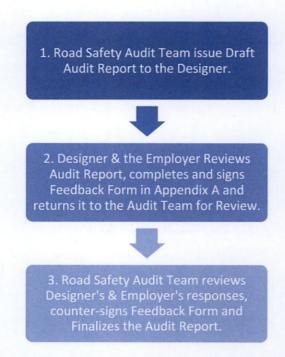
Figure 4.1 – Road Safety Audit Sign-Off and Completion Process

When completed, this form should be signed by the Designer and returned to the Audit Team for consideration. See flow-chart following for further description.

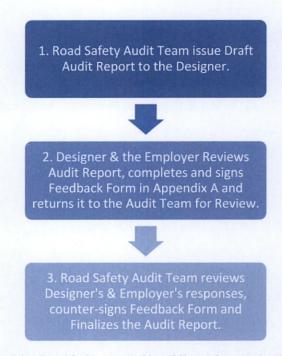
Figure 4.1 – Road Safety Audit Sign-Off and Completion Process

When completed, this form should be signed by the Designer and returned to the Audit Team for consideration. See flow-chart following for further description.
