Intended for
Vantage Data Centers DUB13 Limited

Date
March 2023

VANTAGE DUBLIN DATA CENTER

VOLUME 3: TECHNICAL APPENDICIES

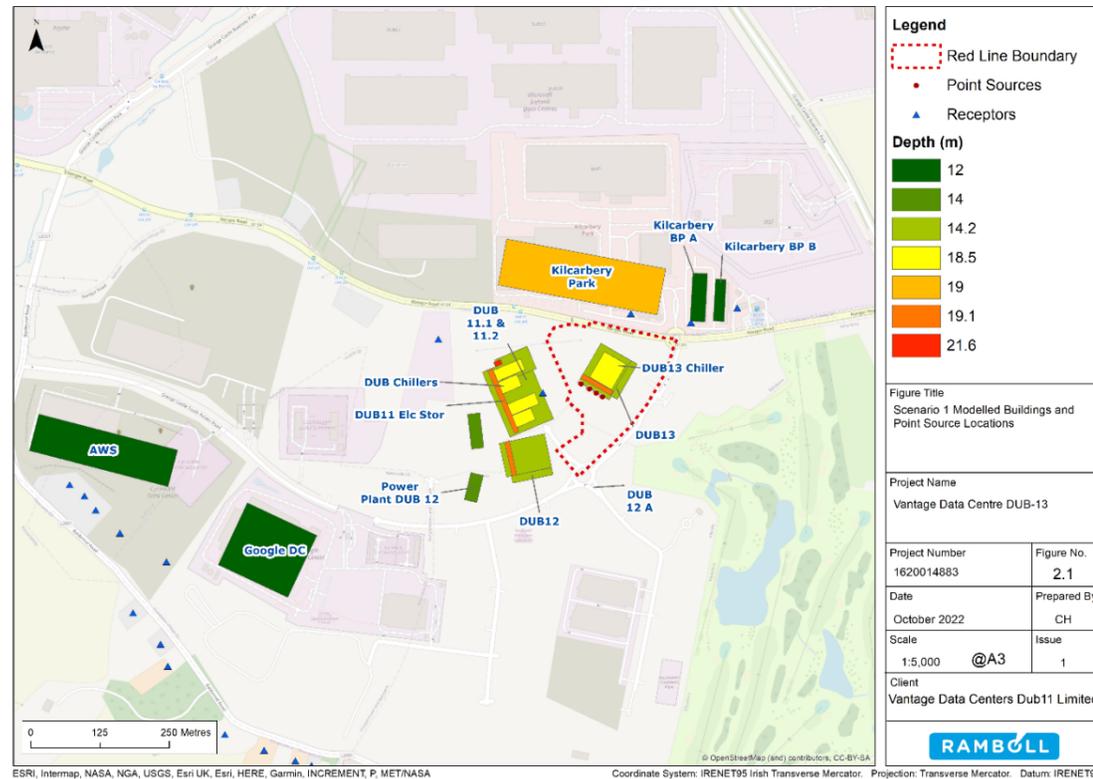
Figure 2.1: Scenario 1 Modelled Buildings and Point Source Locations

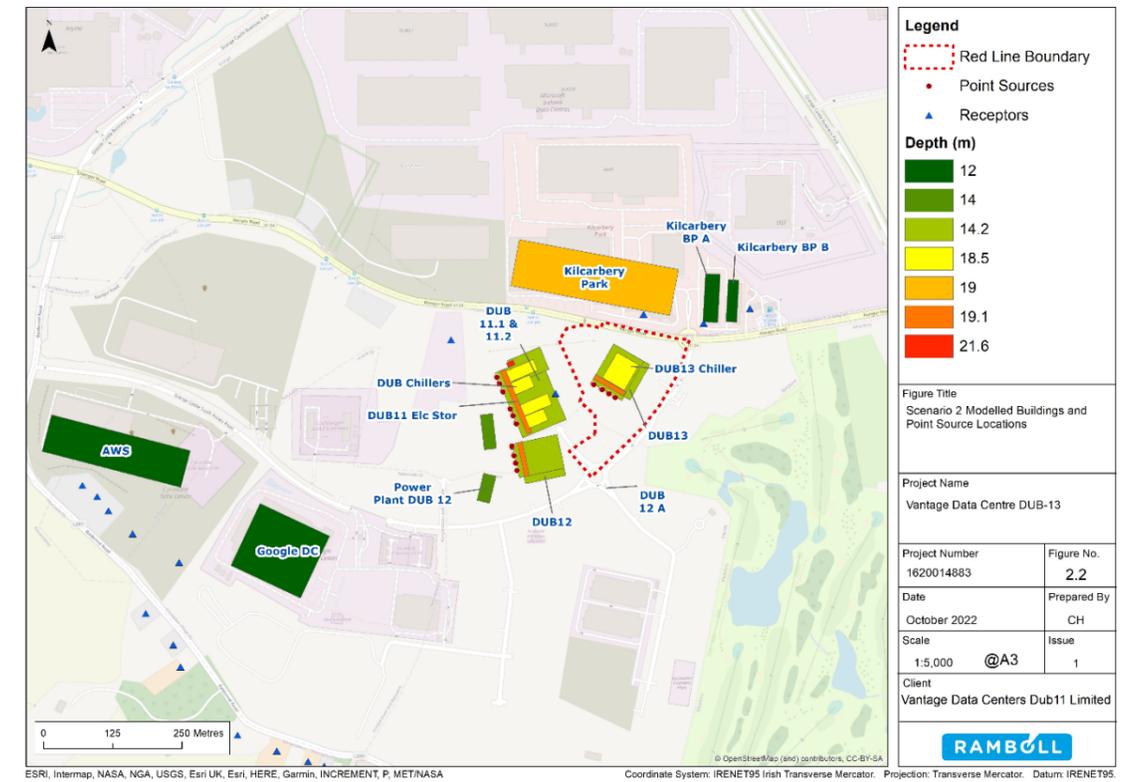
Figure 2-2: Scenario 2 Modelled Buildings and Point Source Locations

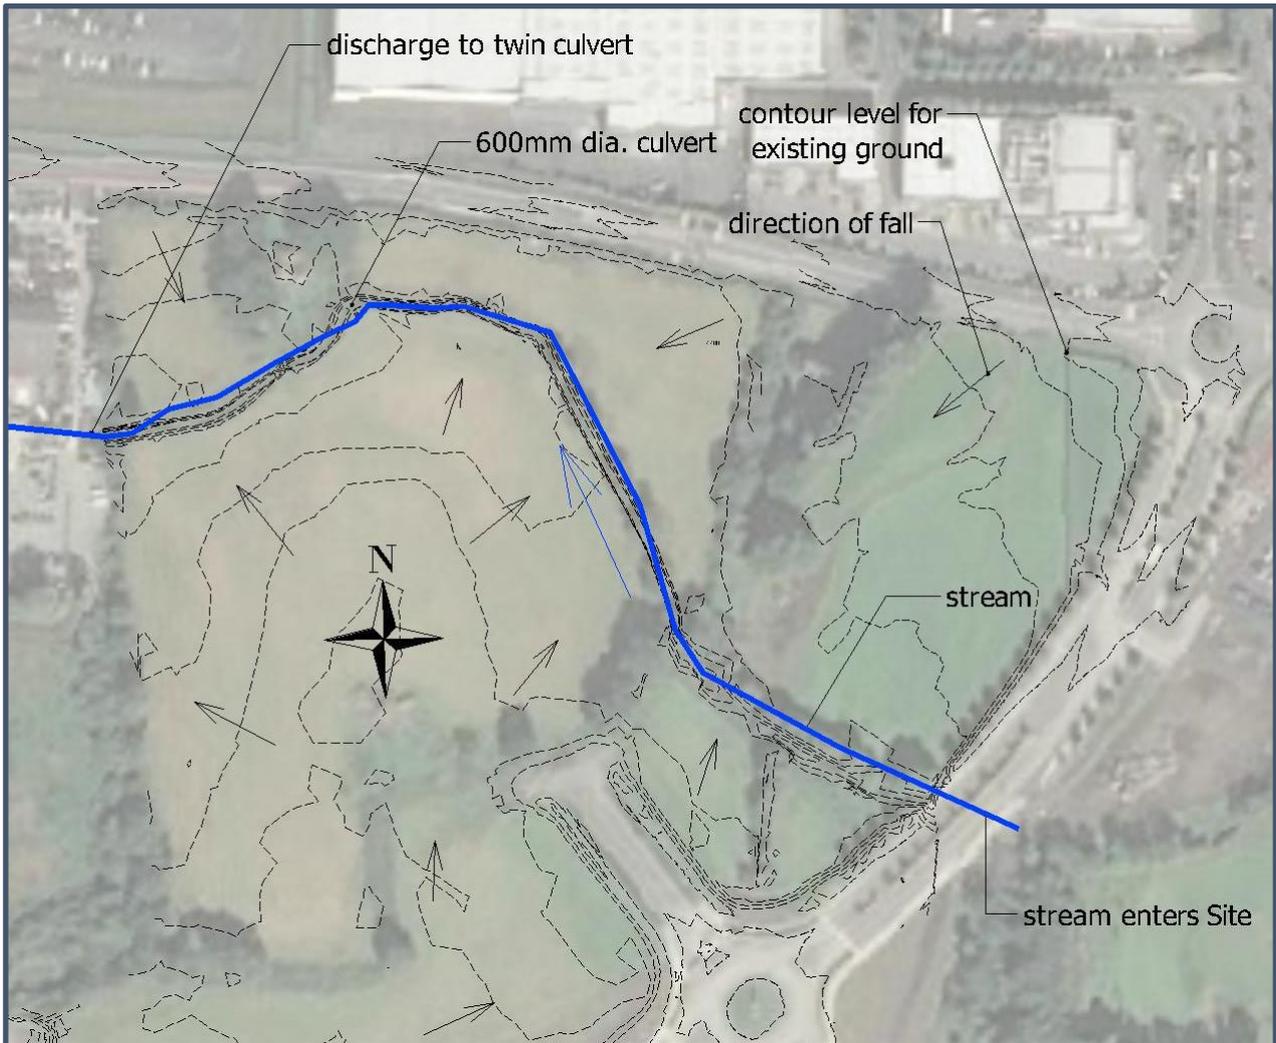
Figure 3-2 Site Topography / Main Drainage Features

The Site can be described as relatively flat, with a general shallow fall from northeast to southwest.

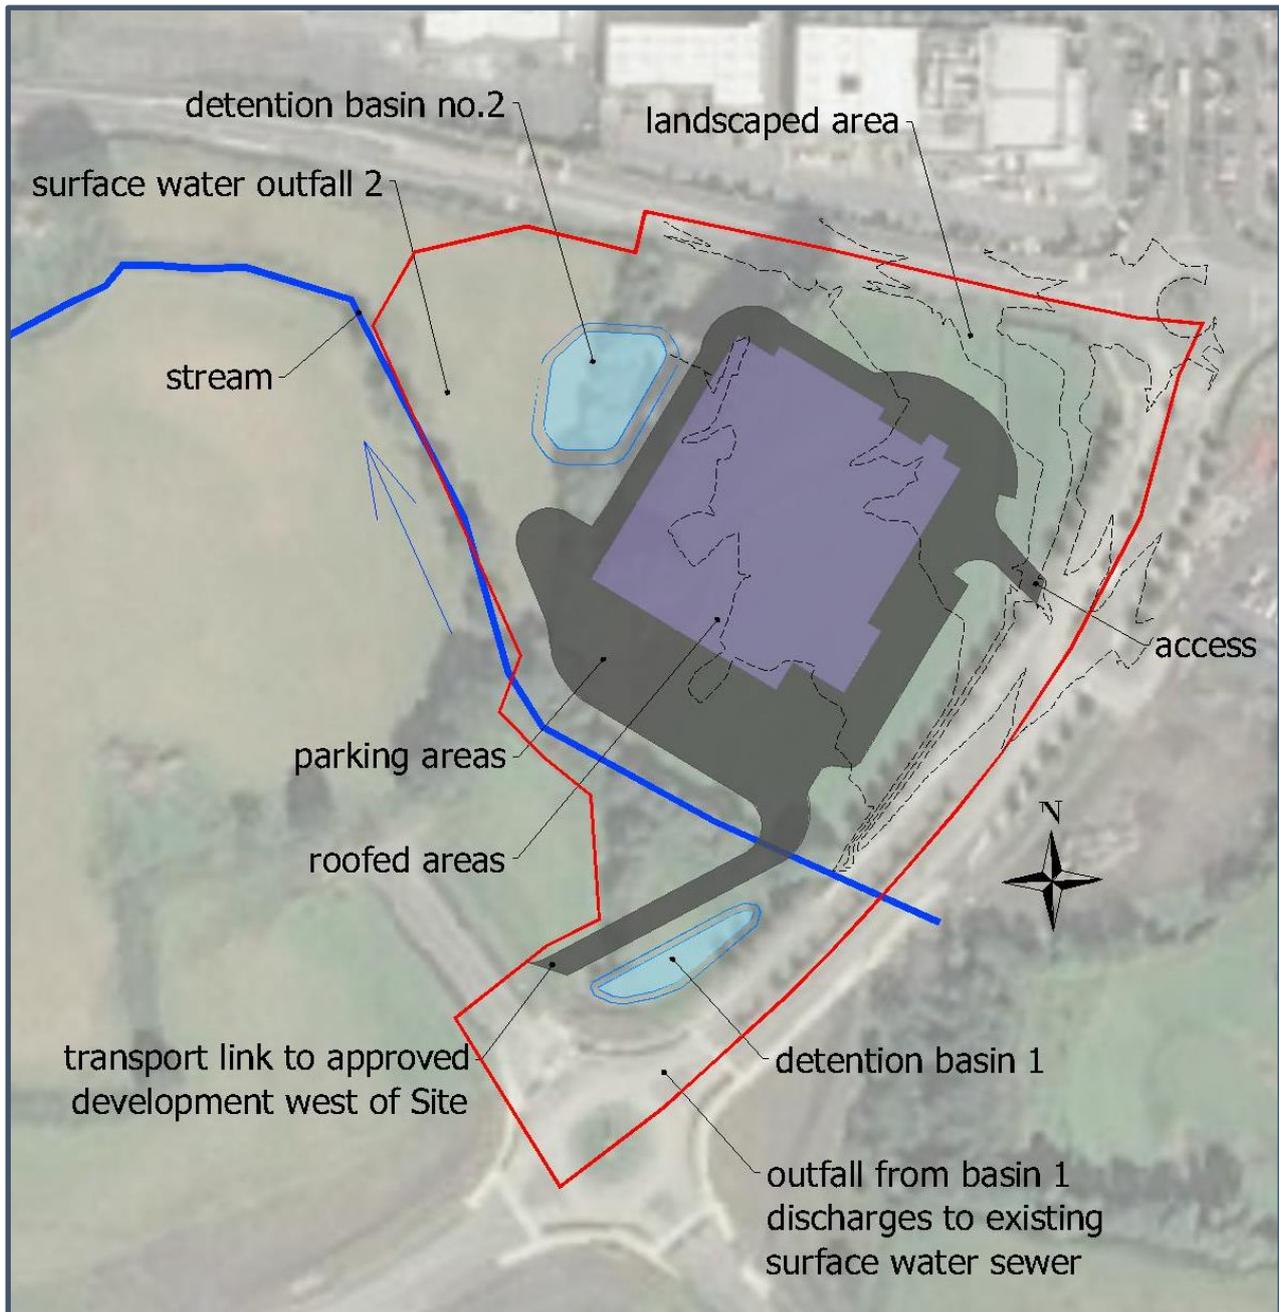
Figure 4-1 Schematic Layout of Proposed Development

A schematic layout for the proposed development is shown in Figure 4-1. Relevant proposals for the development are shown on the schedule of documents contained in Appendix A.

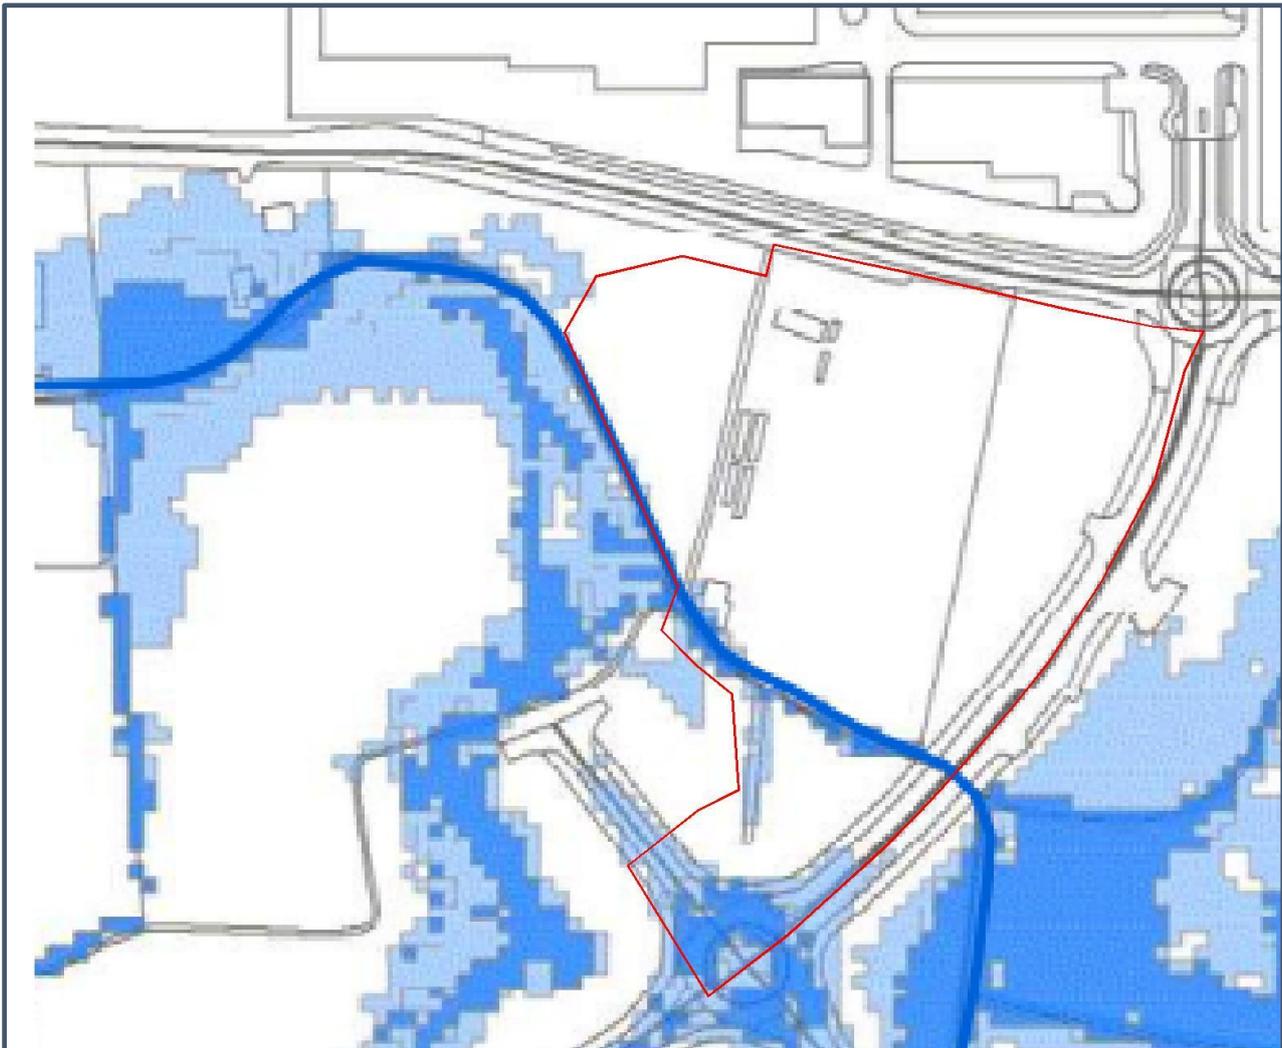
Figure 5-1 Extract from SFRA showing fluvial flood risk at the Site

Mapping prepared as part of the Strategic Flood Risk Assessment for the South Dublin County Development Plan indicates the Site is not affected by either the 0.1% AEP and 1.0% AEP flood events. The only exception is at the southern corner where the existing Park Road is shown to be subject to flood risk. An extract from this mapping is shown in Figure 5-1.

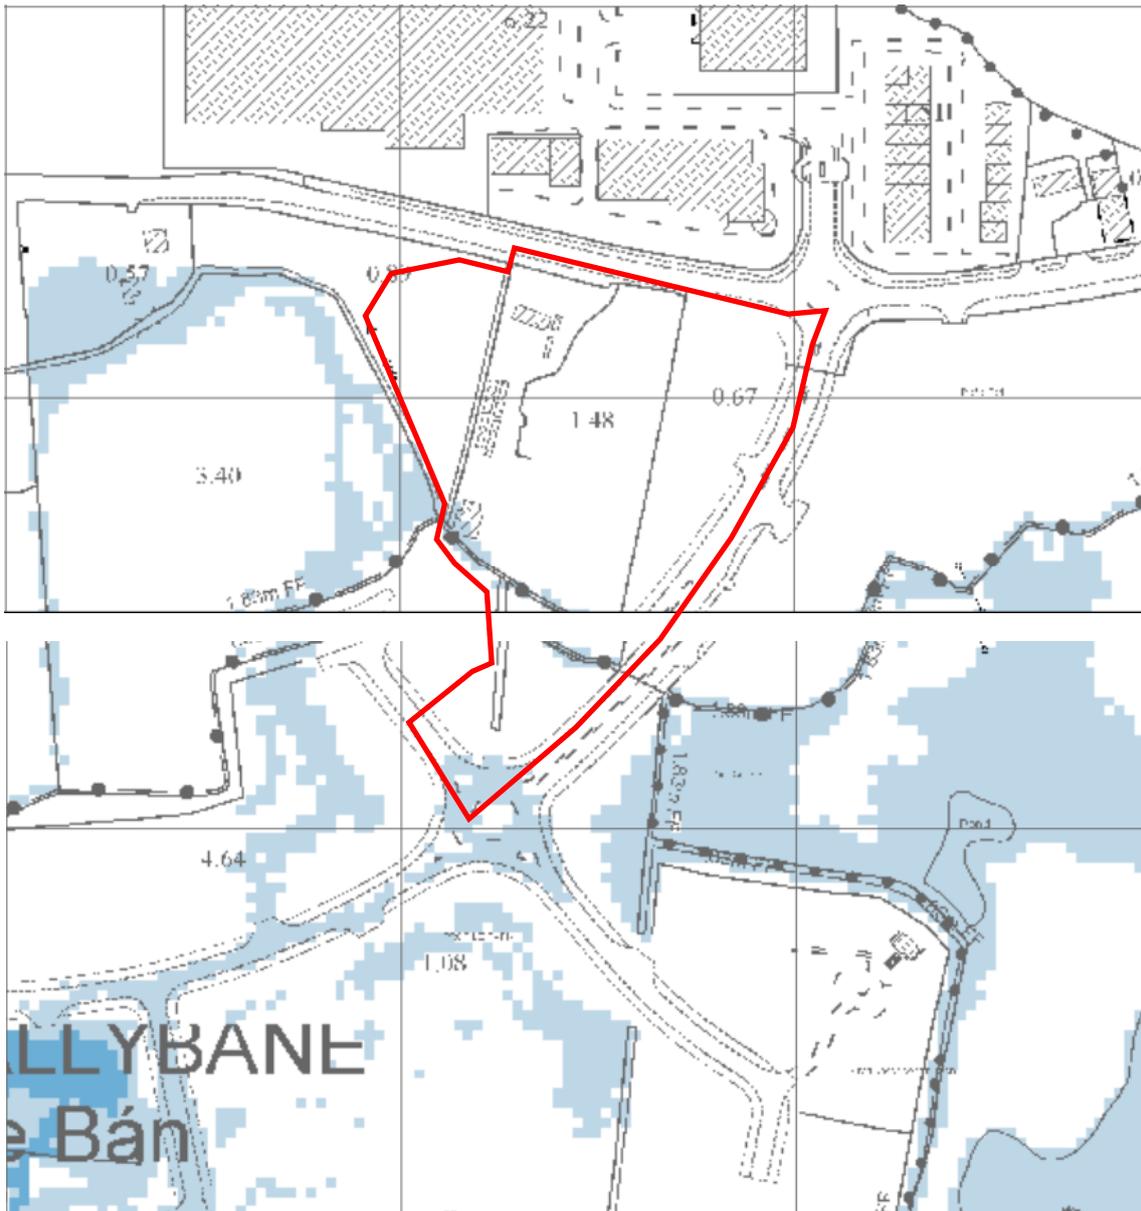
Figure 5-2 Extract from CFRAM mapping showing fluvial flood risk at the Site

Mapping prepared as part of the CFRAM programme indicates the Site is not affected by the 0.1% AEP flood event but not the 1.0% AEP event. As with SSFRA mapping, the only exception is at the southern corner where the existing Park Road is shown to be subject to flood risk. An extract from this mapping is shown in Figure 5-2.

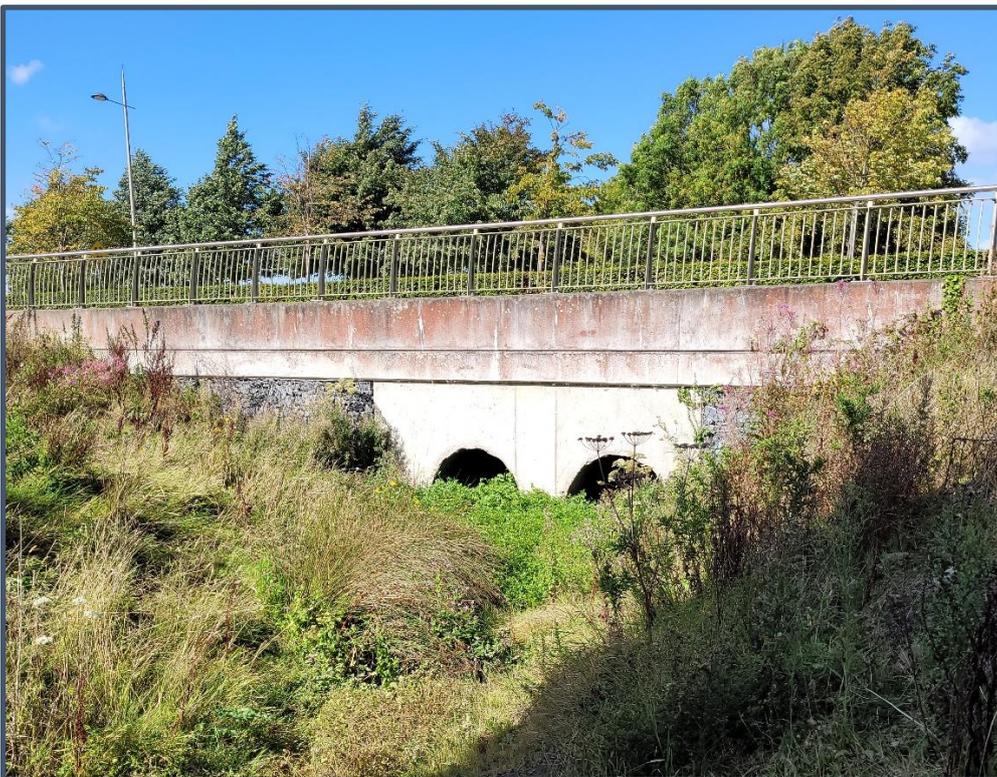
Figure 5-7 Upstream View of Culvert under Park Road

300m downstream of the Site, the Stream discharges to a long twin-pipe culvert. The inlet to this culvert is poorly constructed and hydraulically inefficient; it was observed that in addition to the pipes, the gaps between the pipes also provides a flow path for the stream to discharge to.

A visual assessment of the channel of the stream suggests the twin-pipe culvert will have a significantly lower hydraulic capacity than the channel.

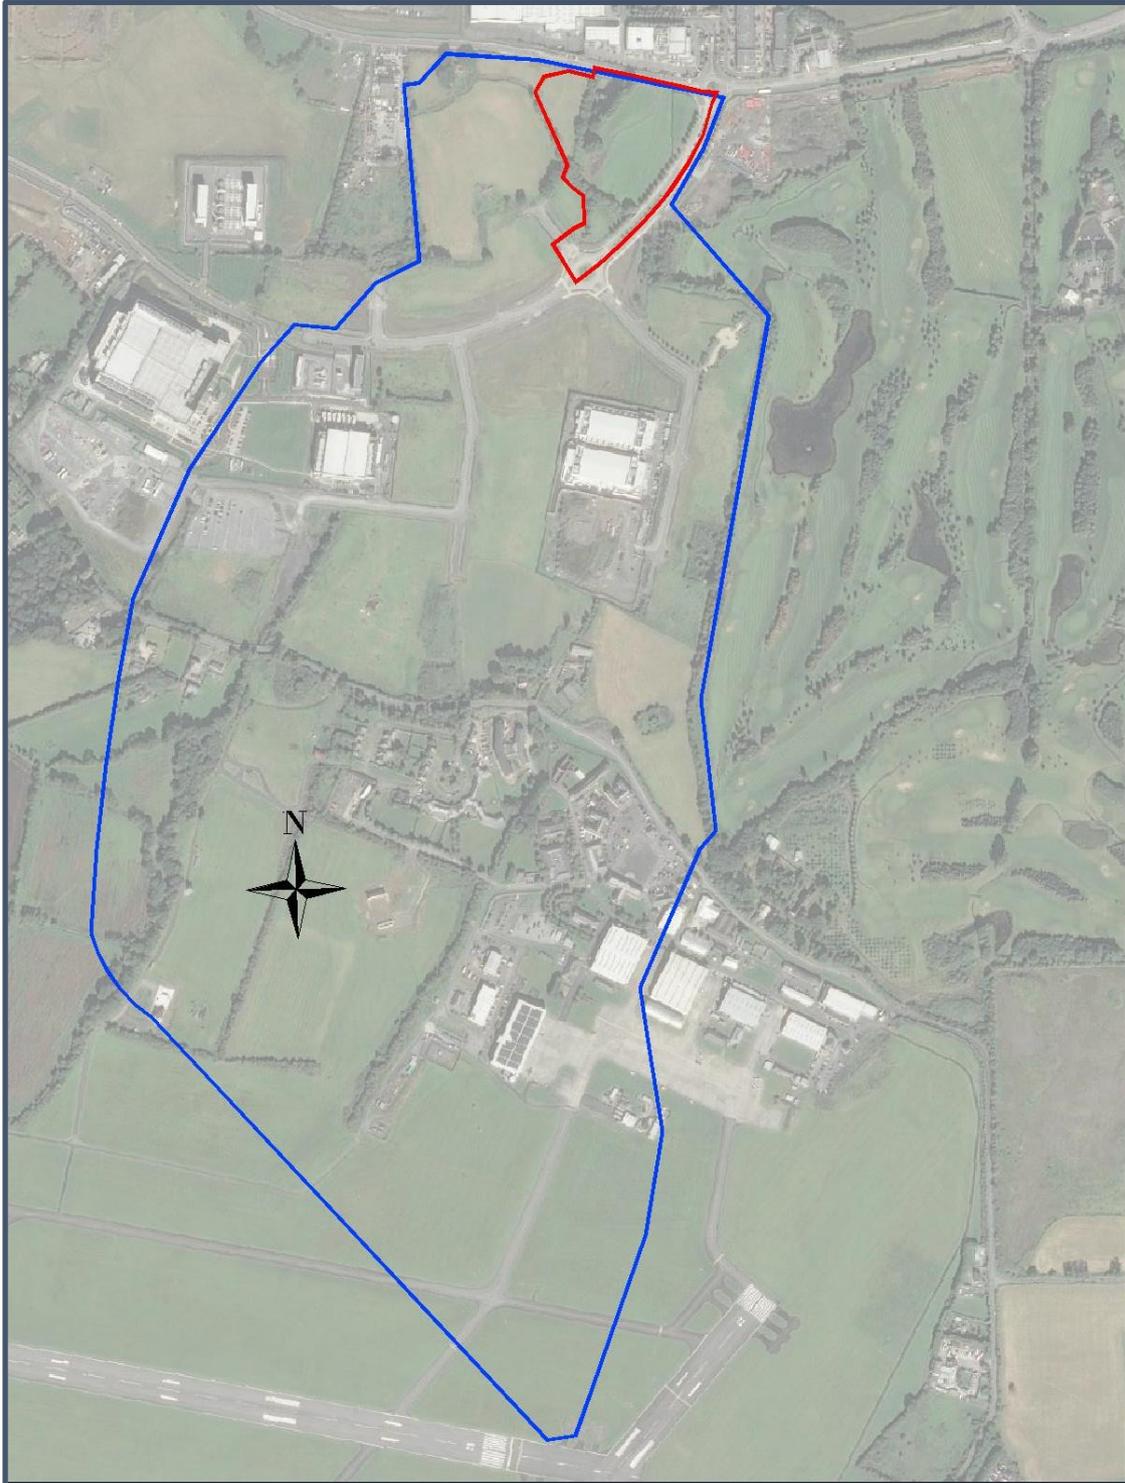
Figure 6-1 Catchment Area for Stream

The catchment area for the stream, shown outlined blue on Figure 6-1, measures 1.0 km².

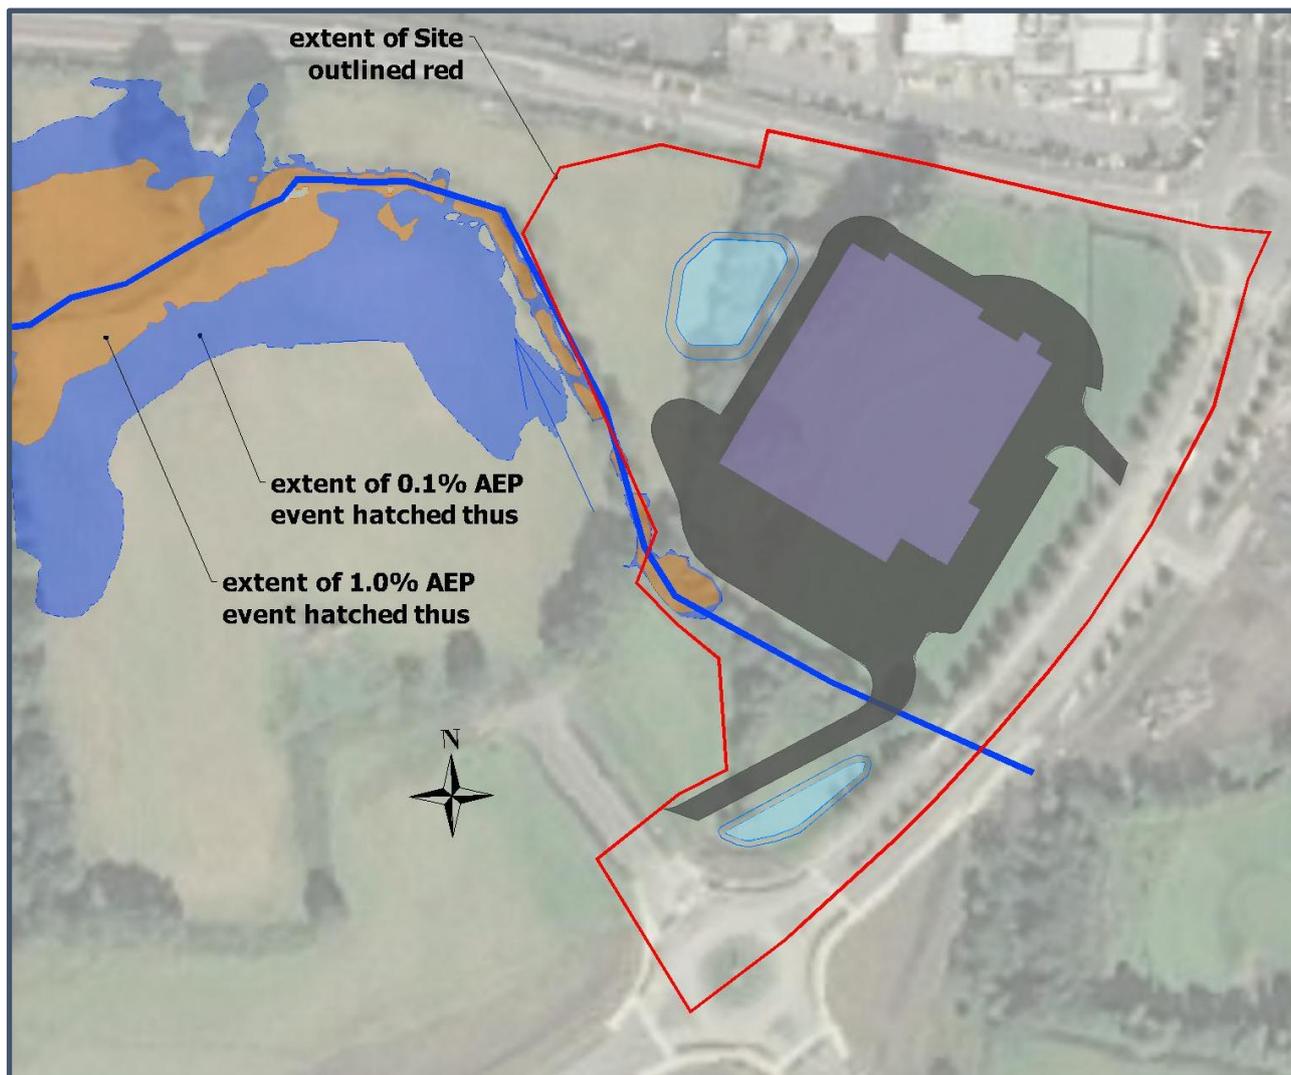
Figure 6-2 Fluvial flood risk zones - Pre-Development

The Site was found to be not affected by either 1% or 0.1% AEP flood risk zones.

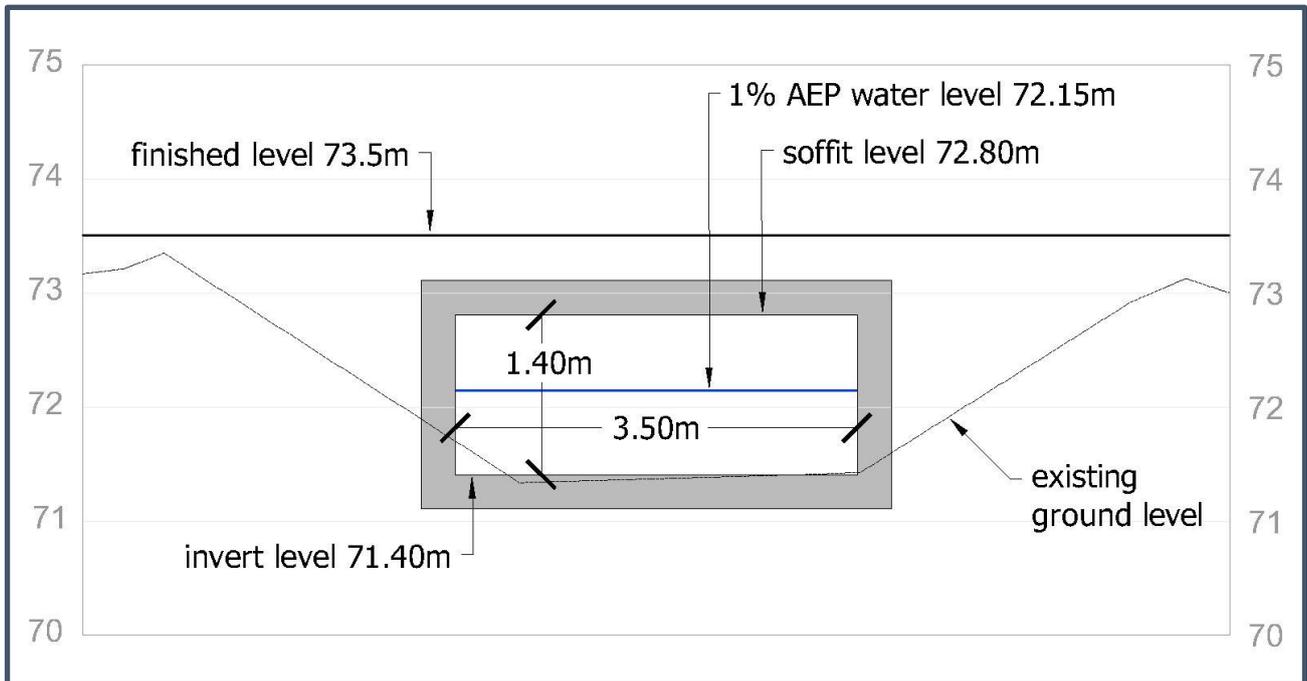
Figure 6-3 Fluvial flood risk zones - Pre-Development

To meet the requirements of the Office of Public Works (OPW) for granting Section 50 approval under the Arterial Drainage Act, culverts are typically required to have a minimum 300mm clearance between the 1% AEP water level and the soffit of the culvert. Figure 6-3 shows the box culvert will have 650mm clearance between the 1% AEP water level and the soffit level, thus comfortably exceeding OPW requirements.

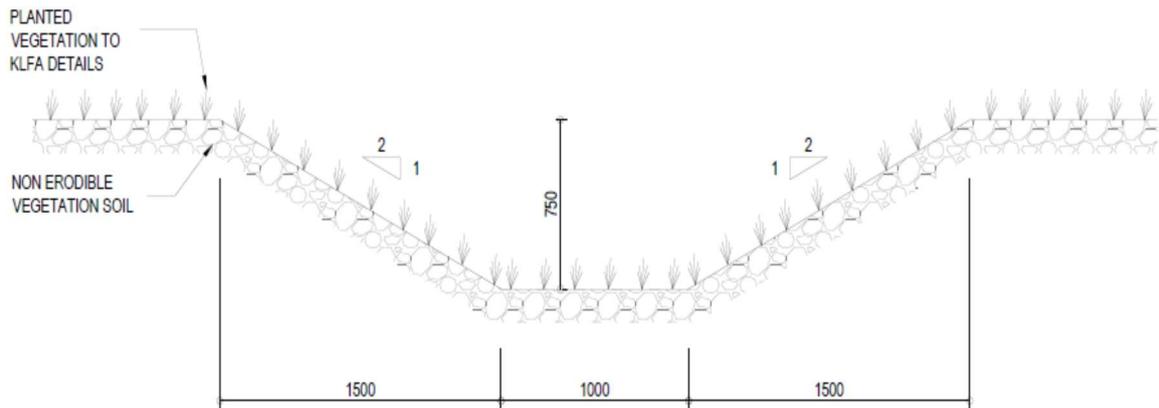
TYPICAL BIO SWALE DETAIL

Typical Bio Swale detail below.

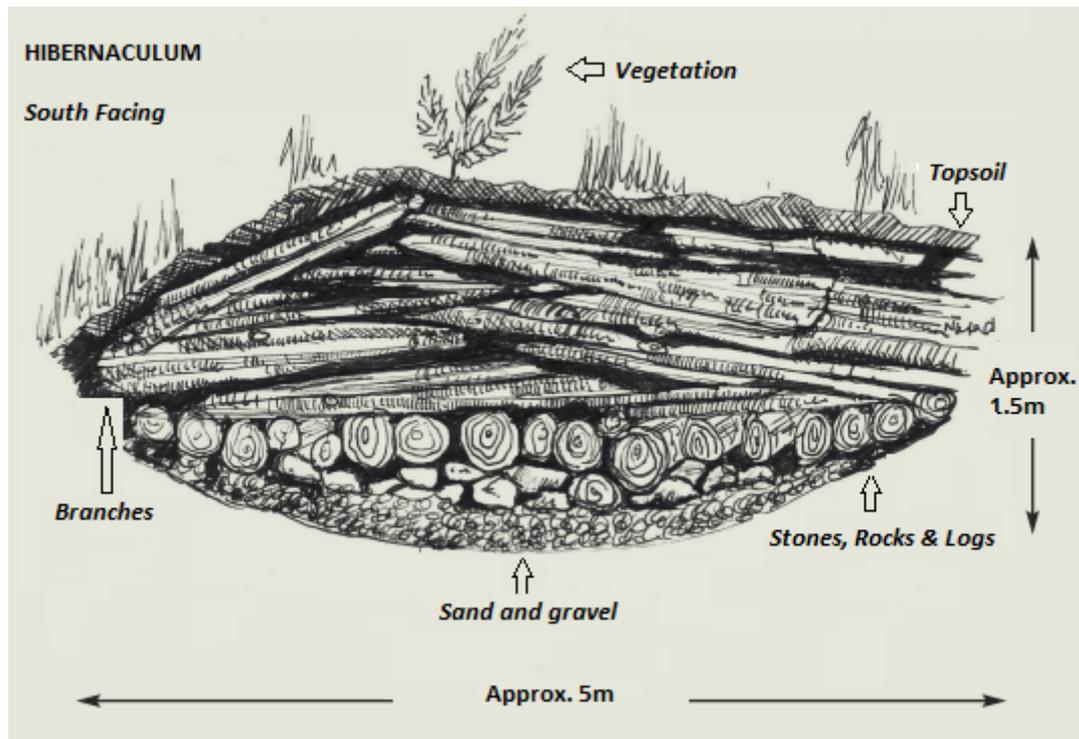
- A 5m long east-west running ditch 1m deep and 1m wide will be dug.
- The base will be lined with sand and gravel.
- This will be followed with layers of stones, rocks and logs.
- Smaller branches will then be placed on top, and covered soil from the excavation will be placed over the pile, leaving gaps for access.
- The soil will be shaped into a mound.
- North facing side of the mound will be seeded / planted with species that will attract insects and will also provide extra shelter.
- South facing side will be maintained with a sparse vegetation cover to provide an area to bask.

- 1.97. The hibernaculum will follow the basic construction set out below, with the log and stone piles situated to the north of the hibernaculum.

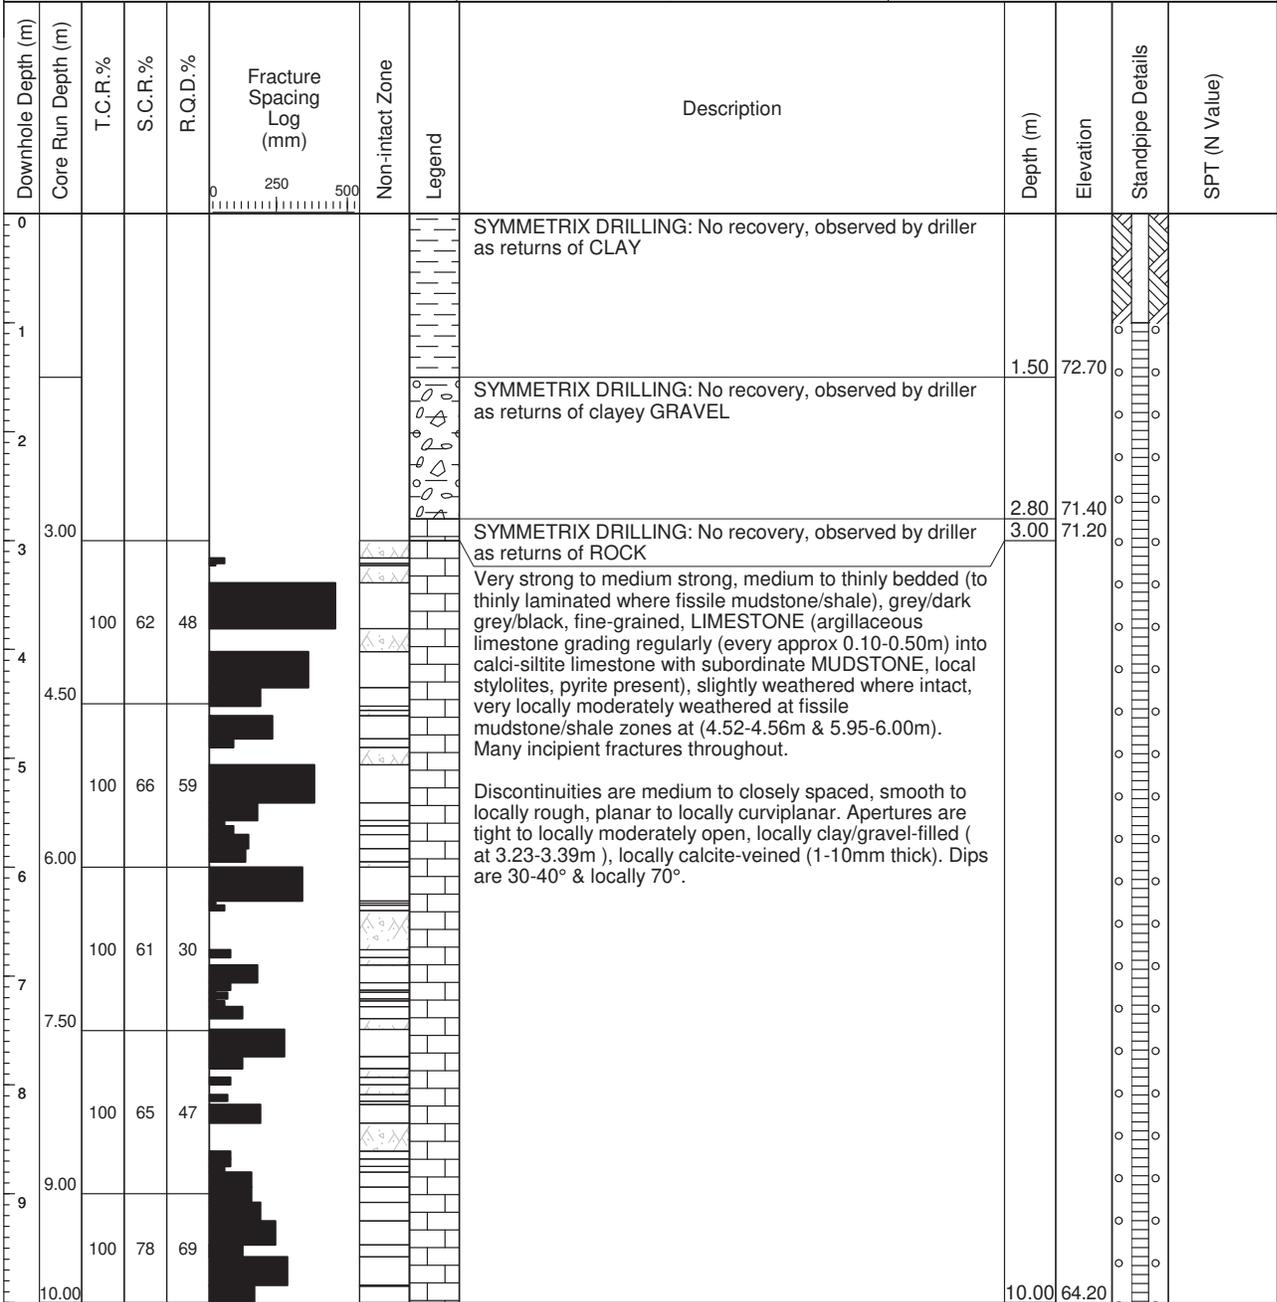
CONTRACT Data Centre Projects 3 - Profile Park	DRILLHOLE NO RC02
CO-ORDINATES 703,864.31 E 730,847.41 N	SHEET Sheet 1 of 1
GROUND LEVEL (mOD) 74.20	DATE COMMENCED 09/08/2022
RIG TYPE BT-44	DATE COMPLETED 10/08/2022
FLUSH Air/Mist	DRILLED BY IGSL - JK
CLIENT F1 Enzo Properties	LOGGED BY D.O'Shea
ENGINEER Ramboll	CORE DIAMETER (mm) 78

REMARKS					End of Borehole at 10.00 m					WATER STRIKE DETAILS		
Hole cased 0.00-3.00m.					Water Strike	Casing Depth	Sealed At	Rise To	Time (min)	Comments		
										No water strike recorded		
					GROUNDWATER DETAILS							
INSTALLATION DETAILS					Date	Hole Depth	Casing Depth	Depth to Water	Comments			
Date	Tip Depth	RZ Top	RZ Base	Type	10-08-22	10.00	3.00	8.80	Water level recorded 5 mins after end of drilling.			
10-08-22	10.00	1.00	10.00	50mm SP

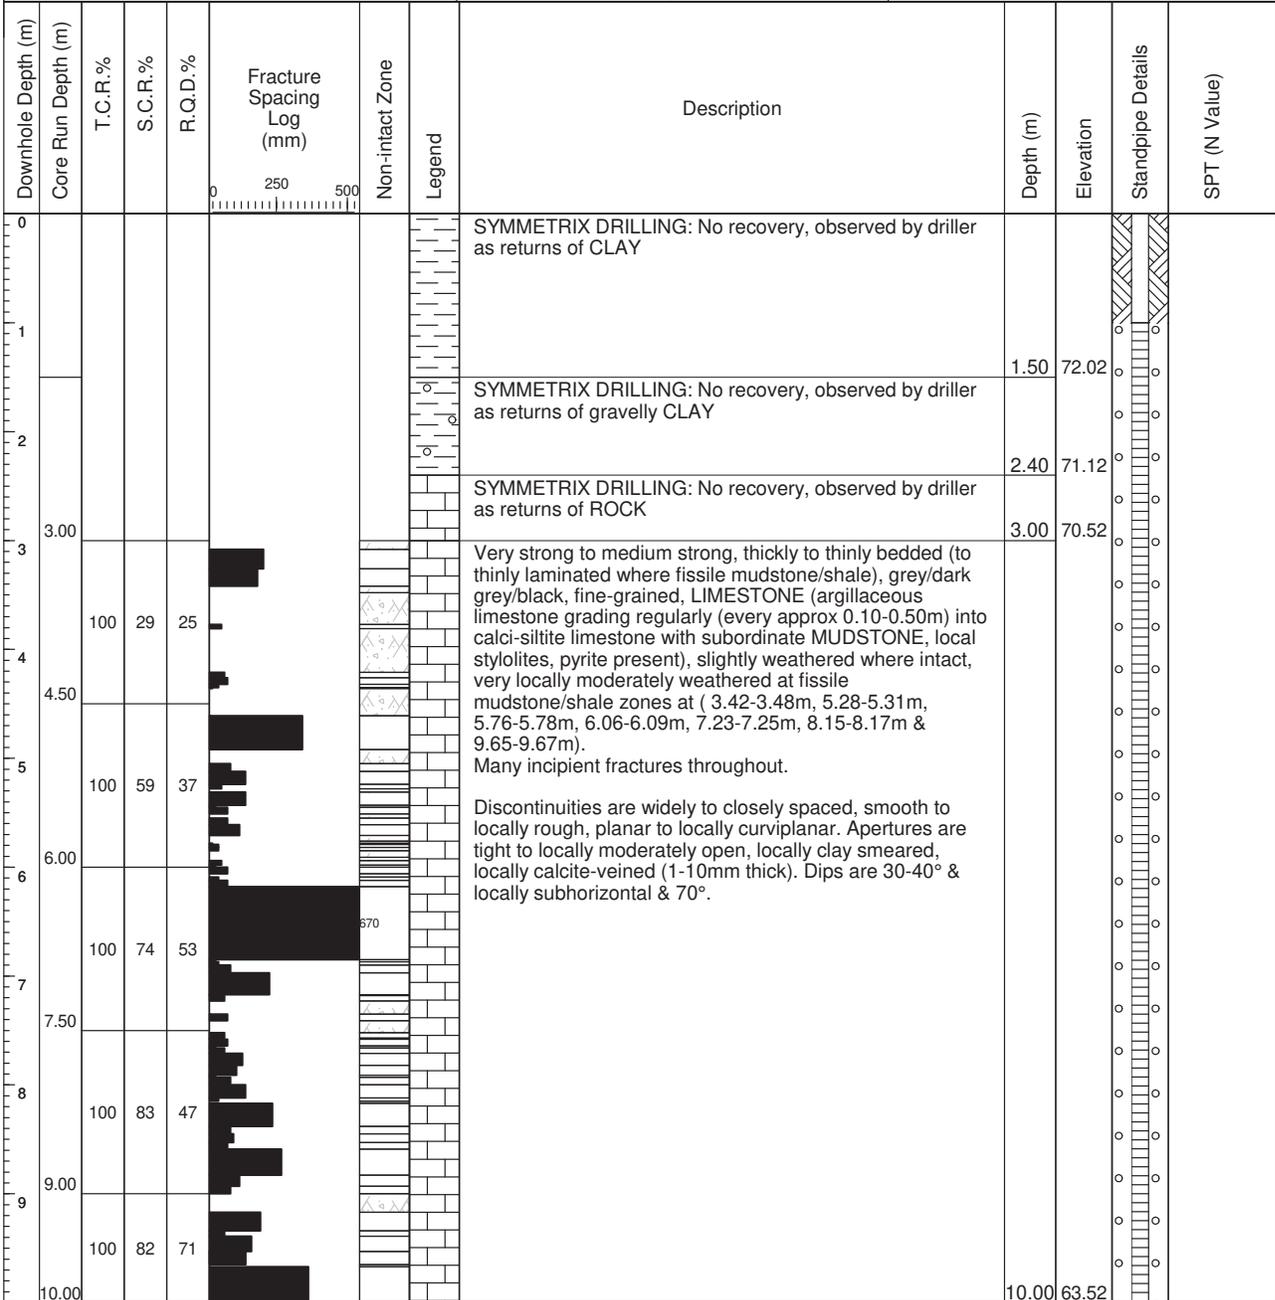
CONTRACT Data Centre Projects 3 - Profile Park	DRILLHOLE NO RC04
CO-ORDINATES 703,851.21 E 730,767.13 N	SHEET Sheet 1 of 1
GROUND LEVEL (mOD) 73.52	DATE COMMENCED 11/08/2022
RIG TYPE BT-44	DATE COMPLETED 12/08/2022
FLUSH Air/Mist	DRILLED BY IGSL - JK
CLIENT F1 Enzo Properties	LOGGED BY D.O'Shea
ENGINEER Ramboll	CORE DIAMETER (mm) 78

REMARKS					End of Borehole at 10.00 m					WATER STRIKE DETAILS		
Hole cased 0.00-3.00m.					Water Strike	Casing Depth	Sealed At	Rise To	Time (min)	Comments		
										No water strike recorded		
					GROUNDWATER DETAILS							
INSTALLATION DETAILS					Date	Hole Depth	Casing Depth	Depth to Water	Comments			
Date	Tip Depth	RZ Top	RZ Base	Type	12-08-22	10.00	3.00	8.40	Water level recorded 5 mins after end of drilling.			
12-08-22	10.00	1.00	10.00	50mm SP

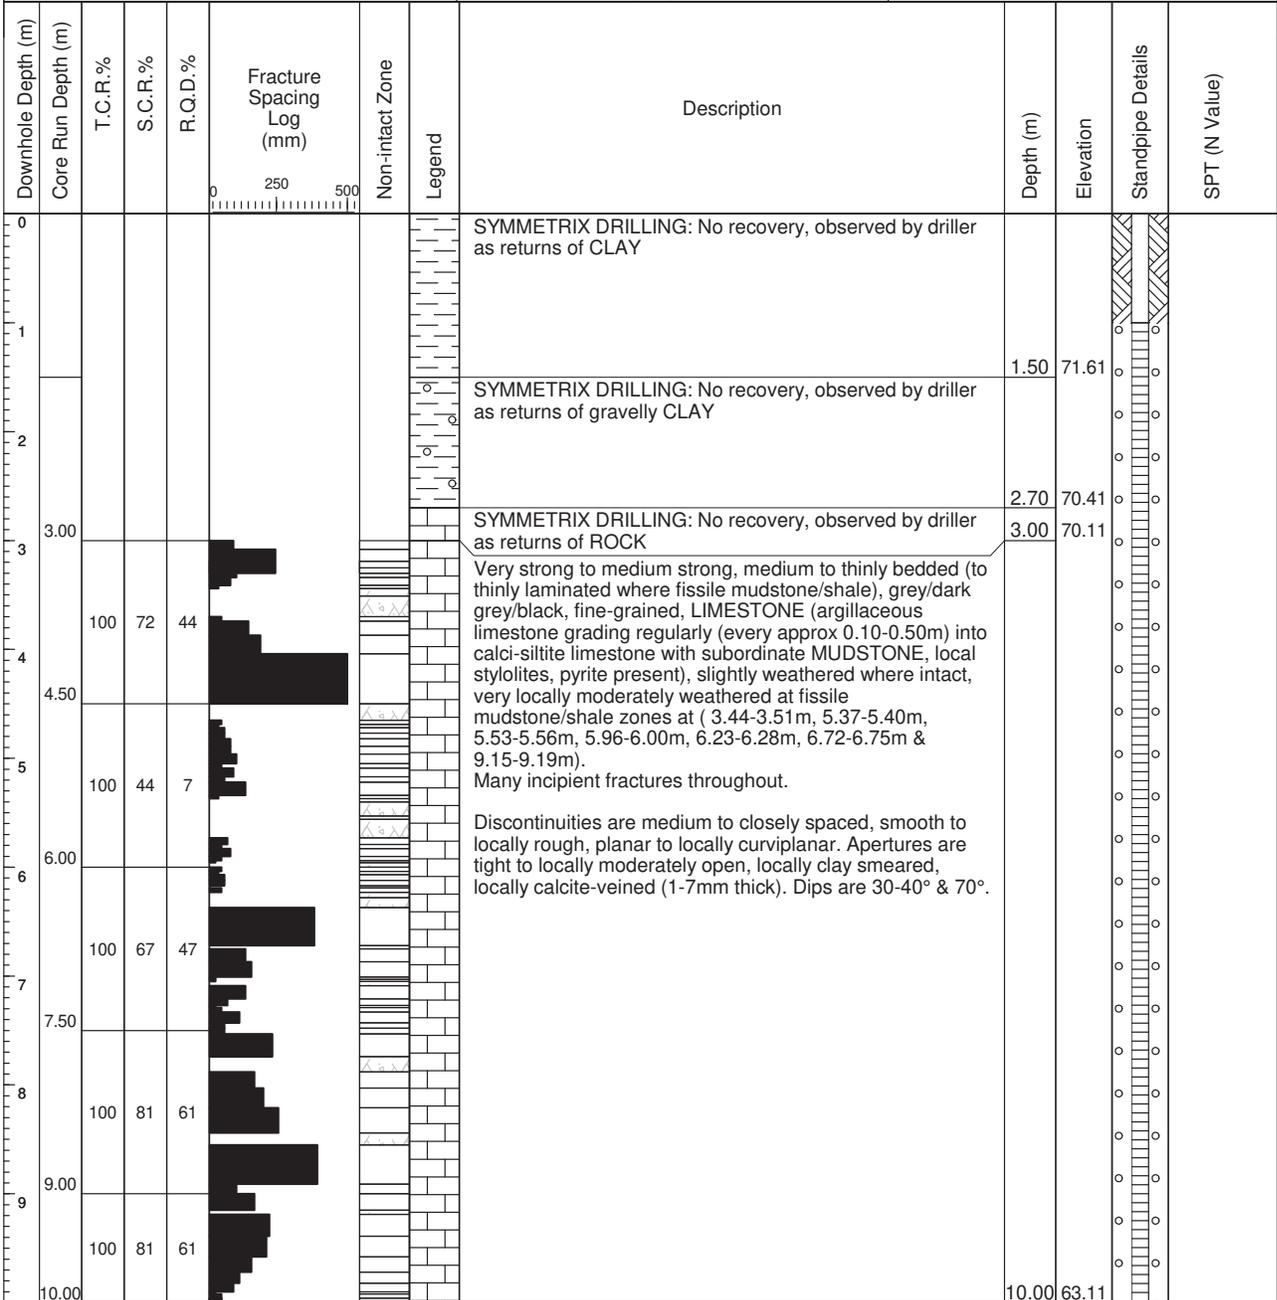
CONTRACT Data Centre Projects 3 - Profile Park		DRILLHOLE NO RC05	
		SHEET Sheet 1 of 1	
CO-ORDINATES 703,826.61 E 730,726.78 N		RIG TYPE BT-44	
GROUND LEVEL (mOD) 73.11		FLUSH Air/Mist	
CLIENT F1 Enzo Properties		INCLINATION (deg) -90	
ENGINEER Ramboll		CORE DIAMETER (mm) 78	
		DATE COMMENCED 12/08/2022	
		DATE COMPLETED 15/08/2022	
		DRILLED BY IGSL - JK	
		LOGGED BY D.O'Shea

REMARKS					End of Borehole at 10.00 m					WATER STRIKE DETAILS		
Hole cased 0.00-3.00m.					Water Strike	Casing Depth	Sealed At	Rise To	Time (min)	Comments		
										No water strike recorded		
					GROUNDWATER DETAILS							
INSTALLATION DETAILS					Date	Hole Depth	Casing Depth	Depth to Water	Comments			
Date	Tip Depth	RZ Top	RZ Base	Type	15-08-22	10.00	3.00	2.70	Water level recorded 5 mins after end of drilling.			
15-08-22	10.00	1.00	10.00	50mm SP

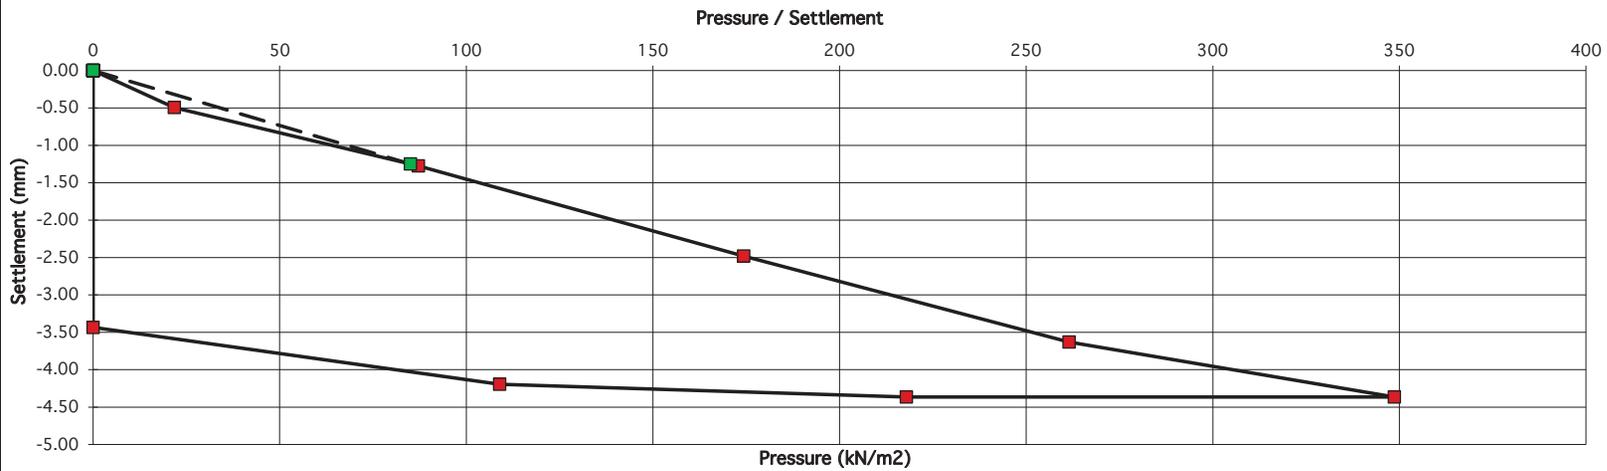
Contract	24188 Profile Park		
Test No.	PT03 Load	Natural Soil - Sandy Clay	Sample Ref No. _____ Depth _____ m bgl
Location	See site Drawing		
Depth	0.3m		
Client	Ramboll		
Plate Diameter:	450 mm		
Test Method	BS 1377: Part 9: 1990 Test4 - Incremental Loading Test		
Technician	M. Brown		
Authorised by	<i>[Signature]</i>		
Date	15/07/2022

Gradient at 1.25 mm settlement intersection = 68
 Modulus of subgrade reaction = 44 MPa/m
 Correction factor applied = 0.64 as per HD 25-26/10

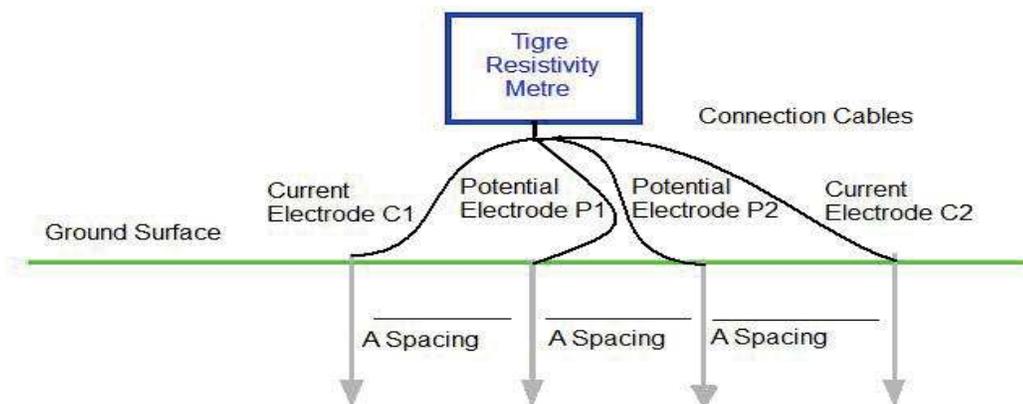
Figure 1: Resistivity Testing using the Wenner Array.

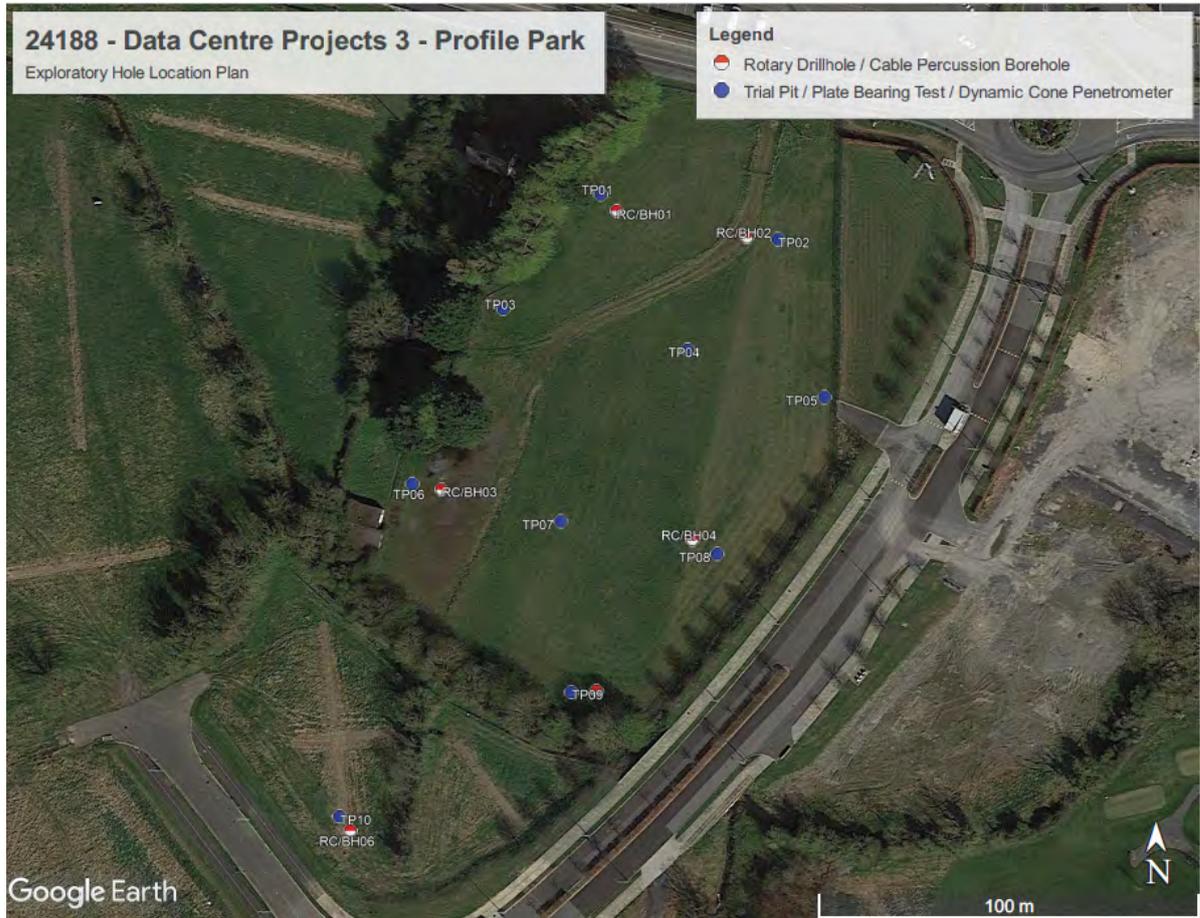
Figure 3: Exploratory Hole Location Plan
