Project Number  
**1620014883**

# **VANTAGE DUBLIN DATA CENTER**

## **VOLUME 3: TECHNICAL APPENDICIES**

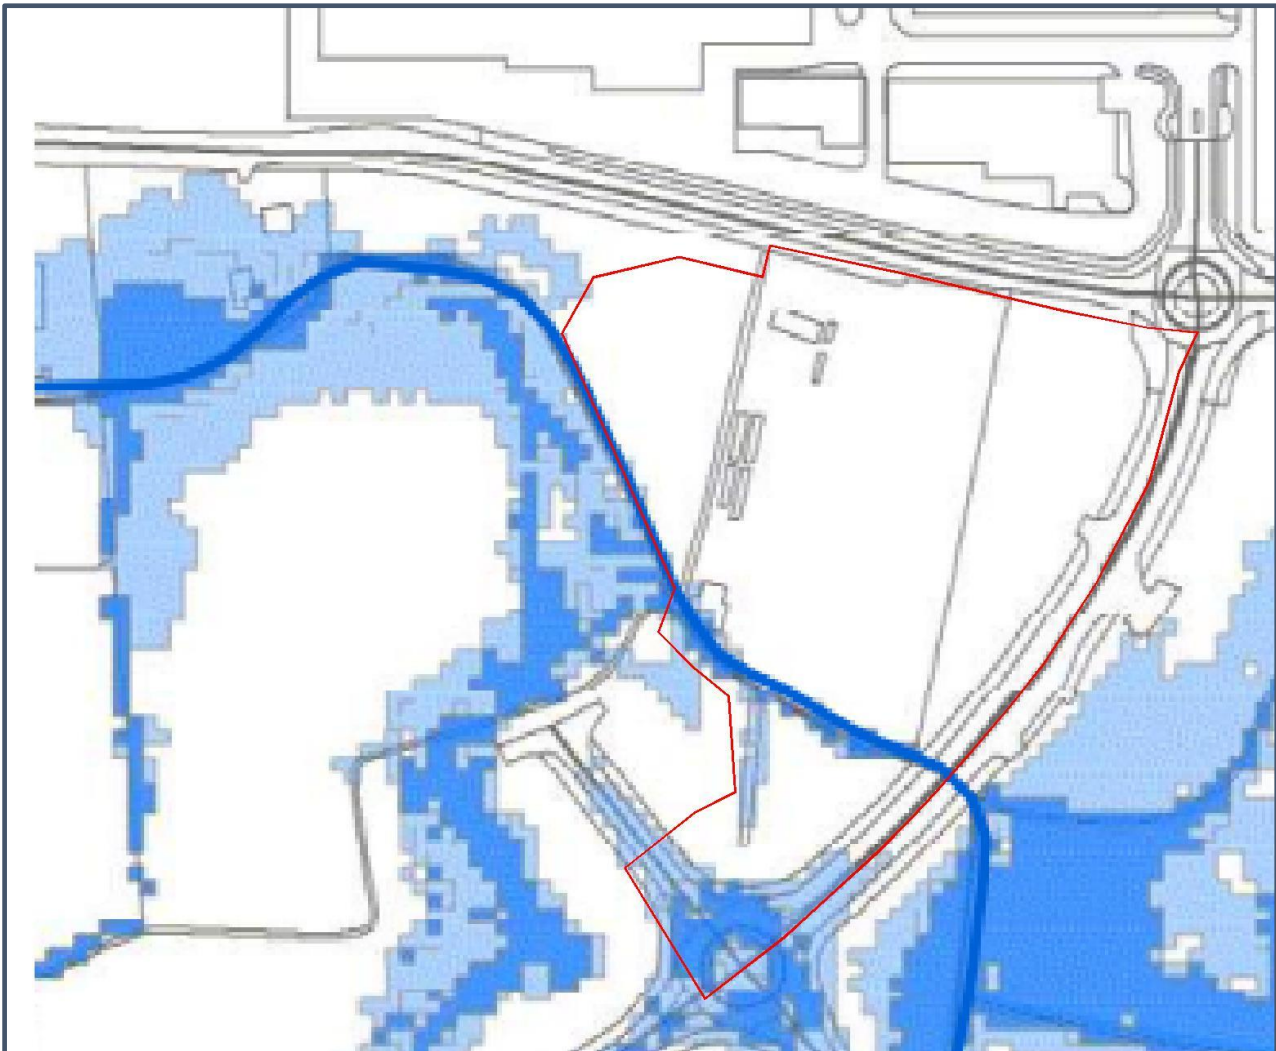
**Figure 5-1 Extract from SFRA showing fluvial flood risk at the Site**

Mapping prepared as part of the Strategic Flood Risk Assessment for the South Dublin County Development Plan indicates the Site is not affected by either the 0.1% AEP and 1.0% AEP flood events. The only exception is at the southern corner where the existing Park Road is shown to be subject to flood risk. An extract from this mapping is shown in Figure 5-1.

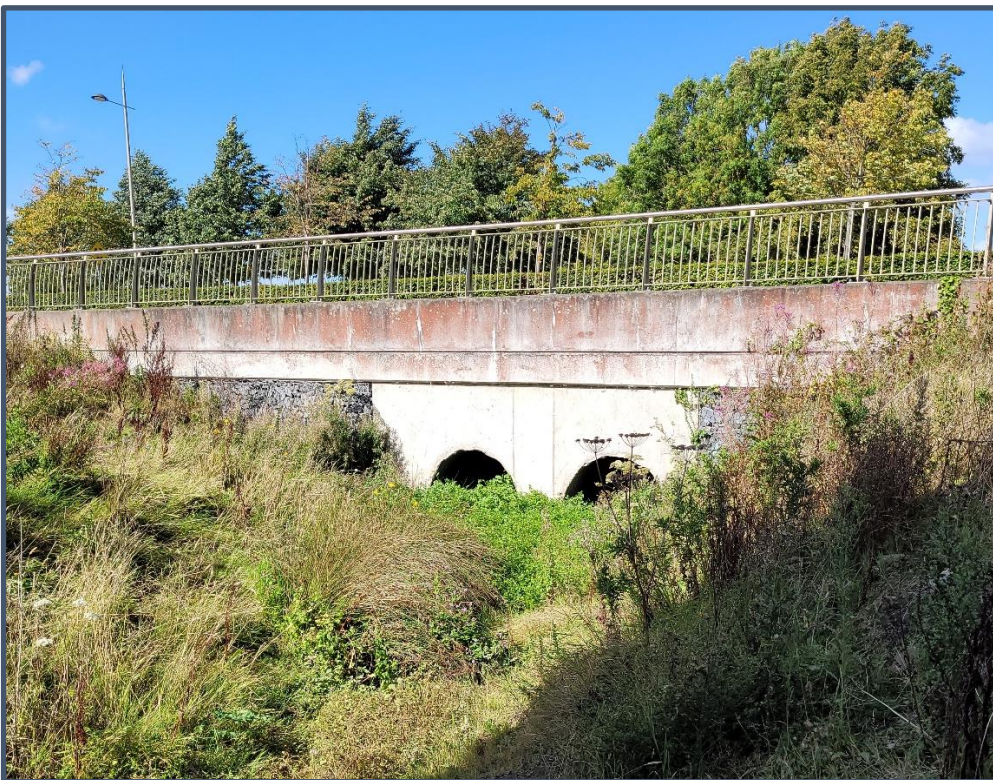
**Figure 5-7 Upstream View of Culvert under Park Road**

300m downstream of the Site, the Stream discharges to a long twin-pipe culvert. The inlet to this culvert is poorly constructed and hydraulically inefficient; it was observed that in addition to the pipes, the gaps between the pipes also provides a flow path for the stream to discharge to.

A visual assessment of the channel of the stream suggests the twin-pipe culvert will have a significantly lower hydraulic capacity than the channel.

As described already, the stream is culverted downstream of the Site. This culvert comprises two 600mm diameter pipes at its inlet. A CCTV survey of the culvert revealed that one of these pipes changes to 450mm diameter approximately 20m from the inlet. Furthermore, the CCTV survey found both pipes to have significant blockages that greatly reduce the overall capacity of the culvert; the extent of these blockages was such that the survey could not be completed for the full length of the culvert.

Therefore, the condition and size of the culvert downstream of the blockages is unknown and there is potential, for example in the event of culvert collapse, of the stream surcharging within the Site to a level exceeding that predicted by the hydrological models. To mitigate this risk, it is recommended that an overflow be constructed from the Site which would allow such excess to discharge to the stream immediately downstream of the Nangor Road. Subject to the capacity being available, this overflow could possibly discharge to existing surface water drainage in the Nangor Road but a dedicated surface water pipe might be required from the Site to a new outfall downstream of the Nangor Road.

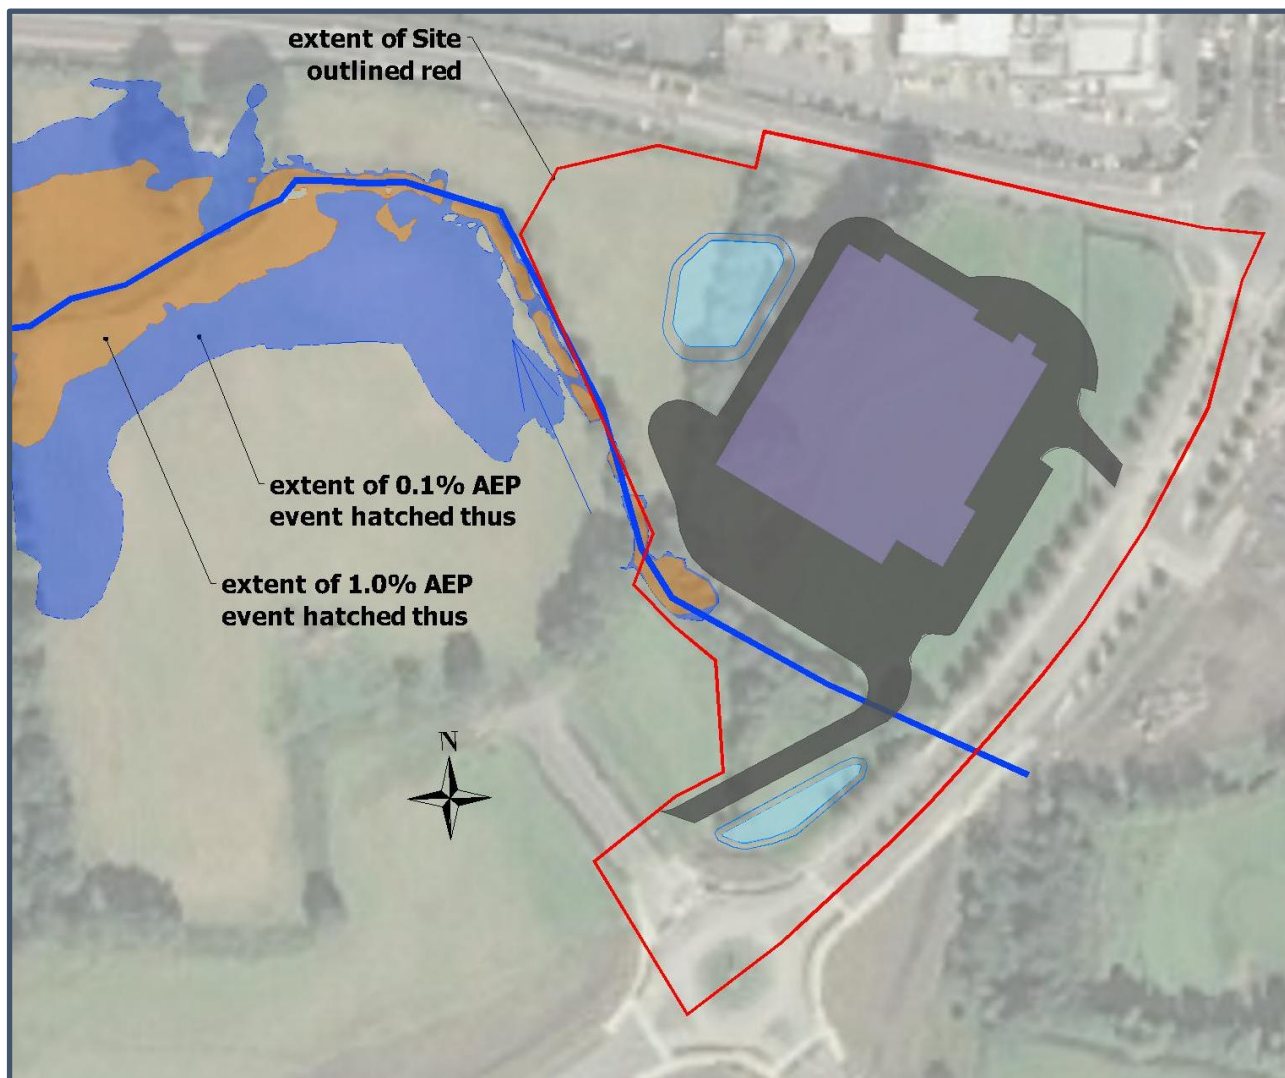
**Figure 6-2 Fluvial flood risk zones - Pre-Development**

The Site was found to be not affected by either 1% or 0.1% AEP flood risk zones.
