Wildlife Aviation Impact Assessment for a proposed cemetery on the grounds of the Citywest Hotel, Saggart, Dublin 24.

17th July 2023

Prepared by: Bryan Deegan (MCIEEM) of Altemar Ltd. **On behalf of:** Cape Wrath Hotel Unlimited.

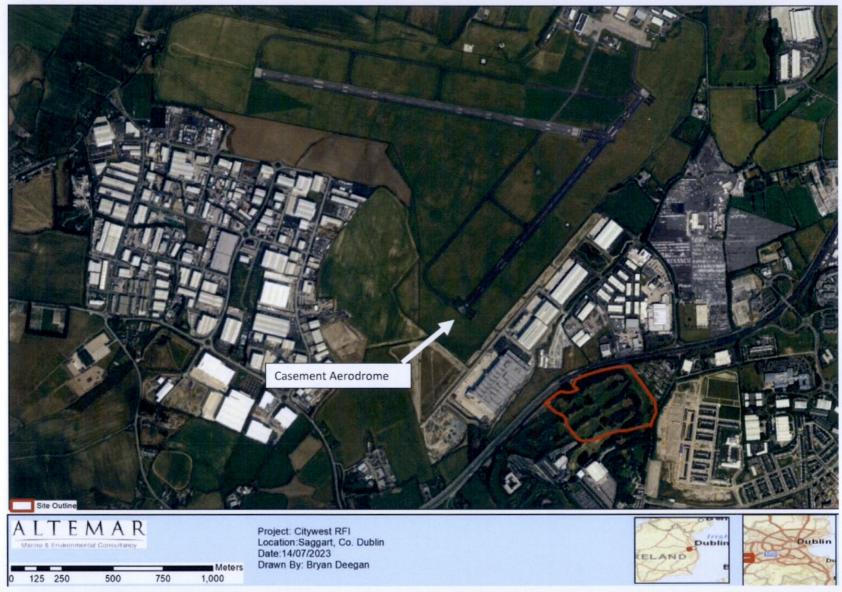
Figure 1. Site outline

The proposed development is approximately 500m from Casement Aerodrome. The Air Corps is the air component of the Permanent Defence Forces and is based at Casement Aerodrome, Baldonnel, Co. Dublin.

Casement Aerodrome or Baldonnel Aerodrome is a military airbase to the southwest of Dublin, Ireland situated off the N7 main road route to the south and south west. It is the headquarters and the sole airfield of the Irish Air Corps, and is also used for other government purposes. The airport is the property of the Irish Department of Defence. Baldonnel Aerodrome is also the home of the Garda Air Support Unit. Airport & runway details are seen in the following tables and flightlines in relation to the proposed development site are seen in Figure 1.

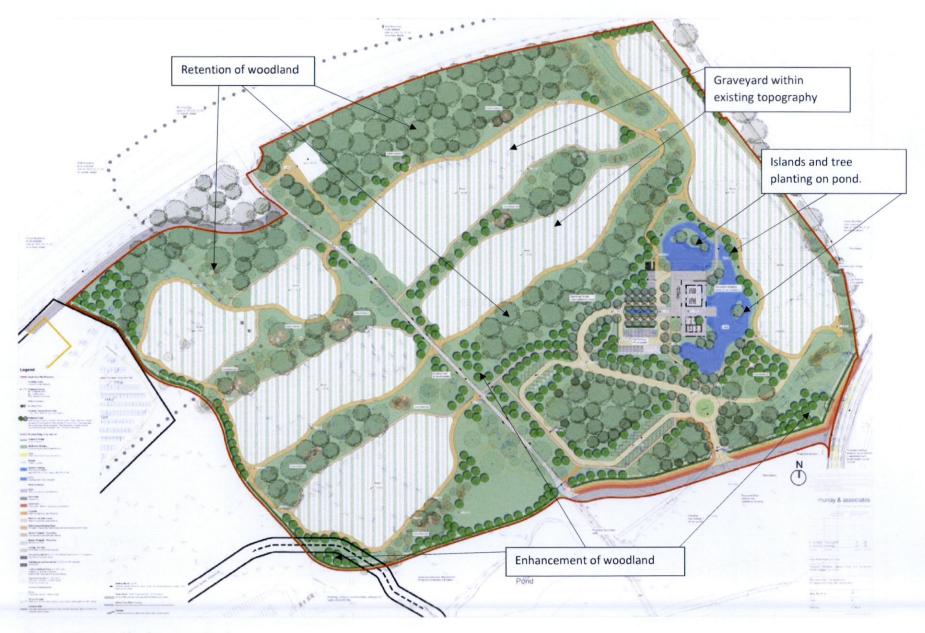
Figure 2. Proposed landscape masterplan

The proposed landscape strategy would be expected to reduce the potential for large flocks of birds to be seen on site and alter the site to a more wooded and enclosed habitat. This would result un more of a garden/woodland typology of smaller bird species more resident bird species which would pose a less aviation risk that the current open grassland habitat.

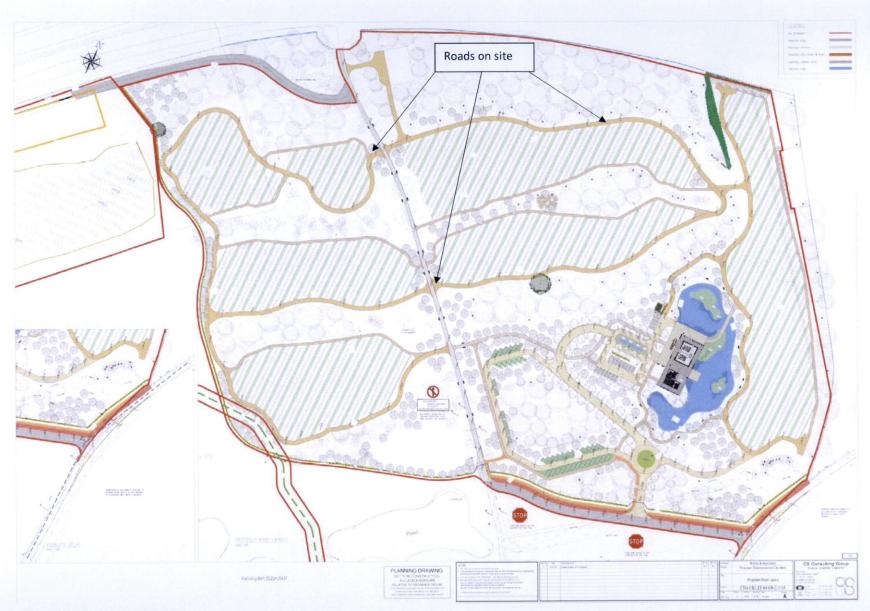
Figure 3. Proposed road layout

The main road will be both vehicular and pedestrian and provide access to the grave plots before and after the ceremonies, as well as for ongoing maintenance of the cemetery. Each fairway includes a secondary pedestrian path that will allow easier access to the burial areas. The proposed paths have organic shapes that are adapted to the existing vegetation and will direct the visitors through the site.

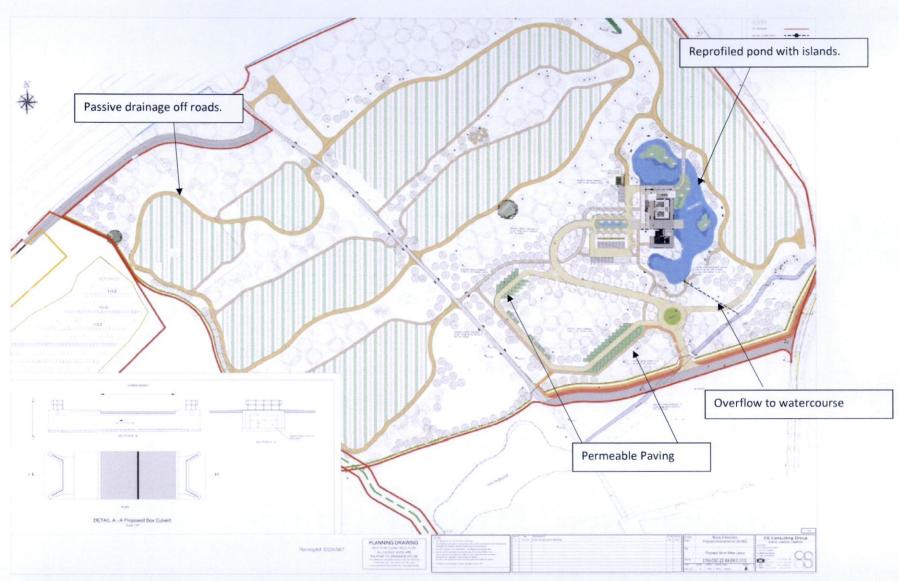
Figure 4. Proposed Suds layout

The proposed site, where hard standing is to be introduced will be attenuated to 2.0l/sec/Ha. The majority of the site will use infiltration systems to allow storm water generated on site to infiltrate the subsoil. The proposed building located close to the existing pond will require storm water attenuation. The volume required for the 1-in-100-year event (increased by 20%) is $163m^3$. This volume will be provided in the re-engineered pond. The current pond serves as part of the golf course and will be redeveloped as a water feature for the development. The second aspect is the policy of the Local Authority is to include Sustainable Urban Drainage Systems, SuDS, for all new applications, as such it is proposed to use a range of SuDS devises for the scheme they are listed below:

- · Permeable paving to all new parking spaces,
- Waterbutts for local irrigation and washing down areas,
- Attenuation tank with flow control device, sized to contain a 1-in-100-year storm event and increased by 20% for the predicted climate change to limit the surface water discharge from the site during extreme rainfall events,
- Proposed roads areas will be drained via infiltration drains,
- As the vast majority of the site will be grass/porous surfaces the scheme will fully allow storm water generated on site to drain into the subsoil.'

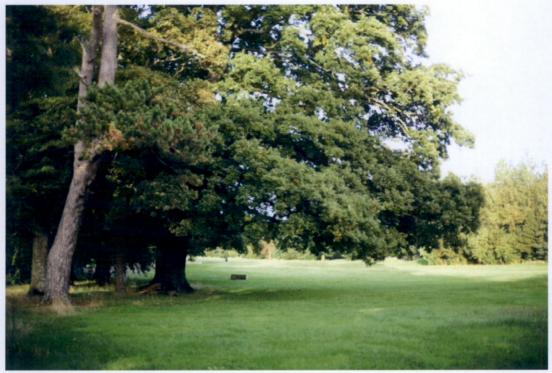
Plate 1: Amenity grassland primarily well managed golf fairways.

The site is a managed golf course and contains approximately 50%-60% well maintained amenity grassland. It should be noted that as seen in Plate 1 the grassland extends beneath tree canopies on site. This habitat has poor species diversity and herbicide use was evident. Species in the area include creeping buttercup (Ranunculus repens), white clover (Trifolium repens), red clover (Trifolium pratense), daisy (Bellis perennis), plantains (Plantago spp.), dandelion (Taraxacum spp.), thistles (Cirsium sp.) and docks (Rumex spp.). Frogs (Rana temporaria) were noted in this habitat, in the south east corner of the site proximate to the stream. A grey heron (Ardea cinerea) was observed foraging on frogs in this area.

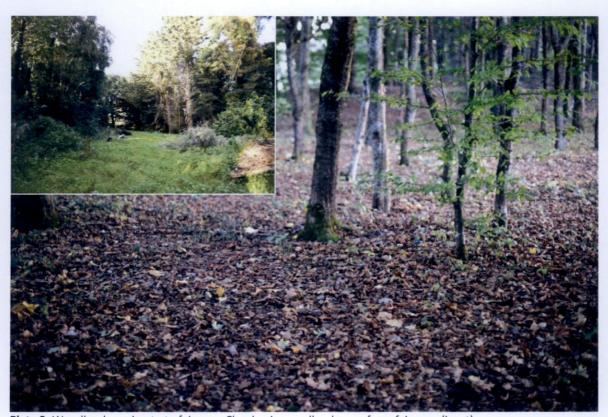
Plate 2. Woodland proximate to fairway. Clearing in woodland away from fairways (inset).

The vast majority of the remainder of the site consists of (Mixed) broadleaved woodland. Although narrow in parts, as the trees run parallel to the fairways, the width of the tree lines are greater than 4m which is the limit for treelines (WL2) within the Fossitt classification. Also, several areas of this woodland habitat may be considered WD5 (Scattered trees and Parkland). However, the trees are within clusters and it was considered that an overall habitat of (Mixed) broadleaved woodland was appropriate, even though mown grass is beneath a portion of the habitat. It should also be noted that the northern boundary of the site is adjacent to the N7 Dual carriageway and the background noise of the road in this area was significant. The understory of flora proximate to the fairways was limited as the site is maintained as a golf course and herbicide use was evident. Further away from the fairways the understory was allowed to develop. However, tree planting in these areas was dense and light hitting the floor of the woodland was limited. As a result a thick understory was not prevalent and many of the trees grew tall and thin, limiting their potential for bat use. Flora in this area included bramble (Rubus fruticosus agg.), dog-rose (Rosa caninanettle), hedge bindweed (Calystegia sepium), dandelion (Taraxacum spp.), rosebay willowherb (Epilobium angustifolium), thistles (Cirsium arvense & C. vulgare), cat's-ear (Hypochaeris radicatathistles), ivy (Hedera helix), honeysuckle (Lonicera periclymenum), cleavers (Galium aparine), cherry laurel (Prunus laurocerasus), rosebay willowherb (Epilobium angustifolium), hoary willowherb (Epilobium parviflorum), hawthorn (Crataegus monogyna), elder (Sambucus nigra), ivy (Hedera helix), honeysuckle (Lonicera periclymenum), and traveller's-joy (Clematis vitalba). Trees include common oak (Quercus robur), beech (Fagus sylvatica), Austrian pine (Pinus nigra), silver birch (Betula pendula), blue cedar (Cedrus atlantica 'Glauca'), Black Poplar (Populus X canadensis), Scots pine (Pinus sylvestris), Norway maple (Acer platanoides), horse chestnut (Aesculus hippocastanum), sycamore (Acer pseudoplatanus), sweet chestnut (Castanea sativa), larch (Larix sp.), Laburnum (Laburnum anagyroides), rowan (Sorbus aucuparia), field maple (Acer campestre), turkey oak (Quercus cerris), common lime (Tilia X europaea), alder (Alnus glutinosa), douglas fir (Pseudotsuga menziesii), lawson cypress (Chamaecyparis lawsoniana), goat willow (Salix caprea) and copper beech (Fagus sylvatica 'Purpurea'). It should be noted that no active borrows or setts were noted on site. However, several trees of bat roosting potential were noted on site (Appendix I). The woodland provides a significant nesting resource for birds that utilise the site.

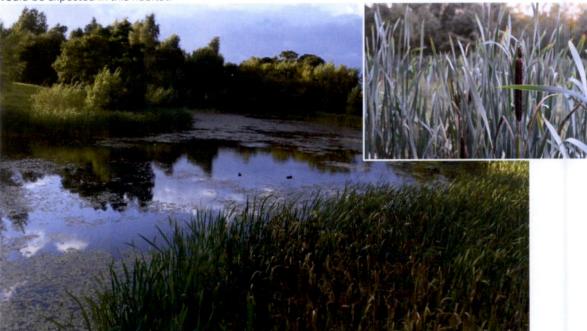
Plate 3. Large Pond

A single large artificial pond is located on the eastern portion of the site. It is proposed to remove this pond. There is also a smaller pond on the southern portion of the redline and it is proposed to partially infill this pond. The prominent species recorded were common bullrush (*Typha latifolia*), sedges (Carex sp.), rushes (Juncus sp.), broad leaved pondweed (Potamogeton natans) and the submerged Eurasian watermilfoil (Myriophyllum spicatum), bistort (*Persicaria amphibia*), water forget-me-not (*Myasotis scorpioides*), common duckweed (*Lemna minor*), yellow flag (*Iris pseudacorus*), water-cress (*Rorippa nastutium-aquatica*), water mint (*Mentha aquatica*), willows (salix sp.). A pair of coot (*Fulica atra*) (amber status) were noted in the pond. Common frog (*Rana temporaria*) was not noted but would be expected in this habitat.

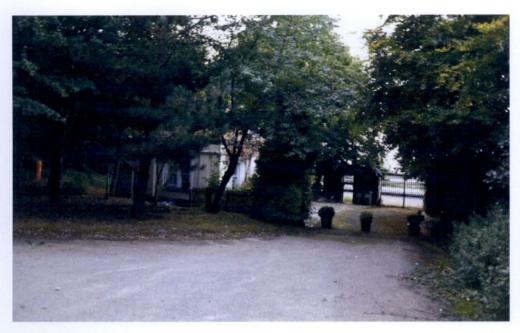
Plate 4. Built Land.

Areas of built land on site primarily consist of active roads and an existing gate lodge. Herbicide use was evident. Species in these areas included nettle (*Urtica dioica*), dandelion (*Taraxacum* spp.), bramble (*Rubus fruticosus* agg.), pineapple weed (*Matricaria discoidea*) creeping buttercup (*Ranunculus repens*), white clover (*Trifolium repens*), red clover (*Trifolium pratense*), daisy (*Bellis perennis*), plantains (*Plantago* spp.), thistles (*Cirsium arvense* & *C. vulgare*), docks (*Rumex* spp.) and scarlet pimpernel (*Anagallis arvensis*). The Gate Lodge was inhabited and no bats were noted emerging from the building during the bat survey. It should be noted that this building is proximate to the N7 dual carriageway, with very high traffic noise levels.

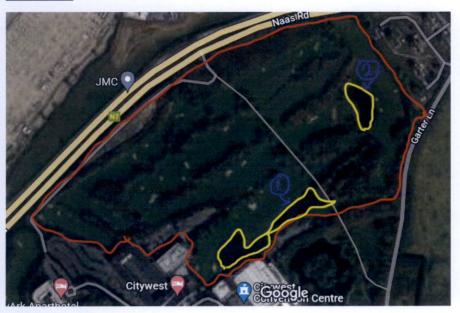
Fig. 1 Citywest site

Site is situated at Saggart, Co Dublin, site concerns the area north of the Citywest convention center complex, bordered to the west and north by the Naas Road and to the east by Garters Lane.
