# Clonburriss Tile 2

## Stage 2 Road Safety Audit

210124-X-90-Z00-XXX-RP-DBFL-CE-0005

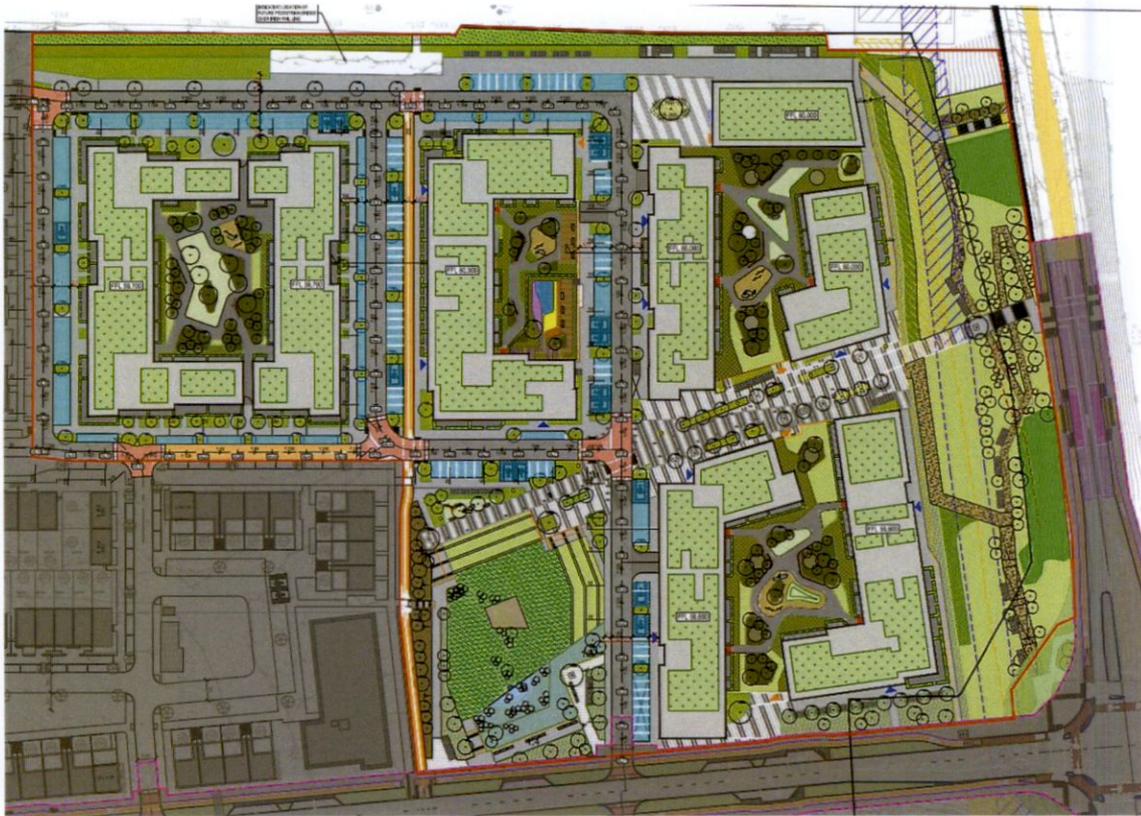
Figure 1-3 Geographical Scope of RSA

The geographical scope of this Stage 2 Road Safety Audit considers all internal transport infrastructure and the subject site access junction on the Clonburris Southern Link Street. The

immediate approaches leading to/from this junction is also included in the scope of the RSA, as illustrated in Figure 1-3 below.

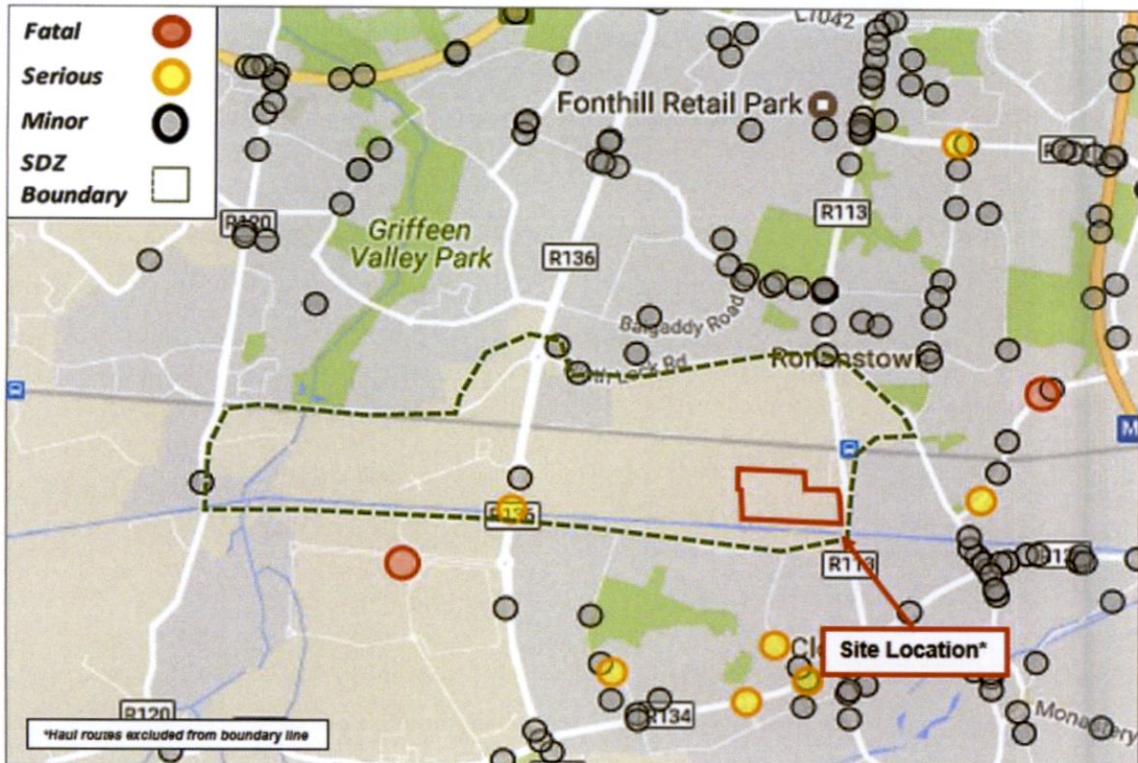
Figure 1-4 Collision Record

The review of the RSA data reveals that there was one fatal accident near Clonburris, which occurred in the Grange Castle Business Park. A cluster of minor accidents was recorded to the south of the site on the New Nangor Road, Fonthill Road South and Lucan Newlands Road. Less dense clusters of minor accidents have also been recorded on the Balgaddy Road and Fonthill Road North. In summary the review confirms that no significant incident trends or significant

safety concerns are evident across the local road network immediately adjoining the subject Tile 2 development plot.

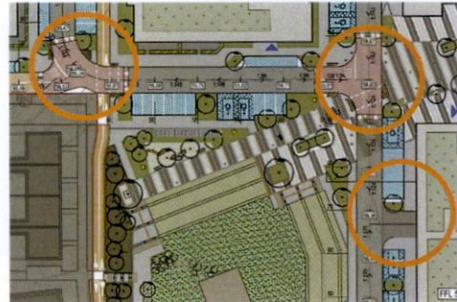
#### 2.1.1 Problem (G1) – Junction Visibility Splay

The proximity of car parking spaces and trees throughout the site may obstruct driver's visibility at the internal junctions. Failure to provide sufficient visibility splays for vehicle drivers at all junctions and access/egress points to off-street car parking areas could result in overshoot incidents or side impact collisions with existing vehicle drivers and opposing vehicles/cyclists travelling along the road.

Ensure sufficient visibility is provided at all junctions and vehicle access points by ensuring tree species are chosen such that trees (canopy height of the trees and trunk girth), landscaping and car parking do not obstruct the visibility splay.

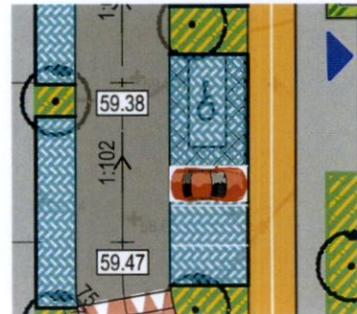
### 2.1.6 Problem (G6) – Disabled Car Parking

A number of parallel disabled car parking bays are proposed within a row of perpendicular car parking bays along the internal roads. It is unclear to the audit team if the disabled parking bays are accessible when the adjacent perpendicular car parking spaces are occupied by vehicles. Failure to provide adequately sized perpendicular parking bays with aisles of sufficient width and length could result in material damage incidents as vehicle drivers try to manoeuvre into/out of parking bays.

It is recommended that all disabled car parking bays are designed in accordance with the appropriate design guidance. A tracking analysis should be undertaken to determine if all disabled parking bays are accessible. Sufficient side clearance to structures should be provided.

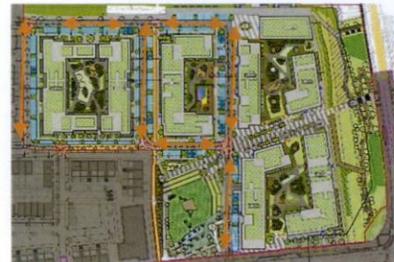
### 2.2.1 Problem (S1) – Long Straight Horizontal Alignment

The internal local roads seem to comprise 6m wide long straight sections. This could lead to high vehicle speeds. Higher speeds would lead to higher severity injury collisions should a driver lose control or come into contact with another road user.

It is recommended that the suitable traffic calming measures are provided to reduce vehicular speeds along the local road and that local streets are compliant with the principles as set out in DMURS. This could include the narrowing of the internal carriageways to 5.5m in accordance with DMURS recommendations for 'local' streets.

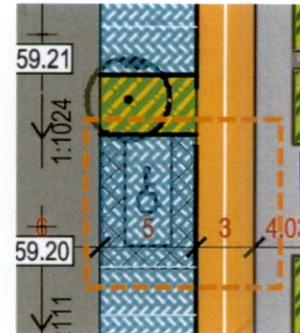
### 2.2.3 Problem (S3) – Mobility Impaired Parking Bays

Two number mobility impaired parking bays are proposed parallel to the cycle track. This will require localised dropped kerb facilities within the cycle track to allow access from parking bay level to cycle track / footpath level. Cyclists travelling at speed may not be aware of the sudden change in level which could lead to cyclists losing control and potentially colliding with other cyclists, pedestrians or parked vehicles.

Further to item S2, it is recommended that a raised buffer area is introduced between the mobility impaired parking parallel bay and the cycle track with dropped kerbs provided. The layout of 'parallel' disabled bays should respect the guidance outlined in the Traffic Signs Manual.

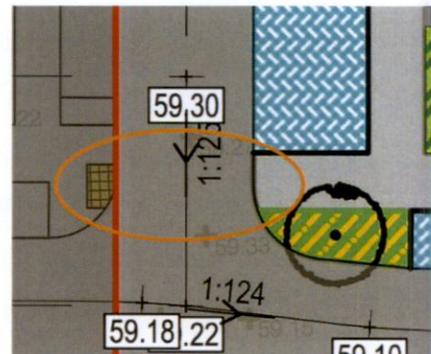
### 2.2.4 Problem (S4) – Dropped Kerbs and Tactile Paving

The auditors note that the corresponding tactile and dropped kerb is missing at the uncontrolled crossing in south western corner of the development. This could lead to confusion for road users particularly wheelchair users and partially sighted pedestrians who may encounter difficulties crossing the road carriageway.

It is recommended that dropped kerbs and / or tactile paving in accordance with the appropriate design recommendations is provided at (i) all key pedestrian travel desire lines that require a pedestrian to cross a road carriageway, (ii) in advance of steps, and (iii) dropped kerbs at disabled car parking bays and pedestrian routes across segregated cycle tracks.

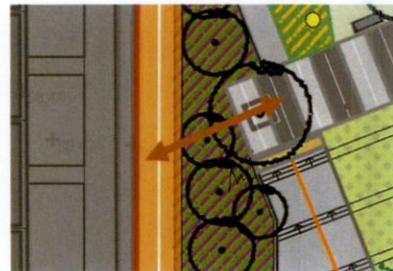
#### 3.1.2 Comment (C2) – Cycle Track Connectivity

It is unclear if the proposed pedestrian facility that runs diagonally through the subject site is proposed to also accommodate cyclists. There is no cycle connection between this facility and the proposed north / south cycle track operating on the western side of the site. Should cyclist be permitted to use this facility, it is recommended that a connection to the cycle track is incorporated into the design.

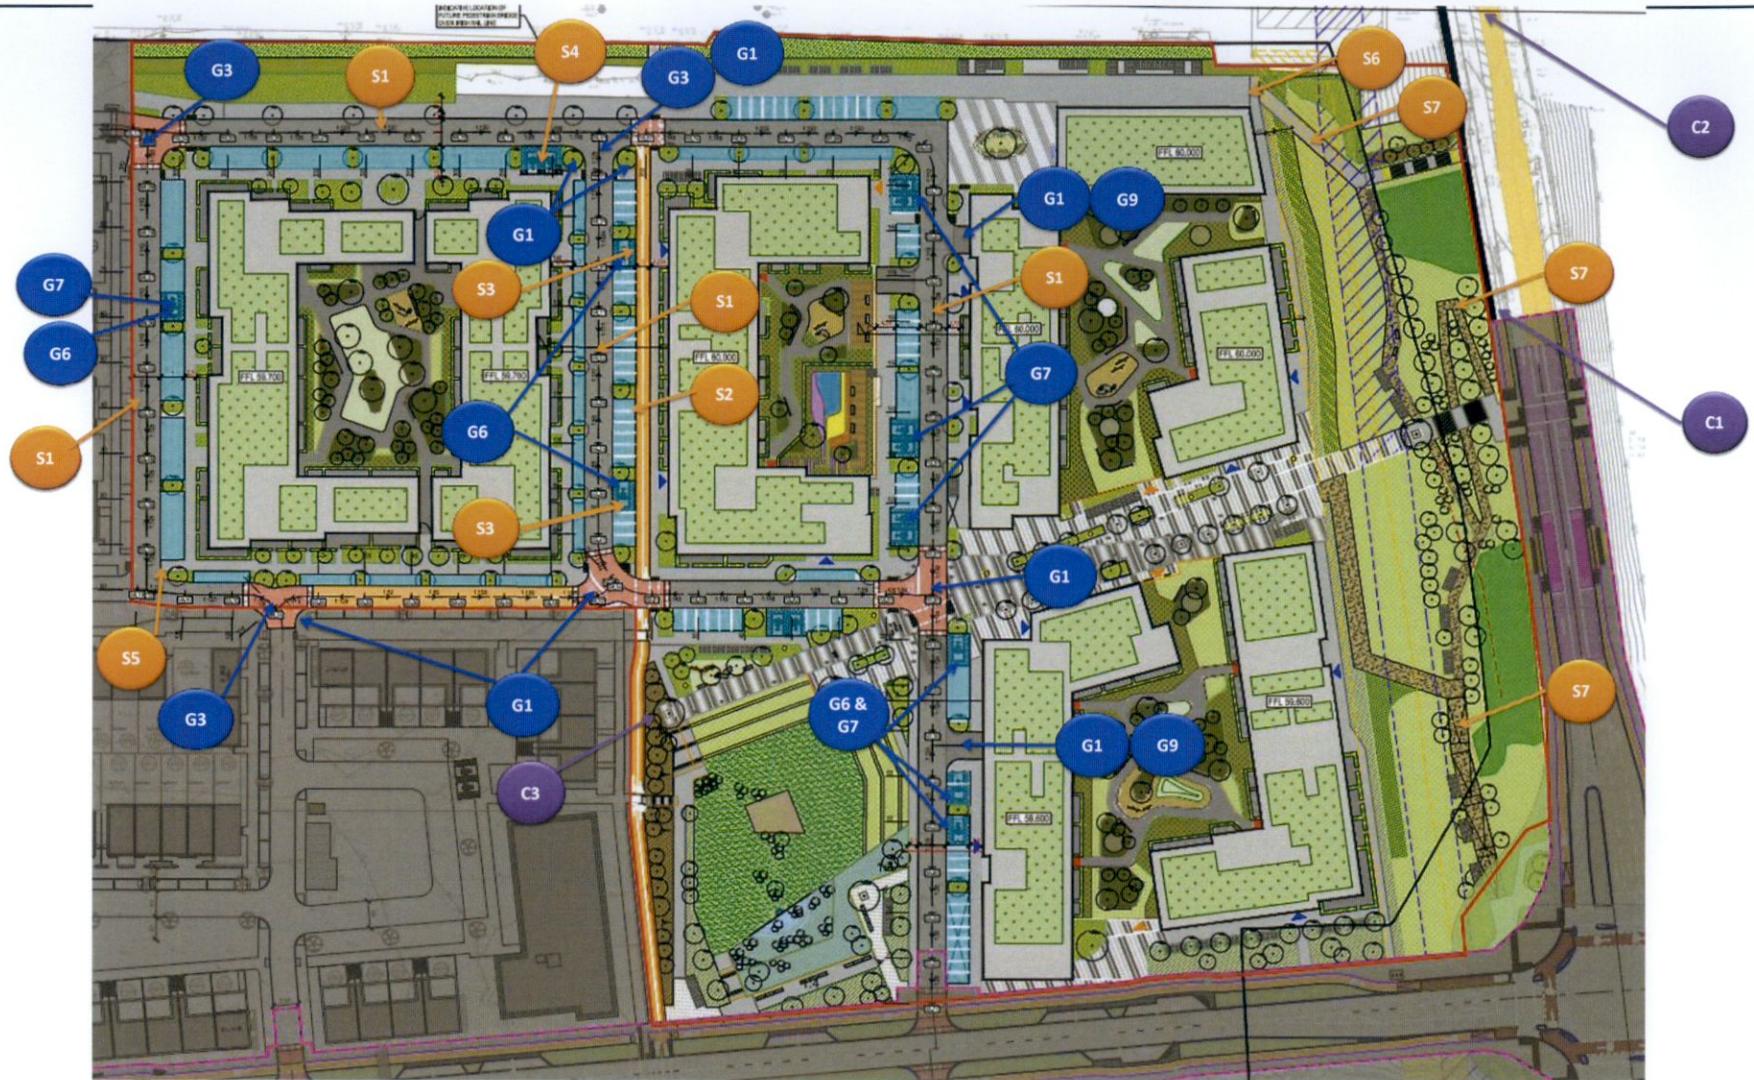
## Appendix A : Problem Location Figure

\*Note: For general problems, examples of locations are indicated. Not all occurrences of the specific general problem reference are shown
