**ARCHAEOLOGICAL ASSESSMENT  
AT  
TILES 2 AND 3,  
CAPPAGH, DUBLIN 22,  
(CLONBURRIS SDZ)**

**LICENCE NOS. 22E0719/ 22R0359**

**ON BEHALF OF: CAIRN HOMES PROPERTIES**

**IAC PROJECT REF.: J3803**

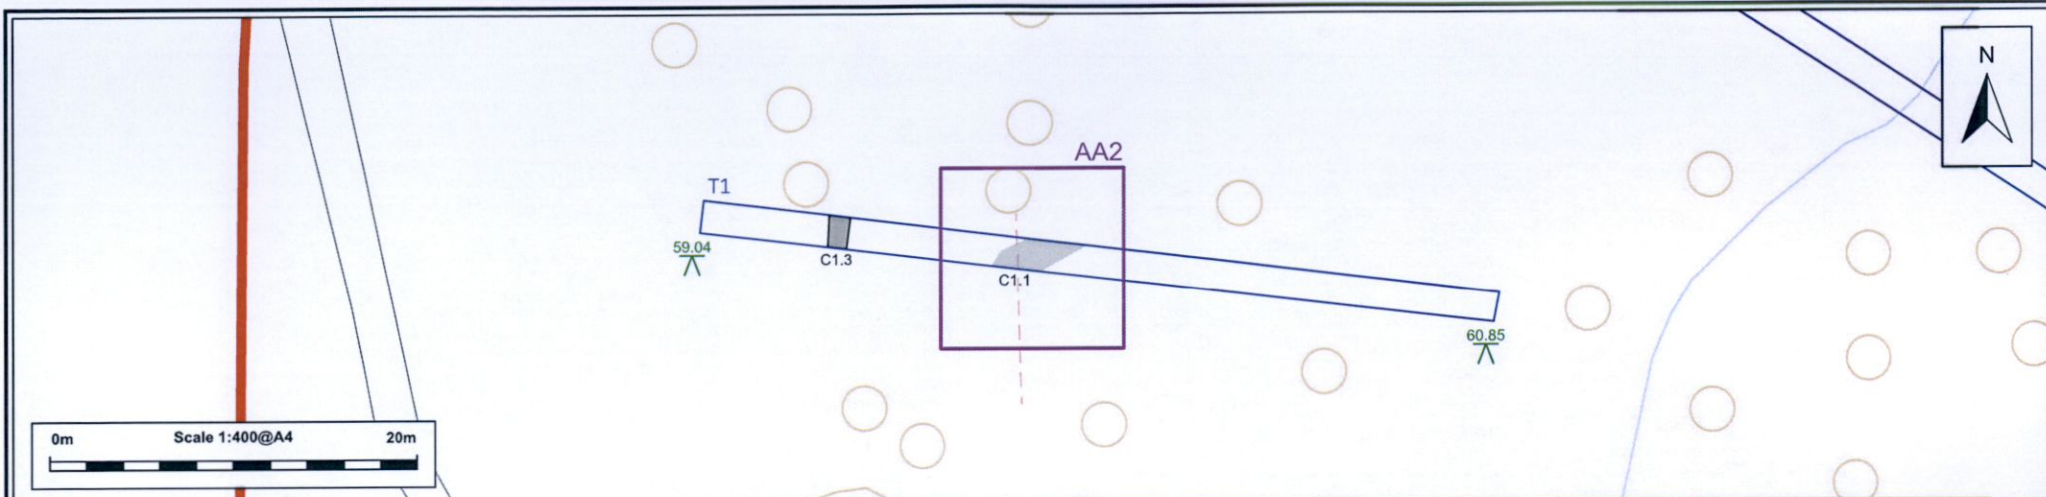
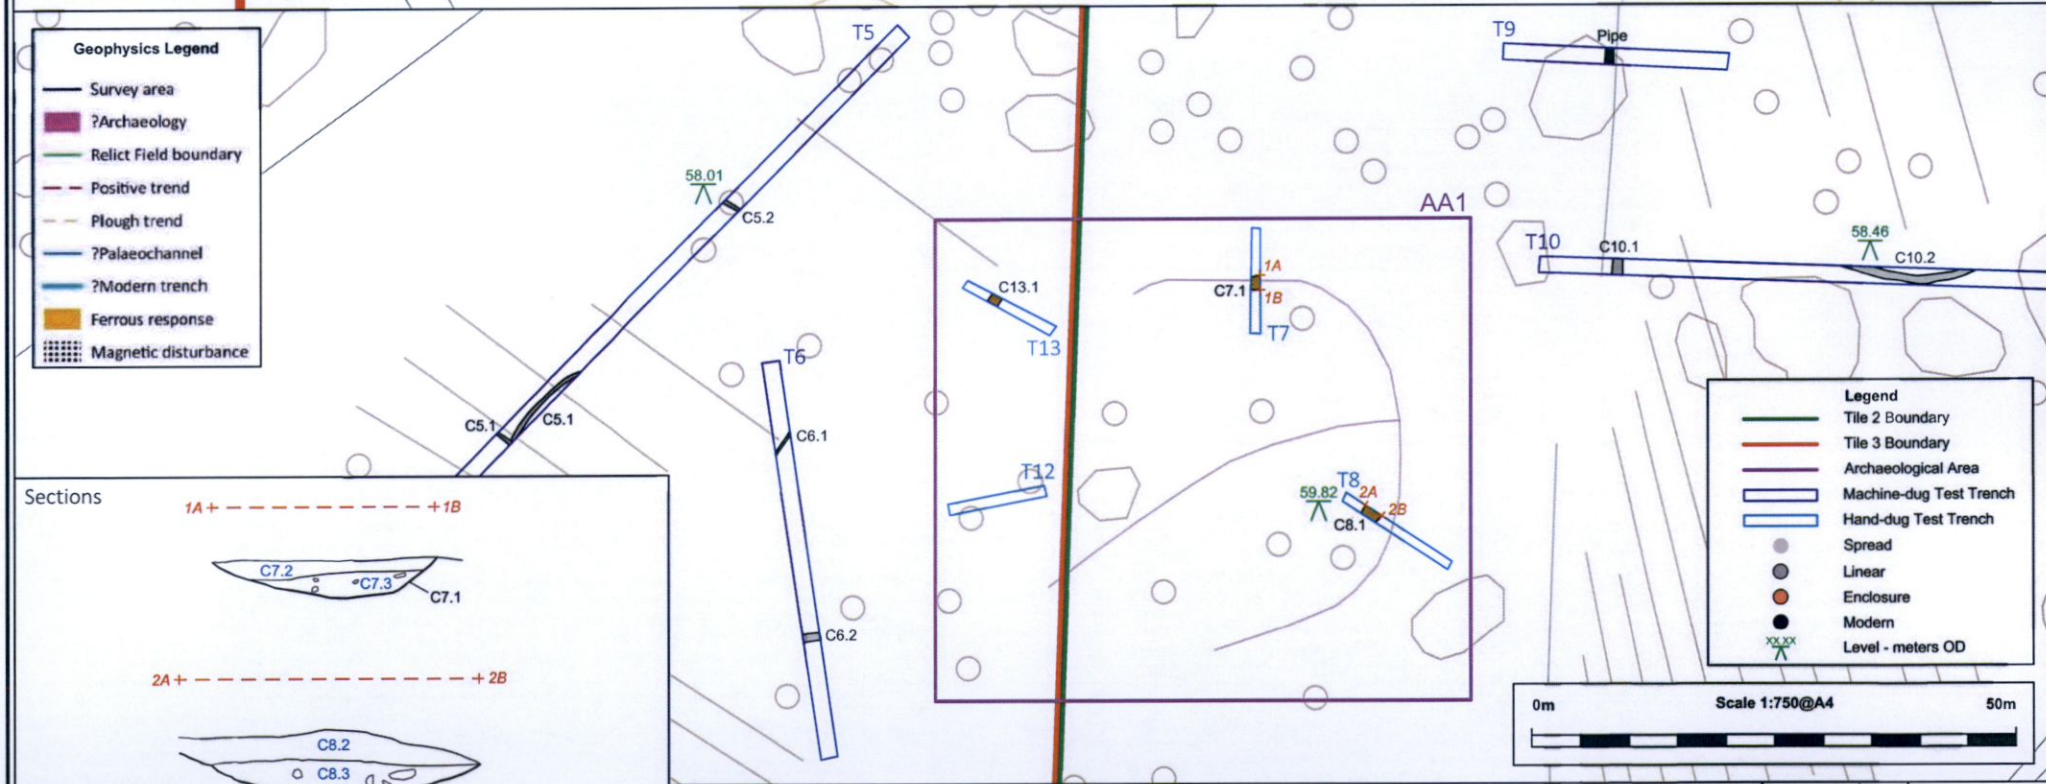
Title	Test trench results	Scale	1:2500@A4	Drawn by	RB
Project	Cappagh, Clonburris SDZ, Dublin 22	Date	27/03/23	Checked by	FM
Job no.	J3803	Fig.	4	Rev.	1

A number of recent agricultural field drains and furrows were noted in Trenches 10 and 12 (Figure 4; Plate 13).

A number of field drains and furrows were noted in Trenches 1, 5, and 6 (Figure 4).

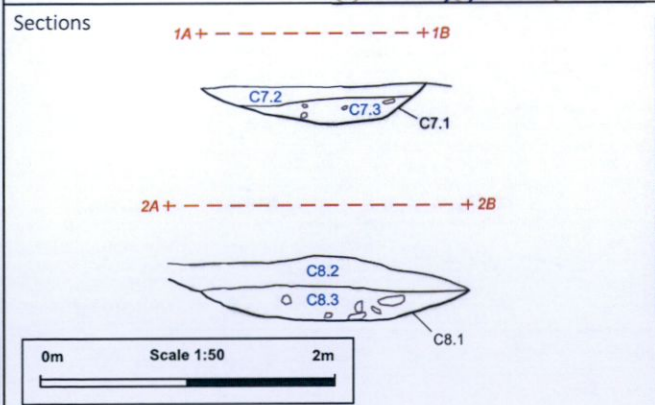
Title	Detail view of Archaeological Areas	Scale	As shown @A4	Drawn by	RB
Project	Cappagh, Clonburris SDZ, Dublin 22	Date	27/03/23	Checked by	FM
Job no.	J3803	Fig.	5	Rev.	1

AA1 was recorded in Trench 7 and 8 and consists of shallow linear features (C7.1 and C8.1) measuring between 1.52m and 2.05m wide and 0.4m to 0.48m deep (Plates 8–10; Figure 5). These features are filled by similar material in both trenches with the upper fill consisting of a compacted bright orange clay and the lower fill consisting of an orange clay with moderate amount of decayed stone present.

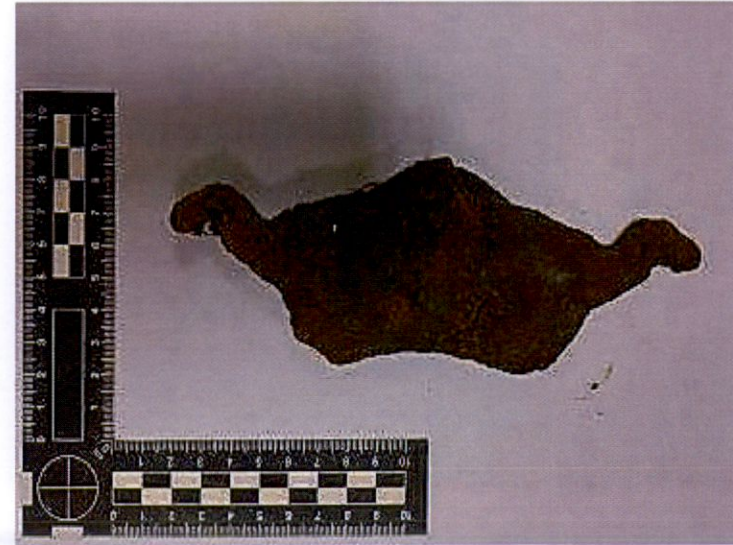
Plate 4 Metal object recovered through metal detection (22R0359)

An Equinox 600 metal detector was utilised on the upcast spoil from all 14 test trenches. One metal item was recovered using this methodology from the north-eastern terminus of Trench 4. It possibly represents a decorative plate such as those seen on garden gates or possibly part of a set of scales (Plate 4). This item was found directly below the sod layer near the field surface.

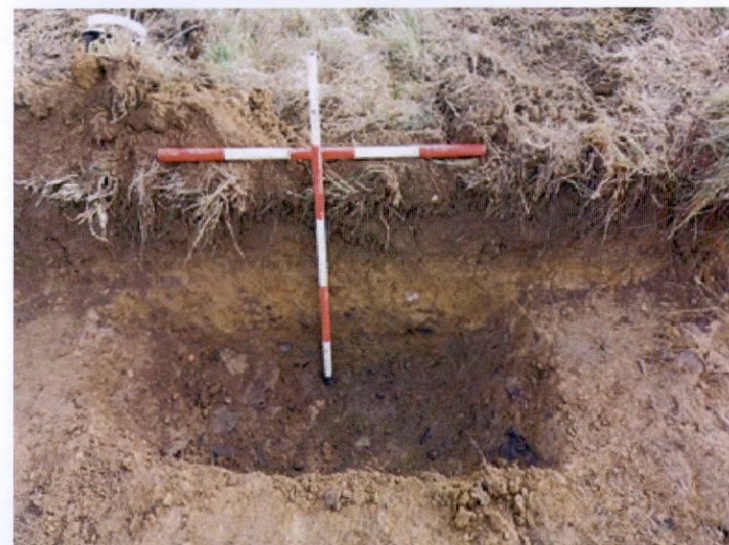
TRENCH	LENGTH (m)	WIDTH (m)	DEPTH (m)	ORIENTATION	DETAILS
7	10	1	0.3–0.4	North–South	A shallow linear feature (C7.1) with a gradual break of slope at top gently sloping sides and a concave base. It measured 1.52m in width and 0.4m in depth. The upper fill (C7.2) consists of a compacted bright orange clay. It is 0.2m deep. The lower fill (C7.3) consists of an orange clay with moderate amount of decayed stone present. A curvilinear geophysical anomaly was targeted in this trench possibly corresponding to DU017-0036. Plate 8, Figures 4 and 5.
8	10	1	0.35–0.4	Northwest–Southeast	A shallow linear feature (C8.1) with a gradual break of slope at top gently sloping sides and a concave base. It measured 2.05m in width and 0.48m in depth. The upper fill (C8.2) consists of a compacted bright orange clay. It is 0.23m deep. The lower fill (C8.3) consists of an orange clay with moderate amount of decayed stone present. It is 0.25m deep. A curvilinear geophysical anomaly was targeted in this trench possibly corresponding to DU017-0036. Plate 8, Figures 4 and 5.

Plate 8 Mid-excavation of linear feature C7.1, facing east

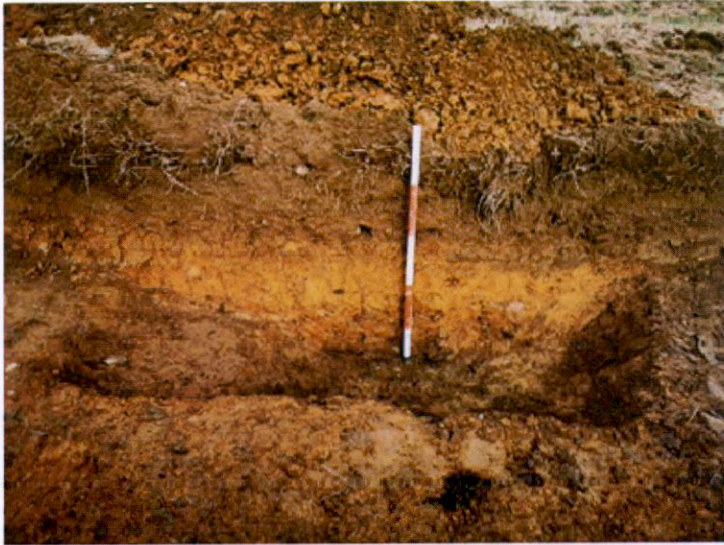
Plate 9 Mid-excavation view of linear feature C8.1, facing northeast

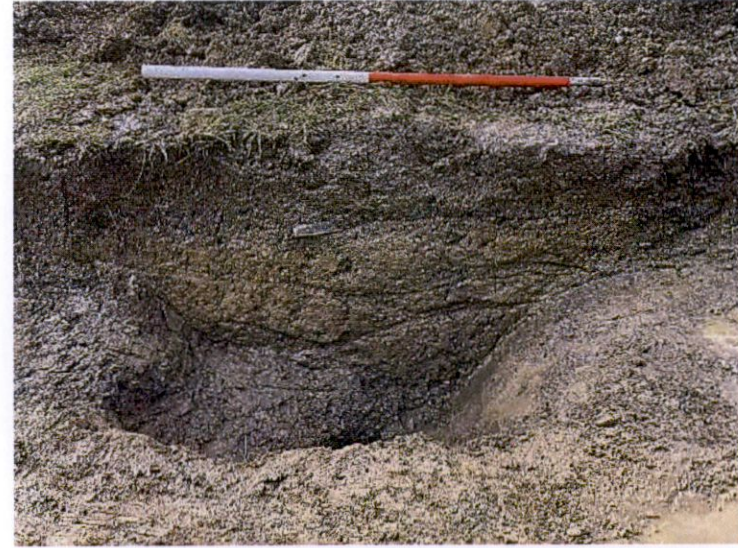
Plate 10 Mid-excavation view of linear feature C13.1, facing southwest

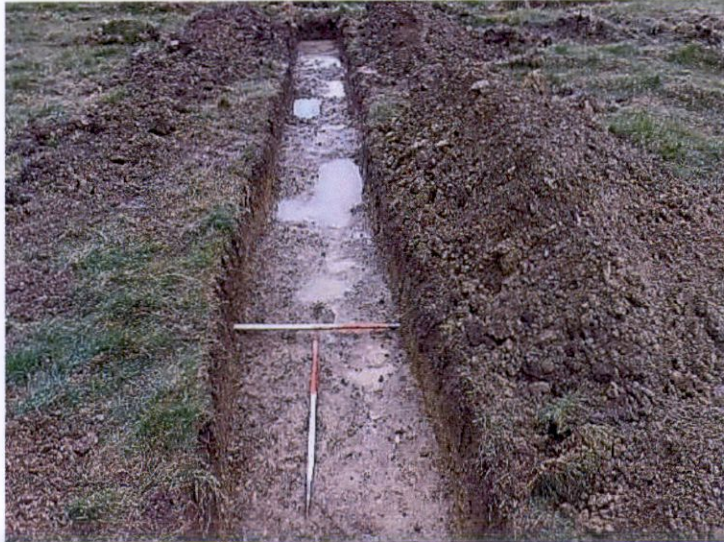
TRENCH	LENGTH (m)	WIDTH (m)	DEPTH (m)	ORIENTATION	DETAILS
					depth. Plate 15, Figure 5. No geophysical anomalies targeted.
2	90	2	0.5–0.8	Northwest–Southeast	No Archaeology found. A curvilinear geophysical anomaly was targeted.
3	40	2	0.3–0.7	Northwest–Southeast	No Archaeology found. A curvilinear geophysical anomaly was targeted.
4	40	2	0.3–0.4	North-northeast–South-southwest	No Archaeology found. A large geophysical anomaly was targeted. A metal object (Plate 4) was recovered here under licence 22R0359 directly below the sod layer. Plate 16
5	90	2	0.3–0.5	Northeast–Southwest	No Archaeology found. A number of probable field drains and small geophysical anomalies were targeted. Plate 17
6	40	2	0.5	North–South	No Archaeology found. No geophysical anomalies targeted.
13	10	1.1	0.5	East–west	A shallow linear feature (C13.1) with a gradual break of slope at top steep sloping sides and a concave base. It measured 1m in width and 0.48m in depth. The upper fill (C13.2) consists of a grey to yellow clay with flecks of charcoal. It is 1m in width and 0.17m deep. The lower fill (C13.3) consists of a grey clay with flecks of charcoal present. It is 0.86m in width and 0.31m deep (Plate 10). The projected line of a curvilinear geophysical anomaly was targeted in this trench possibly corresponding to DU017-036. Plate 11, Figures 4 and 5.

Plate 11 Trench 13, post-excavation facing west

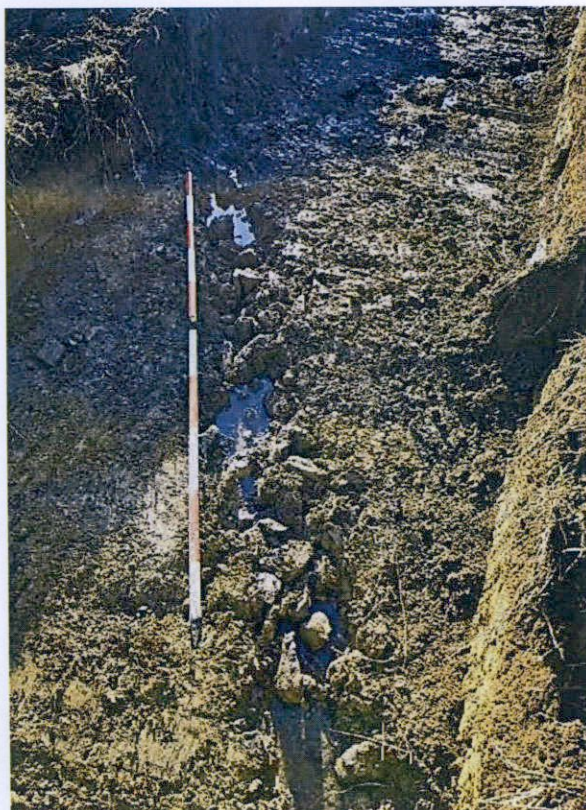
Plate 13 Modern field drain within Trench 12, facing southeast

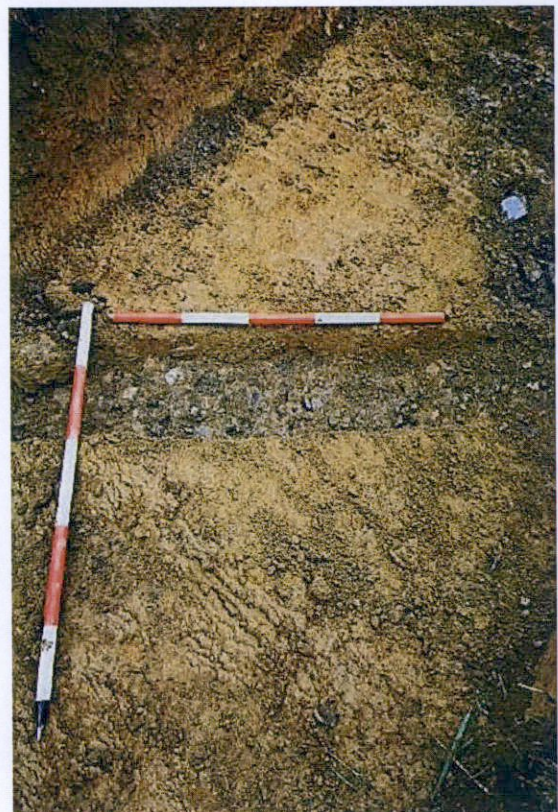
Plate 14 Metallised surface C1.2 below spread C1.1, facing east

- It is recommended that an area measuring c. 10m x 10m be opened around the metallised surface found in Trench 1 in order to facilitate its preservation by record (Archaeological Area 2) with further monitoring to establish the total length. All works should be carried out by an archaeologist under licence to the National Monuments Service of the DoHLGH.

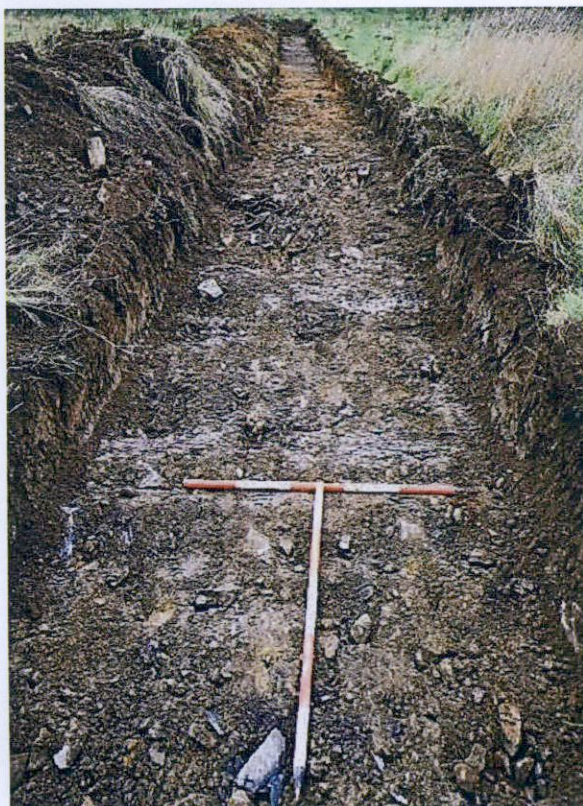
Plate 15 Trench 1, post-excavation facing west

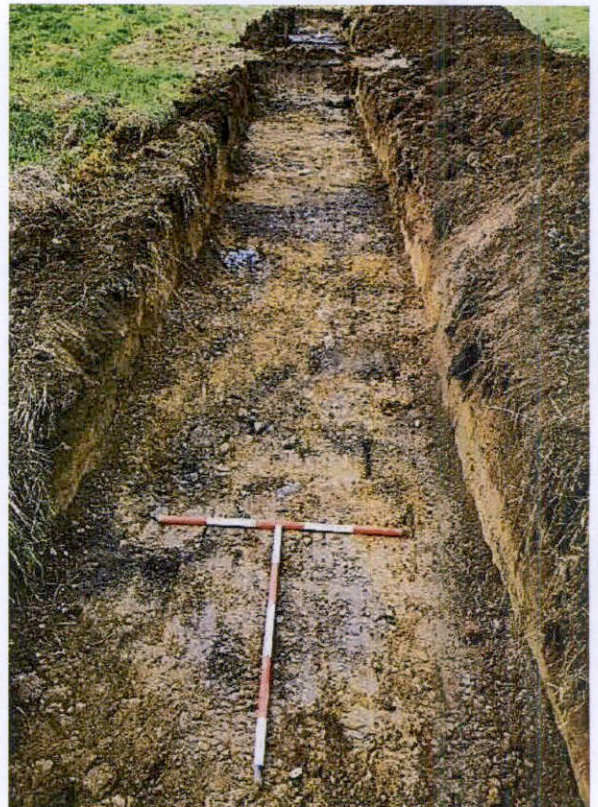
9	20	2	0.4–0.5	West–East	No archaeology found. Trench 9 was spilt to avoid an upstanding metal cap for a bore hole. No geophysical anomalies targeted. Plate 18
10	80	2	0.36–0.7	West–East	No Archaeology found. A linear geophysical anomaly and a separate large anomaly was targeted here. These corresponded to a pipe and some plastic debris on the field surface
11	90	2	0.3–0.8	North–South	No Archaeology found. No geophysical anomalies targeted. Plate 19
12	100	2	0.4–0.5	North–South	No Archaeology found. No geophysical anomalies targeted. Three field drains were noted crossing the trench on a northwest–southeast orientation Plate 20

Plate 18 Trench 9, post-excitation facing west

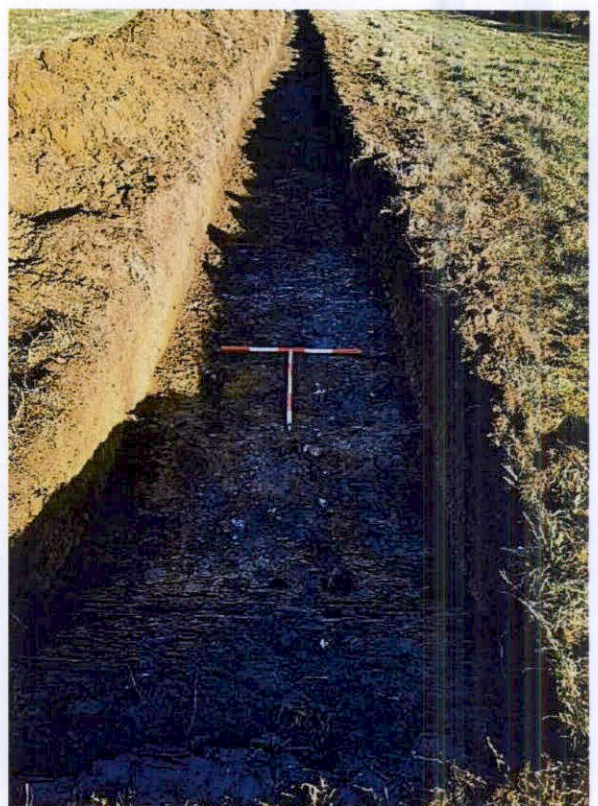
Plate 20 Trench 12, post-excitation, facing north
