# Adamstown Boulevard

Stage 1 Road Safety Audit

Quintain Developments Ireland Ltd.

August 2024

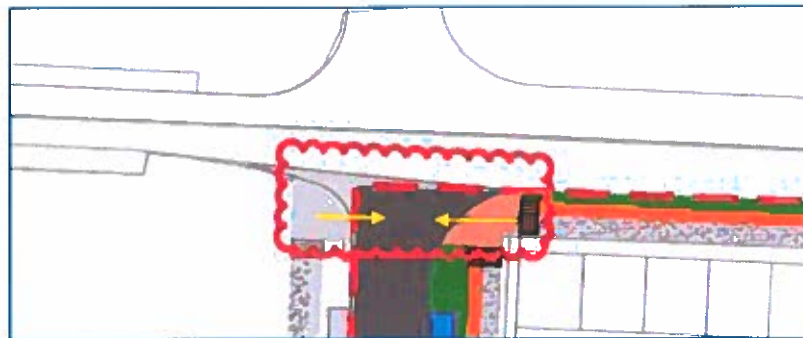
**Figure 2-1 – No Pedestrian Crossing Provision**

There is no crossing provision for pedestrians trying to cross East – West at the location shown in Figure 2-1. This may lead to pedestrians trying to cross the road in a location which is unsafe to do so and may result in them being struck by a vehicle.

The designer should provide appropriate crossing facilities for pedestrians to cross at the junction.

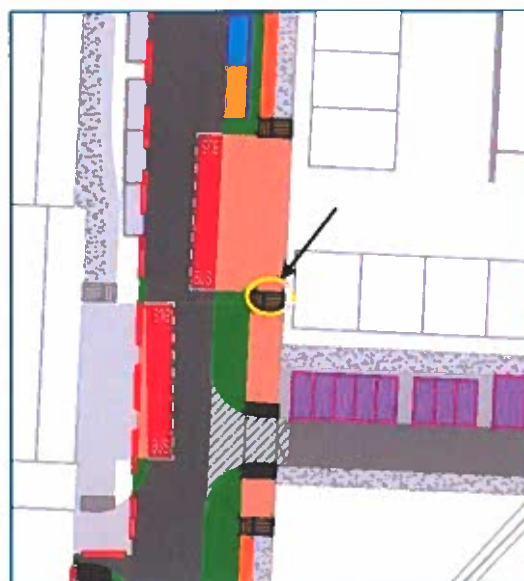
**Figure 2-2 – Ladder and Tramline paving provided in a shared area.**

The provision of ladder and tramline tactile paving throughout the scheme is sporadic and confusing. This could lead to cyclists and pedestrians being unsure whether they are in a shared area or not leading to collisions.

Figure 2-2 shows a location where ladder and tramline paving has been provided in the middle of an area which is understood to be a shared area on either side.

The designer should ensure that all shared areas are denoted correctly for both cyclists and pedestrians with a consistent approach provided across the scheme.

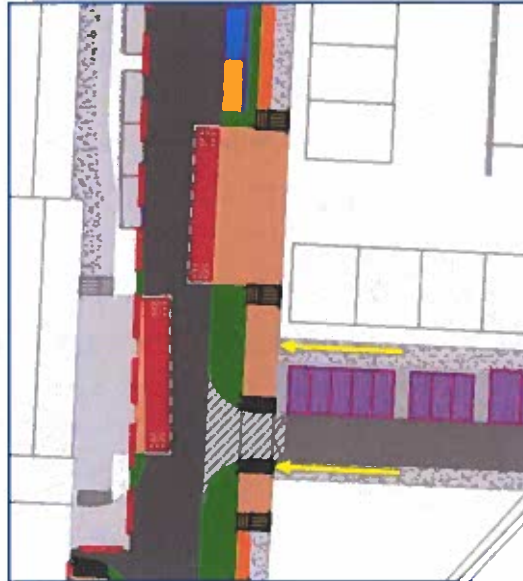
**Figure 2-3 – Location where Pedestrians Enter Shared Area**

Figure 2-3 shows an example of a location where pedestrians could enter a shared area without being aware it is shared.

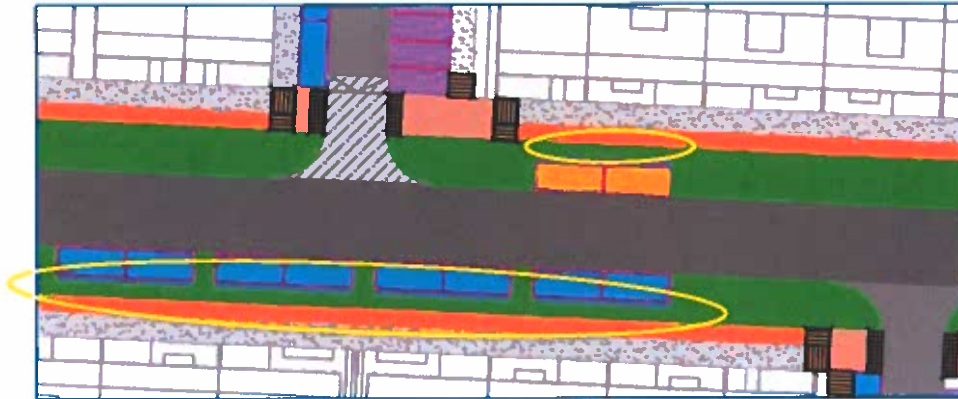
Figure 2-4 – Example of Grass verges Separating Footpath and Parking Bays

The proposed scheme shows parking bays which are separated from the footpath with a grass verge as shown in Figure 2-4. This could lead to pedestrians slipping and falling on the grass particularly in wet conditions or pedestrians may be forced to use the carriageway to access the parking spaces and possibly result in them being struck by a vehicle.

The designer should ensure that safe access to all parking areas is provided throughout the scheme.

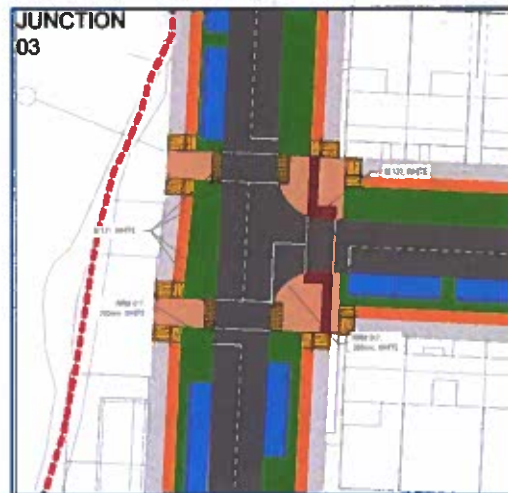
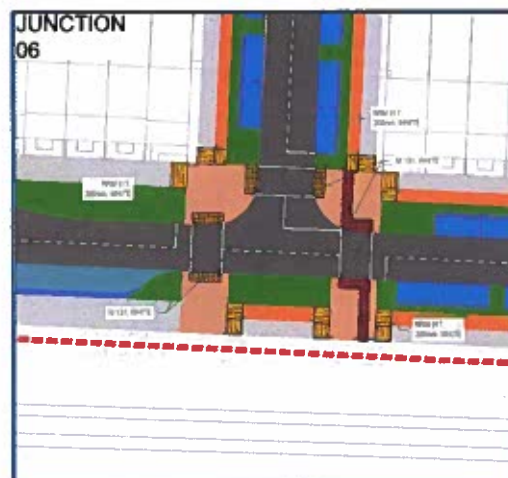
The proposals indicate courtesy crossings on the main north-south streets for the scheme. It appears unlikely that these will adequately allow for safe crossing of these roads and may lead to conflict with pedestrians and vehicles. Additionally the side road shows a controlled crossing, drivers may move on a green signal on the side road and enter the main road when it is unsafe to proceed. This may lead to shunt and side-impact conflict.

**Figure 2-5 – Signalised Junction No.1**

**Figure 2-6 - Signalised Junction No. 2**

**Figure 2-7 - Signalised Junction No.3**

The designer should review the junction strategy ensuring these will cater for the likely demand, provide adequate control and not lead to potential confusion for both pedestrian and vehicles users.

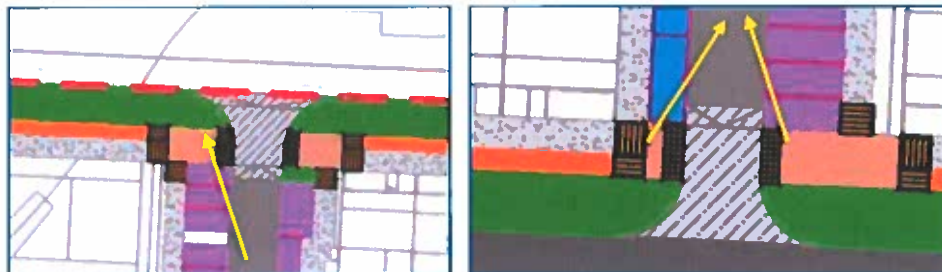
**Figure 2-8 - Visibility Issue Location No.1**

A number of proposed uncontrolled crossings will likely have visibility issues due to parked vehicles directly beside the crossing points. Footpath users particularly smaller individuals including children are unlikely to be able to see vehicles and similarly vehicles will be unable to see children that are attempting to cross. Poor visibility may lead to pedestrians trying to cross the carriageway without being sure it is safe to do so and could lead to them being struck by an oncoming vehicle.

The designer should relocate/set-back the parking to help improve visibility at the proposed uncontrolled crossings.

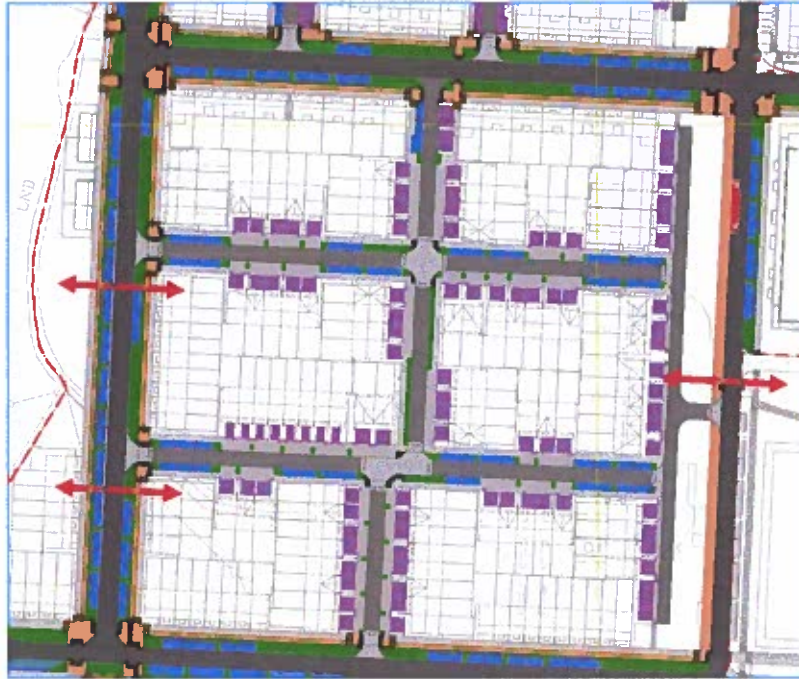
**Figure 2-9 – Potential Desire Lines East-West**

The north south roads to the south of the scheme appears to extend over a relatively long distance. There is no crossing provision made on these roads for those who may wish to move east to west. The scheme includes parking, housing and commercial developments on each side of these roads. It is reasonable to assume that people may desire to cross the road. Without adequate provision, conflict may arise when crossing at undesigned locations.

The designer should assess the proposed layout and buildings/expected building use and determine the likely demand and need to provide pedestrian crossings along the roads highlighted above.
