**Proposed works to:  
'WHITEHALL' - KATHARINE TYNAN HOUSE  
Kingswood, Dublin 24**

## **ARCHITECTURAL HERITAGE IMPACT ASSESSMENT REPORT**

**May 2021**

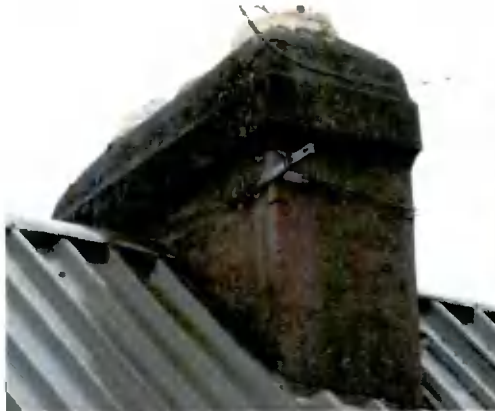
Figure 14: Main chimney stack

The chimneys are rendered and had clay chimney pots. The east gable has clay tiles on its barges (Figure 15).

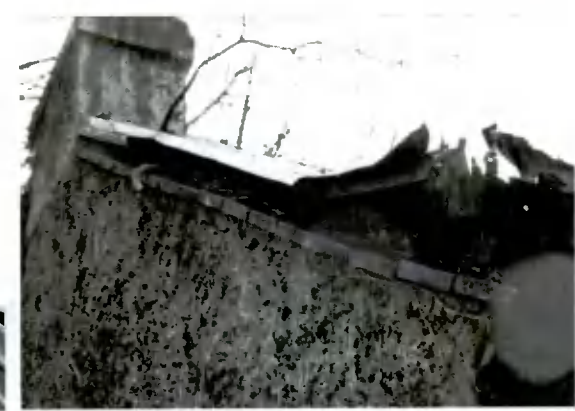
Figure 15: Barge detail

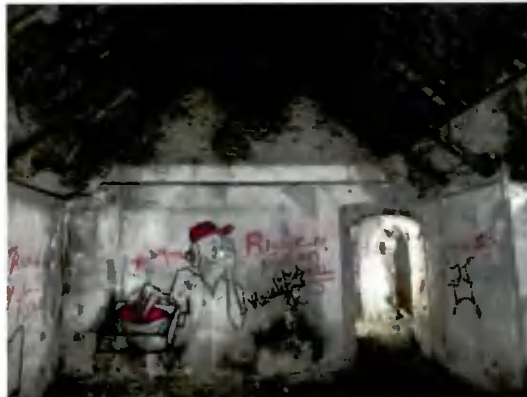
The roof structure is of sawn timbers. Some have been exposed and are decaying. The roof structure remains straight with no evidence of major sagging.

The existing roof structure is of sawn timber rafters set at close centres with some ties at high level. There is evidence of remaining slates fixed to timber battens that are now covered by profiled metal sheeting to protect the structure below. The timber structure remains relatively straight with no evidence of major sagging.

Figure 16: Roof structure (room G04)

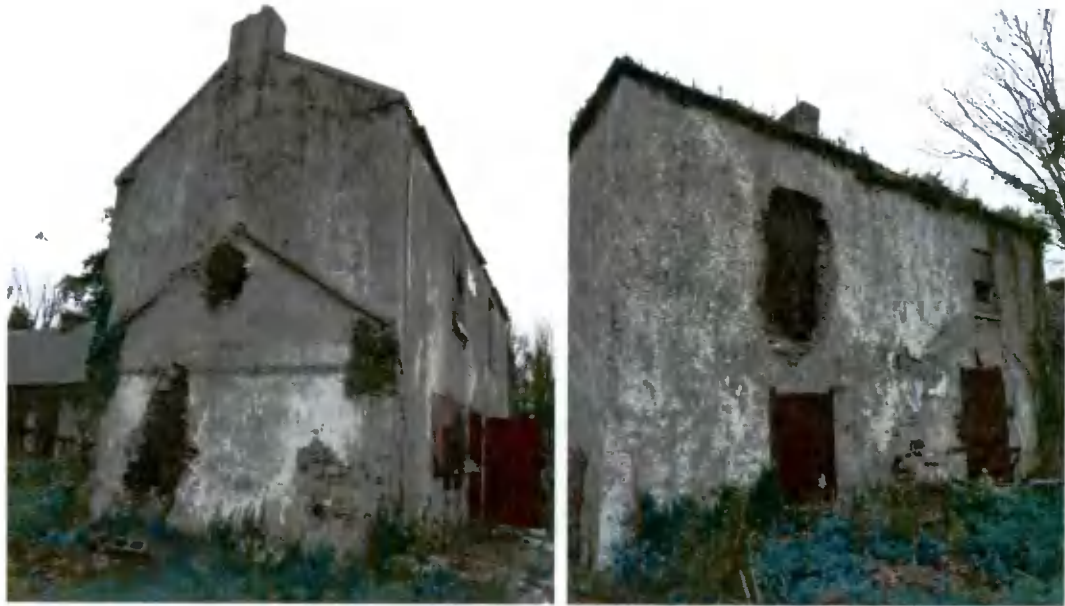
*Figure 18: North and west sides of two-storey section    Figure 19: South elevation*

The ground floor walls are of rubble stone with openings dressed in yellow brick. The upper floor walls are of brick. The walls are generally straight with no evidence of major cracking.

The windows and doors are no longer extant and the openings have been secured against ingress with concrete block and metal sheets.

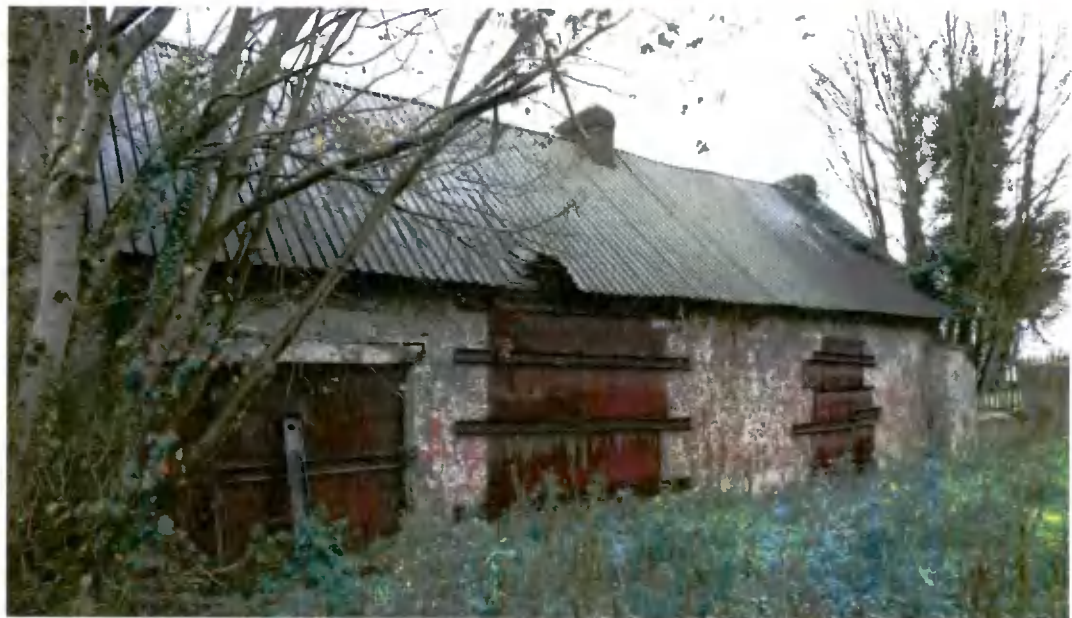
*Figure 20: South elevation of single-storey section*

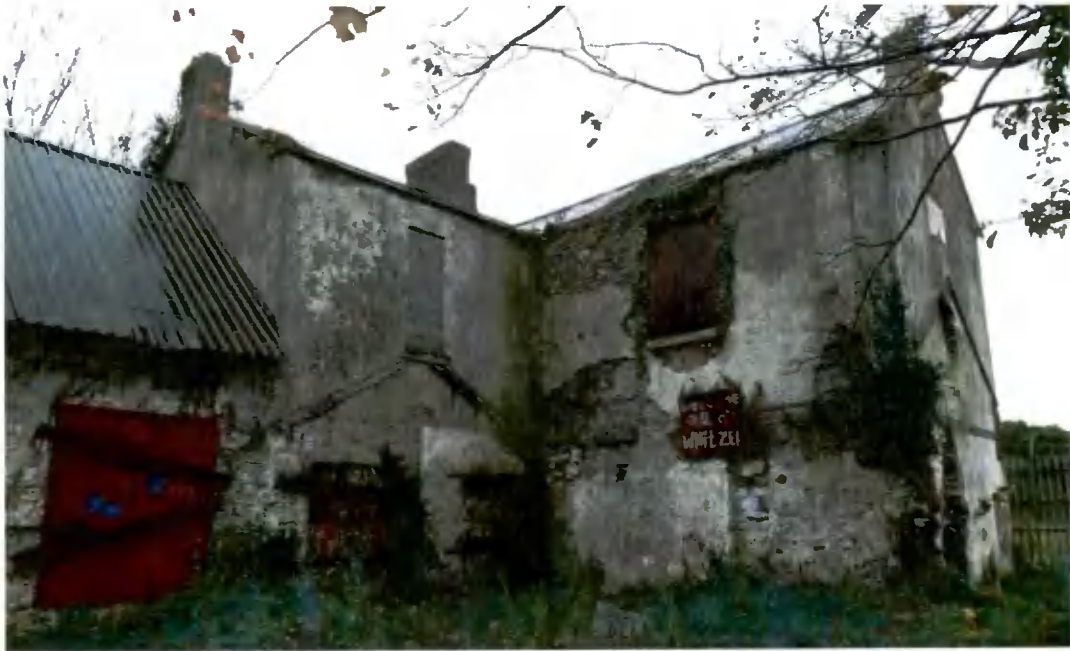
Figure 21: East and north elevations of two-storey section

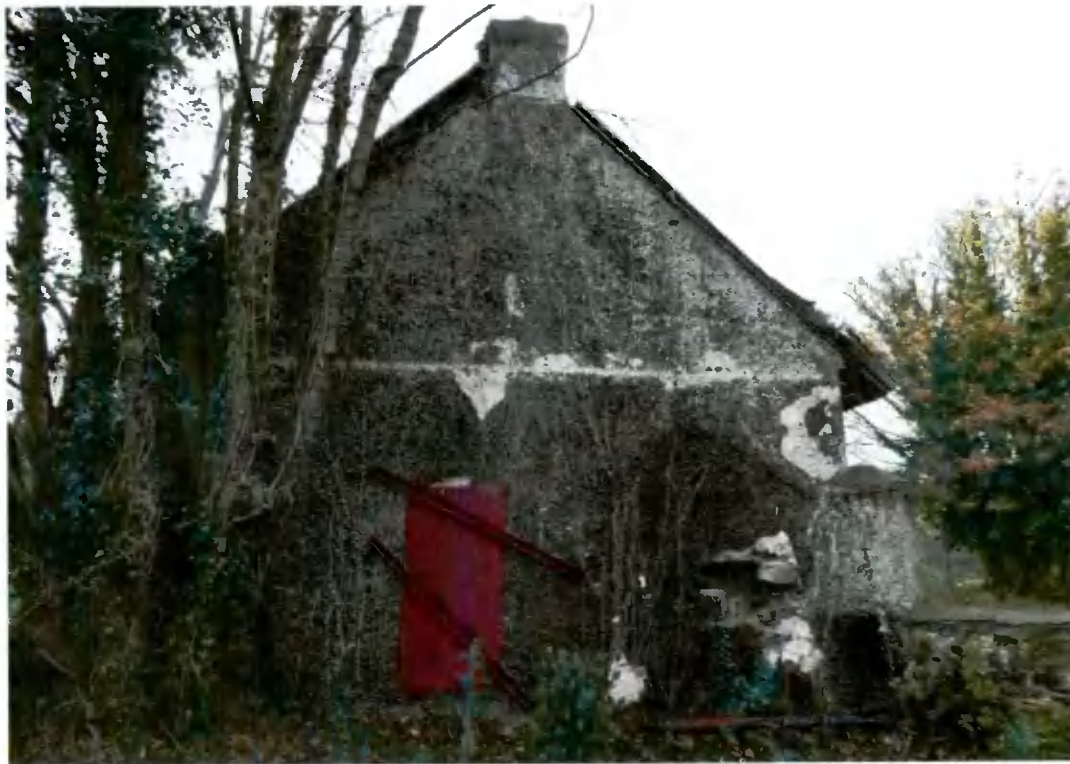
Figure 22: East elevation of single-storey section

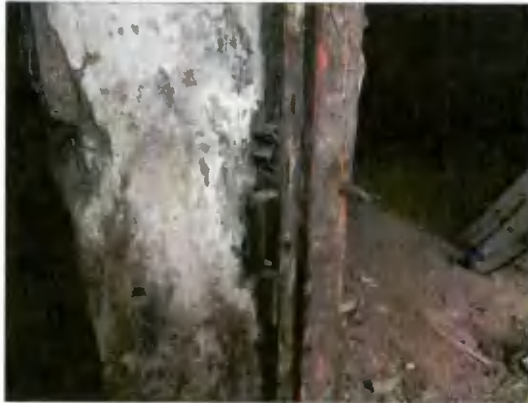
These have been removed throughout the house. Internally there are some remains of internal timber door frames to rooms G03 and G01 (Fig. 26 & 27).

Figure 31: Door frame in room G01

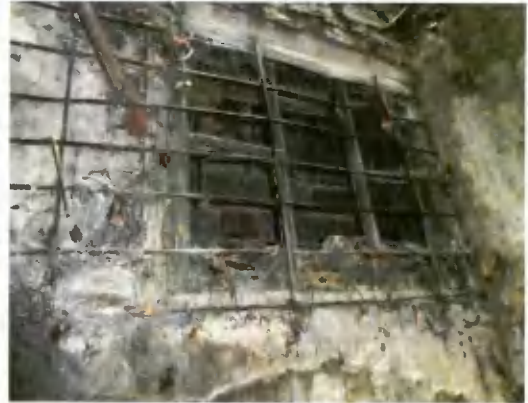
Figure 32: Timber casement window in room G01

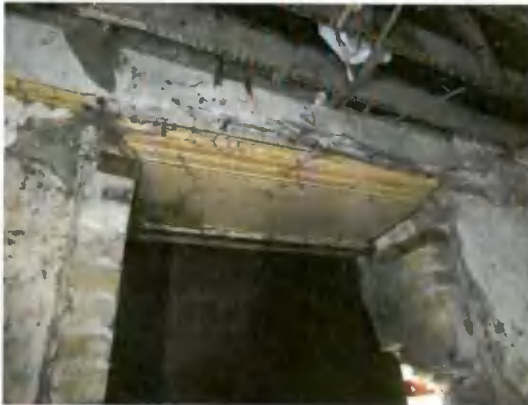
Figure 33: Timber lining to window in room G03

There are remains of internal timber linings in some window openings (Figure 33 & 34).

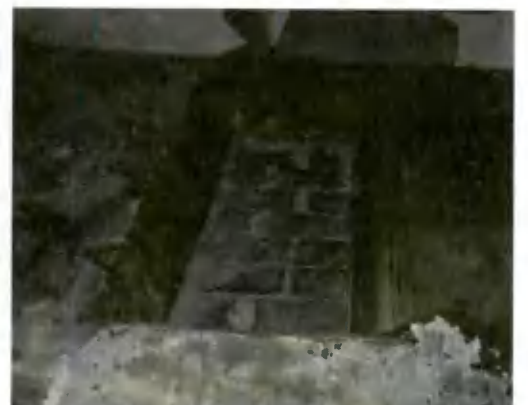
Figure 34: Timber lining to window in room 102

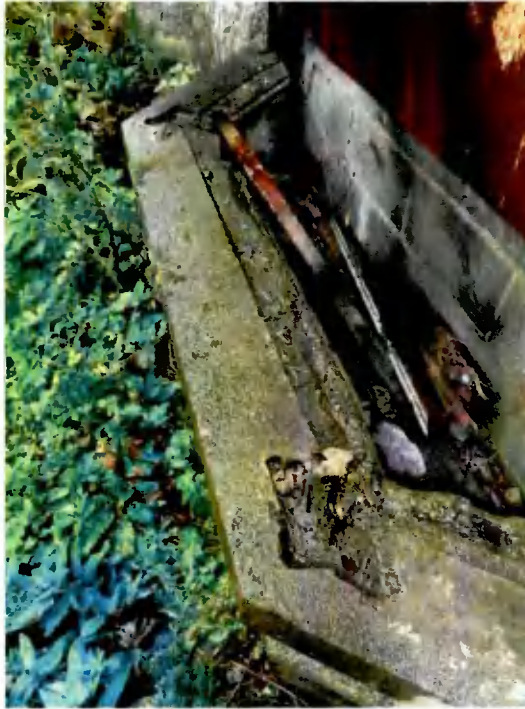
The bay windows shown in historic images are no longer extant. The parapet wall to the north side of room F indicates the position and profile of the external corner (Figure 35).

Figure 35: Bay window of room G05

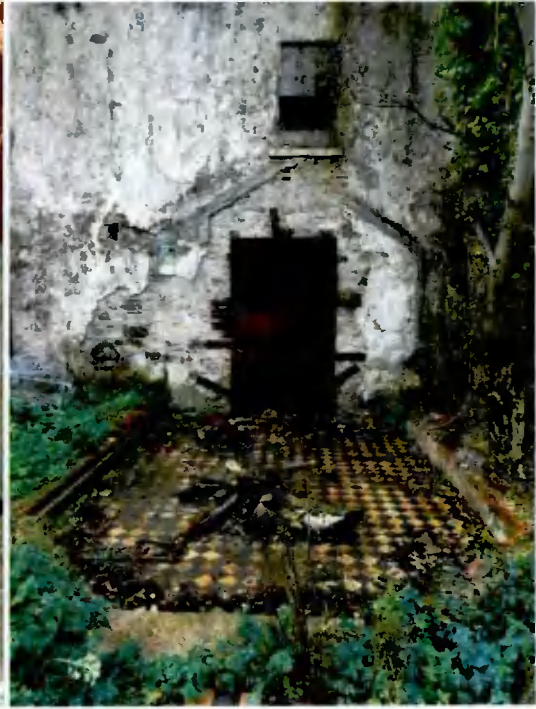
A clay tile floor and kicker wall remain to the former conservatory off G03. This has a large granite threshold to the former entrance at the south end of the conservatory (Figure 36).

Figure 36: Former conservatory beside room DG03

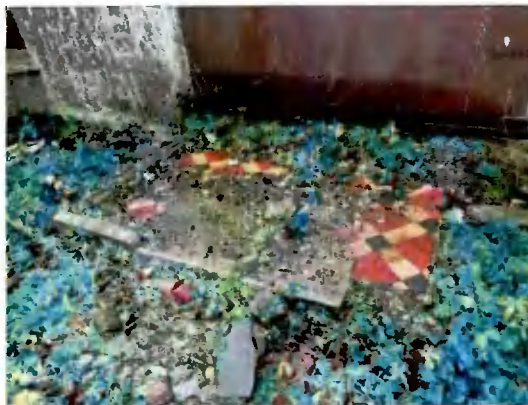
A similar tiled floor and stone threshold remains to the bay window of room G04 (Figure 37)

Figure 37: Floor of bay window in room G04

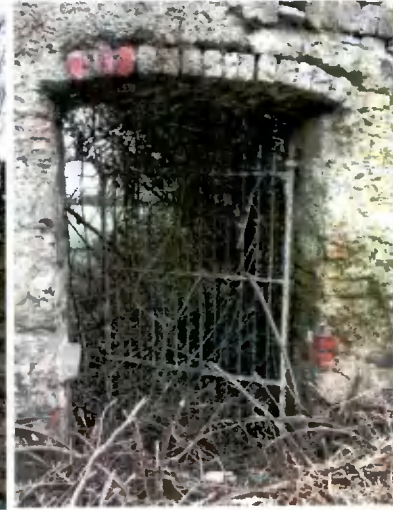
A number of low garden walls remain to the east and south of the house. These connect with tall walls directly to the east which may have been part of a walled garden. They are of rubble stone with some brick dressing. Cappings are of profiled render and slate. Some of the walls have a roughcast render coat. These are damaged and have collapsed in a few areas but are largely intact and stable.

Figure 43: Gate in walled garden wall

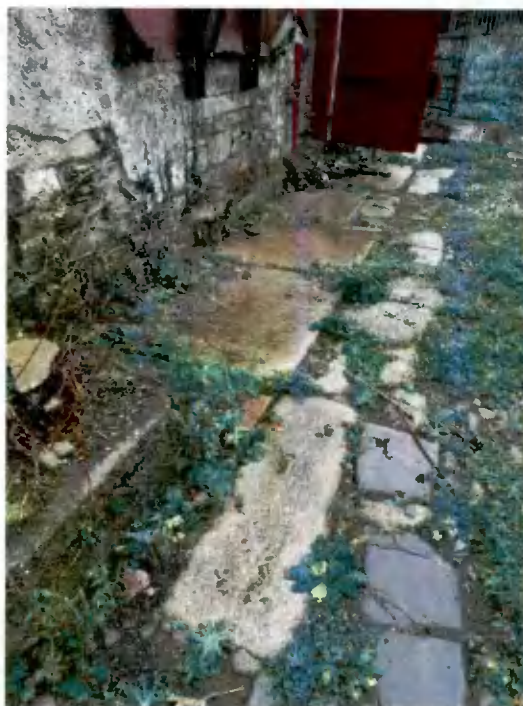
Fine granite and sandstone paving is to be found at the west side of the

house. This extends from the house a good distance to the north. Further investigation is required to map the extent of paving in the historic gardens.

*Figure 44: Stone paving at west side of house*

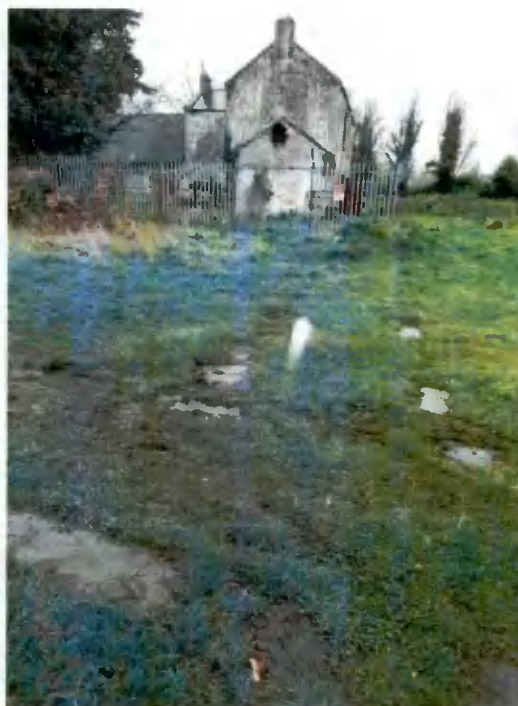
*Figure 45: Paving extending north of house*
