**BALLYROAN HOUSE
RATHFARNHAM
DUBLIN 14**

**ARCHITECTURAL HERITAGE
IMPACT ASSESSMENT**

24th June 2021

**Historic Building Consultants
Old Bawn
Old Connaught
Bray**

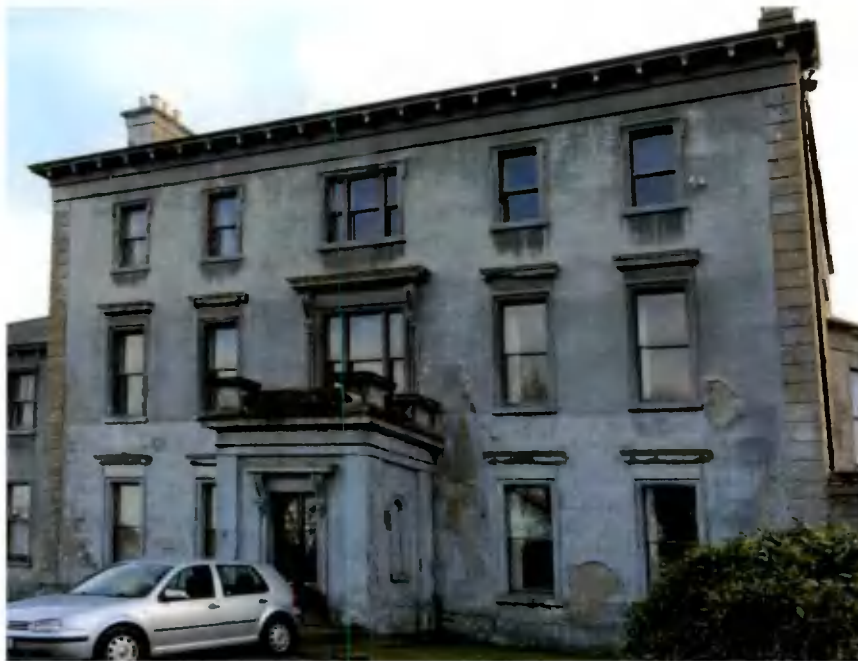
Plate 1: Ballyroan House, front elevation

Ballyroan House is a north-facing, three-storey, five-bay house with a two-storey, three-bay wing on the eastern side. The house is rendered with Roman cement, ruled, lined and painted and has parallel quoins. The windows have rendered architraves, those on the top floor being shouldered, while those at ground- and first-floor level have plain architraves and are surmounted by frieze and cornice. The frieze and cornice over the first-floor central window sits on a dentil moulding and is supported by decorative scroll brackets.

The windows are replacement one-over-one timber sliding sashes. In the centre of the first and second floors the windows are tripartite Wyatt windows with moulded-timber facings to the mullions.

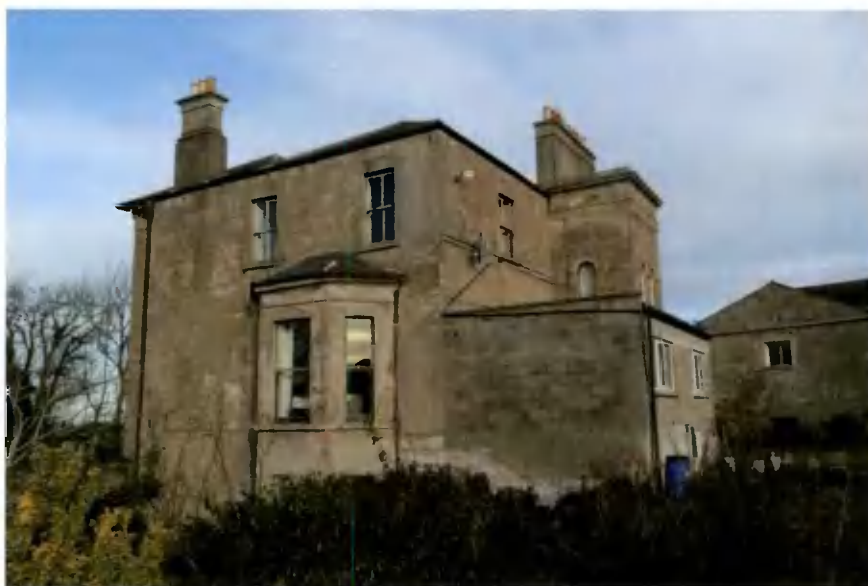
Plate 5: Western side elevation

The western side elevation is rendered, ruled and lined with Roman cement over a rubble-granite wall with brick at the linings of the windows and at the chimney. On the top floor are two two-over-two sash windows. At ground- and first-floor levels a canted bay projects, having one-over-one sashes on each face.

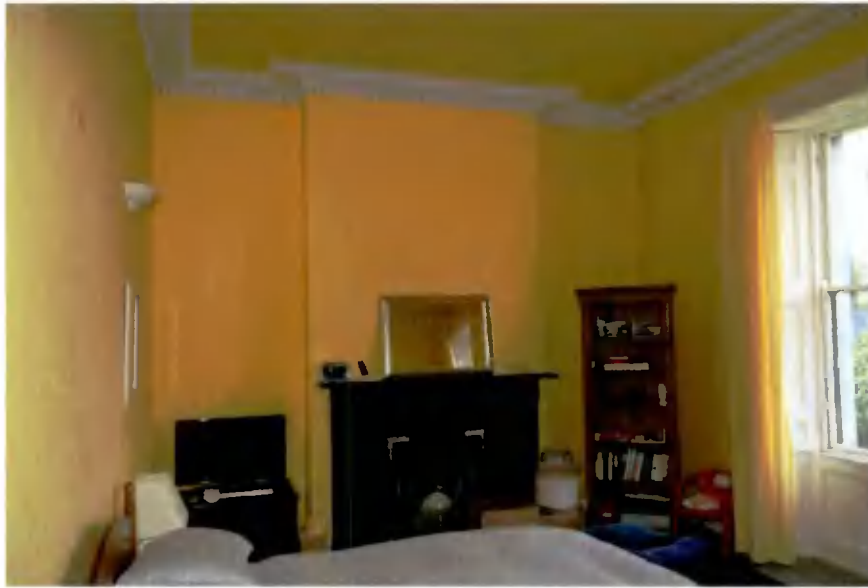
Plate 10: View to west in front bedroom

The room to the west of the entrance hall is entered from a lobby leading off the hall. It has a decorative cornice with key pattern and no centrepiece. A shallow chimneybreast has a black marble chimneypiece. The door is four-panelled and is set in a simple slender architrave. The window is a one-over-one timber sliding sash with concave horns and is set in a moulded-timber architrave with panelled shutters. The floor is boarded and carpeted.

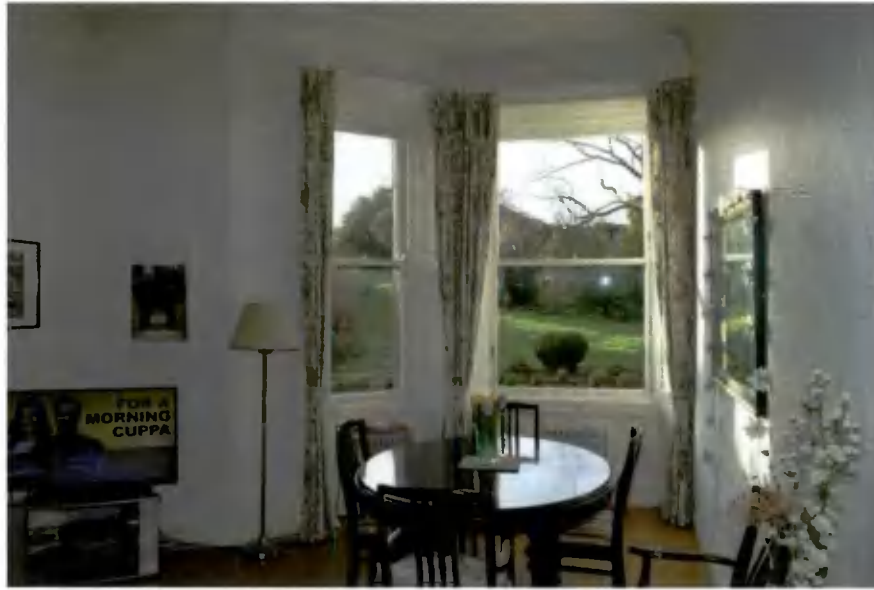
Plate 14: View to west in room G-5

Room G-5 is entered from the same lobby as rooms G-3 and G-4 via a four-panelled door set in a moulded-timber architrave. To the side of the door is a deep alcove that rises most of the height of the room. A substantial plain-run cornice runs around the entirety of the ceiling, including into the window bay. The room is lit by two windows in the canted bay on the western side of the house, each of which is a one-over-one timber sliding sash with concave horns, set in a moulded-timber architrave and with panelled shutters. The room is heated by a simple hearth with no chimneypiece.

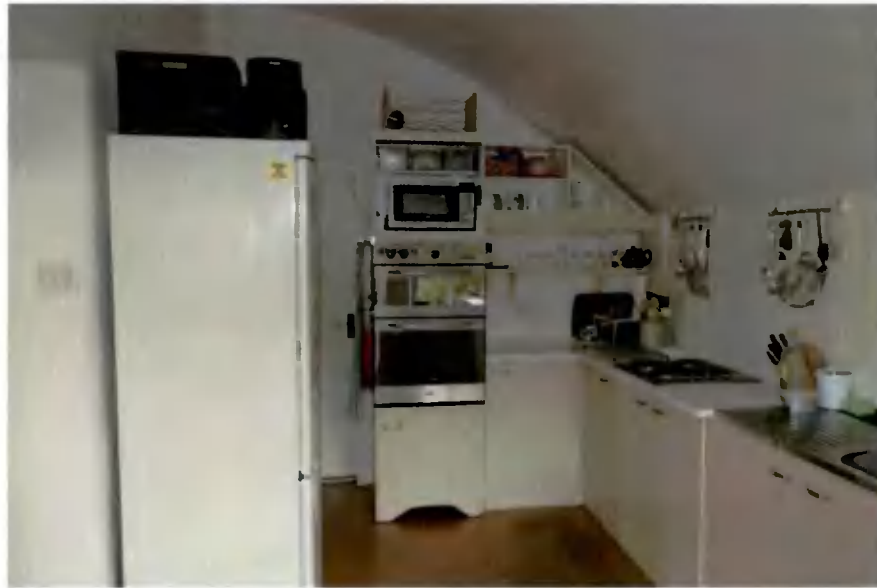
Plate 16: Eastern end of kitchen in room G-6

The kitchen in room G-6 is in the addition to the rear of the house. The ceiling curves towards the south. The room is lined with modern plaster and lit by a glazed door and a casement window, both of late date, in the western elevation. The fittings in the kitchen are of late twentieth century date and the floor has a covering of cork tiles. A hollow door at the eastern end of the kitchen leads to a lobby at room G-7

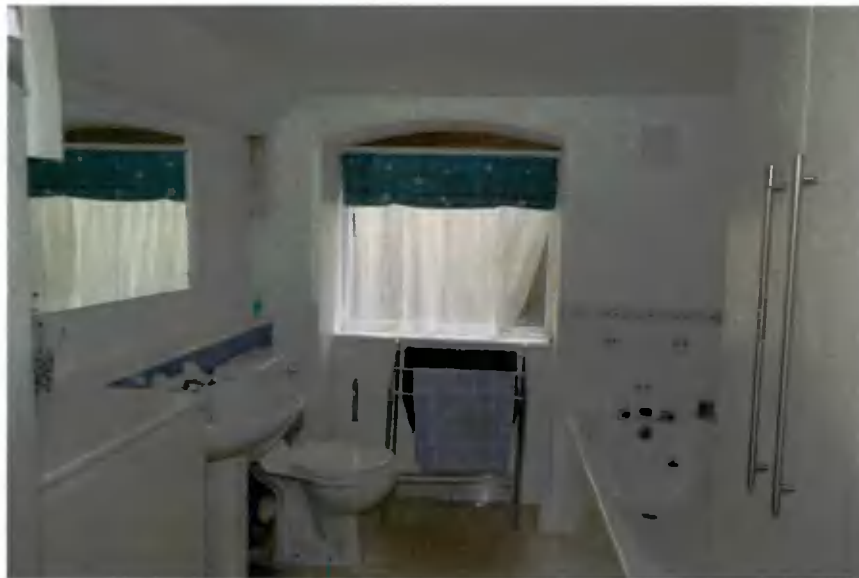
Plate 18: Eastern end of bathroom in room G-8

The bathroom is at the eastern end of the rear addition to the house and is entered via a lobby (room G-7) from the kitchen. The bathroom ceiling is flat, except for a short sloping section along the southern side. The doorway from the lobby is splayed.

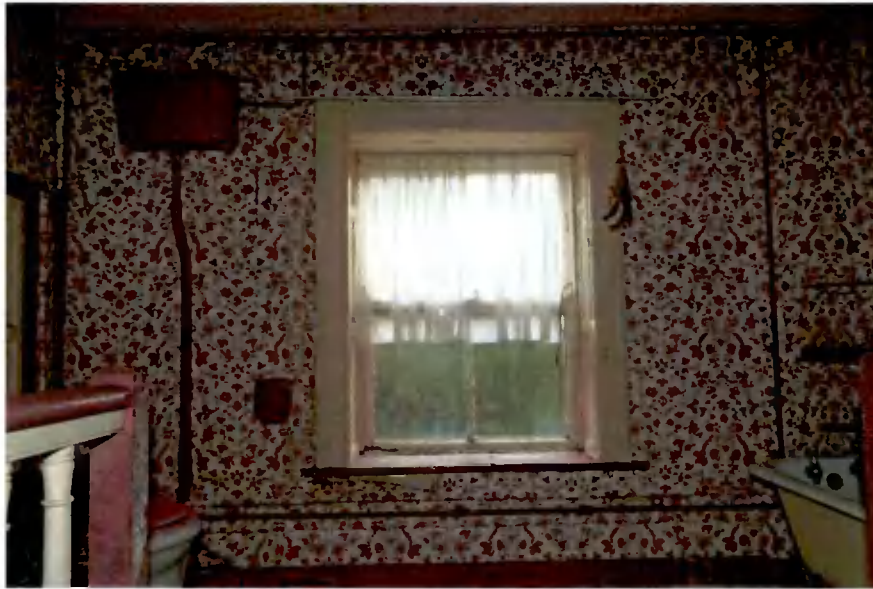
Plate 22: Bathroom in room G-10

Room G-10 is on the southern side of the corridor, at the rear of the original house. It seems likely that this room was subdivided to create the corridor when the eastern wing was built. The room is at a higher level than the corridor and within the doorway a flight of four steps leads up into the room. The door is five-panelled and set in a moulded-timber architrave. The room is lit by a two-over-two timber sliding sash with concave horns and with a moulded-timber architrave and panelled shutters. Two cupboards set into the eastern wall are likely to have been windows prior to the construction of the eastern wing.

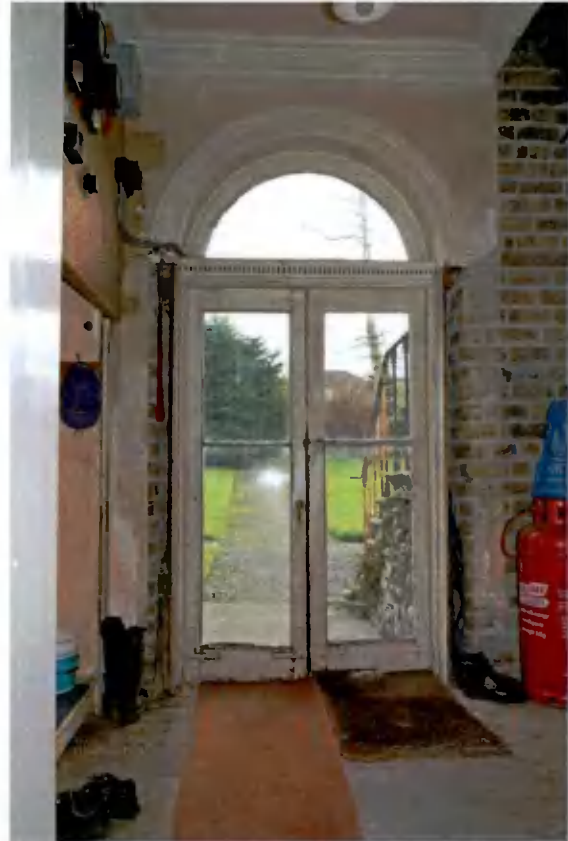
Plate 34: Mezzanine lobby

A mezzanine level above the ground floor, room F-2 is a lobby that gives access to the rear garden via a pair of glazed doors. The doorway has a plaster archivolt at the fanlight, but the architraves are missing. The plaster is missing from the western wall, except in a substantial round-headed niche. This reveals the brick construction of the lobby. There is a plain run cornice.

At mezzanine and first-floor level the staircase and rear lobby will be common circulation areas and there will be no interventions apart from the reinstatement of the missing plaster in the porch that was noted in the survey above and the removal of the partition at the top of the stairway.

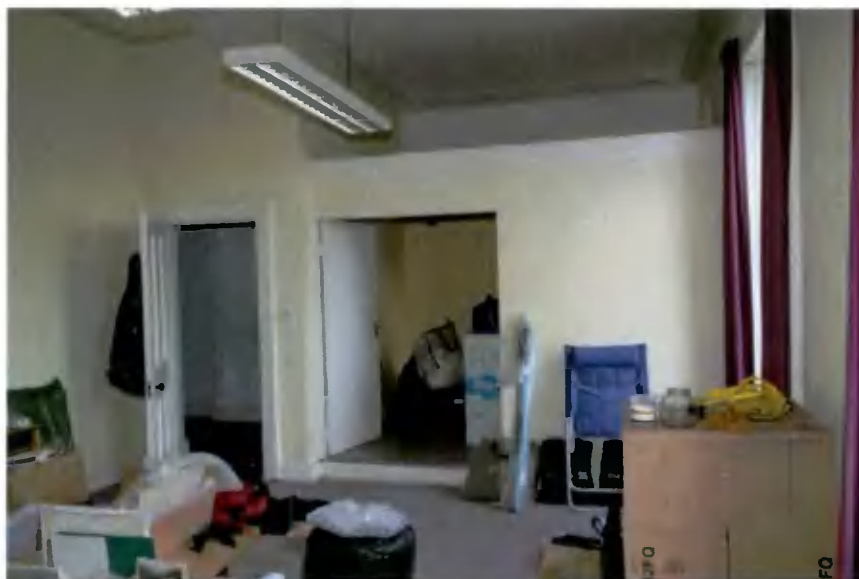
Plate 49: Western end of room F-10

Room F-11 is at the western end of this room and is partitioned off from this room by a partition that does not rise to the ceiling.

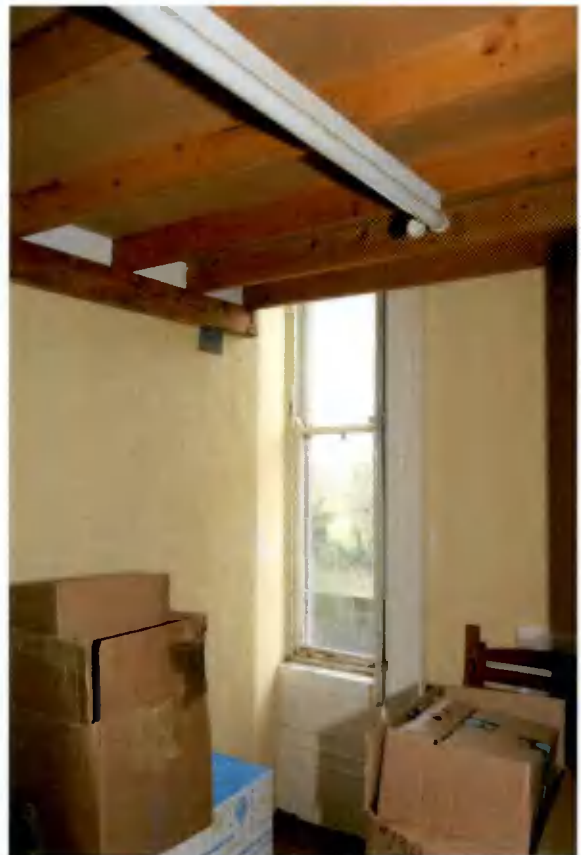
Plate 50: Window in room F-11

This room is lit by a narrow sash window that is the eastern part of the Wyatt window in the centre of the front elevation. The architrave and a shutter survive on the eastern side of the window.

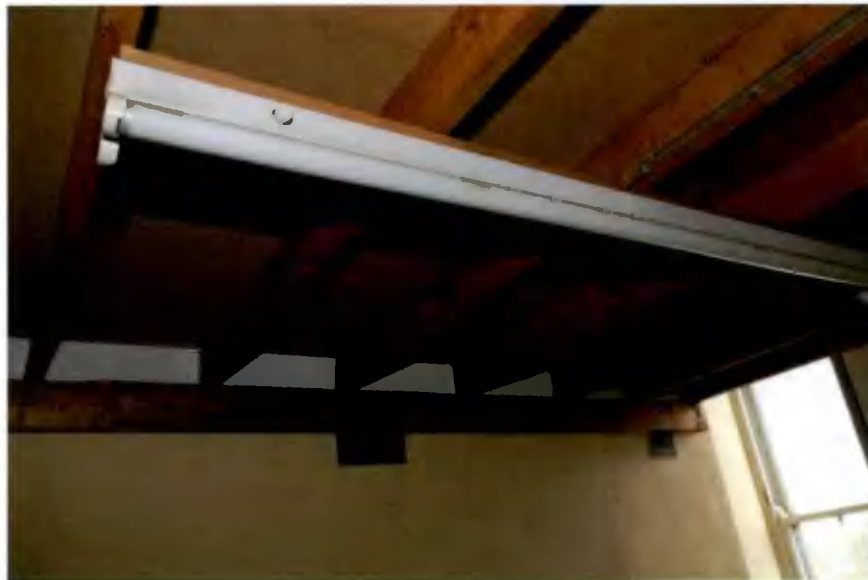
Plate 51: Ceiling in room F-11

As noted above, room F-11 is partitioned off from room F-10 by a low partition. It has its own ceiling, formed with varnished joists supporting a ceiling of chipboard.

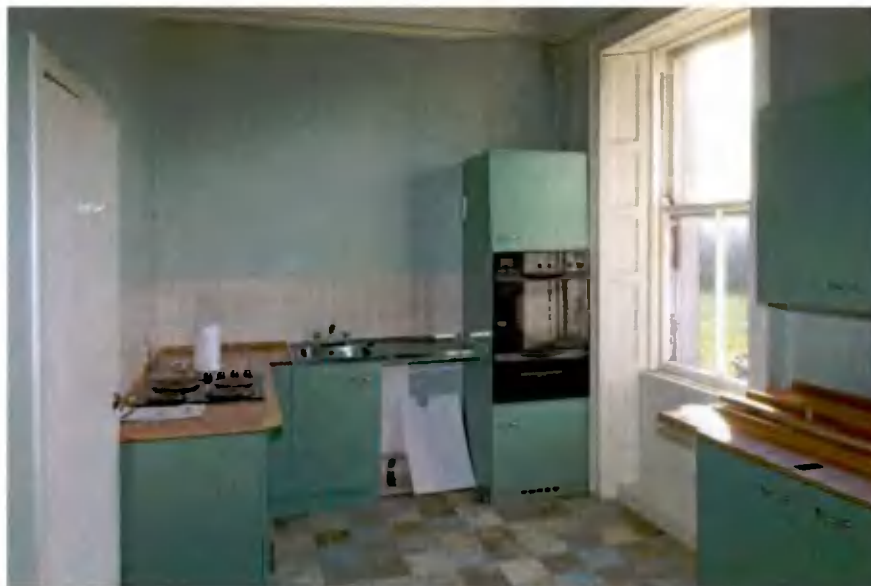
Plate 74: View to south in room S-6

Room S-6 is in the south-western corner of the second floor. It is entered via a modern hollow door, set in a simple narrow architrave, from room S-7 adjacent. A second door leads to room S-5 to the north and has been described above. The room has a plain run cornice and no centrepiece; The cornice stops at the eastern wall to room S-7, which is a later partition. The floor is boarded and varnished.

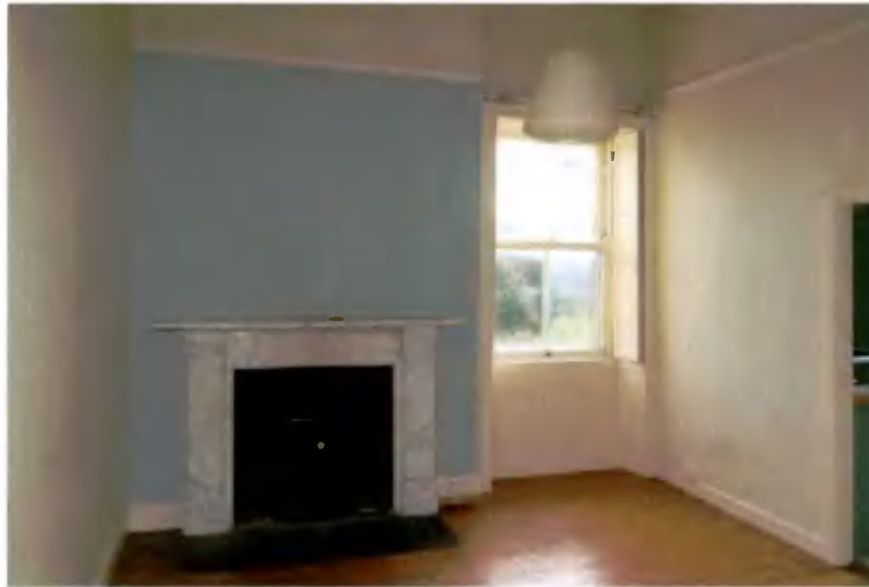
Plate 76: Southern wall in room S-7

Room S-7 is on the southern side of the second floor. It is entered via a four-panelled door set in a moulded-timber architrave. A second doorway leading to room S-6 has a modern panelled door set in a simple timber architrave. The room is lit by a two-over-two timber sliding sash with a moulded-timber architrave and panelled shutters. A chimneybreast at the southern end of the room has a veined marble chimneypiece of relatively late date, with a cast-iron insert. There is a plain run cornice on three sides of the ceiling, the side facing room S-6 not having a cornice. There is a picture rail.

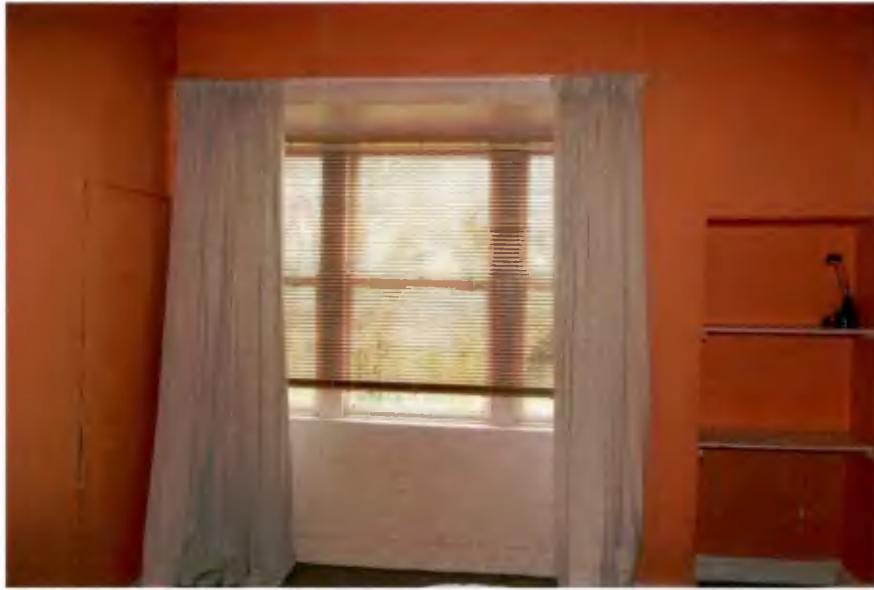
Plate 78: Window in northern wall of room S-8

Room F-8 is in the centre of the northern wall of the second floor. It is entered via a five-panelled door with raised and fielded panels and set in a shouldered timber architrave. The room is lit by a Wyatt window with concave horns and set in a moulded-timber architrave and with panelled shutters. A cornice runs around three sides of the room, the exception being the western wall.

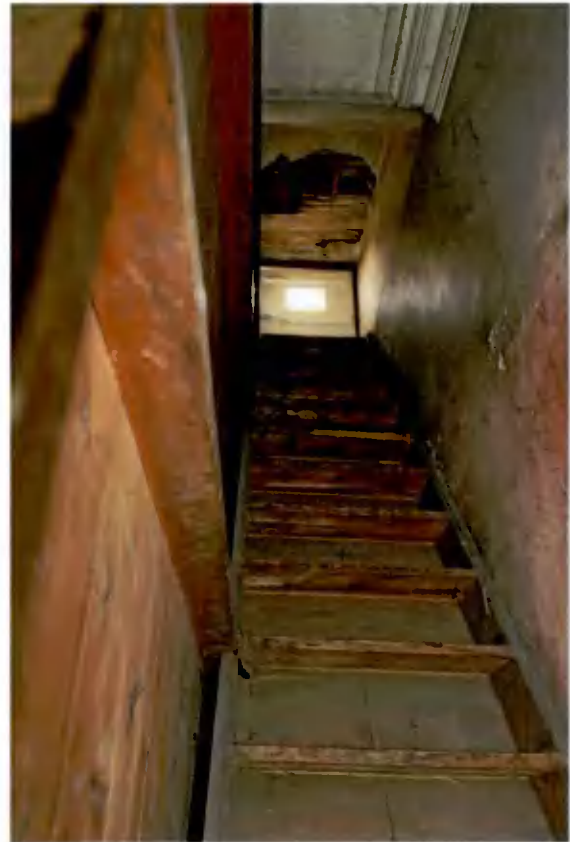
Plate 80: Stairs to attic

A concealed door in the western wall of room S-8 opens to a narrow flight of stairs leading to the attic. The partition wall has a timber frame on which timber boards are fixed. Above the stairs is a ceiling with a plain run cornice – this is the continuation of the cornice in room S-8, indicating that this staircase has been partitioned off from room S-8 at some time in the past.

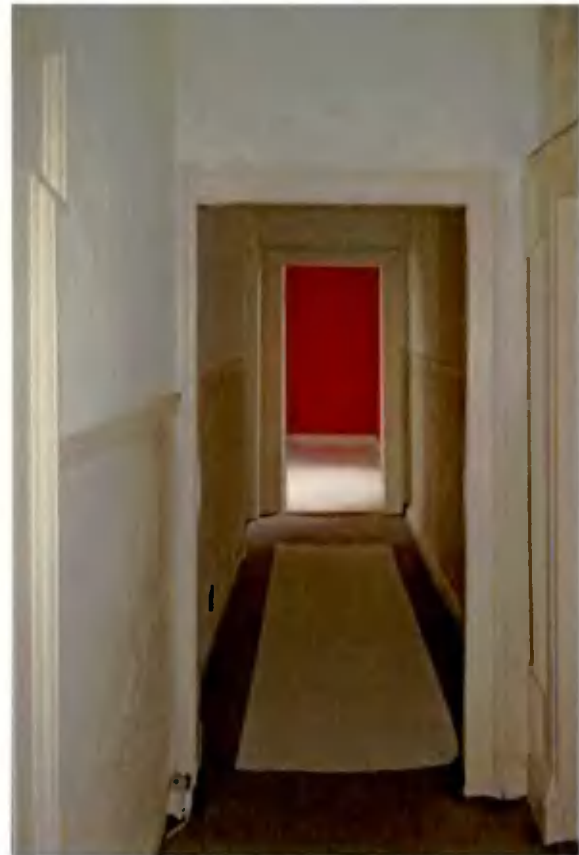
Plate 82: View eastward along corridor

The corridor leading eastward from the staircase has a number of doorways leading off it, some of which have shouldered architraves. A doorway part-way along the corridor, has an architrave that is shouldered on one side.

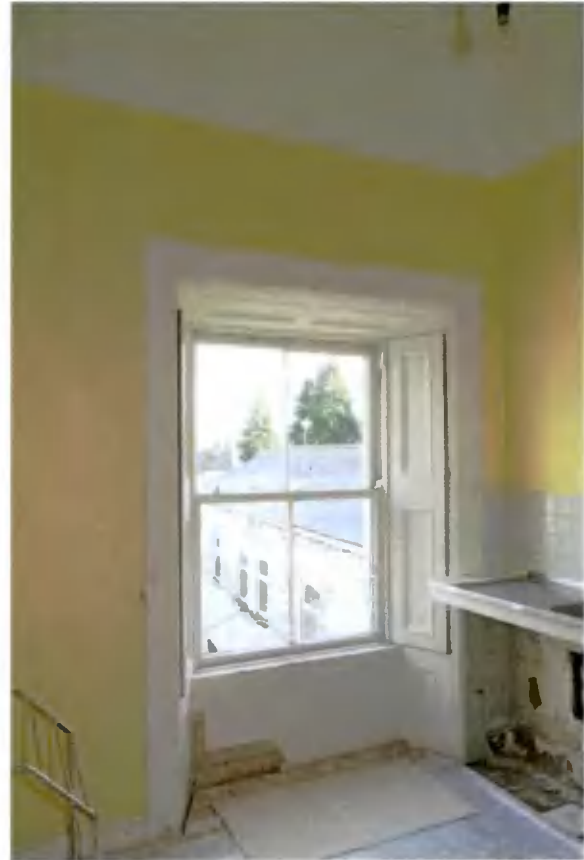
Plate 84: Window in room S-12

The room is entered via a five-panelled door with raised and fielded panels, set in a moulded-timber architrave. There is a plain run cornice. The room is lit by a two-over-two timber sliding sash window with concave horns, set in a moulded-timber architrave and with panelled shutters.

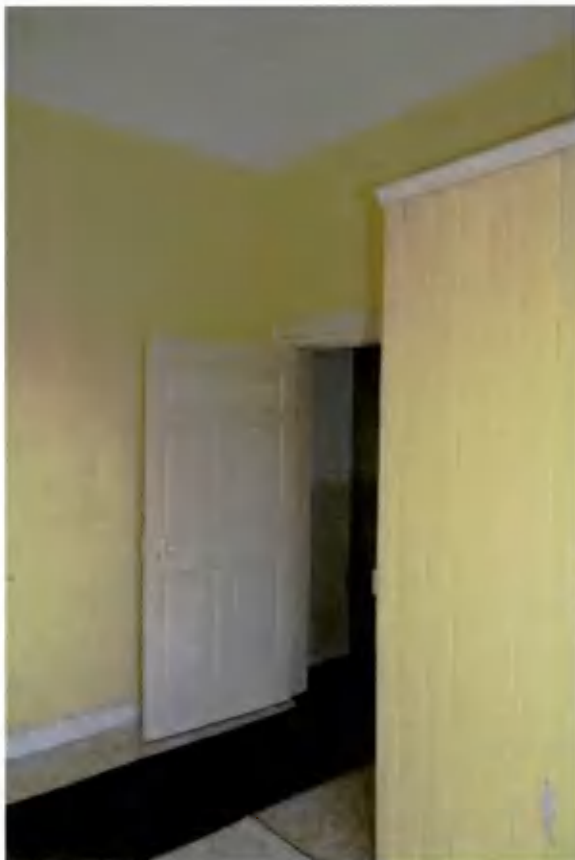
Plate 85: Doorway in room S-12

There is a corner chimneybreast in the south-western corner of the room and this has a mid-twentieth century concrete chimneypiece with a tiled surface.

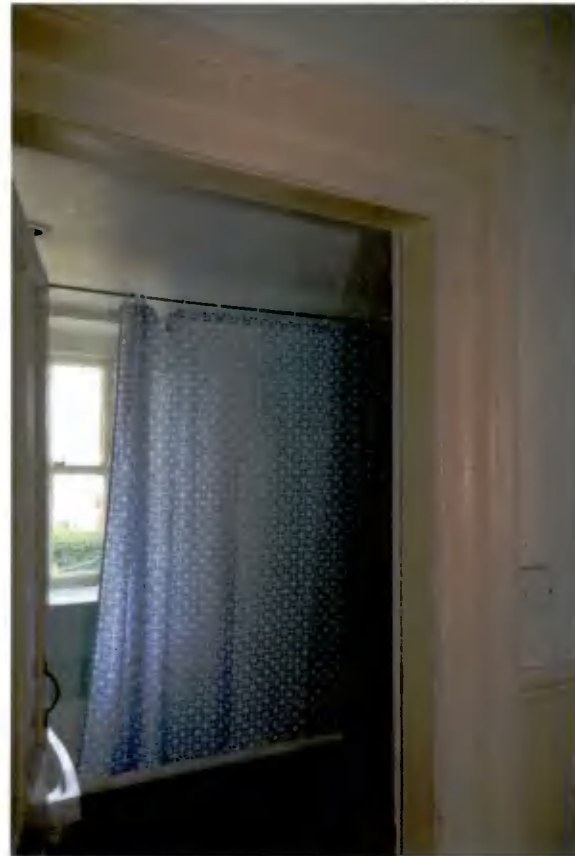
Plate 86: Doorway into bathroom

The bathroom is entered via a four-panelled door set in a moulded timber architrave. The bathroom is lit by a two-over-two timber sliding sash with concave horns and without shutters or architrave.

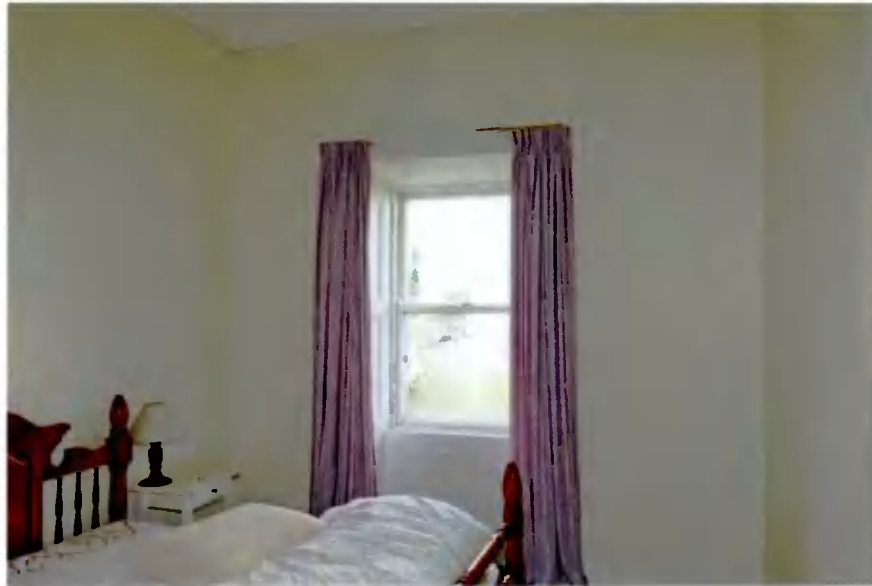
Plate 88: Northern wall of room S-14

Room S-14 is at the northern side of the corridor towards the eastern end of the house. This is a small room and is entered via a four-panelled door set in a moulded-timber architrave. The room is lit by a one-over-one timber sliding sash with concave horns, set in a moulded-timber architrave and with panelled shutters. A plain run cornice runs around two sides of the room, the exceptions being the eastern and southern walls, indicating that rooms S-14, S15 and the eastern end of the corridor were previously one single room.

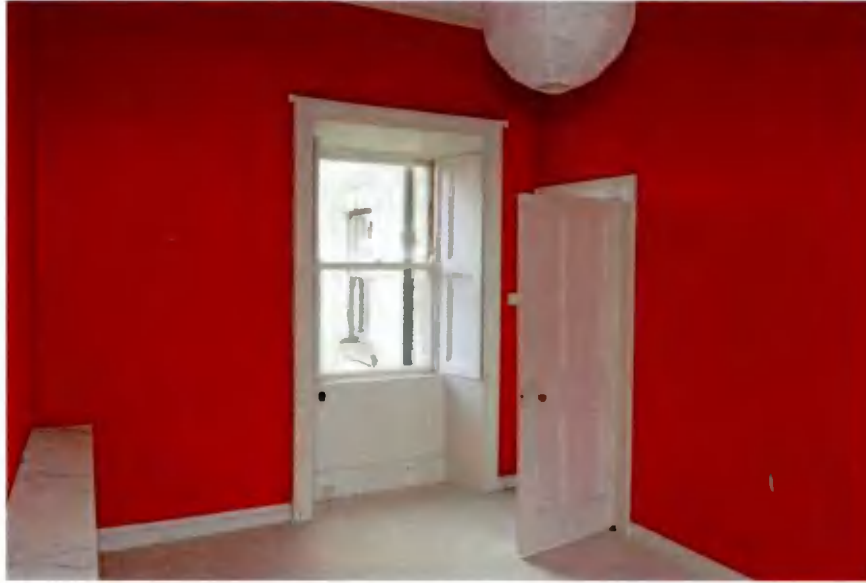
Plate 90: window at rear of room S-15

Room S-15 is at the eastern end of the second floor and is entered via a four-panelled door set in a moulded-timber architrave. The room is lit by a one-over-one timber sliding sash in the northern wall; this has concave horns, a moulded-timber architrave and no shutters.
