North (front) façade of Newbrook House from Taylor's Lane

## INTRODUCTION

This report has been prepared to accompany the planning application for a new care home at Taylor's Lane, Rathfarnham, Dublin 16, Co. Dublin, D16 N9C2, as Newbrook House sits within the site and is a protected structure. The house is recorded as Registration No. 11216028. The rating is "Regional". It is dated in the registration as 1820-1870, although other texts found state an earlier date.

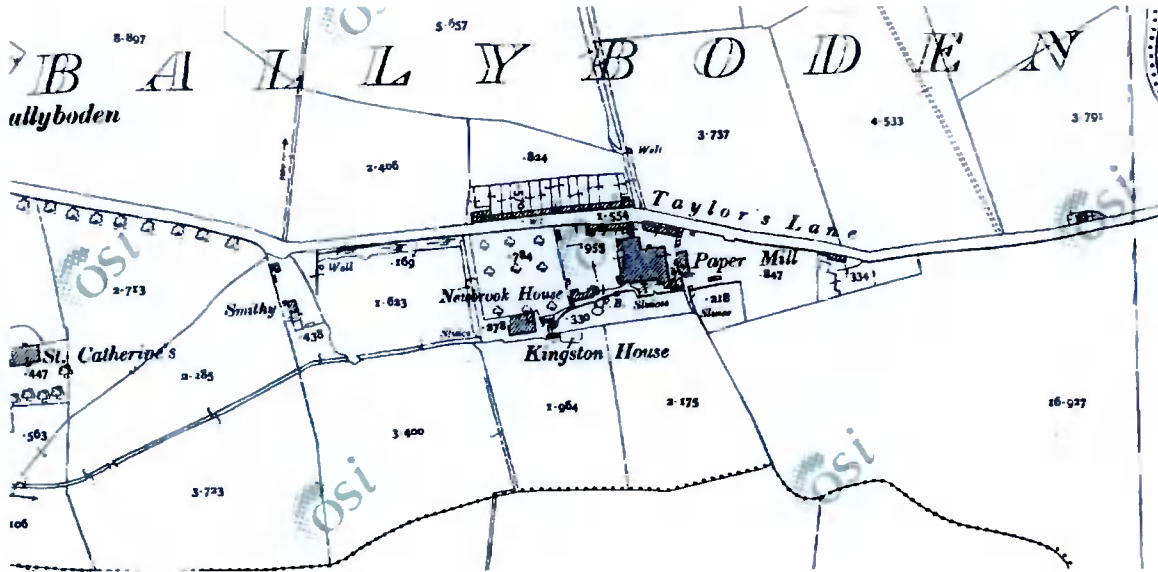
The building appears to have been extended to the west at some point as evidenced when comparing the footprint on the historic map with the current building. There is no visible evidence on the building itself to indicate that there has been an extension or where the extension line started.

Map showing the historic building with no curved bay, and no extension to the west.
