Arboricultural Report

**Tree Survey,
Arboricultural Impact Assessment &
Arboricultural Method Statement**

**Palmyra
Whitechurch Road
Rathfarnham
Dublin 16**

September 2020

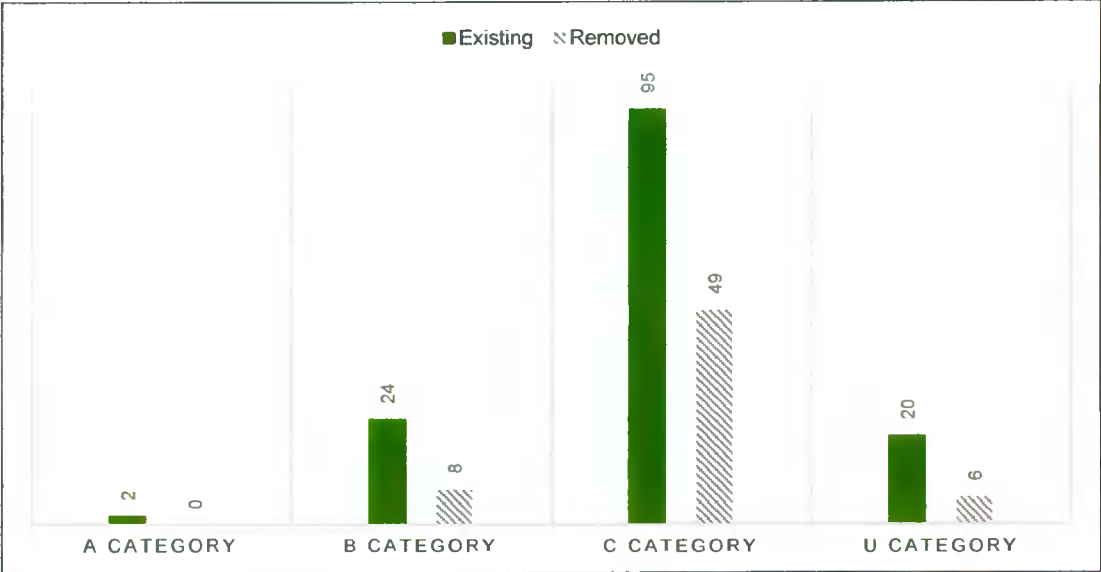
6.1 **Loss of trees** – The proposed development will require the removal of 58 trees, three groups of trees, and the part removal of two groups of trees. Of the 63 survey entries proposed to be removed or part removed, one group of trees and seven trees are of moderate quality and value (B Category), 45 trees and four groups of trees are of low quality and value (C Category), and six trees are of poor quality (U Category). A breakdown of the proposed tree removals according to their BS 5837:2012 category is outline in Figure 3. Details of the proposed removals are specified within the Tree Work Schedule at Appendix A and are highlighted on the Tree Removals Plan at Appendix B.

Figure 3: Breakdown of the tree removals required to facilitate the development in accordance with their BS Category.

- 6.4 The loss of trees will have an impact on the visual appearance and canopy cover of the immediate surrounding area. Replacement planting within the site will be required in order to help mitigate some of this tree loss and enhance the visual appearance of the development. Completely replacing the loss of trees within the application site will not be possible; however, there is an opportunity, under the guidance and consent of the Local Authority, to carry out sufficient new high-quality tree planting elsewhere within the surrounding local area. There are several green spaces located within the surrounding residential housing estates that could benefit from such new tree planting. This would help to replace the canopy cover that will be lost on site in the medium to long term and can have a positive visual and environmental impact on the wider local surrounding area.
