**Proposed works to:  
'WHITEHALL' - KATHARINE TYNAN HOUSE  
Kingswood, Dublin 24**

## **ARCHITECTURAL HERITAGE IMPACT ASSESSMENT REPORT**

**December 2021  
Revision A**

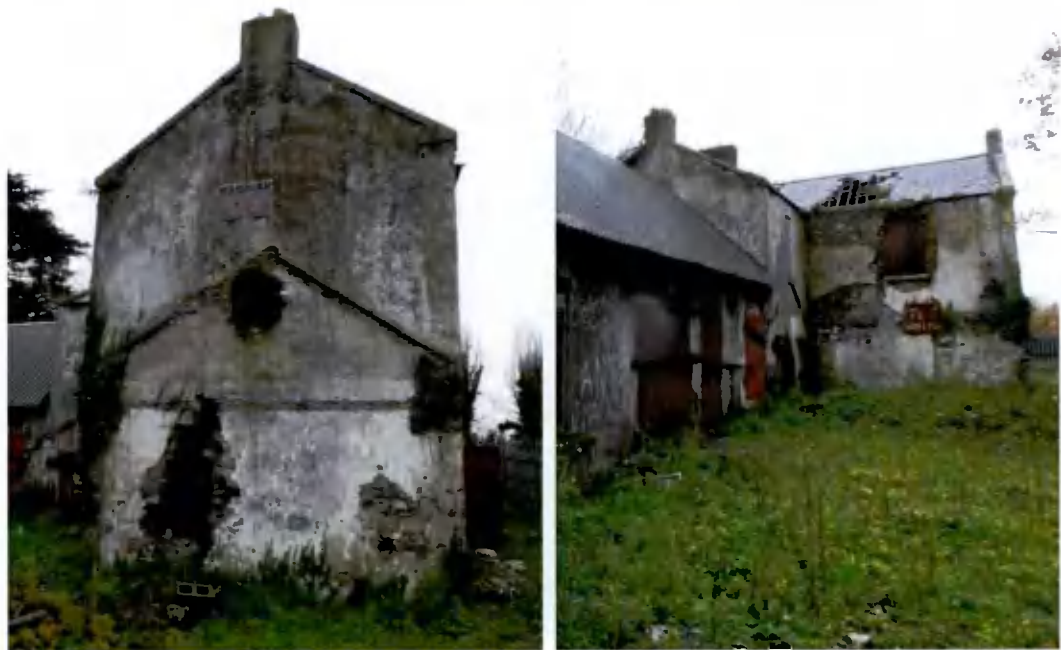
Figure 10: North gable with stone barge copings

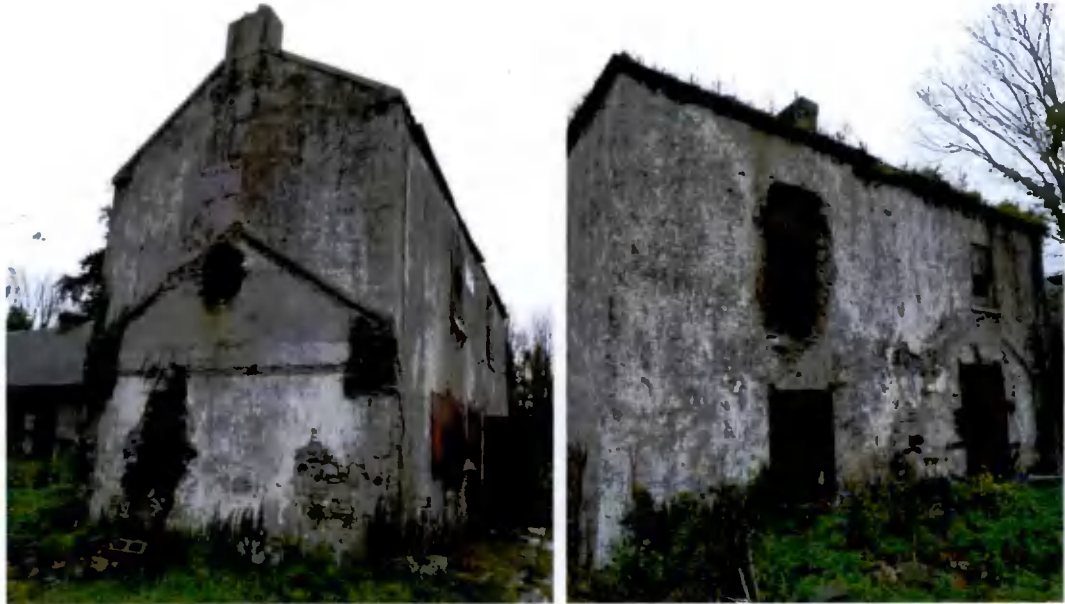
Figure 18: North and west sides of two-storey section    Figure 19: South elevation

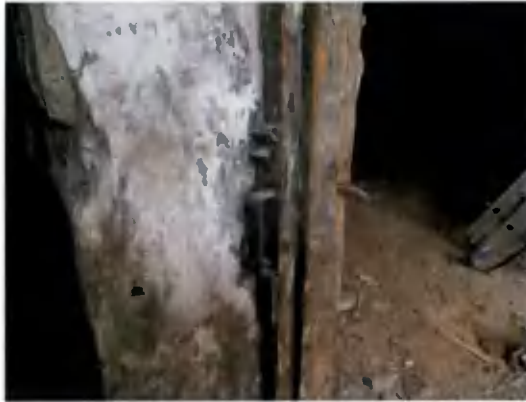
These have been removed throughout the house. Internally there are some remains of internal timber door frames to rooms G03 and G01 (Fig. 32 & 33).

Figure 31: Door frame in room G01

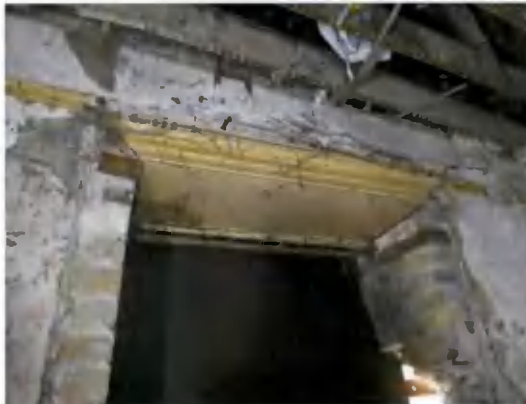
Figure 33: Timber lining to window in room G03

There are remains of internal timber linings in some window openings (Figure 33 & 34).

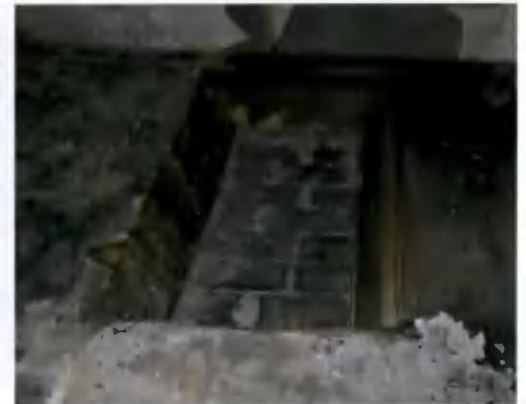
Figure 34: Timber lining to window in room 102

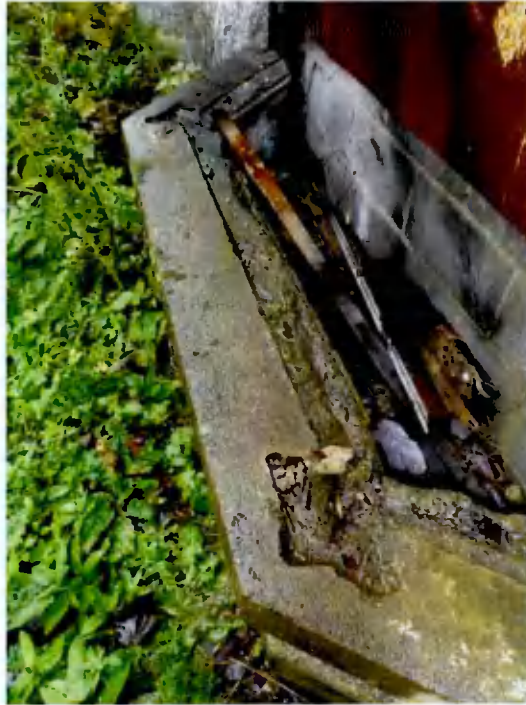
The bay windows shown in historic images are no longer extant. The parapet wall to the north side of room G05 indicates the position and profile of the external corner (Figure 35).

Figure 35: Bay window of room G05

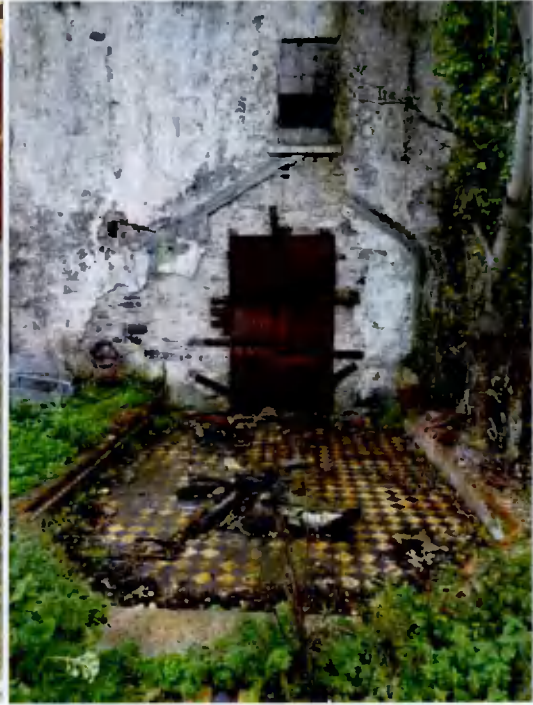
A clay tile floor and kicker wall remain to the former conservatory off G03. This has a large granite threshold to the former entrance at the south end of the conservatory (Figure 36).

Figure 36: Former conservatory beside room DG03

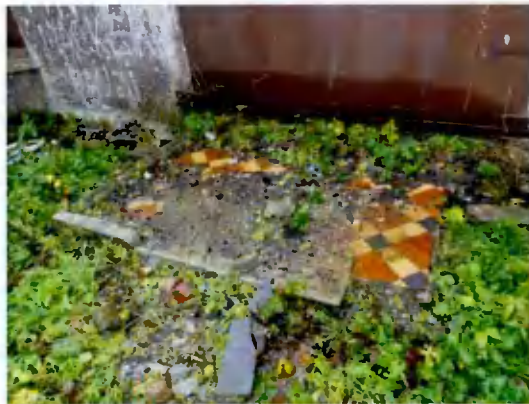
A similar tiled floor and stone threshold remains to the bay window of room G04 (Figure 37)

Figure 37: Floor of bay window in room G04

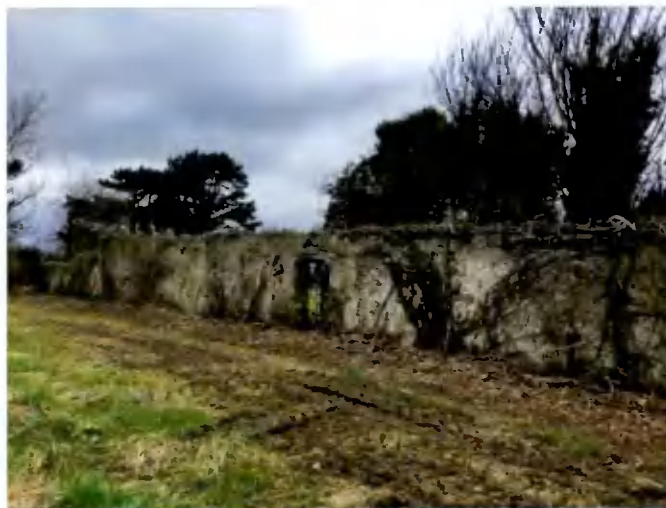
A number of low garden walls remain to the east and south of the house. These connect with tall walls directly to the east which may have been part of a walled garden. They are of rubble stone with some brick dressing. Cappings are of profiled render and slate. Some of the walls have a roughcast render coat. These are damaged and have collapsed in a few areas but are largely intact and stable.

Figure 42: Walled garden east of house
