This report has been prepared to accompany the planning application for a new care home at Taylor's Lane, Rathfarnham, Dublin 16, Co. Dublin, D16 H3V2, as Newbrook House sits within the site and is a protected structure. The house is recorded as Registration No. 11216028. The rating is "Regional". It is dated in the registration as 1820-1870, although other texts found state an earlier date.

Condition Report

Scope of Works

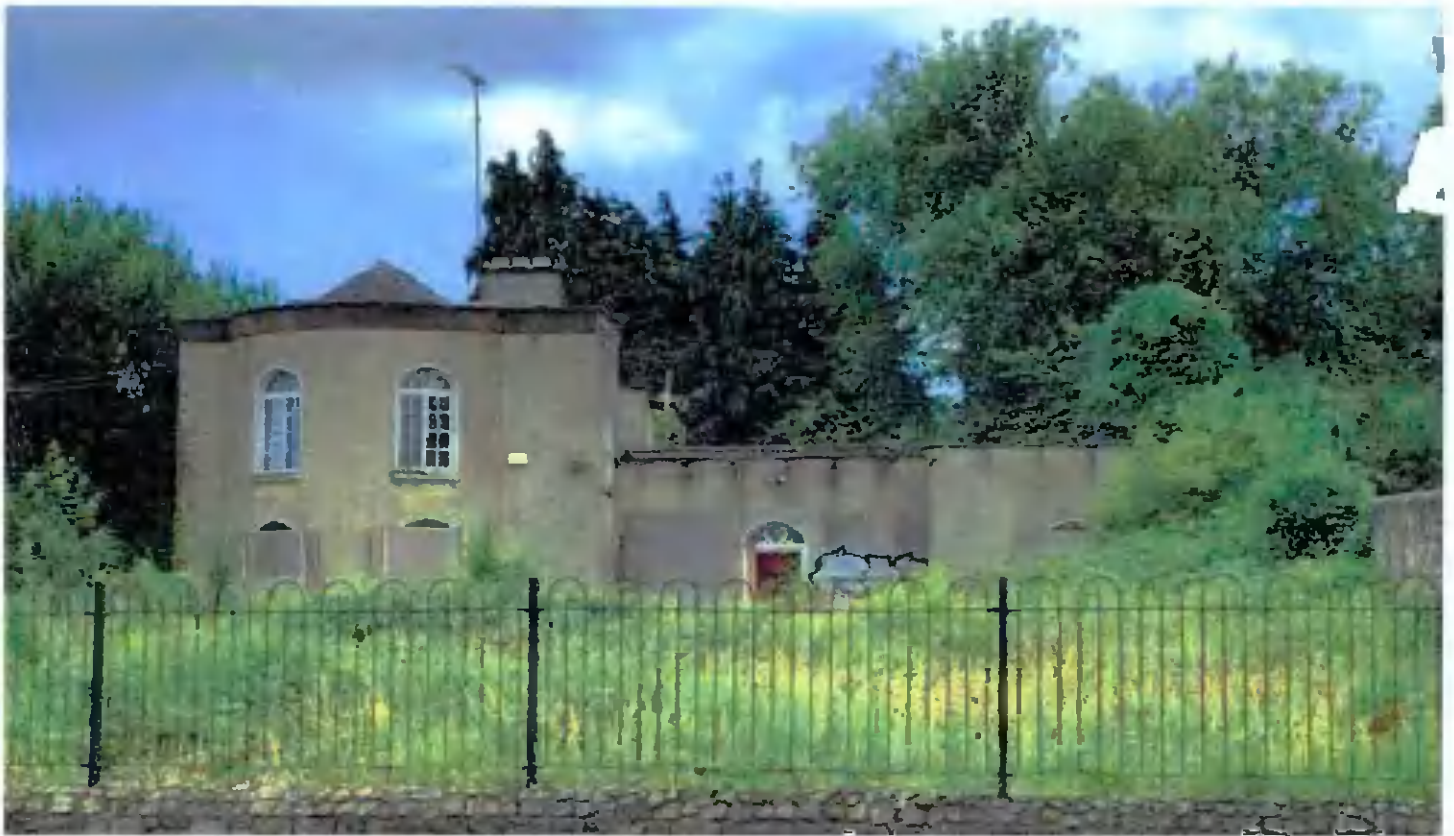
North (front) façade of Newbrook House from Taylor's Lane

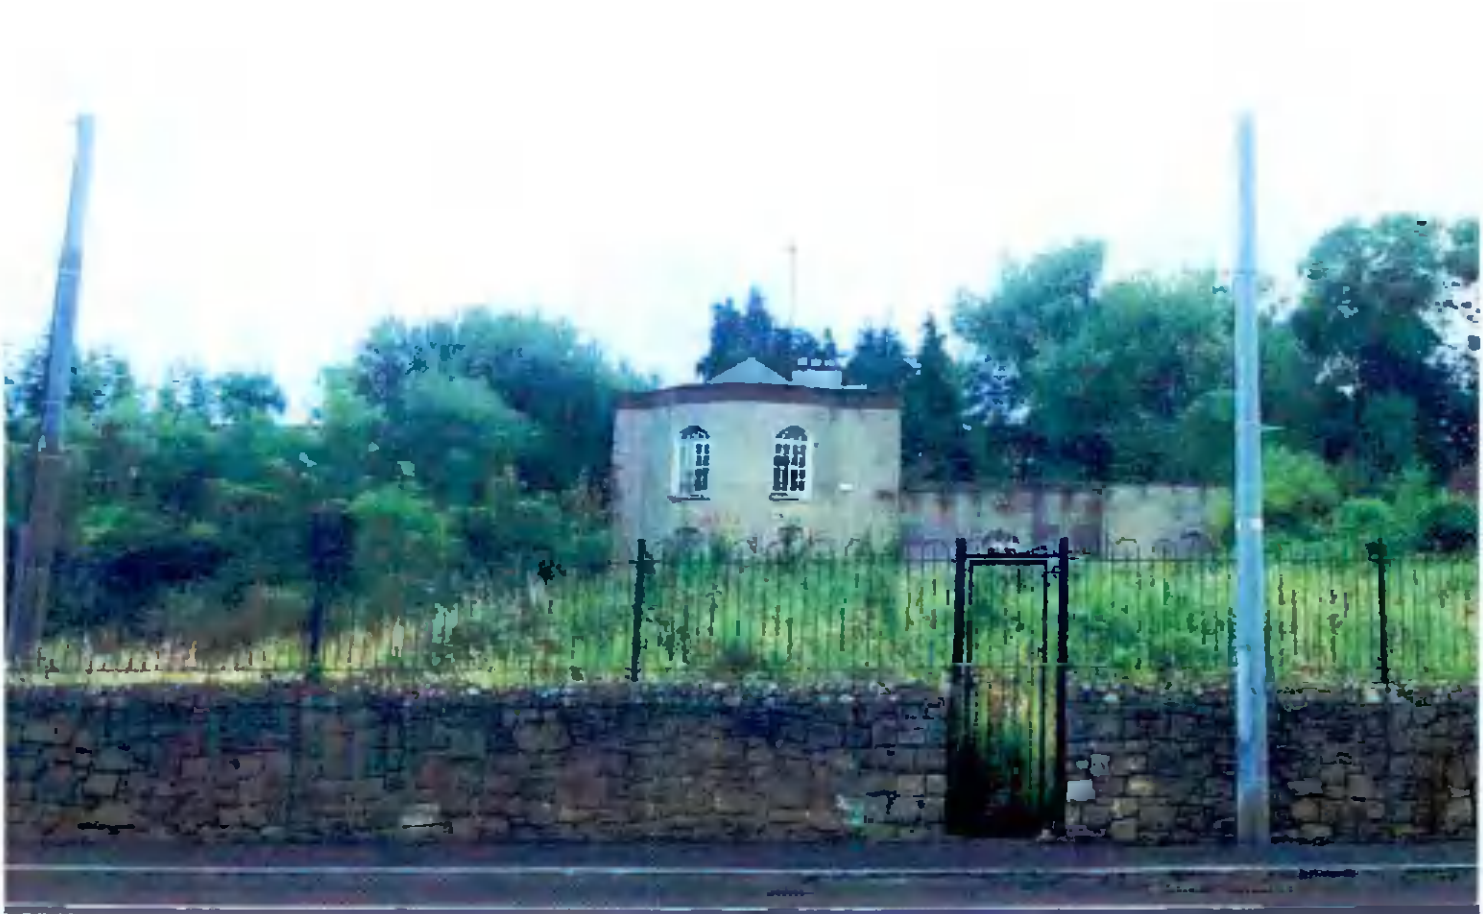
Eye level view of Newbrook House from Taylor's Lane - note scrubland in front of house

Firstly, the vegetation is to be removed from the building and all the scrubland removed from the front of the building so that the rather austere Georgian beauty of Newbrook House is revealed. Nothing is to be built in front of the house so that it is clearly visible from Taylor's Lane.
