Arborist Associates Ltd.

An Arboricultural Assessment on the Site Area for the 'Edmondstown SHD Application', Whitechurch Road, Rathfarnham, Dublin 16.

Prepared for: BCDK Holdings Ltd. & Coill Avon Ltd.

Date: 10th December 2021

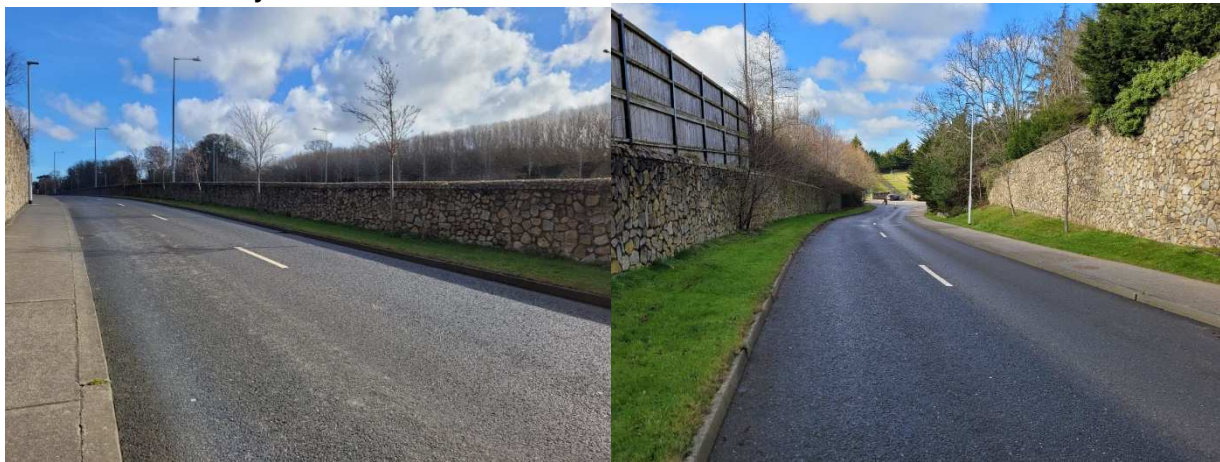
<p>It consists of a line of trees, I suspect initially planted at regular intervals into the grass verge along the boundary wall to the M50 Motorway. But, some of the trees have failed or have been removed, creating wider spacing between some trees. While there are signs of some replacement planting, with planting stakes and ties present, there are quite large gaps between some of the trees.</p> <p>The following trees are located along this tree line.</p>									Remove or adjust planting stakes and ties where present.	They will require repeat pruning to maintain clearance over the surrounding surface and structures.	C1

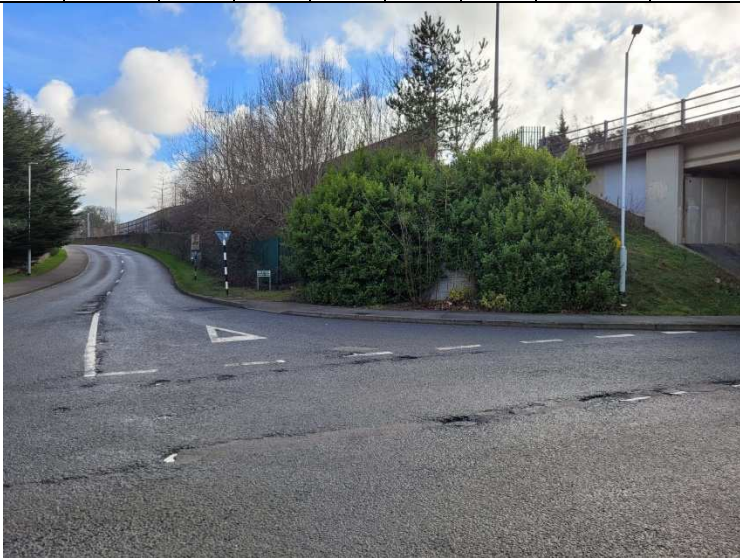
<p>It consists of a number of standard trees under-planted with large shrubs, planted on a steep embankment to a motorway bridge.</p> <p>The following trees are located within this tree group.</p>									undergrowth, to reduce density and allow trees better quality space to develop.			The undergrowth would also benefit from cutting back, to tidy and open up the area under the trees, reducing competition.
Tree Nos. 33 & 34	Rowan <i>Sorbus aucuparia</i> (2 trees)	A. 3.5	A.80	A1	A1	A1	A1	A 1.8	Young	Fair	Fair Originally a short line of three trees, the central tree has failed. The planting stakes and ties are still attached.	Adjust / remove tree ties and stakes as appropriate.	10-20	C1

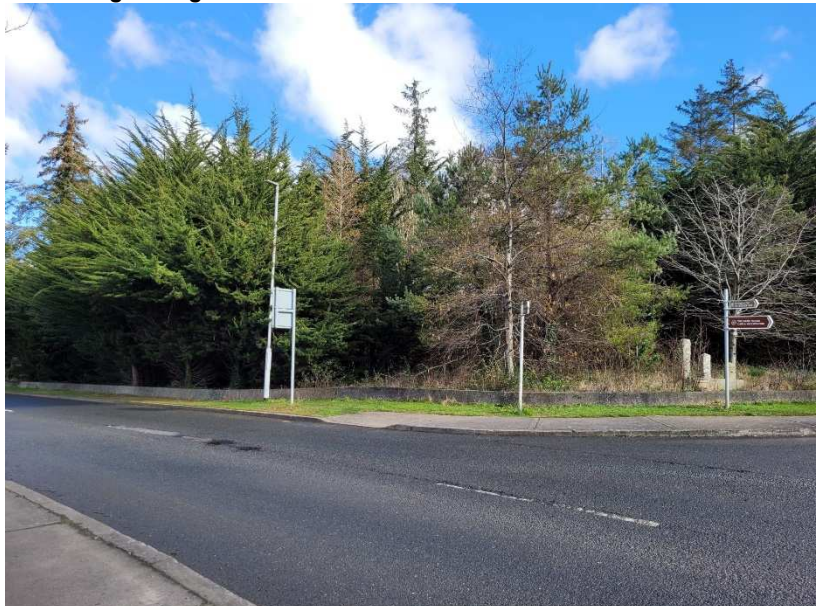
Tree No.	Tree Species	Ht. (m)	Stem Dia. (mm)	Branch Spread (m)				C-Ht. (m)	Age Class	Phys Con.	Structural Condition Other Comments	Preliminary Recommendation	Remain Contribute in years	Cat. Grade
				N	S	E	W							
				N	S	E	W				N=North S=South E=East W= West Phys Con. = Physiological Condition.	A= Average C-Ht= Crown Height		
		<p>The planting is located behind a low concrete wall and consists of a mix of tree species planted at close centers. They have grown up together and share a group canopy formation, providing support and shelter to one another. Bramble and Ivy have established as an understorey. Sycamore and Alder seedlings are developing near the edges of the group. Collectively, they form an attractive landscape feature at this location.</p> <p>The following trees form part of the outer canopy edge, bordering with the road.</p>												
Tree No. 39	Scots Pine <i>Pinus sylvestris</i>	6	230	0	2	3	3	0	Semi Mature	Fair	Fair It has been drawn up and out to the south for light due to competition from larger trees to the north, affecting structure. There is some bark wounding to the main stem.	Tidy up around the base. I would consider it for removal , as part of selective thinning of the group.	10+	C2
