The scope of this CCTV Survey / Investigation to determine no Surface Water enters the existing 900mm diameter Culvert with the demise of the site development denoted as Point E below from the existing Old Mill Drainage Channel flowing from west to east through Points A, B and E:-

Project Name: douglas and stewart con23198

Project Date: 4/19/2022

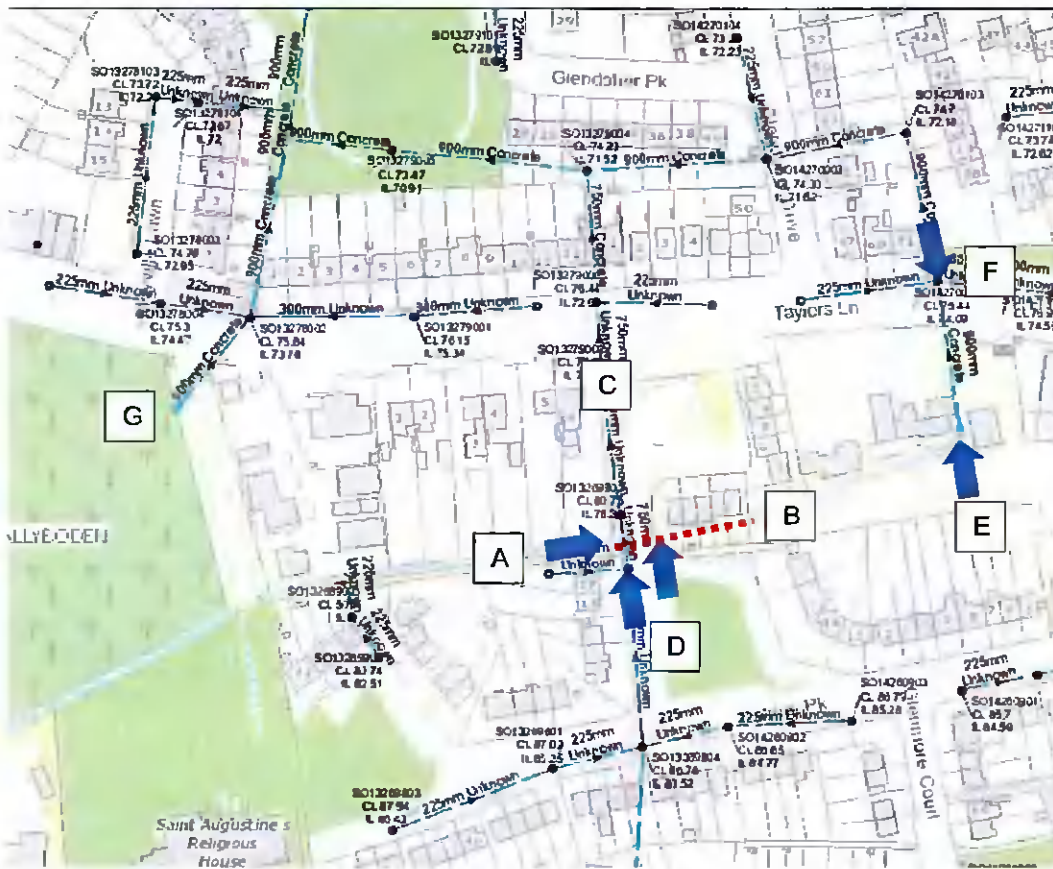
- Verify route / connection / blockages from points A – B (We believe the existing drainage channel has been divert to existing 750mm diameter culvert below Palmer Street flowing towards point C).
- Examine Surface water route from Point A (in stream) to Point C
- Verify Surface water routes by lifting manholes on Palmers Park at Point D towards point C.
- Verify existing Surface water routes by lifting manholes on Taylor Lane east and west of Point F.
- CCTV Survey of existing 900mm diameter Surface water Culvert from Point F to Point E.
- Verify existing Surface water routes by lifting manholes on Taylor Lane east and west of Point G.

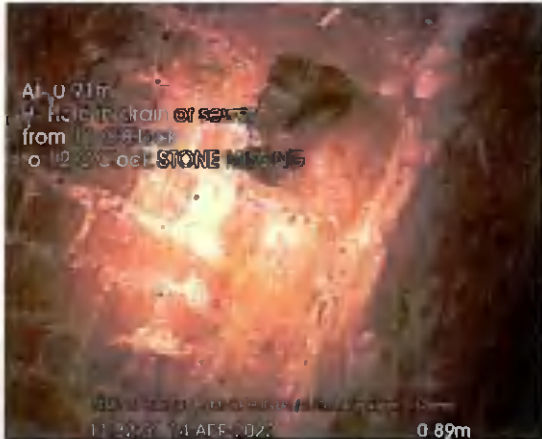
0.89	H	Hole in drain or sewer from 11 o'clock to 12 o'clock: STONE MISSING	00:00:45		
	1.29	REM	General remark: STONE NOT MISSING INLET COMING	00:00:55

START OF CULVERT US TO END_0-89m_113251.jpg,
00:00:45, 0.89 m
Hole in drain or sewer from 11 o'clock to 12 o'clock, STONE

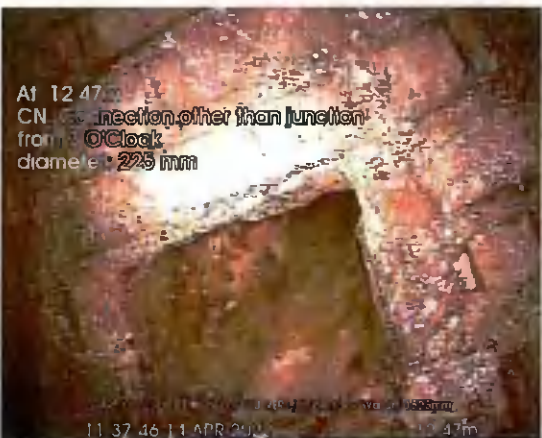
START OF CULVERT US TO END_12-47m_113746.jpg,
00:04:26, 12.47 m
Connection other than junction at 3 o'clock, 225mm dia

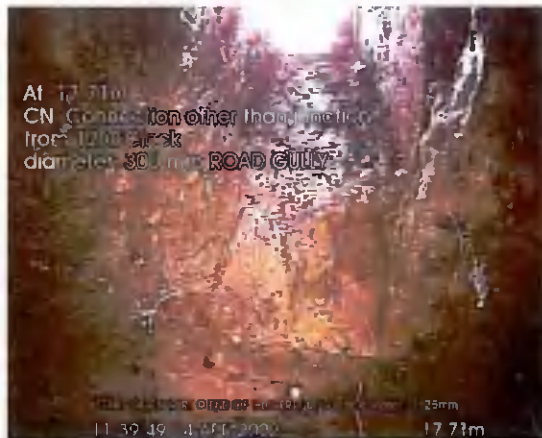
START OF CULVERT US TO END_17-71m_113949.jpg,
00:05:31, 17.71 m
Connection other than junction at 12 o'clock, 300mm dia,

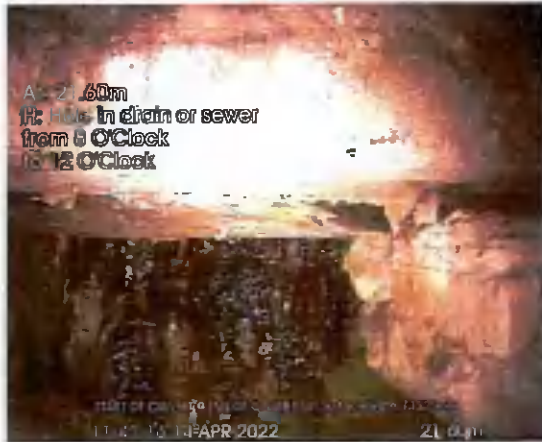
START OF CULVERT US TO END_21-60m_114116.jpg,
00:06:32, 21.60 m
Hole in drain or sewer from 8 o'clock to 12 o'clock

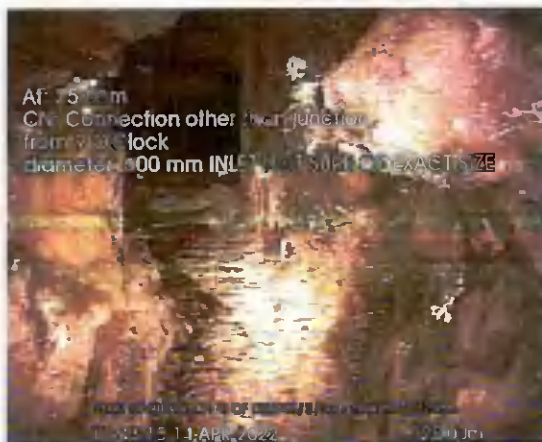
START OF CULVERT US TO END_25-00m_114315.jpg,
00:07:29, 25.00 m
Connection other than junction at 9 o'clock, 300mm dia, INLET

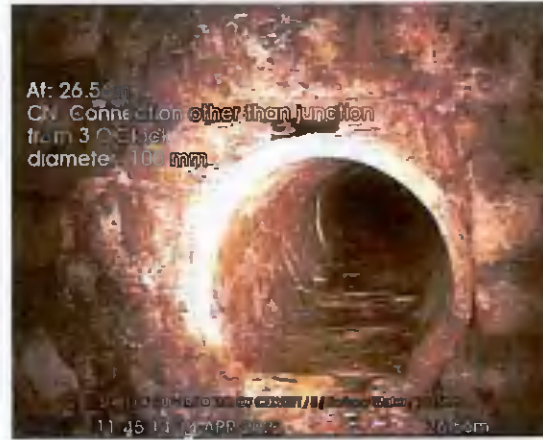
START OF CULVERT US TO END_26-56m_114514.jpg,
00:08:22, 26.56 m
Connection other than junction at 3 o'clock, 100mm dia

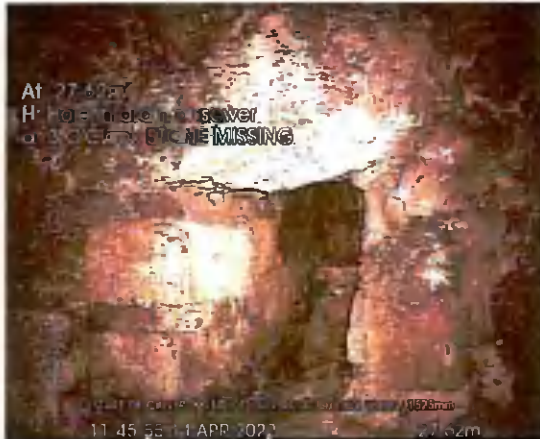
Scale:	1:235	Position [m]	Code	Observation	MPEG	Photo	Grade		
<p>END OF CULVERT</p> <p>Depth: m</p>	27.62	H	Hole in drain or sewer at 3 o'clock: STONE MISSING	00:08:44					
	27.62	H	Hole in drain or sewer at 5 o'clock: STONE MISSING	00:08:49					
	27.70	H	Hole in drain or sewer at 9 o'clock: STONE MISSING	00:09:01					
	27.70	H	Hole in drain or sewer at 7 o'clock: STONE MISSING	00:09:10					
	29.08	CN	Connection other than junction at 11 o'clock, 100mm dia	00:09:25					
	29.14	H	Hole in drain or sewer at 7 o'clock: STONE MISSING	00:09:32					
	32.27	REM	General remark: ROCK ON THE SIDES BUILD UP SCALE	00:10:16					
	36.77	MHF	Finish node, manhole, reference: END OF CULVERT: END OF CULVERT CAGED	00:11:17					
STR No. Def	STR Peak	STR Mean	STR Total	STR Grade	SER No. Def	SER Peak	SER Mean	SER Total	SER Grade
0	0.0	0.0	0.0	1.0	0	0.0	0.0	0.0	1.0

START OF CULVERT US TO END_27-62m_114555.jpg,
00:08:44, 27.62 m
Hole in drain or sewer at 3 o'clock, STONE MISSING

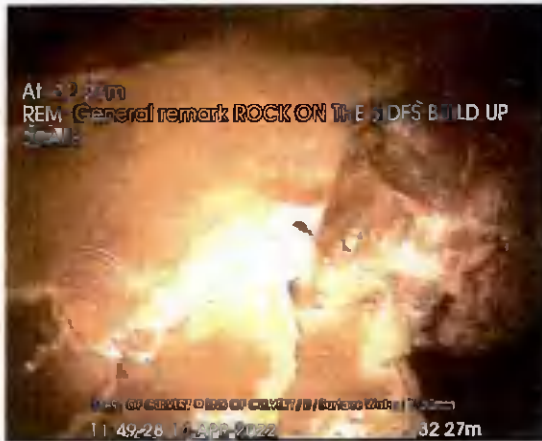
START OF CULVERT US TO END_32-27m_114928.jpg,
00:10:16, 32.27 m
General remark, ROCK ON THE SIDES BUILD UP SCALE

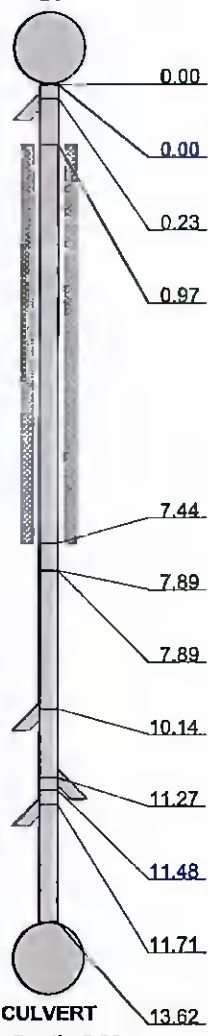
<table><tr> <td style="width: 15%;">Depth: 0.00 m</td> <td style="width: 15%;">S1</td> <td style="width: 15%;"></td> <td style="width: 10%;"></td> <td style="width: 40%;"></td> <td style="width: 10%;"></td> <td style="width: 10%;"></td> <td style="width: 10%;"></td> </tr><tr> <td>10.14</td> <td>CXI</td> <td>Connection defective, connecting pipe is intruding at 2 o'clock, 225mm dia, intrusion: 15%</td> <td></td> <td>00:01:39</td> <td>CULVERT</td> <td>X_a9b2f89</td> <td>0-dc0d-4c</td> </tr><tr> <td>11.71</td> <td>CXI</td> <td>Connection defective, connecting pipe is intruding at 2 o'clock, 225mm dia, intrusion: 20%</td> <td></td> <td>00:02:38</td> <td>CULVERT</td> <td>X_7c944c</td> <td>0c-449c-4</td> </tr></table>

Recommendations: CUTTING

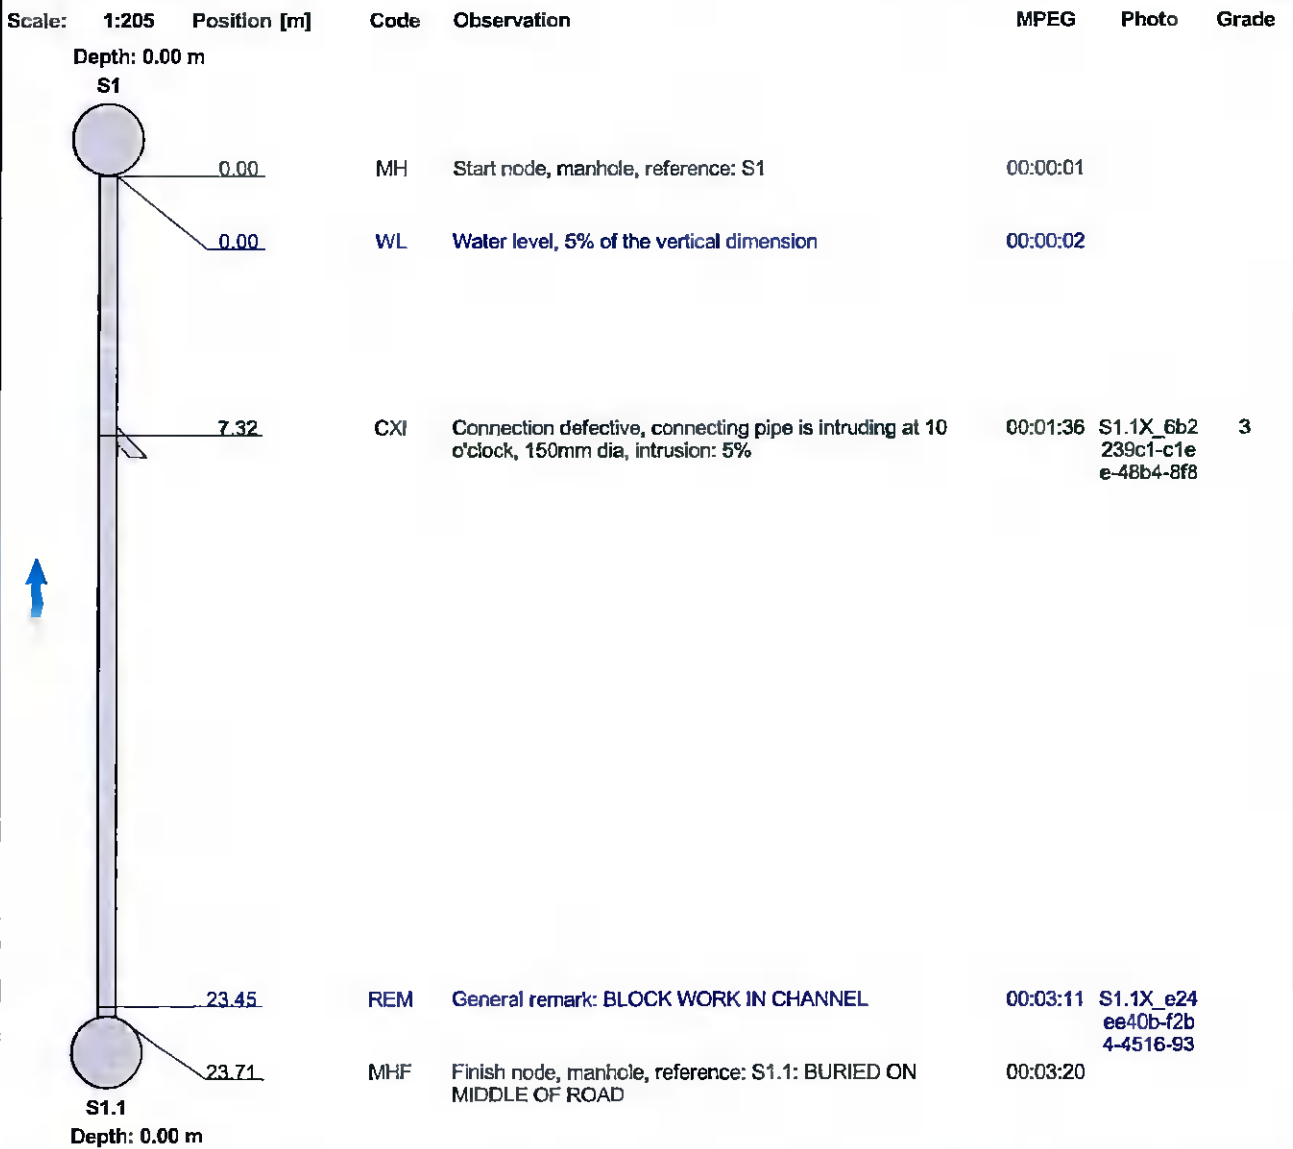
Construction Features					Miscellaneous Features				
Structural Defects					Service & Operational Observations				
STR No. Def	STR Peak	STR Mean	STR Total	STR Grade	SER No. Def	SER Peak	SER Mean	SER Total	SER Grade
0	0.0	0.0	0.0	1.0	1	2.0	0.3	2.0	3.0

Comments:
Recommendations: CUTTING

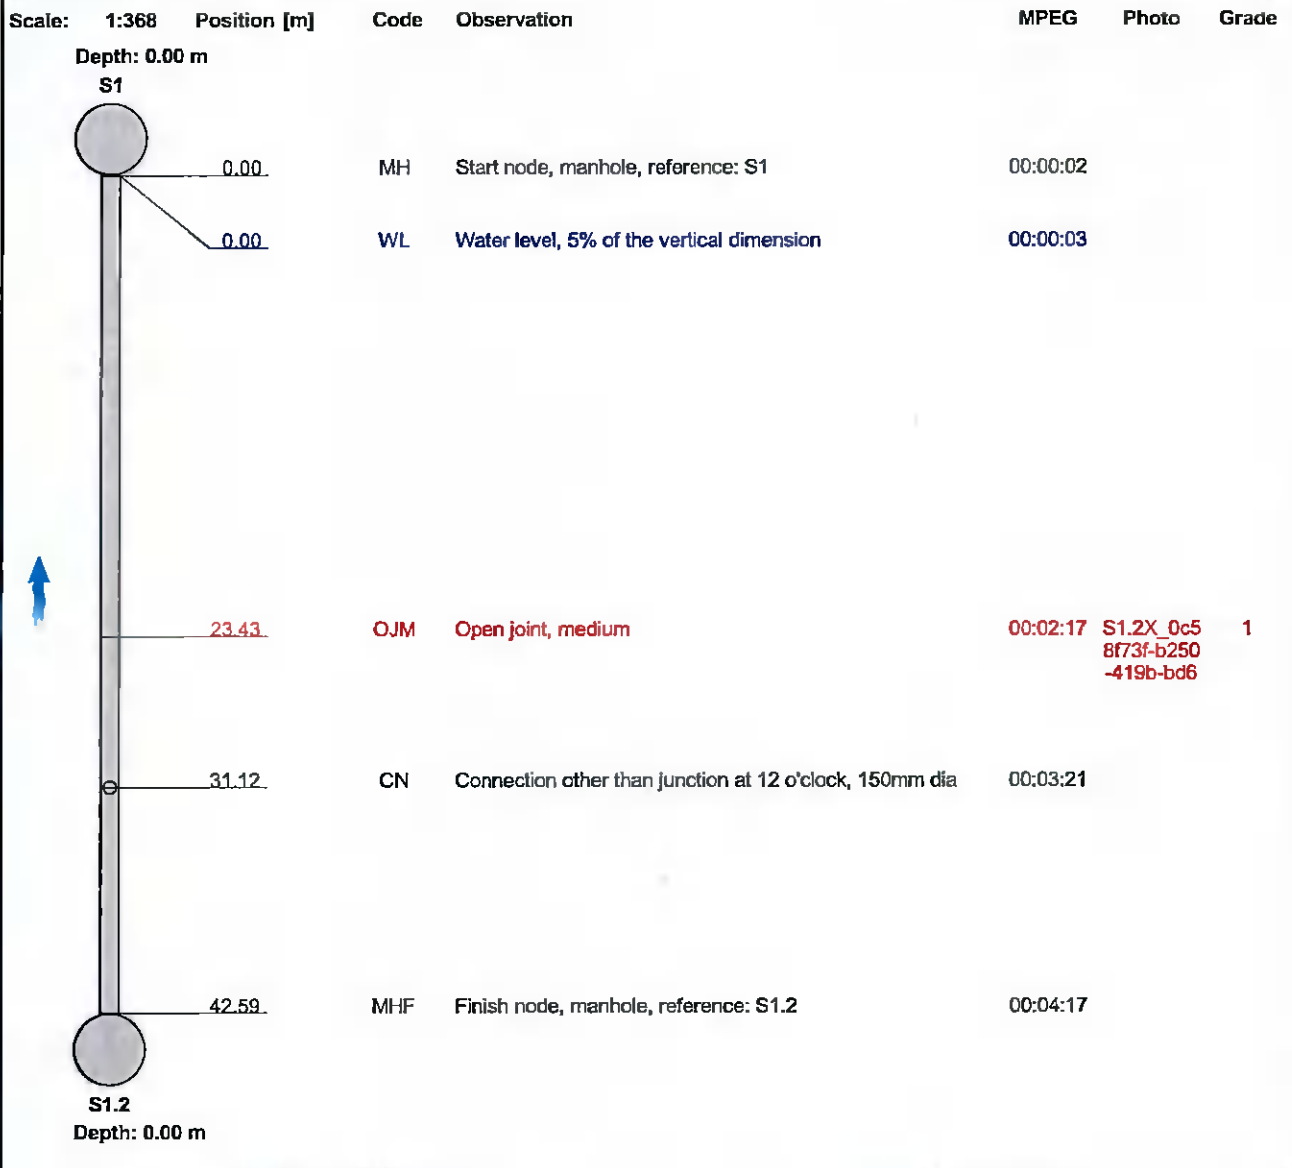
Construction Features					Miscellaneous Features				
Structural Defects					Service & Operational Observations				
STR No. Def	STR Peak	STR Mean	STR Total	STR Grade	SER No. Def	SER Peak	SER Mean	SER Total	SER Grade
1	1.0	0.0	1.0	1.0	0	0.0	0.0	0.0	1.0

Comments:
Recommendations: PATCHING

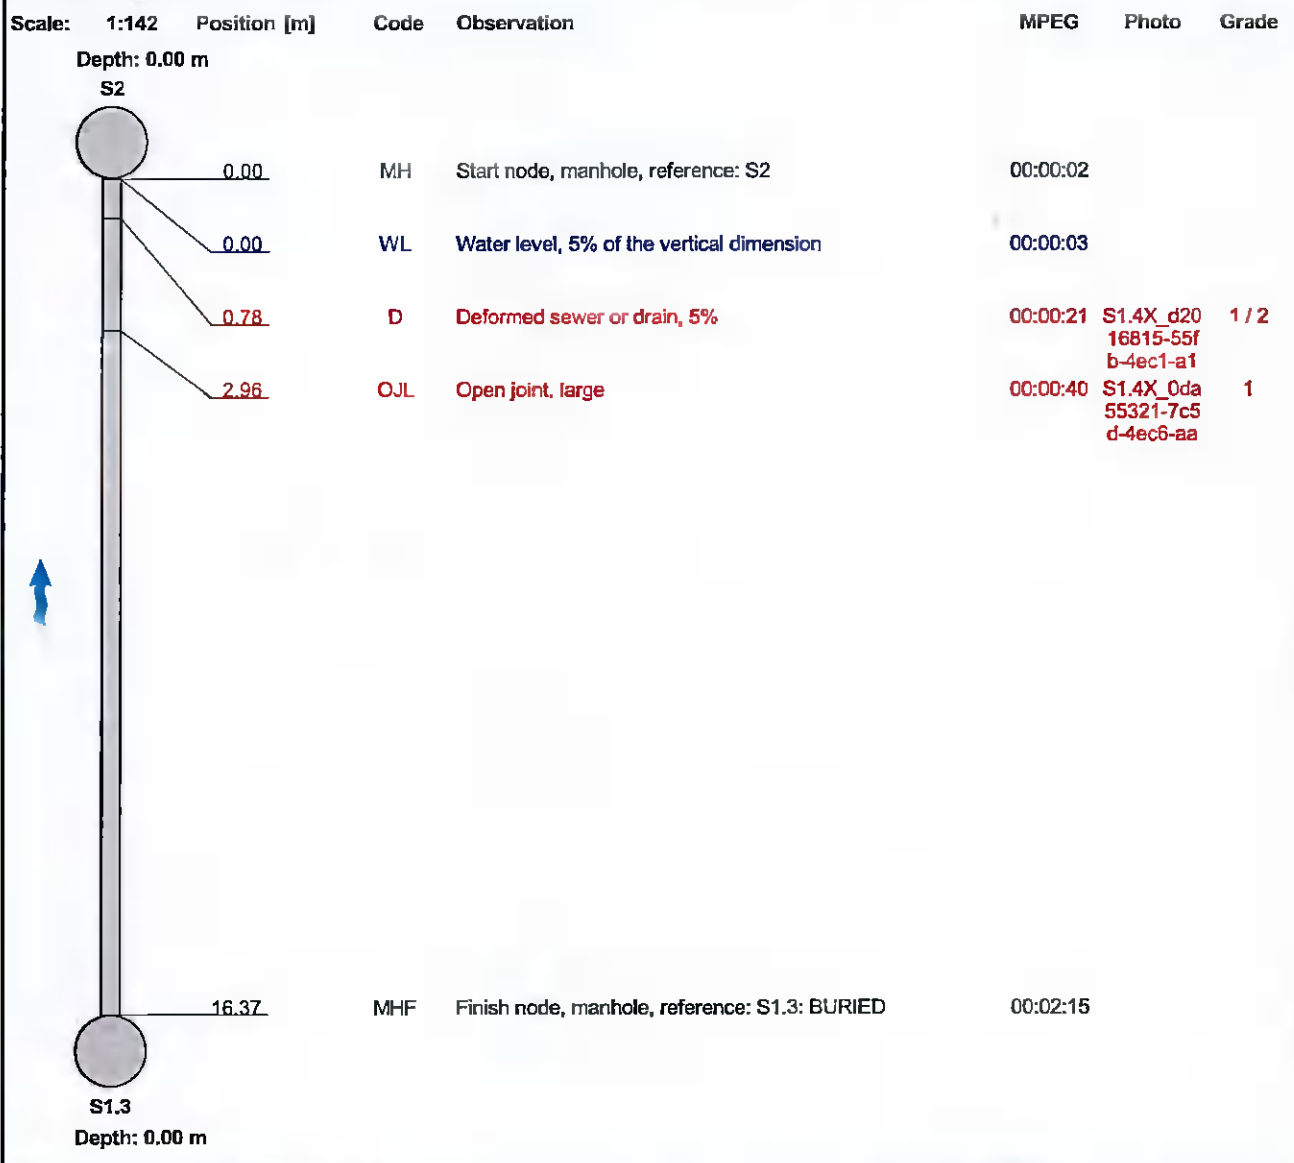
Construction Features					Miscellaneous Features				
Structural Defects					Service & Operational Observations				
STR No. Def	STR Peak	STR Mean	STR Total	STR Grade	SER No. Def	SER Peak	SER Mean	SER Total	SER Grade
2	2.0	0.1	2.0	1.0	1	1.0	0.1	1.0	2.0

Comments:
Recommendations: PATCHING

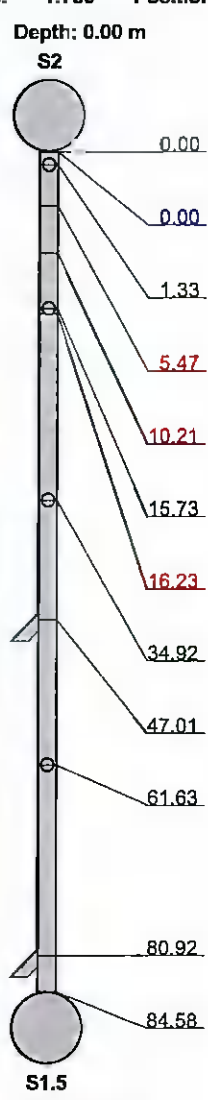
0.00	MH	Start node, manhole, reference: S2	00:00:03		
		0.00	WL	Water level, 5% of the vertical dimension	00:00:04

1.33	CN	Connection other than junction at 12 o'clock, 150mm dia	00:00:23		
		5.47	OJM	Open joint, medium	00:00:54	S1.5X_56c f7e4f-ee3f-42b9-b3f8-	1
		10.21	OJM	Open joint, medium	00:01:55	S1.5X_e49 f8bd9-b689-4d84-87	1

Comments:
Recommendations: PATCHING

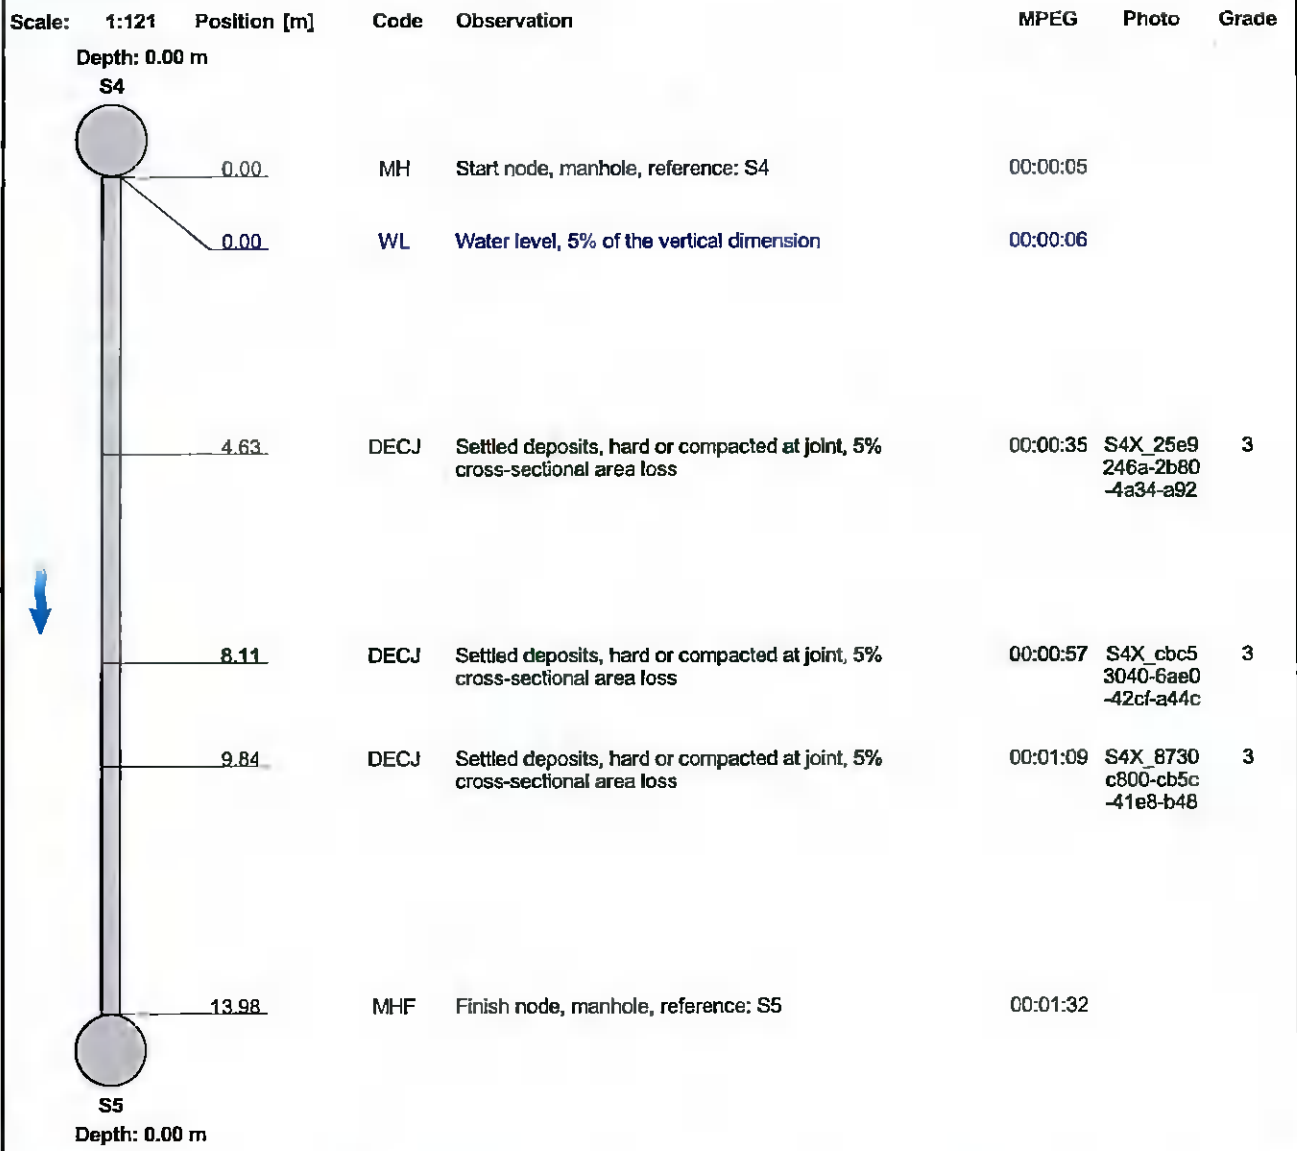
Construction Features					Miscellaneous Features				
Structural Defects					Service & Operational Observations				
STR No. Def	STR Peak	STR Mean	STR Total	STR Grade	SER No. Def	SER Peak	SER Mean	SER Total	SER Grade
0	0.0	0.0	0.0	1.0	3	2.0	1.3	6.0	3.0

Comments:
Recommendations: CUTTING

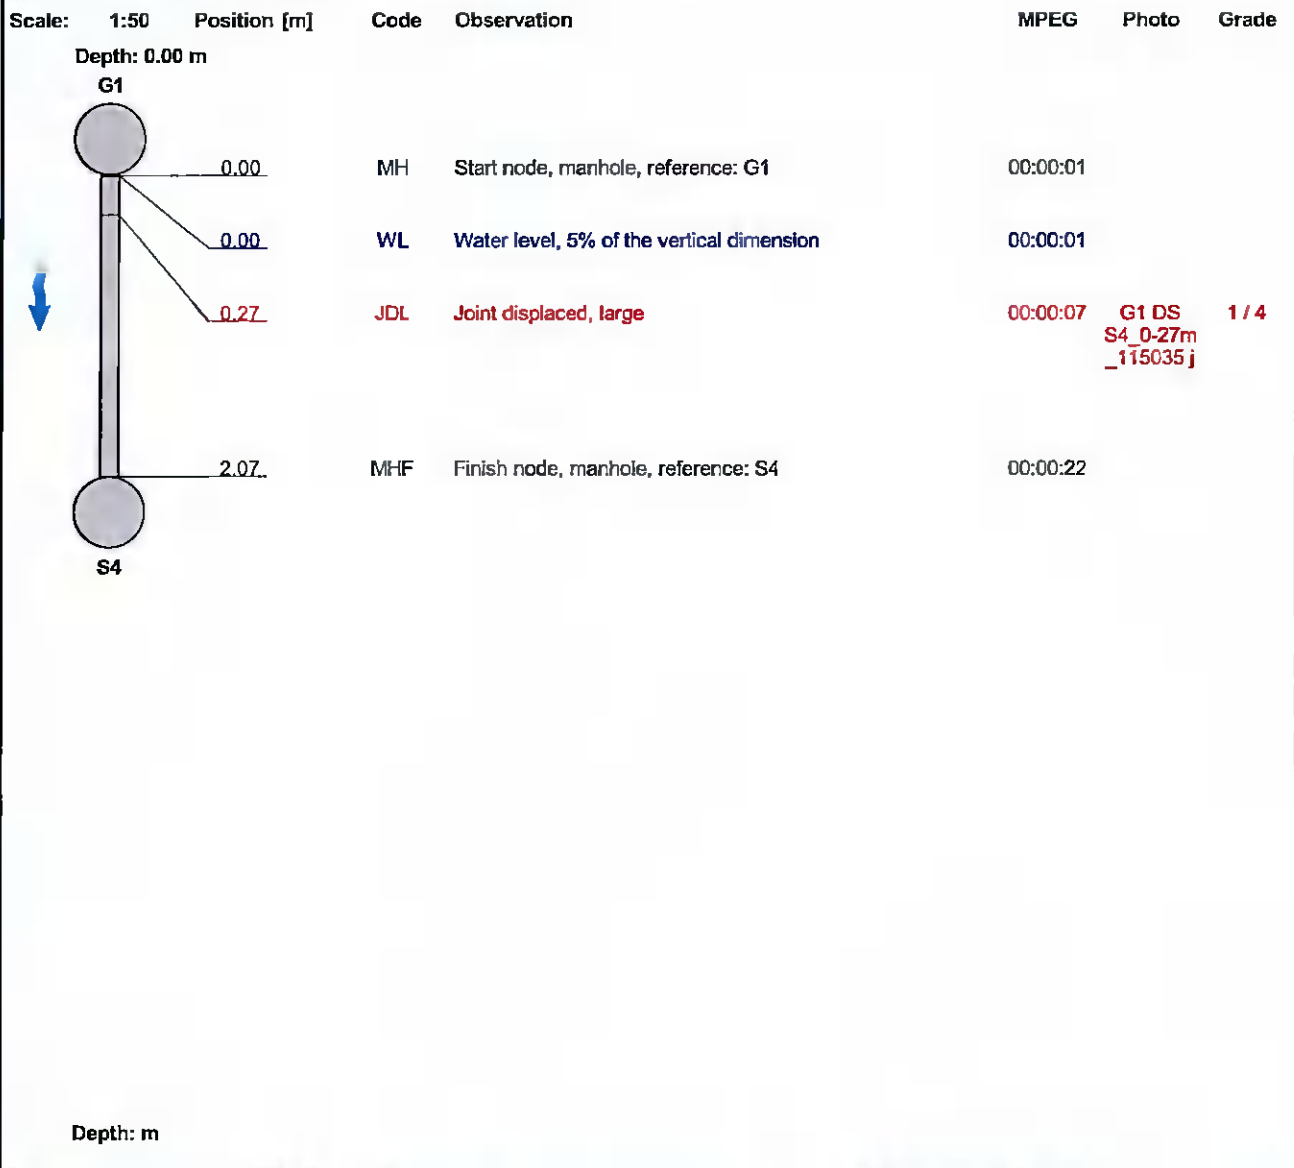
Construction Features					Miscellaneous Features				
Structural Defects					Service & Operational Observations				
STR No. Def	STR Peak	STR Mean	STR Total	STR Grade	SER No. Def	SER Peak	SER Mean	SER Total	SER Grade
1	2.0	1.0	2.0	1.0	1	5.0	2.4	5.0	4.0

Town or Village:	Rathfarnham	Inspection Direction:	Downstream	Upstream Node:	G1
Road:	Palmer PK	Inspected Length:	2.07 m	Upstream Pipe Depth:	0.000 m
Location:	Other walkway	Total Length:	2.07 m	Downstream Node:	S4
Surface Type:	Asphalt Footway	Joint Length:		Downstream Pipe Depth:	
Use:	Surface water	Pipe Shape:	Circular		
Type of Pipe:	Gravity drain/sewer	Dia/Height:	150 mm		
Flow Control:	No flow control	Material:	Concrete		
Year Constructed:	1990	Lining Type:	No Lining		
Inspection Purpose:	Routine inspection	Lining Material:	No Lining		
Comments:					
Recommendations:	PATCHING

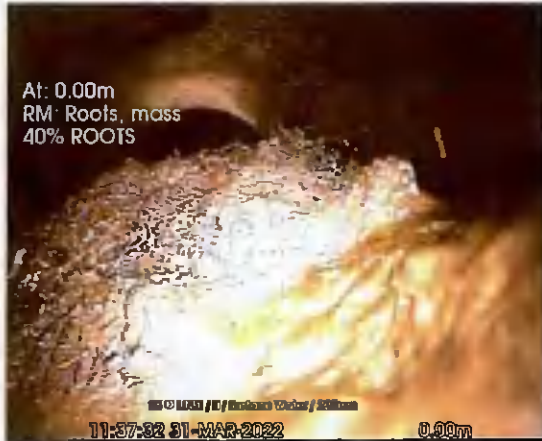
S5 US LINE1_0-00m_113732.jpg, 00:00:02, 0.00 m
Roots, mass, 40% cross-sectional area loss, ROOTS

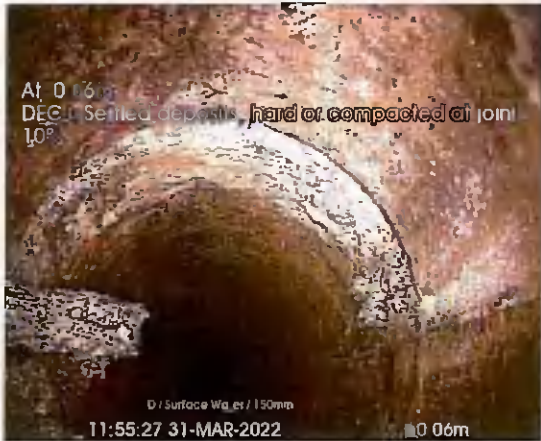
G2 DS S4_0-06m_115527.jpg, 00:00:05, 0.06 m
 Settled deposits, hard or compacted at joint, 10%
 cross-sectional area loss

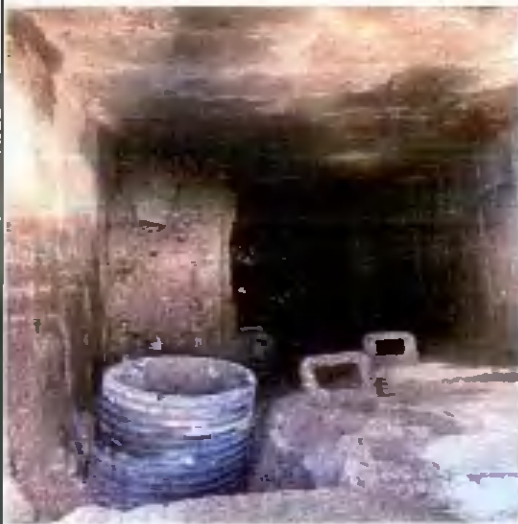
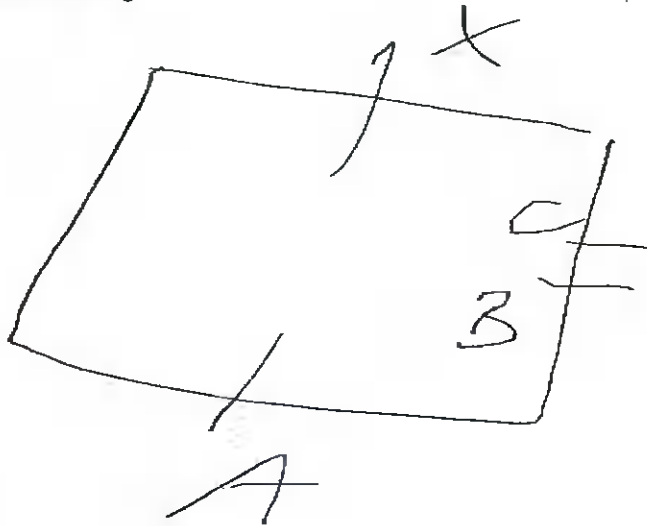
1	Road Type	Footpath	19	Cover Size	600				
2	Comment	1.10m	20	Frame Material	Cast Iron				
3	Map number		21	Frame Depth	0.07				
4	Node type	Manhole	22	Frame Size	600	37		Chamber Infiltration	Seeper
5	Location	1 Taylor's Ln, Bally	23	Shaft access	None	38		Chamber Roots	None
6	GPS X	713902.809	24	Access condition	OK	39		Shaft Infiltration	None
7	GPS Y	727074.283	25	Shaft Depth	0.35	40		Shaft Roots	None
8	GPS Cover level	76.599	26	Shaft Size	600x600	41		Bench Infiltration	None
9	Weather	Above freezing	27	Chamber Steps		42		Bench Roots	None
10	Manhole Status	Local Authority	28	Chamber Lads	4	43		Invert Infiltration	None
11	Survey status	Yes	29	Chamber Ldns		44		Invert Roots	None
12	Soffit type	Reducing Slab	30	Chamber Size	1000x1000	45		Cover Condition	OK
13	System Type	Surface	31	Chamber Construction	Precast Units	46		Shaft Condition	OK

14	Cover Shape	Circular	32	Toxic Atmosphere	N/A	47		Chamber Condition	Attention Needed
15	Cover material	Cast Iron	33	Vermin	N/A	48		Benching Condition	Attention Needed
16	Cover Duty	Medium	34	Flow %	10	49		Frame condition	Not Defective
17	Cover Hinged	No	35	Silt %	0	50		Year Built	2000-2004
18	Cover Locked	No	36	Surcharge		51	Comments

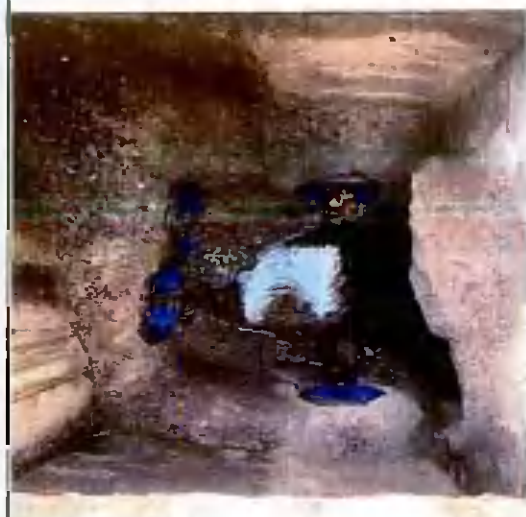
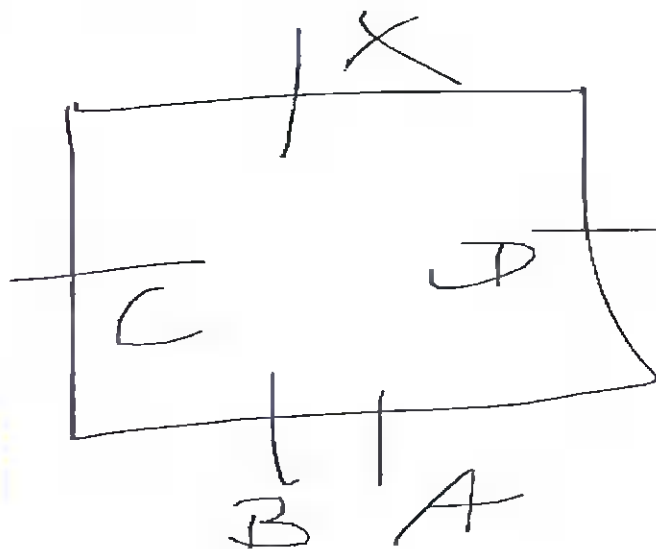
Start	2022-04-06 11:33:06	Node name	S2	Location		
1	Road Type	Footpath	19	Cover Size	650x650	
2	Comment	no lader	20	Frame Material	Cast Iron	
3	Map number		21	Frame Depth	0.05	
4	Node type	Manhole	22	Frame Size	650x650	
5	Location	Newbrook Estate,	23	Shaft access	None	
6	GPS X	713783.293	24	Access condition	OK	
7	GPS Y	727064.839	25	Shaft Depth	0.47	
8	GPS Cover level	75.684	26	Shaft Size	600x600	
9	Weather	Above freezing	27	Chamber Steps	0	
10	Manhole Status	Local Authority	28	Chamber Lads	0	
11	Survey status	Yes	29	Chamber Ldrns	0	
12	Soffit type	Reducing Slab	30	Chamber Size	1200x1000	
13	System Type	Surface	31	Chamber Construction	In-Situ	
14	Cover Shape	Square	32	Toxic Atmosphere	N/A	
15	Cover material	Cast Iron	33	Vermin	N/A	
16	Cover Duty	Medium	34	Flow %	5	
17	Cover Hinged	No	35	Silt %	0	
18	Cover Locked	No	36	Surcharge		
				37	Chamber Infiltration	None
				38	Chamber Roots	None
				39	Shaft infiltration	None

40	Shaft Roots	None
				41	Bench Infiltration	None
				42	Bench Roots	None
				43	Invert Infiltration	None
				44	Invert Roots	None
				45	Cover Condition	OK
				46	Shaft Condition	OK
				47	Chamber Condition	OK
				48	Benching Condition	Urgent Attention Needed
				49	Frame condition	Not Defective
				50	Year Built	2000-2004
				51	Comments

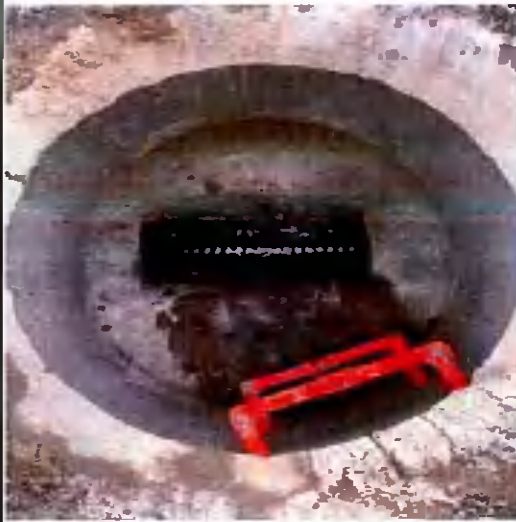
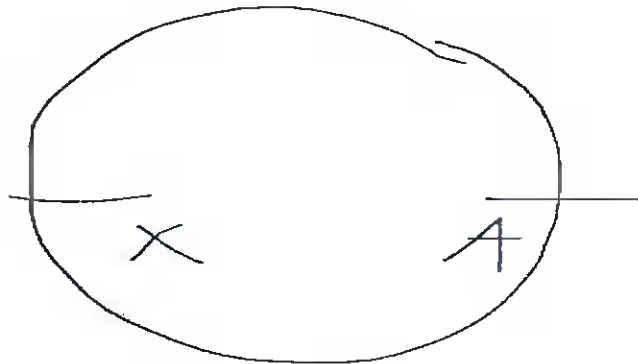
Tank Pipe and Drain 10 Taylor's Ln, Ballyboden, Dublin 16, D16 V4Y6, Ireland	
1 Road Type	Footpath	19 Cover Size	650x650			
2 Comment	0.54m	20 Frame Material	Cast Iron			
3 Map number		21 Frame Depth	0.05			
4 Node type	Manhole	22 Frame Size	650x650	37 Chamber Infiltration	None	
5 Location	10 Taylor's Ln, Bal	23 Shaft access	None	38 Chamber Roots	None	
6 GPS X	713870.104	24 Access condition	OK	39 Shaft Infiltration	None	
7 GPS Y	727070.831	25 Shaft Depth	0.39	40 Shaft Roots	None	
8 GPS Cover level	76.405	26 Shaft Size	600	41 Bench Infiltration	None	
9 Weather	Above freezing	27 Chamber Steps		42 Bench Roots	None	
10 Manhole Status	Local Authority	28 Chamber Lads	2	43 Invert Infiltration	None	
11 Survey status	Yes	29 Chamber Ldns		44 Invert Roots	None	
12 Soffit type	Reducing Slab	30 Chamber Size	900	45 Cover Condition	OK	
13 System Type	Surface	31 Chamber Construction	Precast Units	46 Shaft Condition	OK

14 Cover Shape	Square	32 Toxic Atmosphere	N/A	47 Chamber Condition	OK	
15 Cover material	Cast Iron	33 Vermin	N/A	48 Benching Condition	OK	
16 Cover Duty	Medium	34 Flow %	0	49 Frame condition	Not Defective	
17 Cover Hinged	No	35 Silt %	0	50 Year Built	2000-2004	
18 Cover Locked	No	36 Surcharge		51 Comments

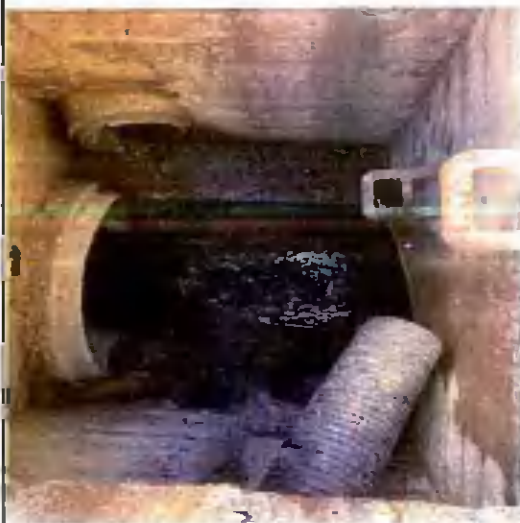
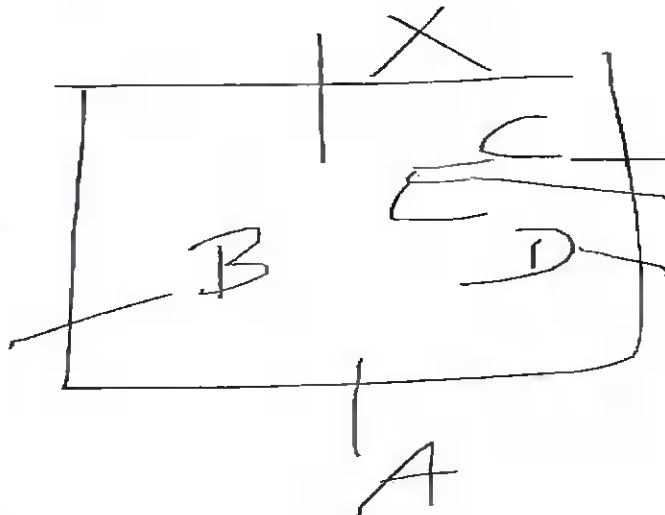
1	Road Type	Footpath	19	Cover Size		650x650
2	Comment	0.48m	20	Frame Material		Cast Iron
3	Map number		21	Frame Depth		0.05
4	Node type	Manhole	22	Frame Size		650x650
5	Location	Mountain View, T	23	Shaft access	None	
6	GPS X	714013.700	24	Access condition	OK	
7	GPS Y	727082.904	25	Shaft Depth	0.39	
8	GPS Cover level	76.563	26	Shaft Size	600x600	
9	Weather	Above freezing	27	Chamber Steps		
10	Manhole Status	Local Authority	28	Chamber Lads	2	
11	Survey status	Yes	29	Chamber Ldns		
12	Soffit type	Reducing Slab	30	Chamber Size	1200x1200	
13	System Type	Surface	31	Chamber Construction	In-Situ	
14	Cover Shape	Square	32	Toxic Atmosphere	N/A	
15	Cover material	Cast Iron	33	Vermin	N/A	
16	Cover Duty	Medium	34	Flow %	10	
17	Cover Hinged	No	35	Silt %	0	
18	Cover Locked	No	36	Surcharge		
				37	Chamber Infiltration	Seeper
				38	Chamber Roots	None
				39	Shaft Infiltration	None

40	Shaft Roots	None
				41	Bench Infiltration	None
				42	Bench Roots	None
				43	Invert Infiltration	None
				44	Invert Roots	None
				45	Cover Condition	Attention Needed
				46	Shaft Condition	OK
				47	Chamber Condition	Attention Needed
				48	Benching Condition	OK
				49	Frame condition	Not Defective
				50	Year Built	2000-2004
				51	Comments

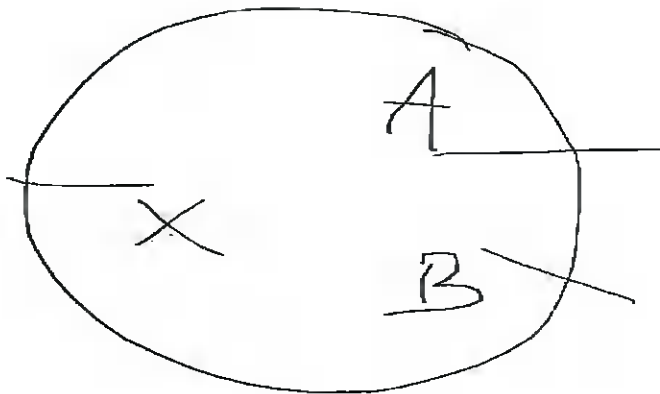
1	Road Type	Footpath	19	Cover Size	650x650	36 Whitecliff, Rathfarnham, Dublin 16, D16 HY72, Ireland		
2	Comment	0.45	20	Frame Material	Cast Iron			
3	Map number		21	Frame Depth	0.05			
4	Node type	Manhole	22	Frame Size	650x650	37	Chamber Infiltration	None
5	Location	36 Whitecliff, Rathfarnham, Dublin 16, D16 HY72, Ireland	23	Shaft access	None	38	Chamber Roots	None
6	GPS X	714058.010	24	Access condition	OK	39	Shaft Infiltration	None
7	GPS Y	727085.407	25	Shaft Depth	0.30	40	Shaft Roots	None
8	GPS Cover level	76.707	26	Shaft Size	700x700	41	Bench Infiltration	None
9	Weather	Above freezing	27	Chamber Steps		42	Bench Roots	None
10	Manhole Status	Local Authority	28	Chamber Lads	4	43	Invert Infiltration	None
11	Survey status	Yes	29	Chamber Ldms		44	Invert Roots	None
12	Soffit type	Reducing Slab	30	Chamber Size	1200	45	Cover Condition	OK
13	System Type	Surface	31	Chamber Construction	Precast Units	46	Shaft Condition	OK

14	Cover Shape	Square	32	Toxic Atmosphere	N/A	47	Chamber Condition	OK
15	Cover material	Cast Iron	33	Vermin	N/A	48	Benching Condition	OK
16	Cover Duty	Medium	34	Flow %	0	49	Frame condition	Not Defective
17	Cover Hinged	No	35	Silt %	0	50	Year Built	2000-2004
18	Cover Locked	No	36	Surcharge		51	Comments

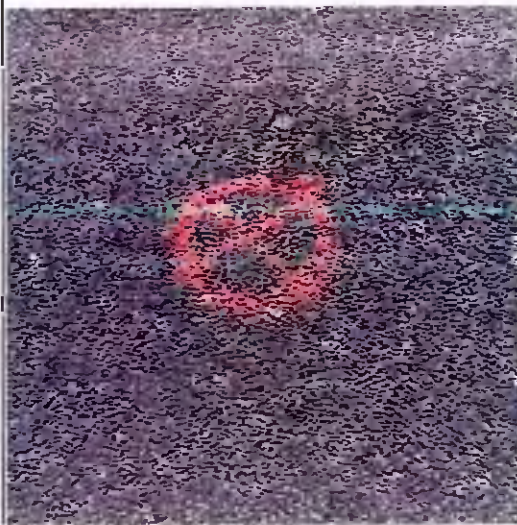
37 Whitecliff, Rathfarnham, Dublin 16, D16 WY07, Ireland	
1	Road Type	Road	19	Cover Size		
2	Comment		20	Frame Material		
3	Map number		21	Frame Depth		
4	Node type	Manhole	22	Frame Size		
5	Location	37 Whitecliff, Rath	23	Shaft access		
6	GPS X	714038.449	24	Access condition		
7	GPS Y	727080.341	25	Shaft Depth		
8	GPS Cover level	76.801	26	Shaft Size		
9	Weather	Above freezing	27	Chamber Steps		
10	Manhole Status	Local Authority	28	Chamber Lads		
11	Survey status	Buried	29	Chamber Ldns		
12	Soffit type		30	Chamber Size		
13	System Type		31	Chamber Construction		
14	Cover Shape		32	Toxic Atmosphere		
15	Cover material		33	Vermin		
16	Cover Duty		34	Flow %		
17	Cover Hinged		35	Silt %		
18	Cover Locked		36	Surcharge		
				51	Comments	MH BURIED UNDER TARMAC
