EDMONDSTOWN SHD
KILMASHOGUE
DUBLIN 16

Project No.	Project name	Date	Revision
TEDM001	Edmonstown SHD	28/10/21	-

Report Prepared by

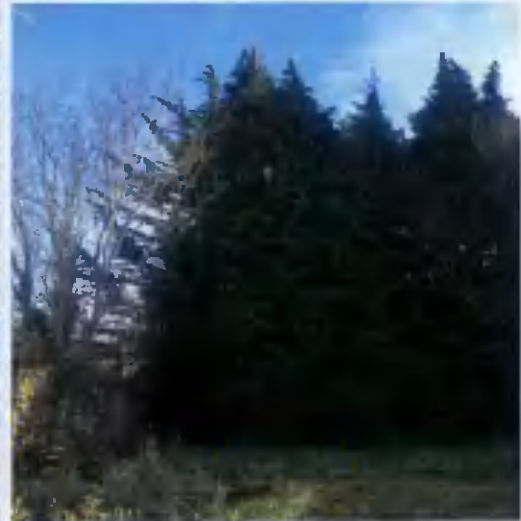
A beech hedge at the entrance to the house has long been allowed to develop without appropriate management with the result that the individual trees are generally drawn and poorly formed due to competition between specimens (image 6). To the east of the house a planting of Leyland cypress (*xCuprocyparis leylandii*) appears to have been planted as a screen (image 7). It is composed of 4 specimens which are developing into trees. None are of particular merit with one specimen in decline.

Image 7. Leyland cypress within garden area

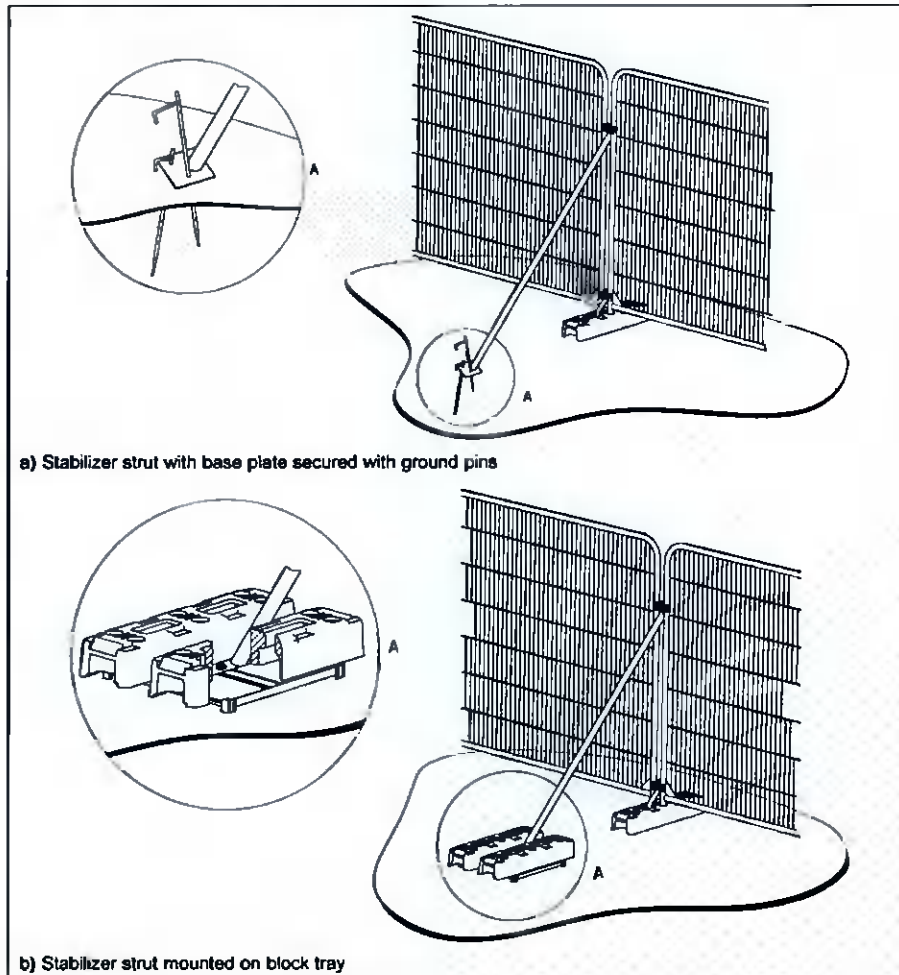
Fig 1. Tree Protection Detail (Herras type fencing or similar approved).

A post construction report on the condition of trees should be undertaken and all recommendations made within this report should be carried out to BS3998 Tree Works.
