Bat Roost Survey Report

Kiltipper Woods Care Home, Tallaght,
Dublin

Planning Application Ref: SD21A/0287

March 2022

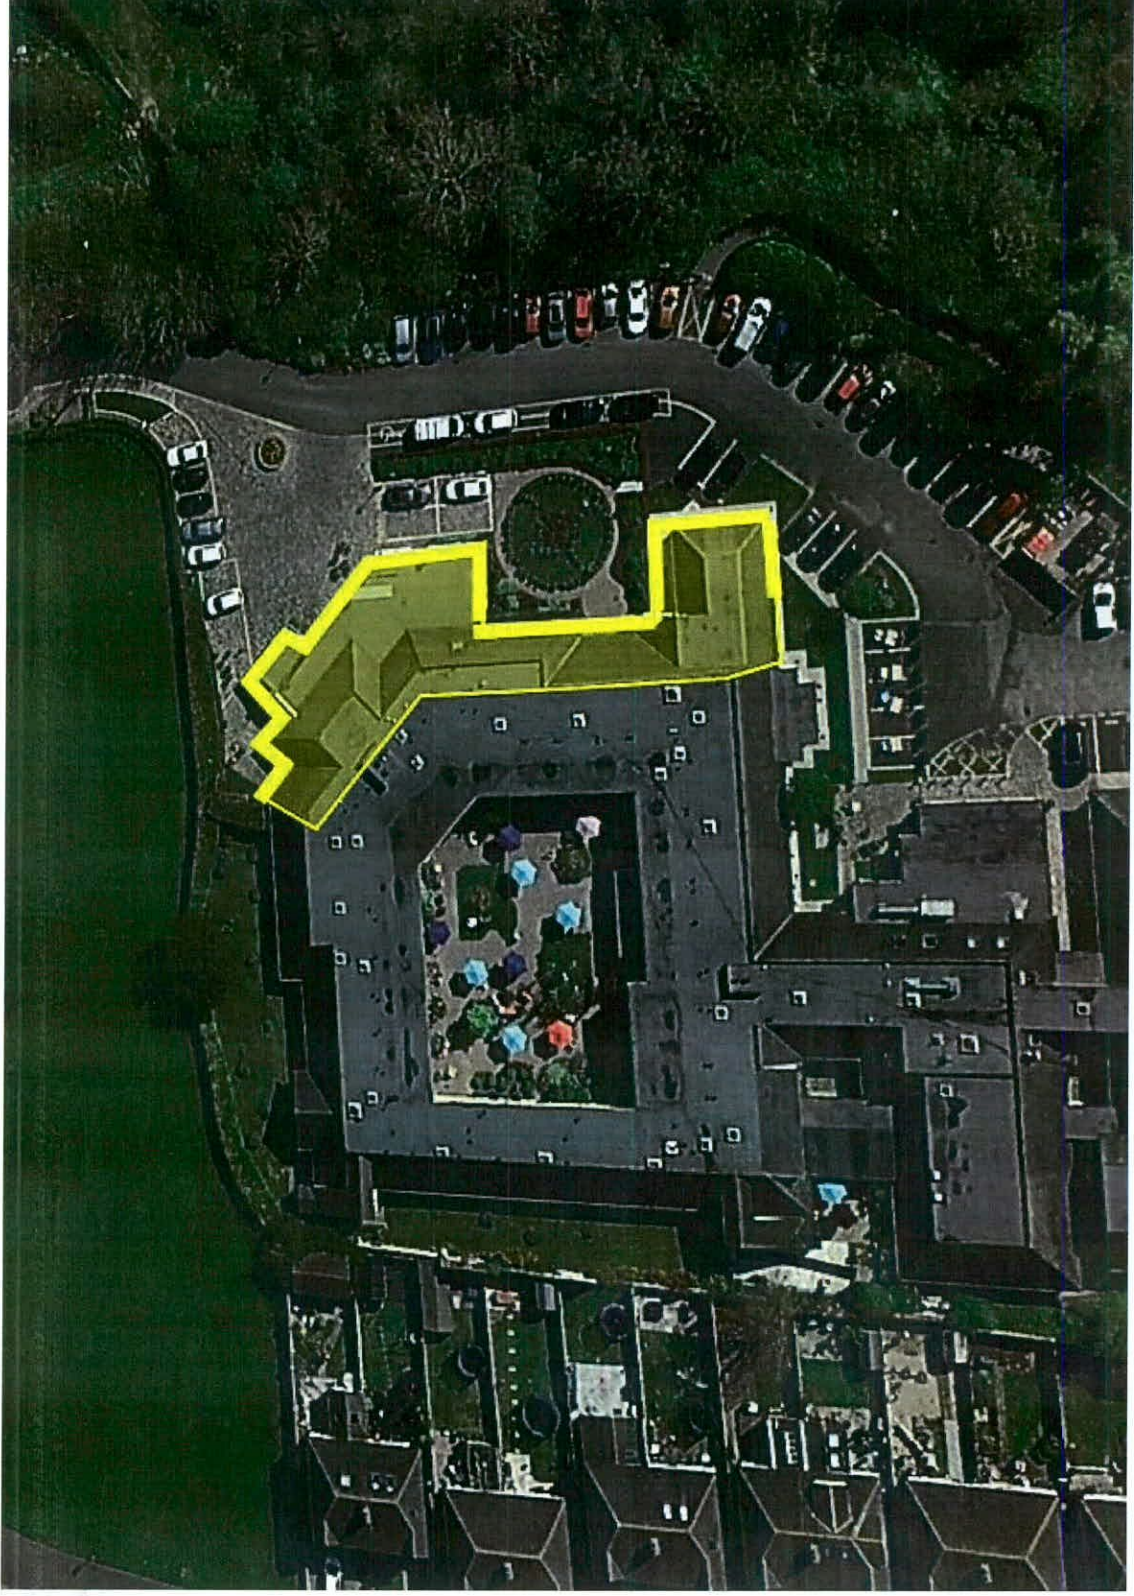
Appendix 4 Area of building surveyed

- 5.5 The interior roof voids were accessed by CM only in order to ensure compliance with the terms of the licence and to avoid potential disturbance to hibernating bats. The whole of the interior roof space was accessible for an internal assessment through doors or hatches within the partition walls. Some areas were fitted with electric light but darker areas were investigated by torchlight. Any evidence of occupation such as droppings, urine staining and prey remains were searched for throughout the roof space area.

- 5.8 No roosting bats, bat droppings or other evidence of bat occupation such as staining or prey remains were found within the roof spaces or around the exterior of the building. Bird droppings were evident on some exterior window sills. Staff spoken to had not encountered any bats within the building.
